# A Case for CHP Commissioning

Combined Heat and Power (CHP) for Commercial Buildings: Best Practices and Pitfalls

Richard Sweetser  
*EXERGY Partners Corp.*  
April 23, 2008

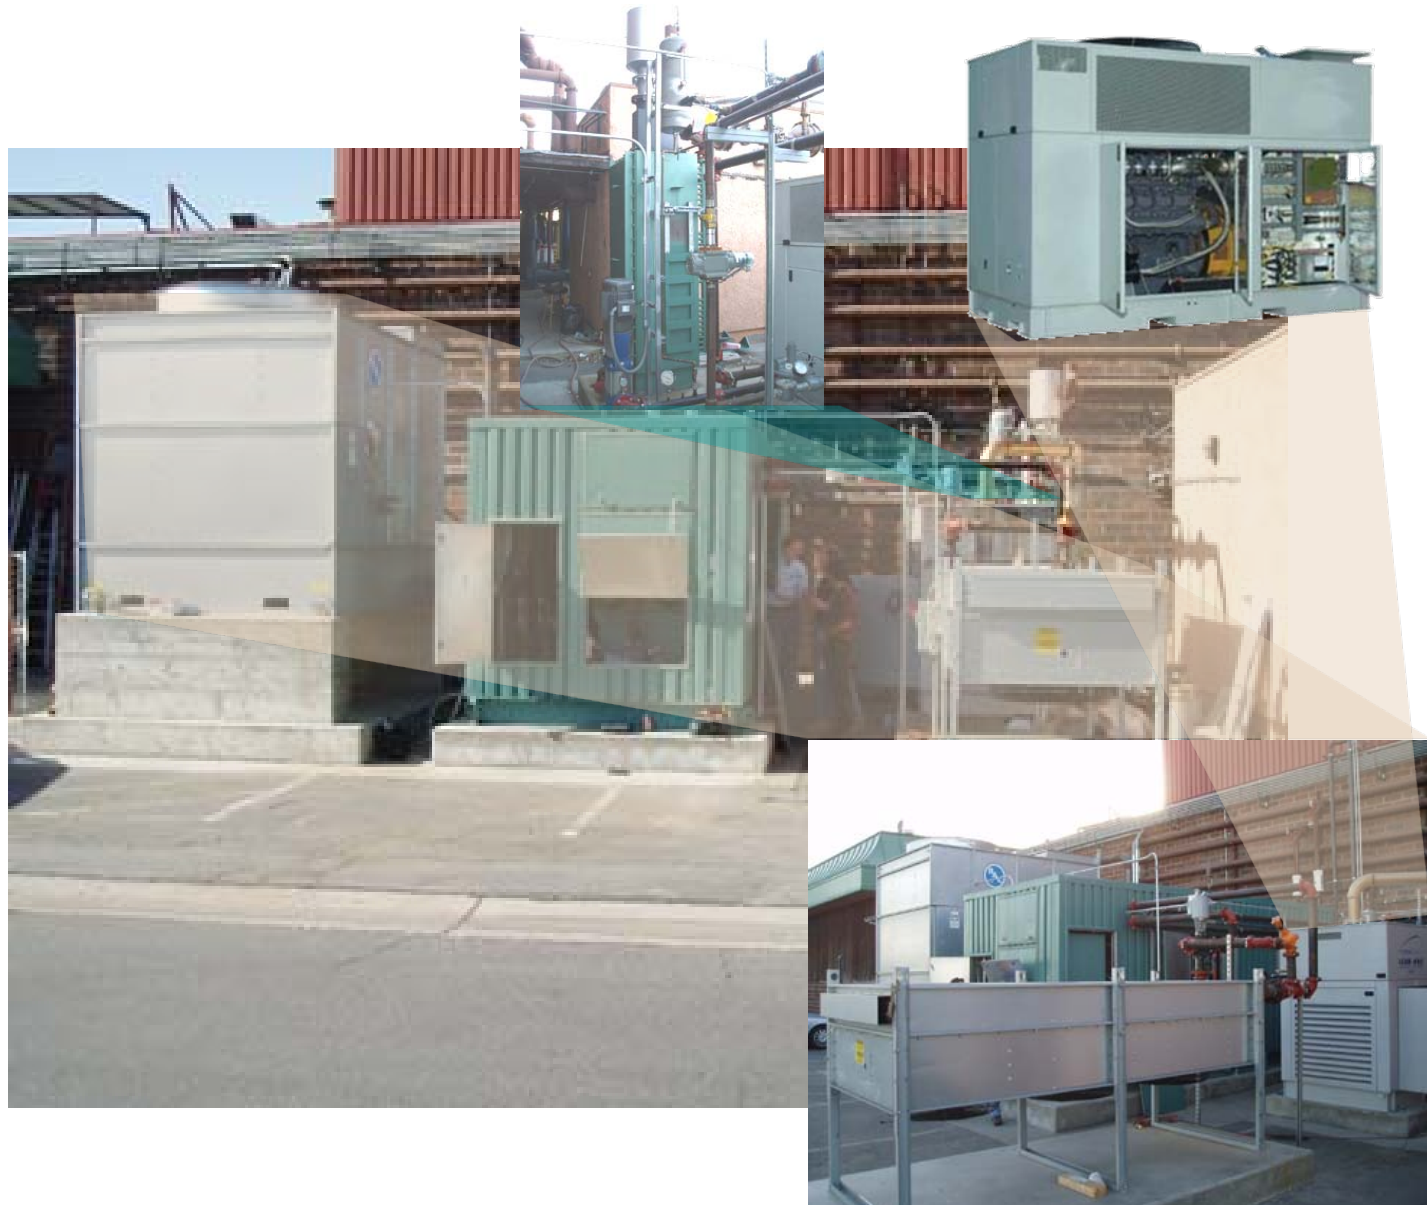
SLIDE 21

- Electricity is supplied from the local electric utility. Existing chillers include a 4-compressor 80 ton reciprocating chiller and a 120 ton centrifugal chiller. Space heating needs are minimal and domestic hot water is provided by two boilers with integrated storage tank.
- **CHP System Design**
  - *255 kW generator module*
  - *Gas Heat Recovery Module*
  - *Thermal System Module with a 75 ton chiller*
  - *Cooling Tower*
  - *Engine Dump Heat Exchanger*

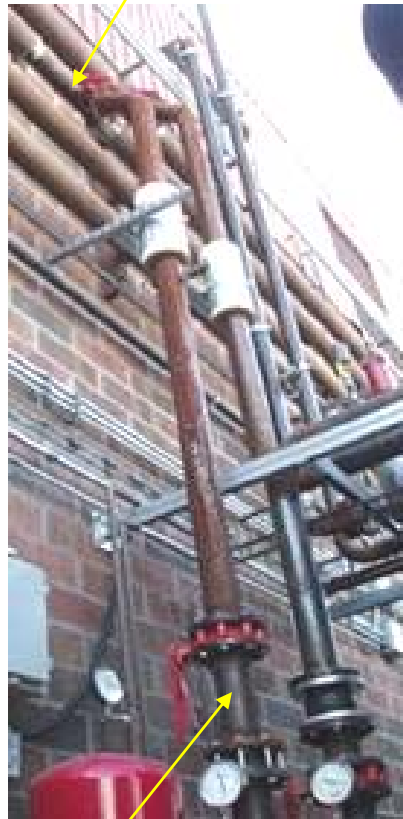
Chilled Water Header

← (Recip Chillers in adjacent room)

- The CHP chiller was tied into a common header with the existing two chillers and each chiller had its own pump feeding 6 AHU's
- Flow balancing problems were immense and the design provided no way to baseload the thermal chiller.
- Note that the three way valves supplying the six air handlers had been replaced with two way valves eliminating the ability to bypass causing low flow alarms on both the reciprocating compressor chiller and absorber.

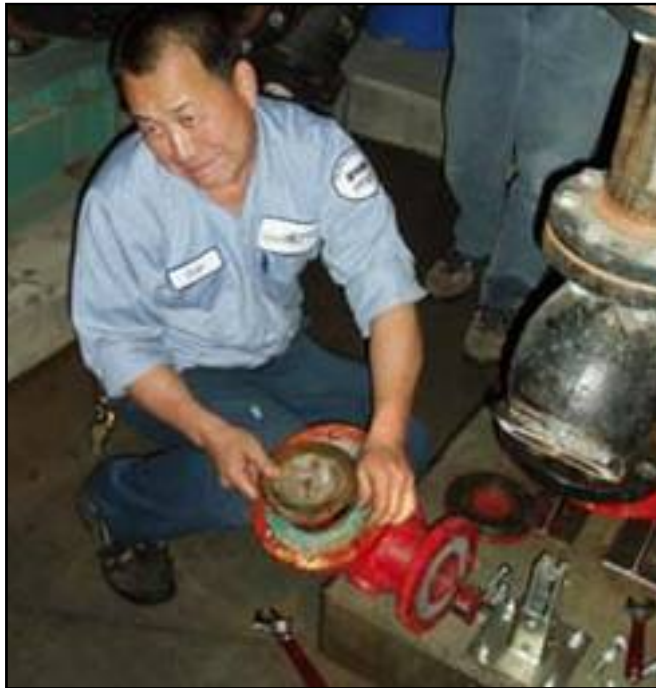
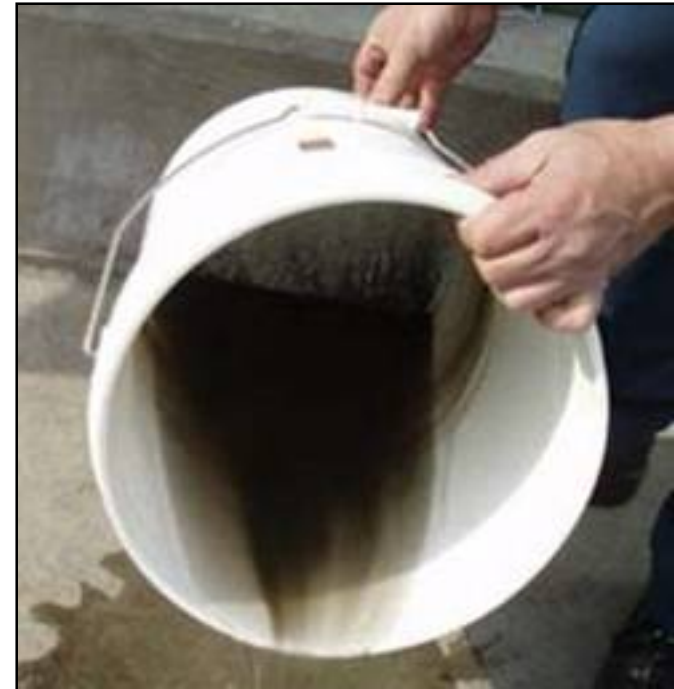
Do remove packing caps and flush lines

- Factory test proved performance
- Site test at commissioning did not allow for full load but did prove system operation.
- Weather during commissioning is a large factor in generating heating or cooling load.
- Site engineering is a vital ingredient particularly for retrofit CHP installations “as built” drawings of complete building systems are often inaccurate or incomplete.
- Series flow should be used on all CHP thermal loops to balance flow and eliminate pumping problems especially in retrofit situations.
- Miscellaneous problems: packing caps not removed from piping, field lines not flushed, pressure reducing valves not set, expansion tanks not charged and filters not included on pumps.

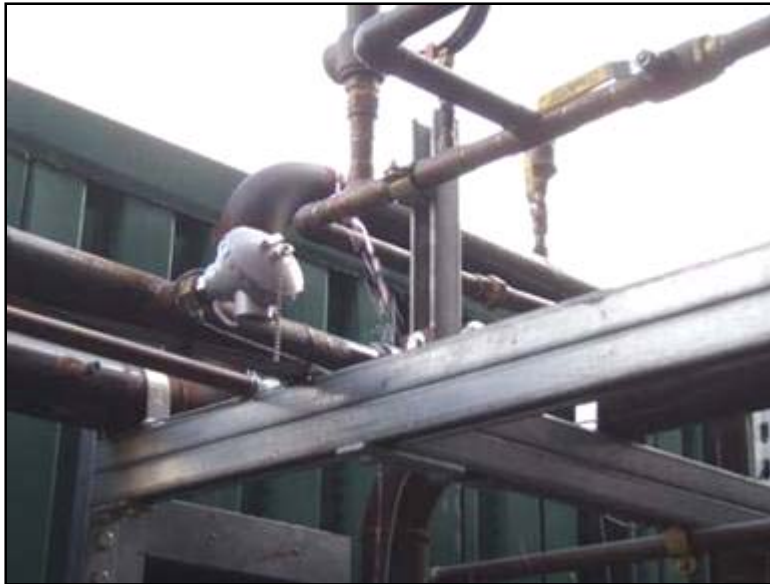
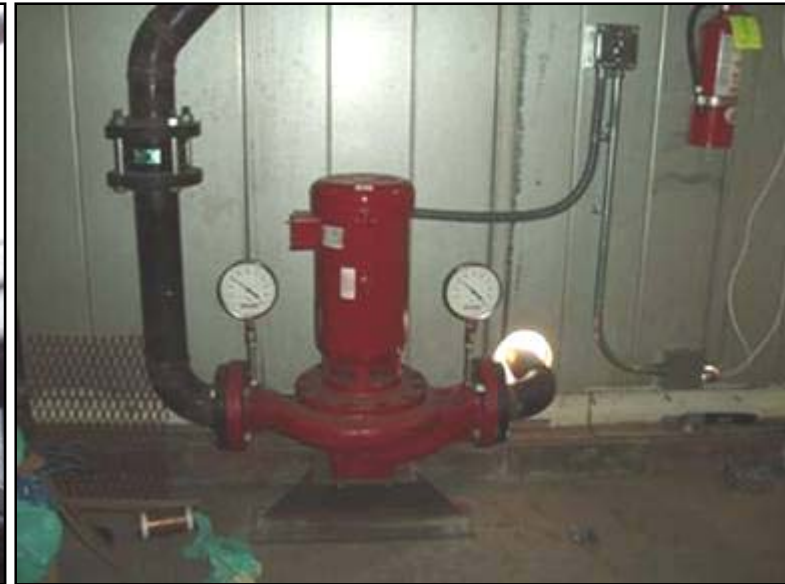
- Set PRV's and charge expansion tanks
- Include filters on pumps

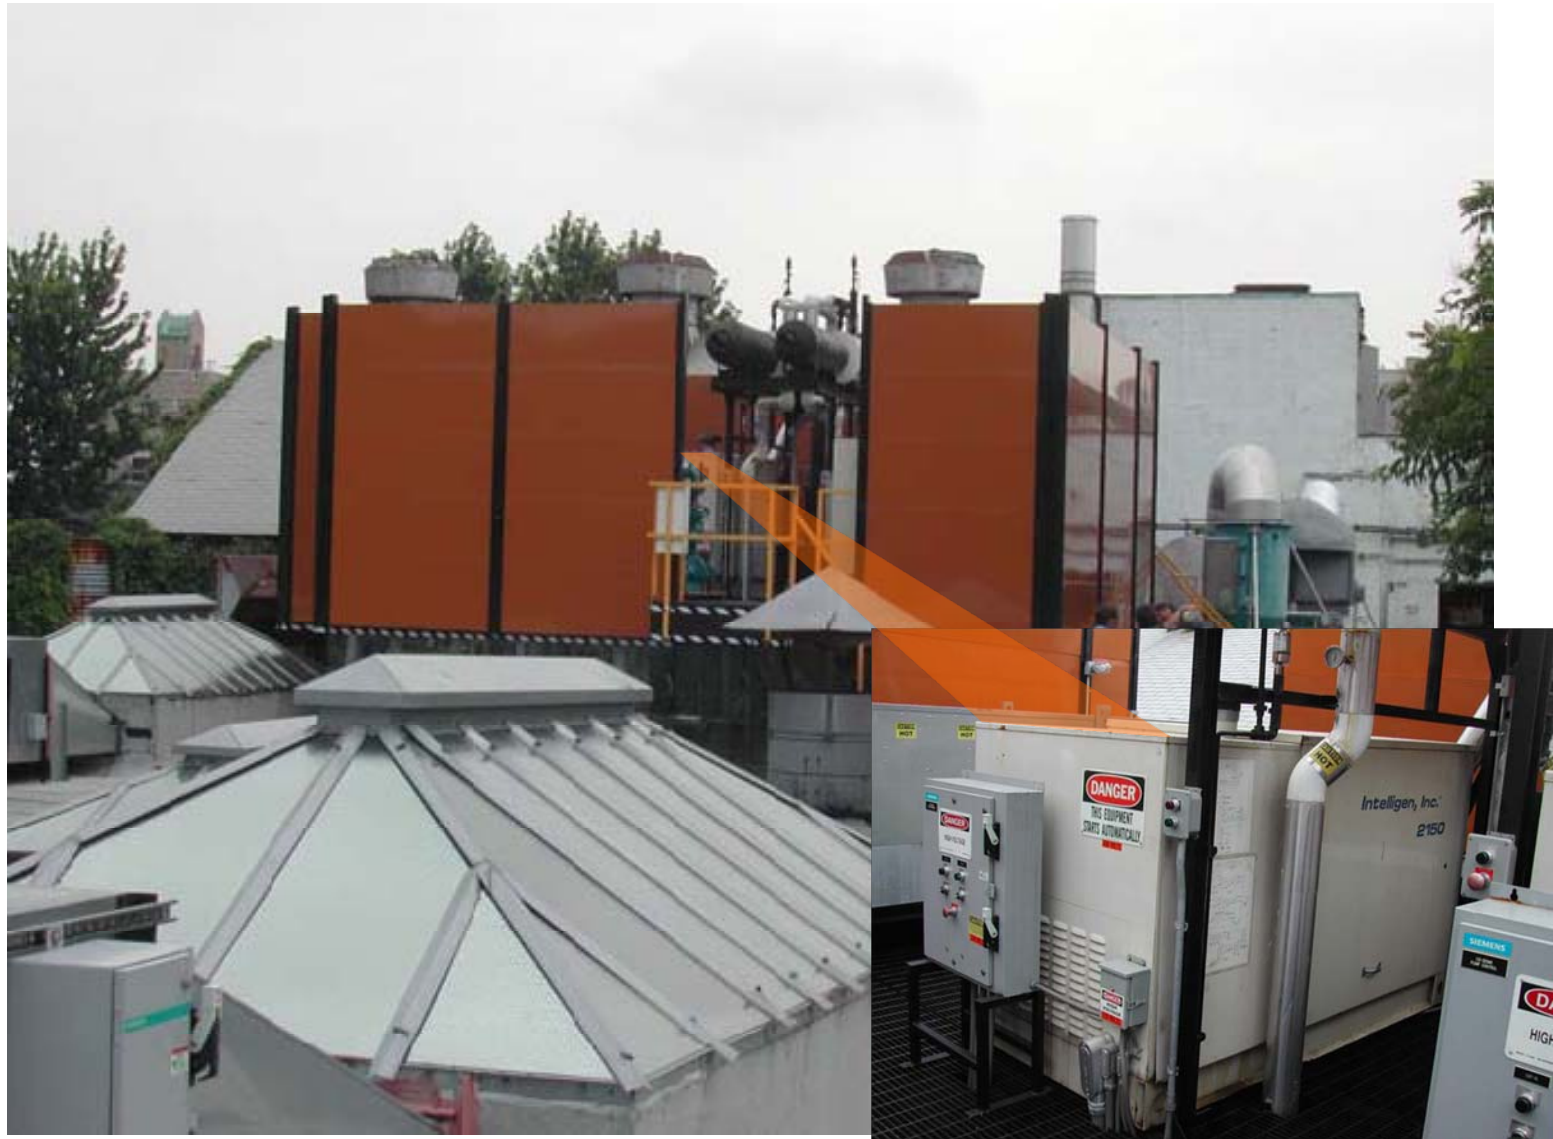
# CHP Plant

- Comprised of two reciprocating engine packages with a maximum aggregated output of 300 kW.
- The system was sized to meet the average electrical load for the plant.
- The system recovers waste energy from the engines' cooling water and hot exhaust to supply most of the hot water needs at plant.
- The system has operated exceptionally well since its installation, supplying 70% of the plant's power needs and 14% of its thermal needs with an overall efficiency of 76%.

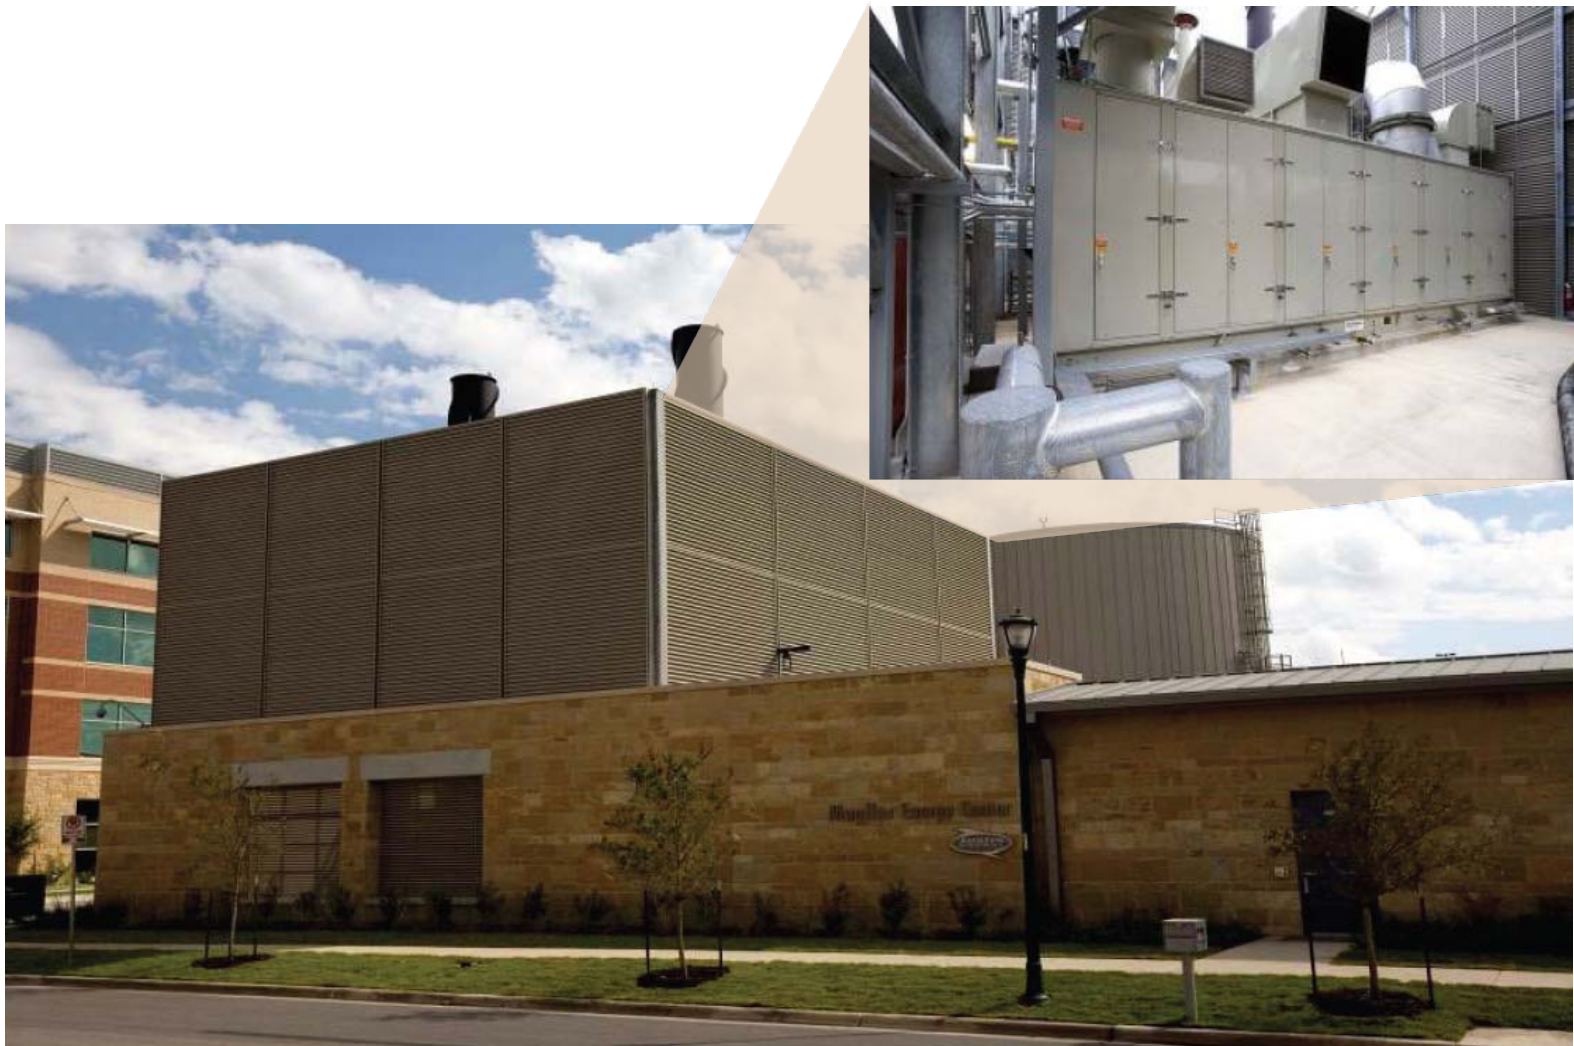
SLIDE 48

- Chiller water primary and secondary pump module
- Packaged duplex electrical centrifugal chiller plant totaling 1,500 refrigeration tons
- Packaged boilers totaling 22,000 lbs/hr of steam
- Thermal energy storage tank totaling 8000 ton-hours of chilled water
- 1,500 kW black start engine generator
- Fuel gas compressor module
- 4.3 MW combustion turbine
- Turbine exhaust diverter valve and stack
- Steam absorption chiller totaling 1,000 refrigeration tons
- Heat recovery steam generator (HRSG)
- HRSG Exhaust Stack
