***DOE Vehicular Tank Workshop
Sandia National Laboratories
Livermore, CA***

***Nondestructive Evaluation and Monitoring Projects
NASA White Sands Test Facility (WSTF)***

WSTF Orbiter COPV Instrumentation and NDE During Rupture and Stress Testing

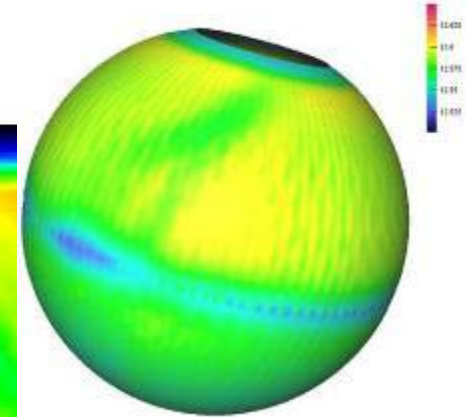
Laser Profilometry Accurately Quantifies Liner Buckling and Other Surface Features

Calibration traceable to National Standard and demonstrated 0.001 in. accuracy/repeatability on 26-in. and better than 0.002 in. accuracy/repeatability on 40-in.

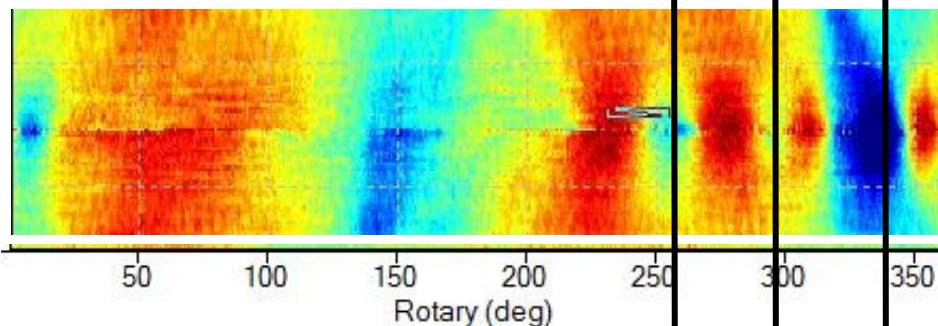
Interior Profilometry Scan of the Equator

- Profilometer scan of the inside surface of the liner at the equator shows 0.020 to 0.040 in. liner deformations (large ripples) at these same locations.

Profile of COPV Liner ID

- Large ripples around the girth weld raised a question
 - Eddy current sensors were placed over the peak of each girth ripple and monitored during pressurization to verify the liner did not flex causing a metallic fatigue concern
 - Stand-off remained fixed during pressure cycles, indicating that the indications were not a concern

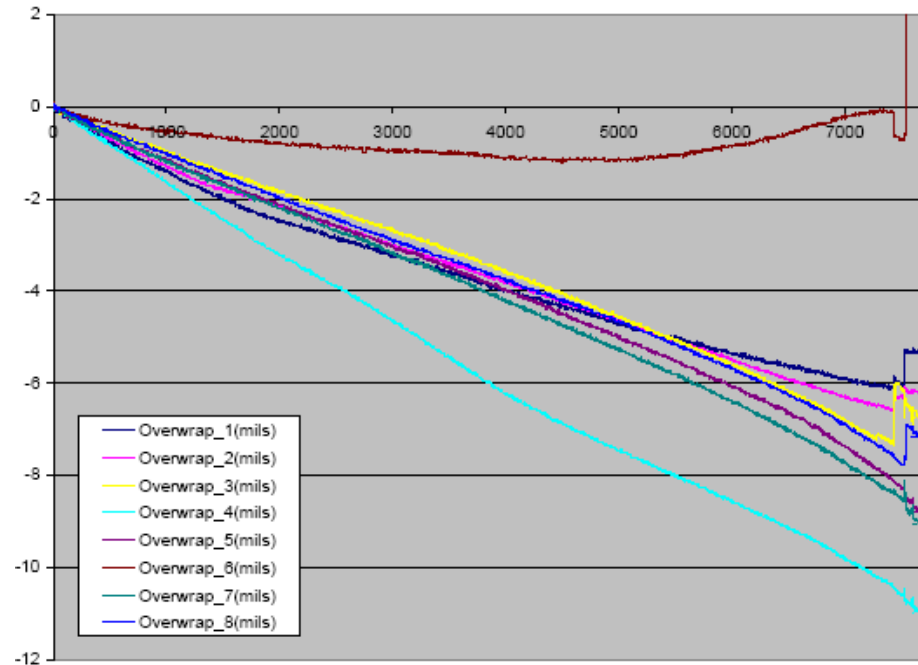
Overwrap Thickness Vs. Pressure

Example of Overwrap and Liner Thickness Evaluation by Eddy Current

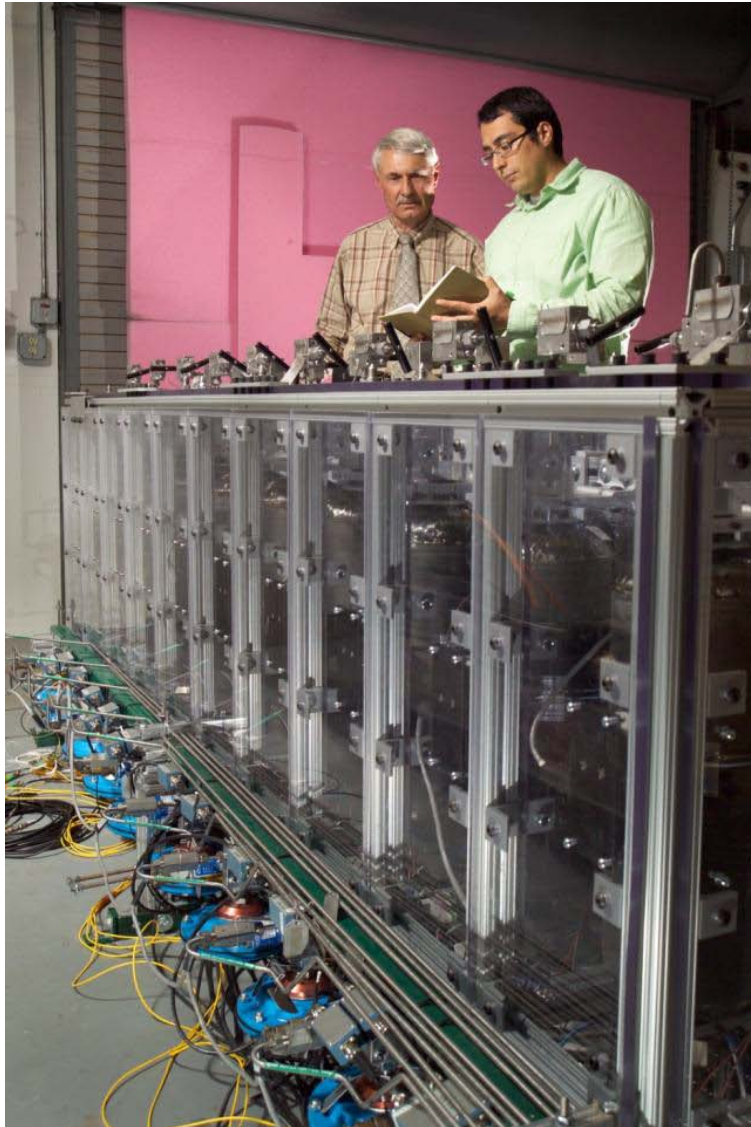
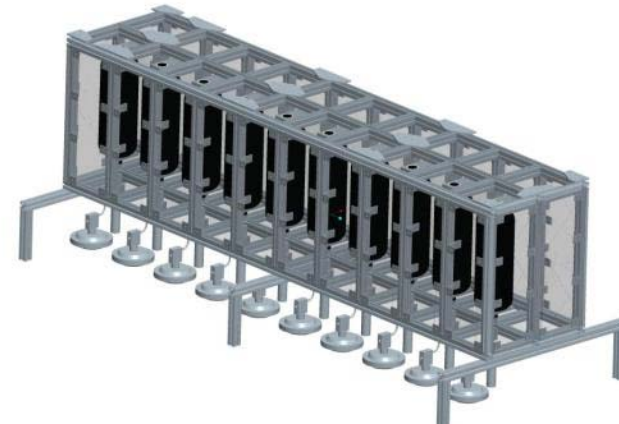
20 carbon vessels and
real-time NDE in WSTF
Lexan protective
enclosure allows
inspection while at test
pressure

- State-of-the-art 20 station test system brought on-line
 - Maintains pressure at approximately 27 ± 2 psi regardless of temperature swings (appears to be a first for the Stress Rupture test industry)
 - Rapidly auto-isolates bottles as they rupture
 - Protective enclosures allow inspection of vessels up to rupture pressure
 - Extensive data acquisition and real-time NDE capability to validate sensors and NDE

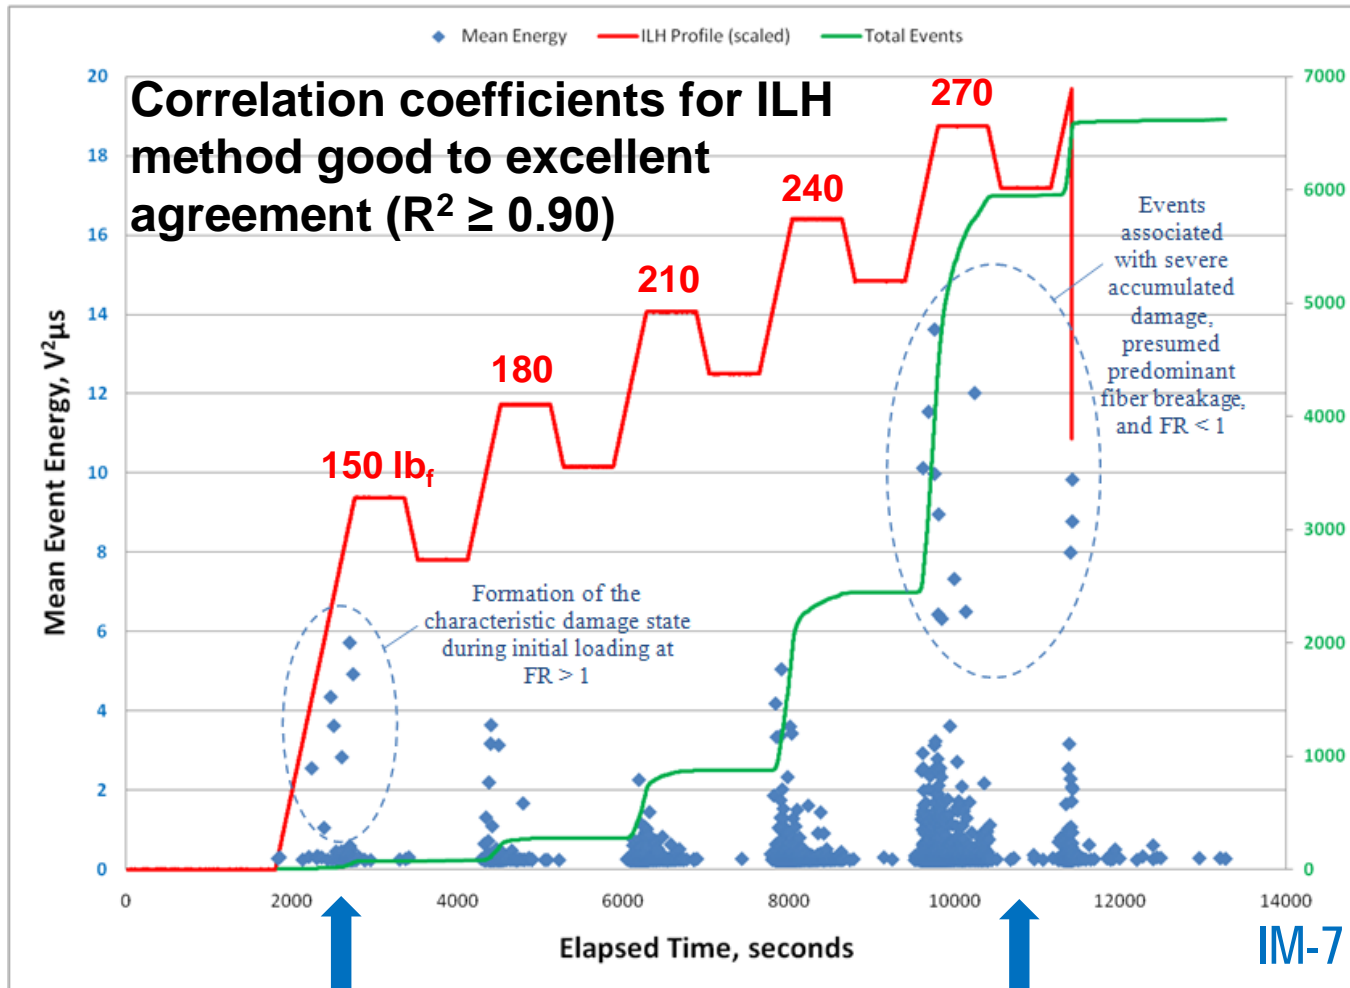
Regions of high AE activity correspond to events occurring early in COPV life cycle up to catastrophic failure

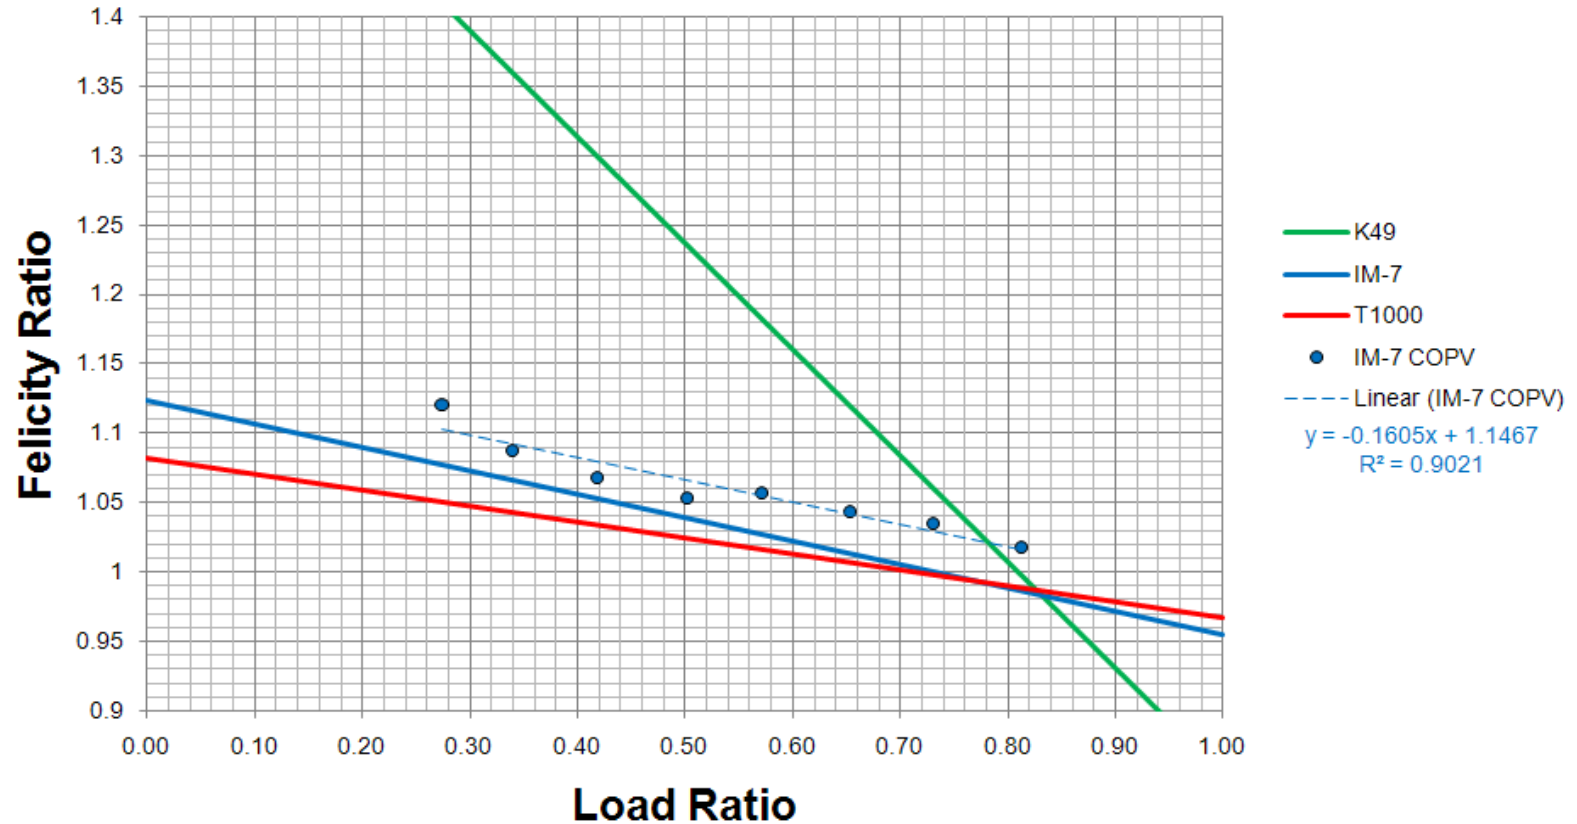
Correlation of IM7 C/Ep COPV AE Felicity Ratio to Strand Data

IM-7 tow data (solid blue line) consistent with IM-7 COPV data (blue symbols)

Proof-of-concept Felicity ratio analysis of an IM-7 reinforced C/Ep COPV (blue dots) superimposed on Kevlar[®] 49 (green line), T1000 (red line), and IM7 (blue line) single tow data
