OPERATING EXPERIENCE SUMMARY

U.S. Department of Energy
Office of Health, Safety and Security
OE Summary 2012-01
March 27, 2012

Preparing for Tornadoes and Their Aftermath

Accident Investigation Results — Worker Injured in Fall from Scaffold

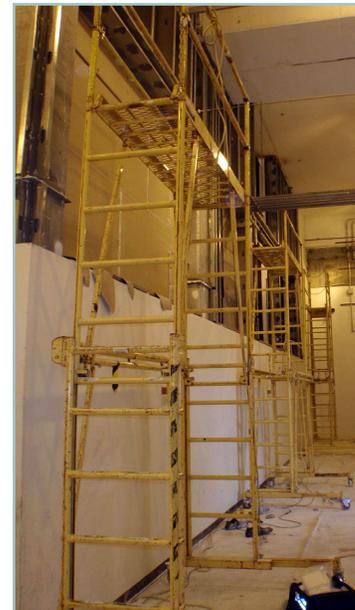
On July 1, 2011, at the Savannah River Site (SRS), a worker demolishing and removing gypsum wallboard fell approximately 12 feet from a scaffold Tele-Tower® to the concrete floor below. Figure 2-1 shows the scaffolding that workers were using at the time of the accident. The worker was transported by helicopter to a local hospital where he was diagnosed with head trauma and broken ribs. (ORPS Report EM-SR--SRNS-KAREA-2011-0002)

Figure 2-1. Scaffolding in use when accident occurred

- Strengthen implementation of the work planning process by applying a graded approach and considering more rigorous methods of identifying hazards, removing ambiguities in work steps (e.g., “when necessary” and “as required”), and clearly identifying hazards and controls to ensure that a re-evaluation is performed when workers approach safety boundaries.

- Evaluate HPI implementation to ensure that it is effective.
- Evaluate and modify the procedures, training, and proficiency for scaffold users and competent persons to ensure that scaffolding is erected and used in accordance with Occupational Safety and Health Administration (OSHA) requirements and 10 Code of Federal Regulations 851, *Worker Safety and Health Program*.

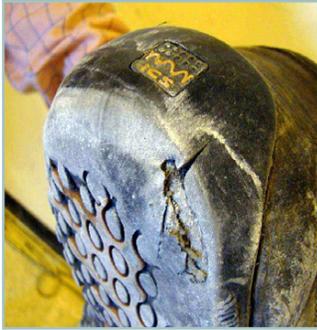
The Board could not establish the exact cause of the injured worker's fall and it could not interview him because of the nature of his injuries. Although the Board observed that the injured worker's shoes showed wear and were in questionable condition (Figure 2-2), it could not determine if the worn footwear contributed to the accident.

Figure 2-2. Wear pattern on worker's shoe

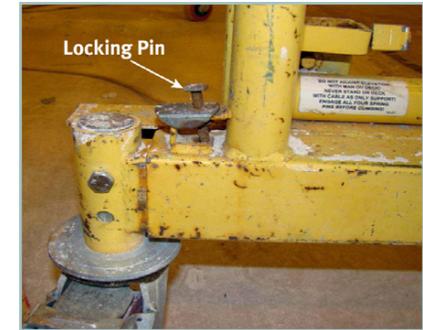
The Board also identified deficiencies that may have affected the stability of scaffolding Unit A, including loose wing nuts, non-uniform ladder spacing, unhooked safety chains at all four platform edges, and locking pins that were not engaged (Figure 2-3). In addition, because of the narrowness of the work platform and its construction, it was not as stable as other scaffolding that workers could have used.

Figure 2-3. Example of locking pin not fully engaged

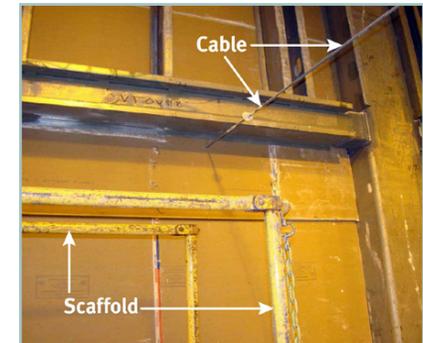
There was an overhead cable near the west ladder of Unit A. The Board believes that the injured worker may have been exiting the scaffold, and the cable may have interfered with his egress and contributed to the fall. The cable height was 63 inches above the working platform, which would have been about chin high when he was standing on the platform.

Figure 2-4 shows the location of the cable.

Figure 2-4. Cable near end of scaffold
