Moisture Monitoring Results in an R-40 Wall

Building America Webinar 2014
High Performance Enclosure Strategies

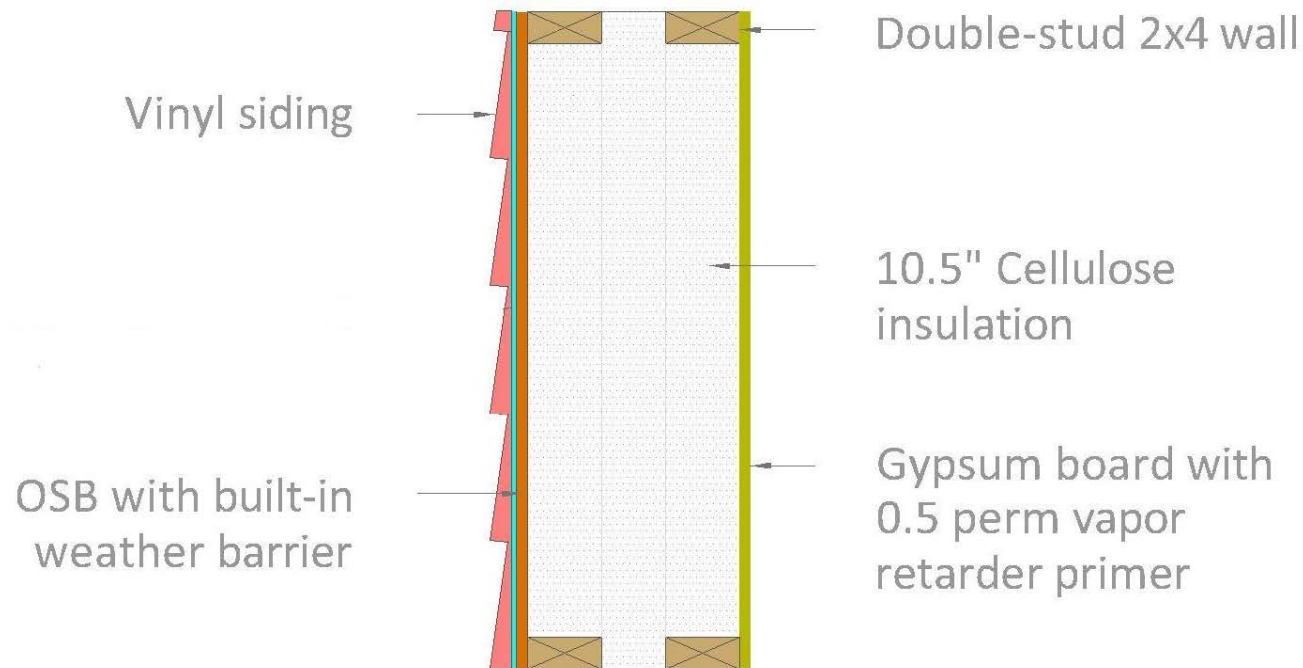
Assembly Evaluated

- NOTE: Exterior sheathing and studs in outer wall will be cold since they are "outside" the insulation

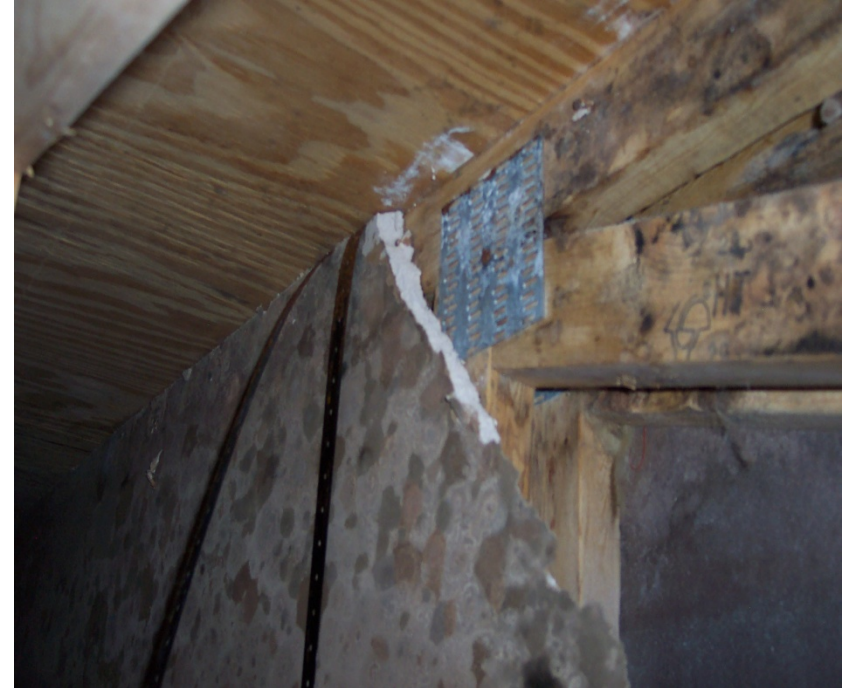
Failure Criteria

- Total Water Content of Assembly
- Moisture Content (MC)
- Condensation
- Mold growth

- Both predicted & actual data was analyzed.

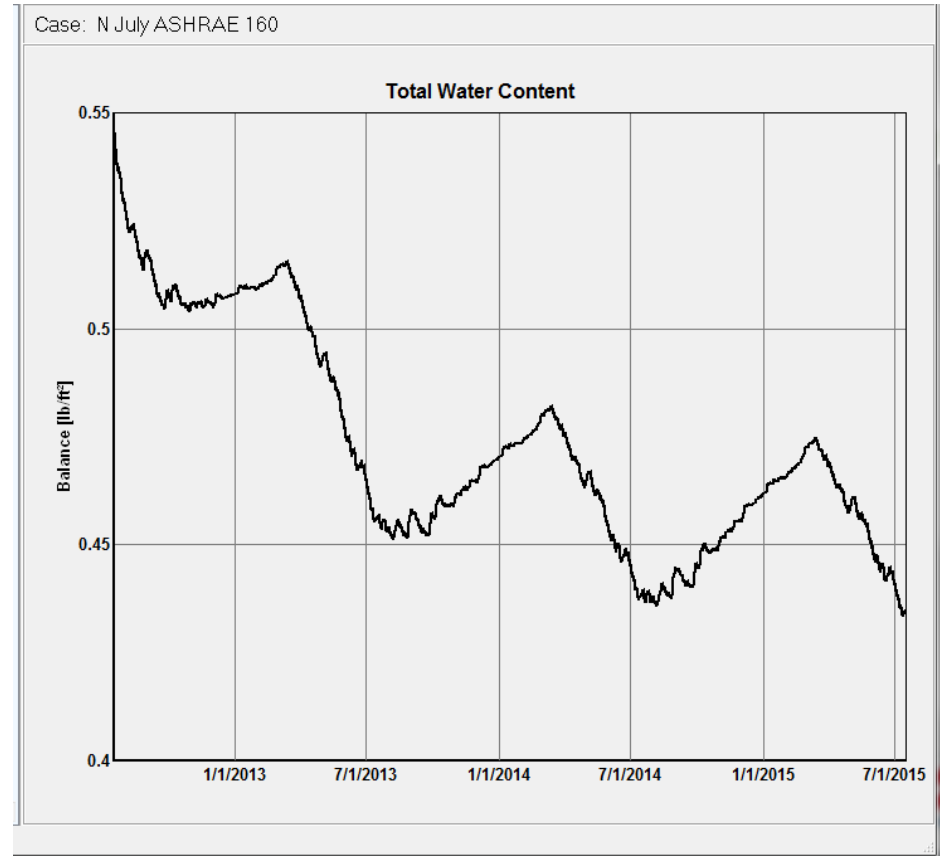
Failure Criteria: Total Water Content

☑ Total water content of assembly decreases w/ time

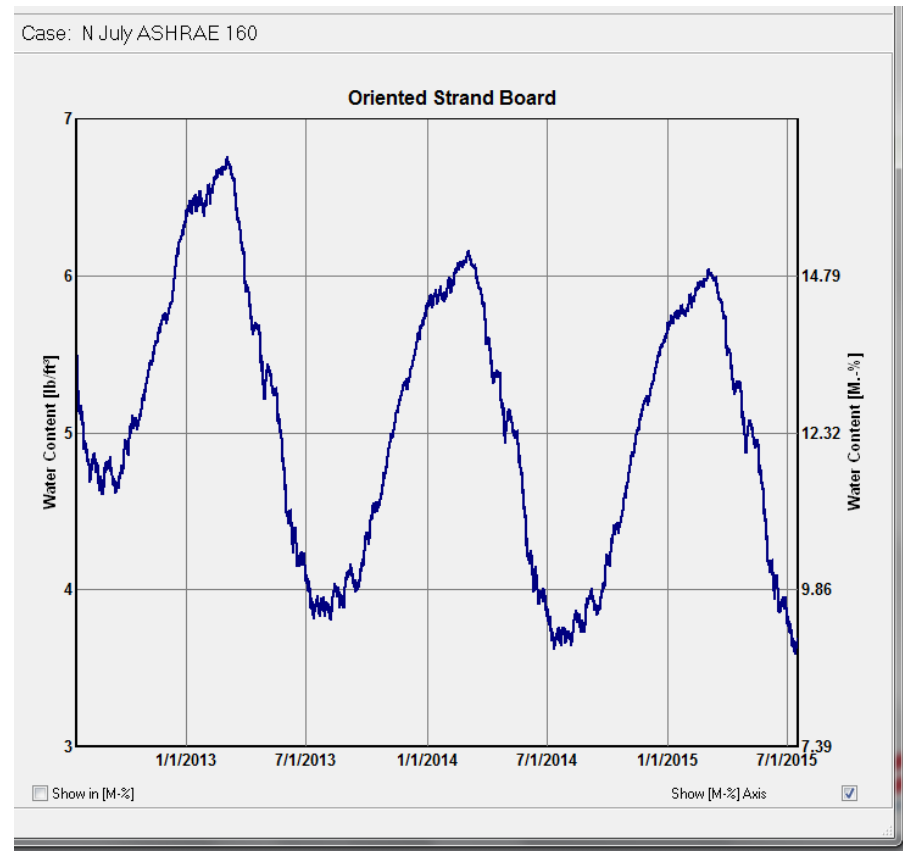
Failure Criteria: Moisture Content

☑ Moisture Content (MC) of wood components $<$ 20%

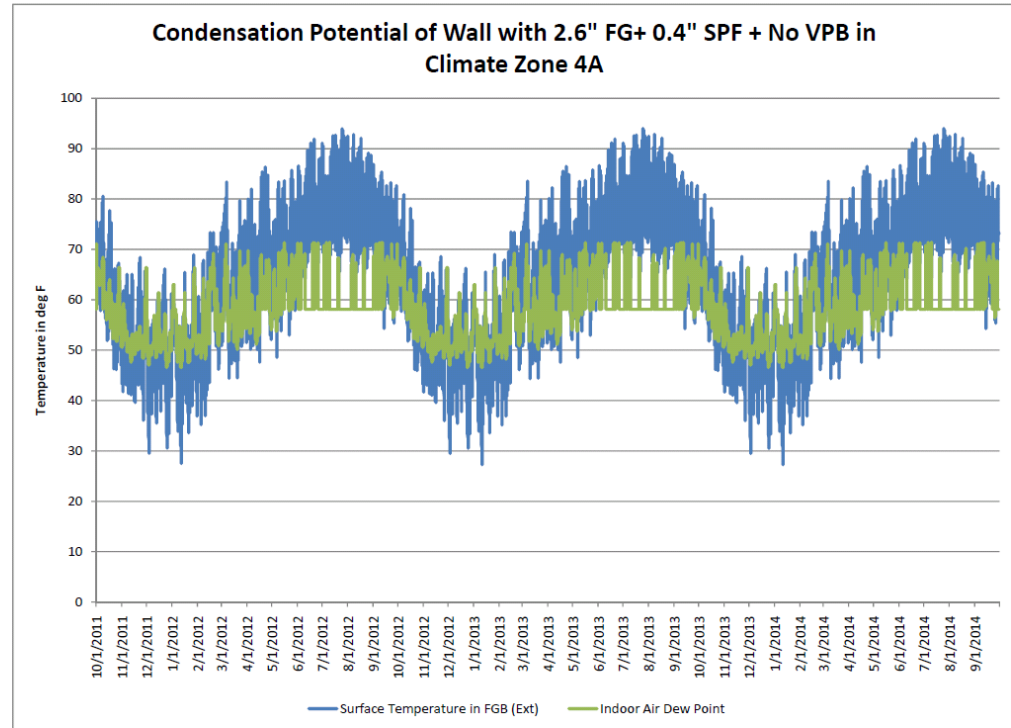
Failure Criteria: Condensation Potential

☑ Surface temp > interior air dew point temp

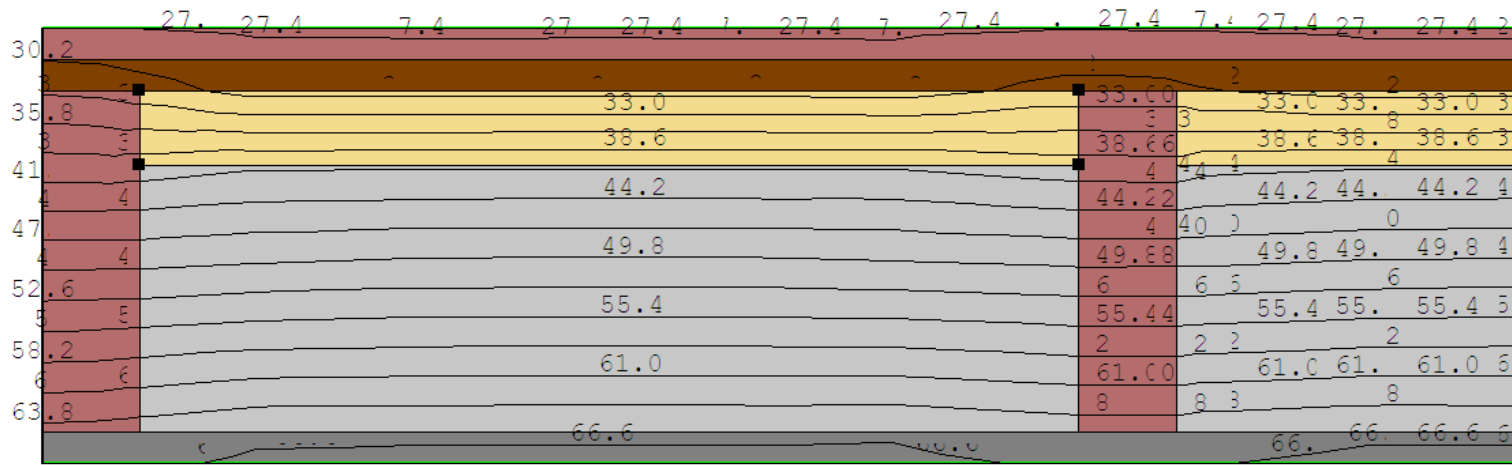
Failure Criteria: Condensation Potential

- Ambiguous – what % of time is surface below dewpoint?
- Several interfaces analyzed – OSB/foam, foam/cavity insulation, interior surface of brick

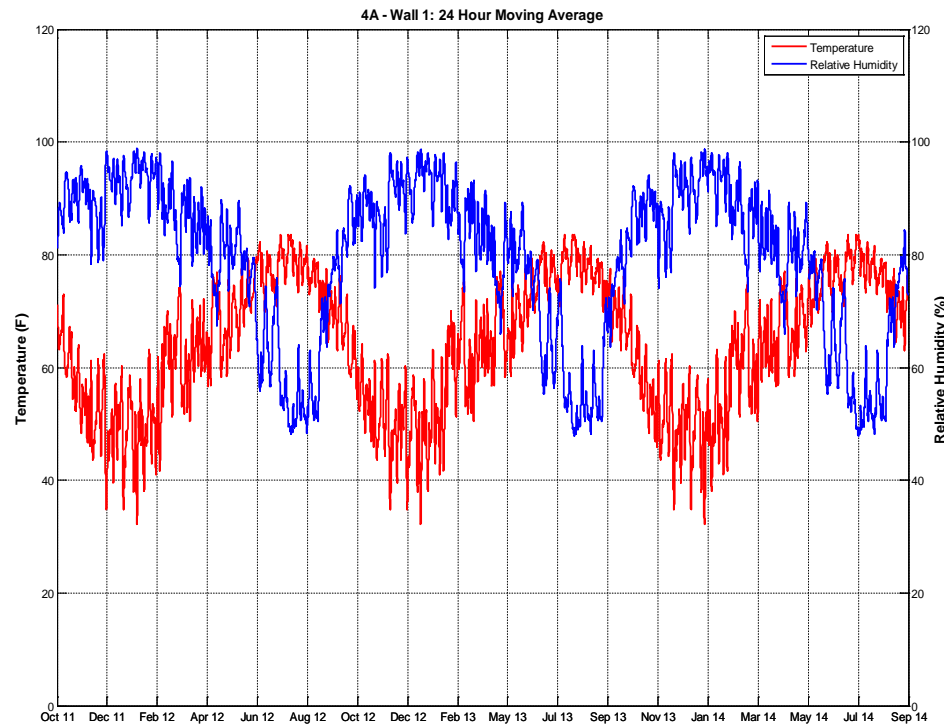
Failure Criteria: Mold Growth

- ☑ ASHRAE Standard 160 performance criteria:
 - 30-day running average: surface RH < 80% when temp 41°F to 104°F

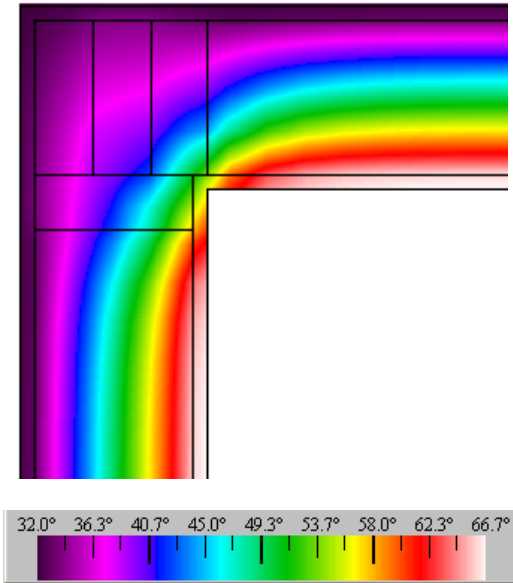
Image from THERM

- WUFI can only analyze continuous components
- Want to analyze condensation potential due to thermal bridging at framing members - THERM

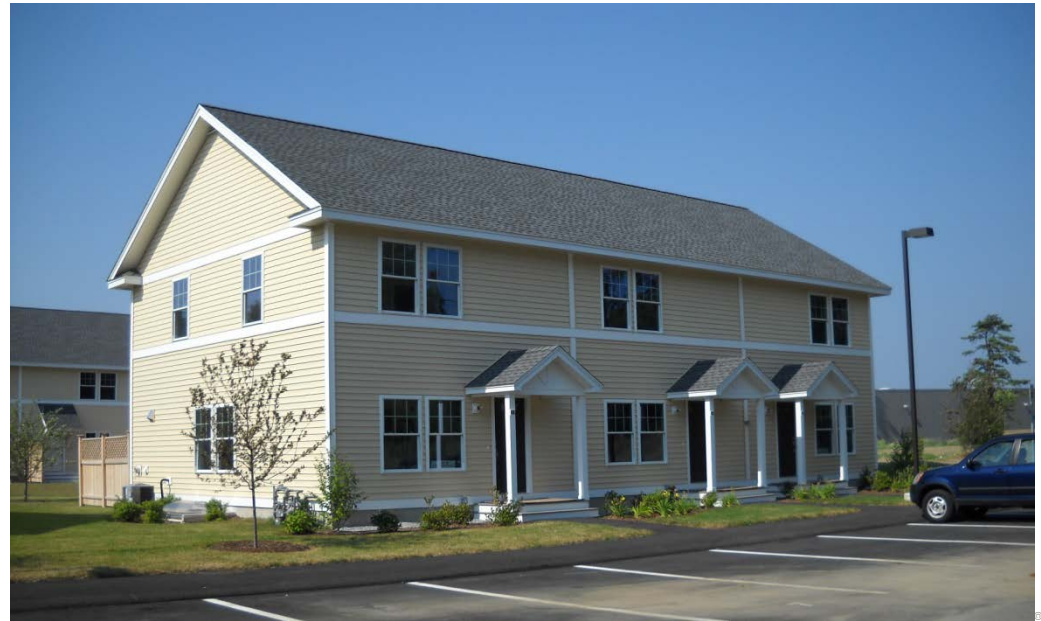
Test Home – Climate Zone 5A

- North of Boston
- 1900 ft²
Townhome
- 10.5" double-stud walls
- Dense-packed w/ cellulose
- North & South walls tested

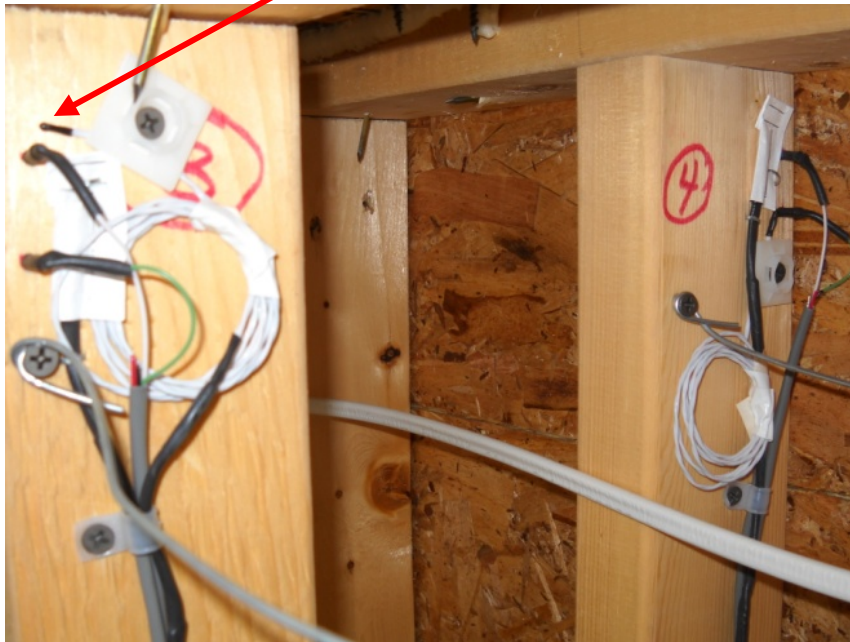
Temperature
Sensor

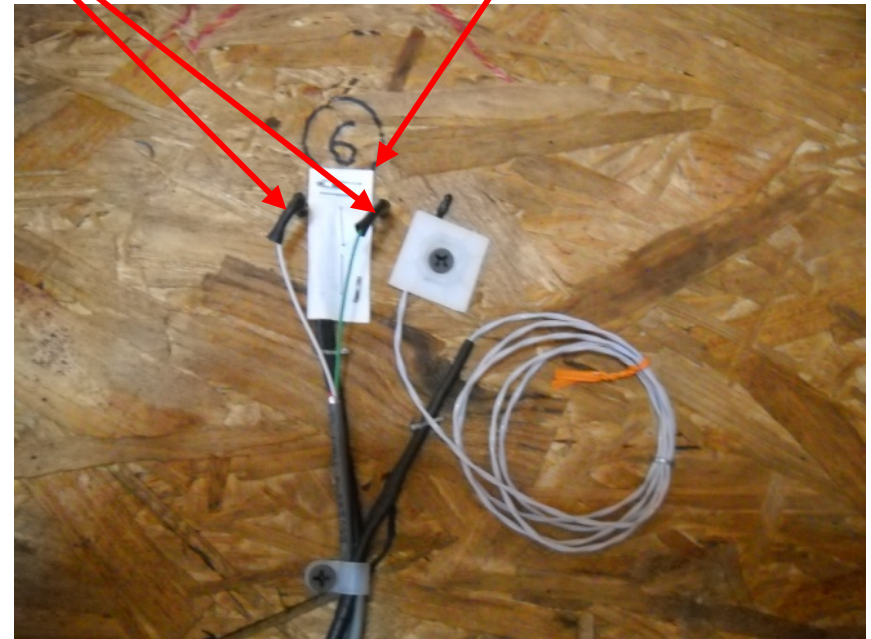
Moisture
Sensor Pins

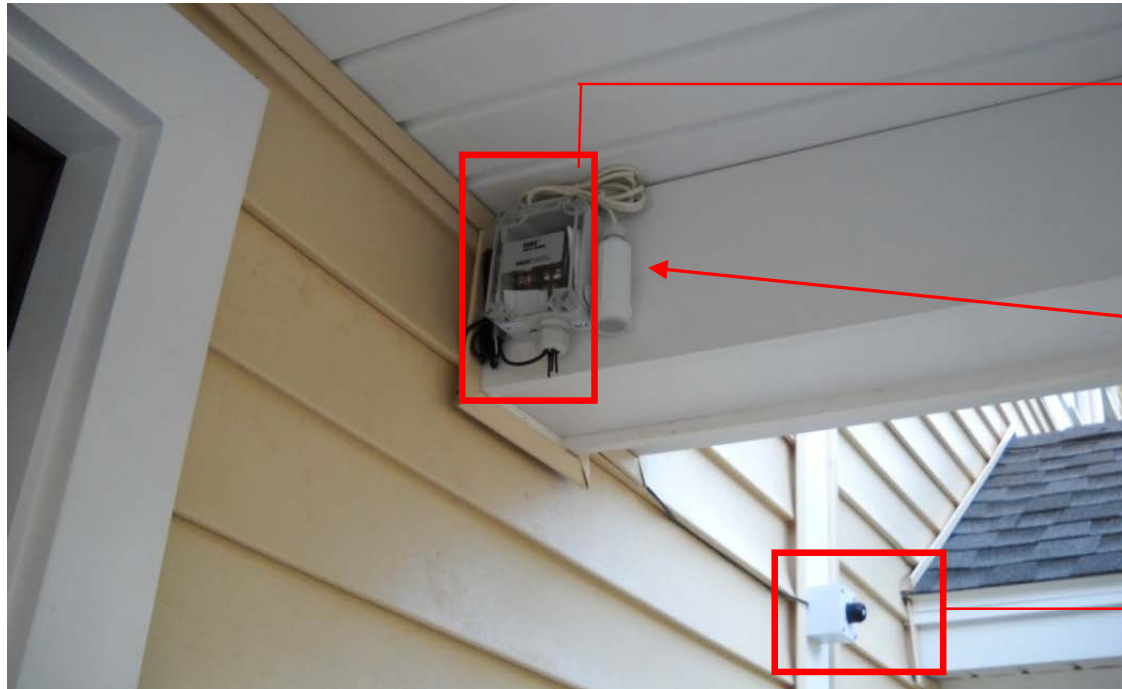
Exterior Sensors

Data logging equipment under porch overhang

HOBO sensor to collect exterior temperature and RH

Pyranometer located on the exterior side of the South bay

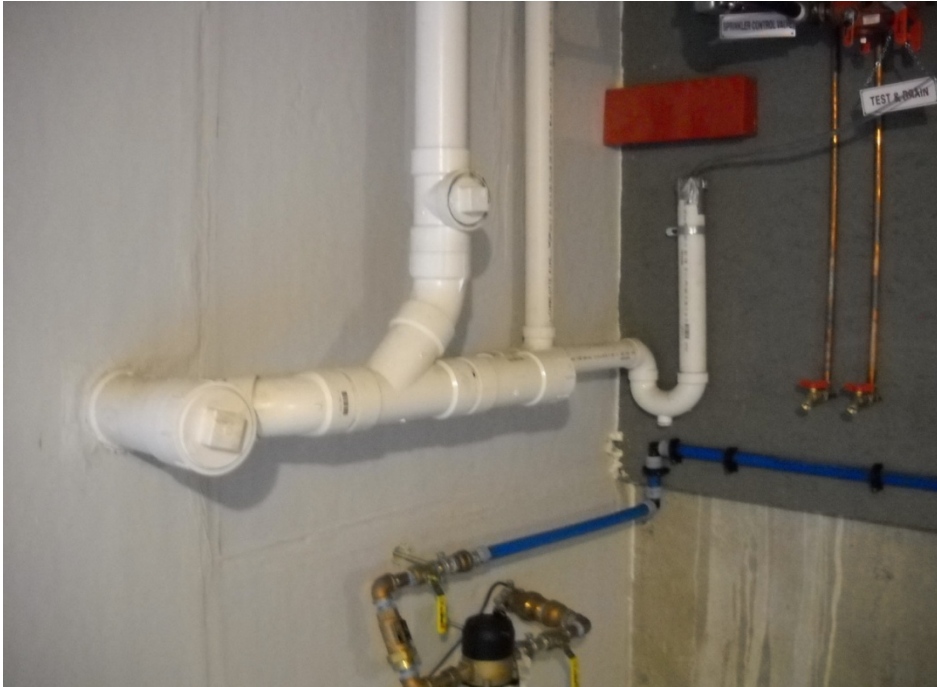
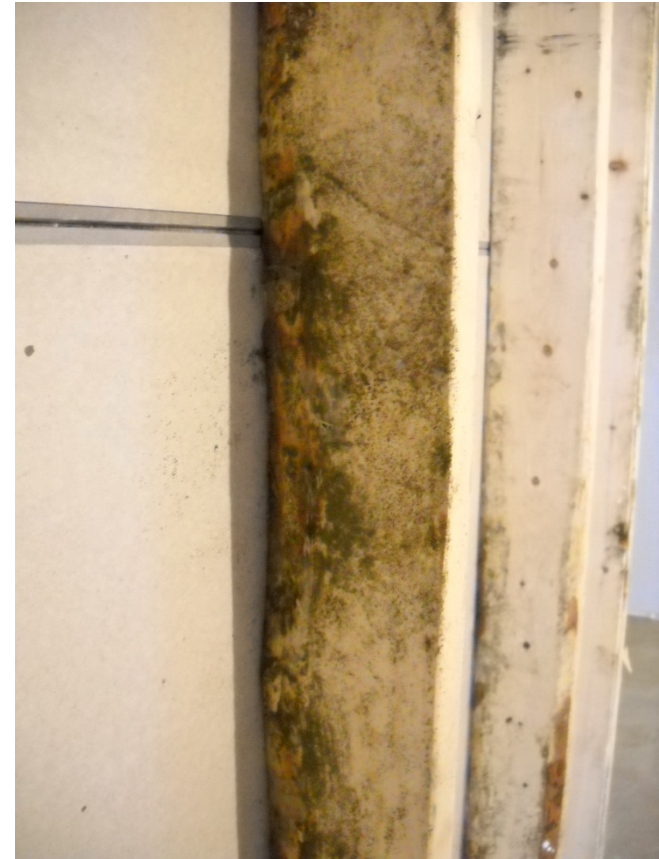
Initial Conditions

Level	Parameter Measured	Result
1 st Floor	Interior Temperature	78°F
	RH	69%
	Drywall MC	0.5 to 1%, no mold visible
Basement	Temperature	72°F
	RH	83%
	Stud MC	18%, mold visible

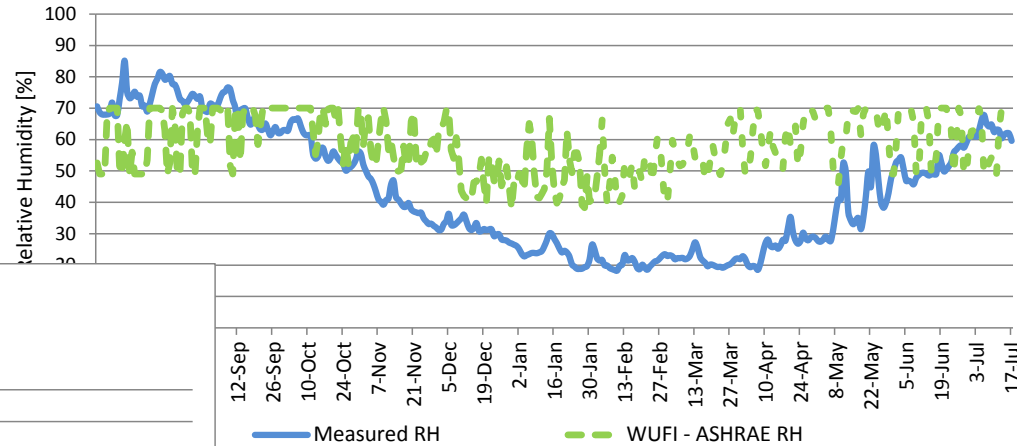
Indoor Conditions: Daily Average RH WUFI vs. Measured

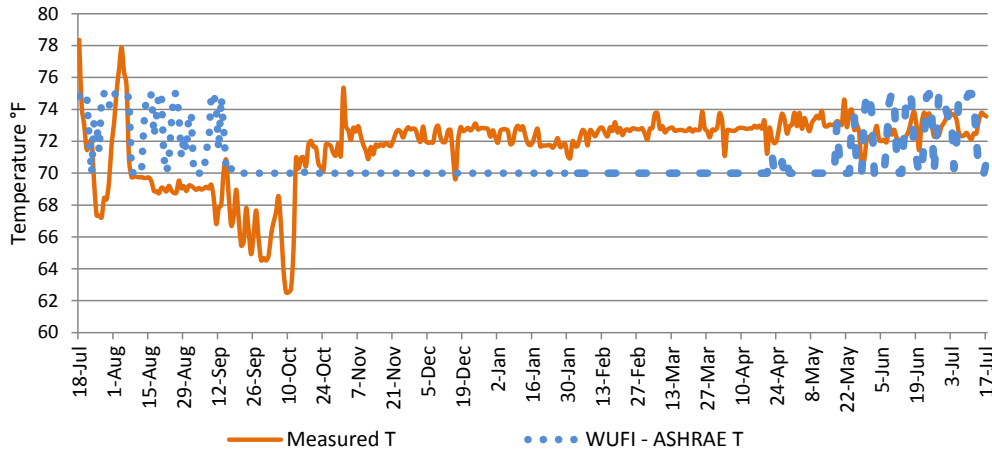
Indoor Conditions: Daily Average T WUFI vs. Measured
