SEISMIC CAPACITY OF THREADED, BRAZED AND GROOVED PIPE JOINTS

Brent Gutierrez, PhD, PE
George Antaki, PE, F.ASME

DOE NPH Conference
October 25-26, 2011

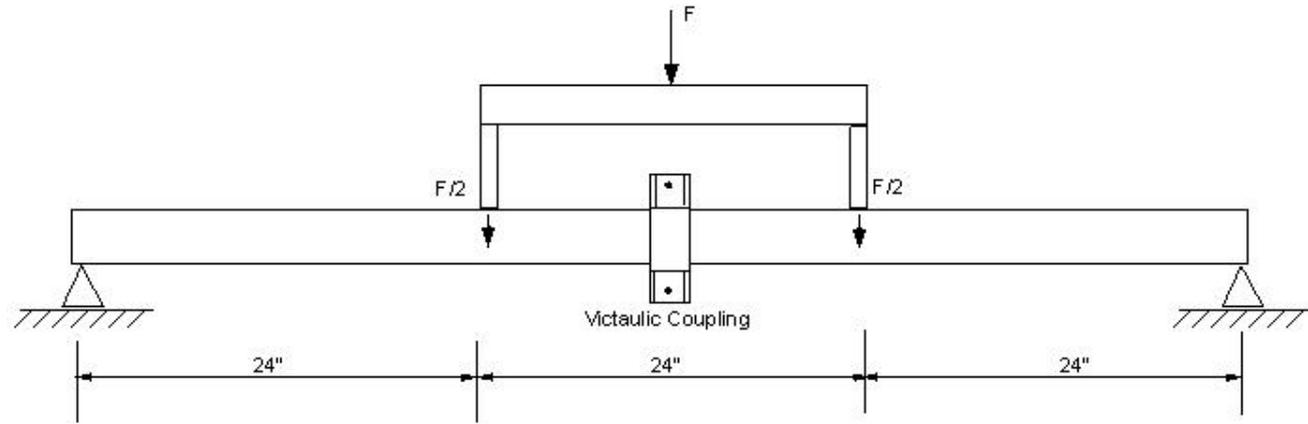
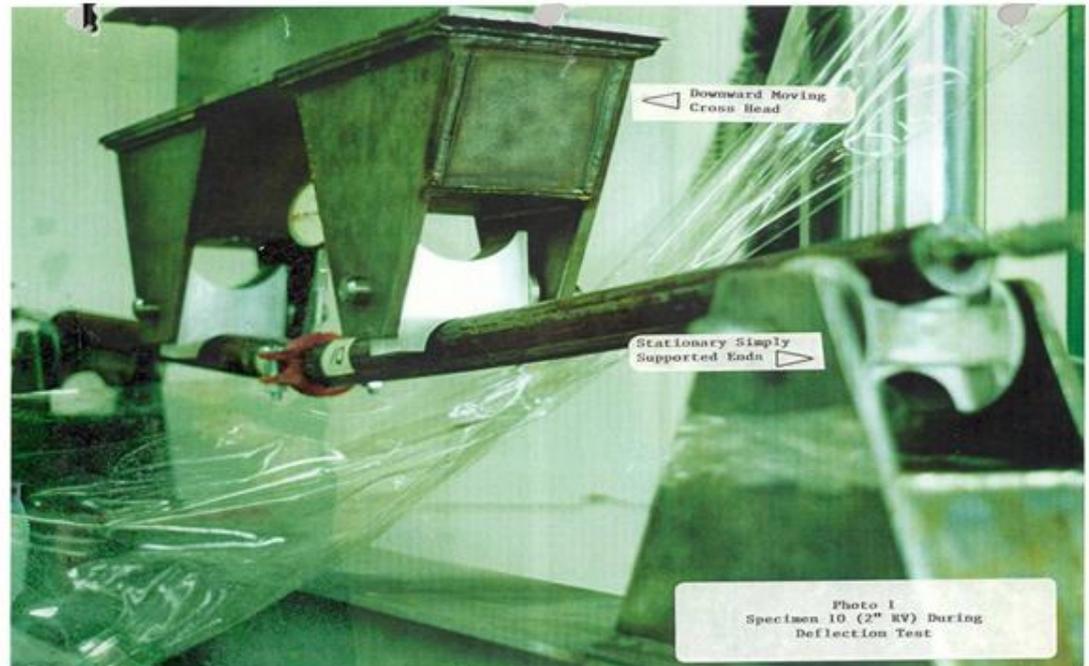
Figure 1 – Static Test Arrangement Four-Point Bend Test

- Pressurized spool to 150 psi
- Steady downward force applied while recording deflections
- Grooved clamped mech. joints
 - 16 tests performed
- Threaded joints
 - 4 tests
- Brazed (copper)
 - 4 tests

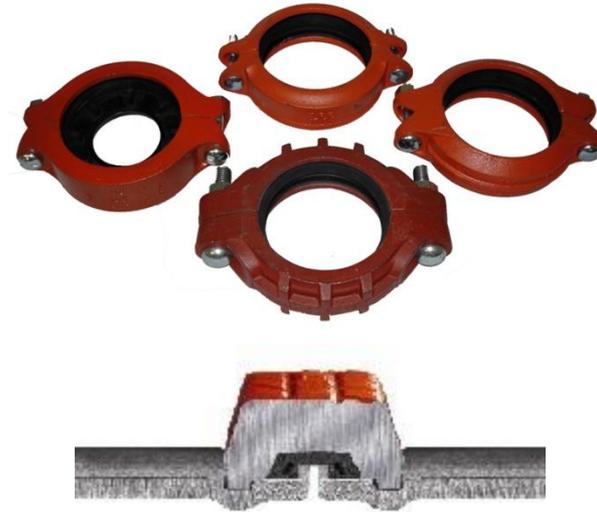
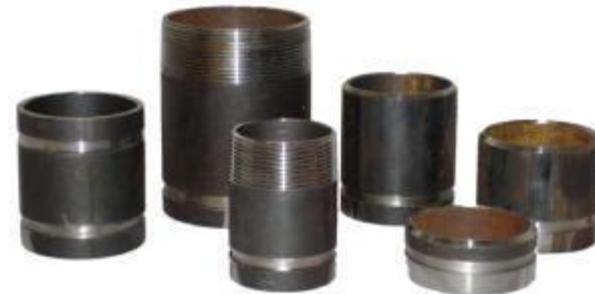
4" Dia. Grooved Couplings

Rupture of coupling followed by leakage

All specimens exhibited same failure mode; cracked housing followed by loss of gasket preload and leakage

- Joints performed beyond manufacturer's installation recommendations
- Dynamic failure mode of grooved couplings same as static failure mode
 - Failure moment consistent with static
- Threaded couplings did not perform as expected
 - Leakage at onset of shaking but no visible damage to threads

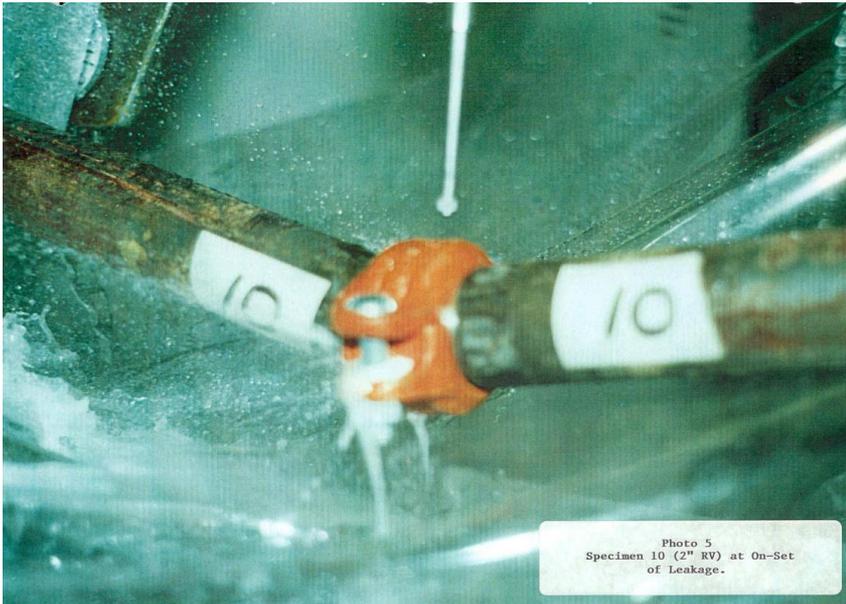
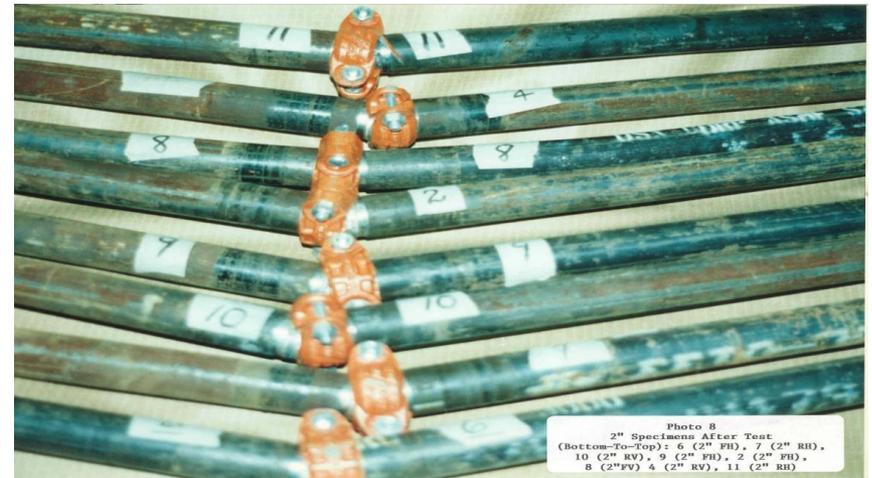
2" Dia. Grooved Couplings

Typical failure mode

All but two failed by cracked housing, loss of gasket preload followed by leakage

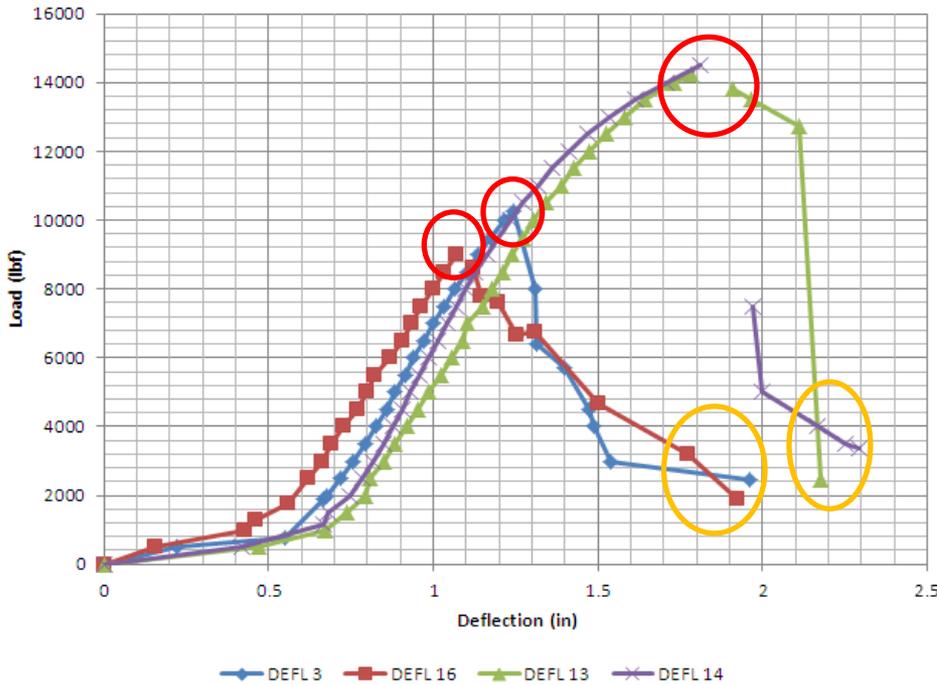
4" Flexible Couplings

4" Dia. Couplings Load – Deflection Curves

○ Loss of stiffness regions

○ Onset of leakage regions

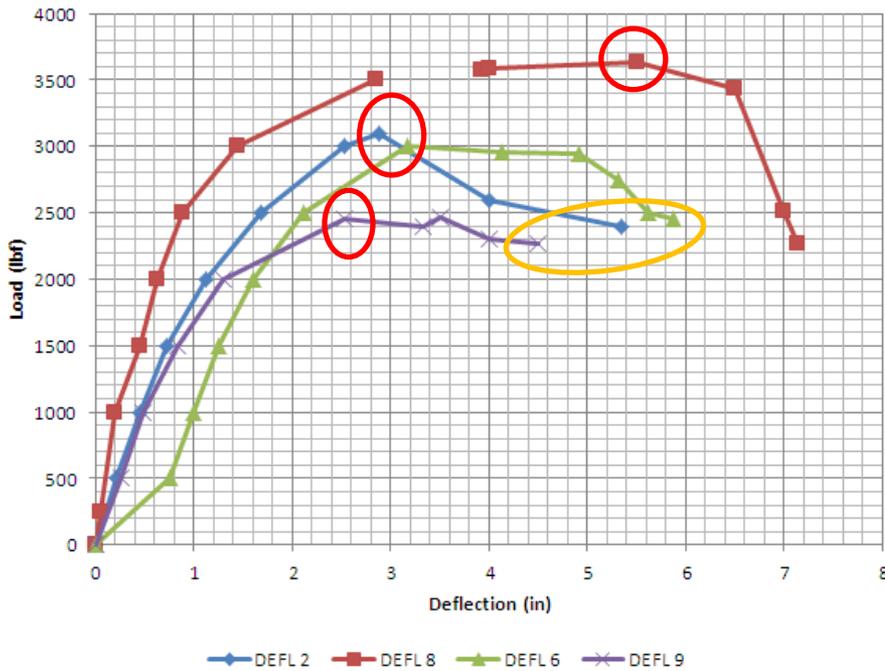
2" Flexible Couplings

2" Dia. Couplings Load – Deflection Curves

○ Loss of stiffness regions

○ Onset of leakage regions

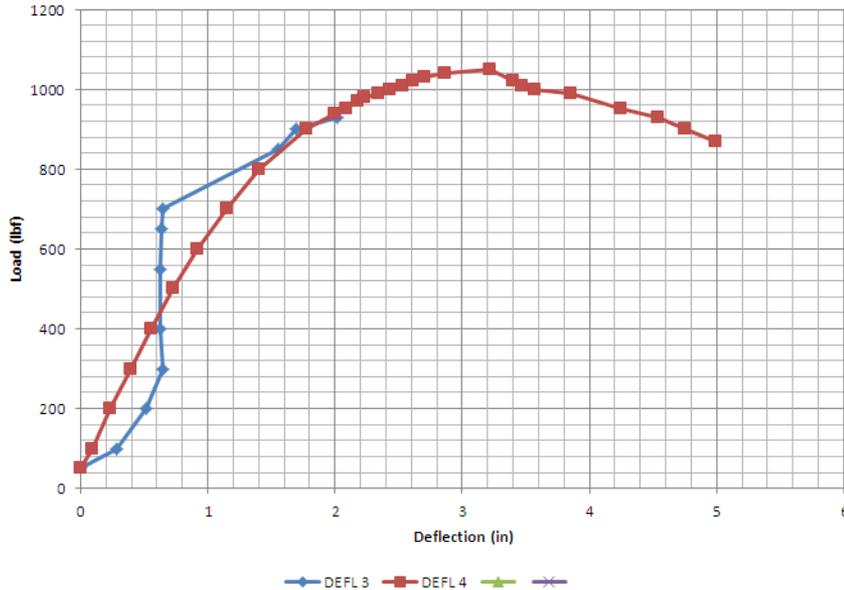
2" Brazed Copper Joints

The brazed fittings joint 2" ASTM B 88 type L seamless tubing (0.061 inch wall).

Brazed couplings have a slight inward depression all around their circumference which serves as an abutment to the two pipe ends. Three specimen failed by rupture of the brazed fitting at the coupling's centerline, where the inward depression is located. One specimen crimped (buckled) at the bearing point between the machine's cross head and the pipe (The two points of load application F/2 in Figure 1), with the 24" long center section remaining straight, causing practically no bending at the joint

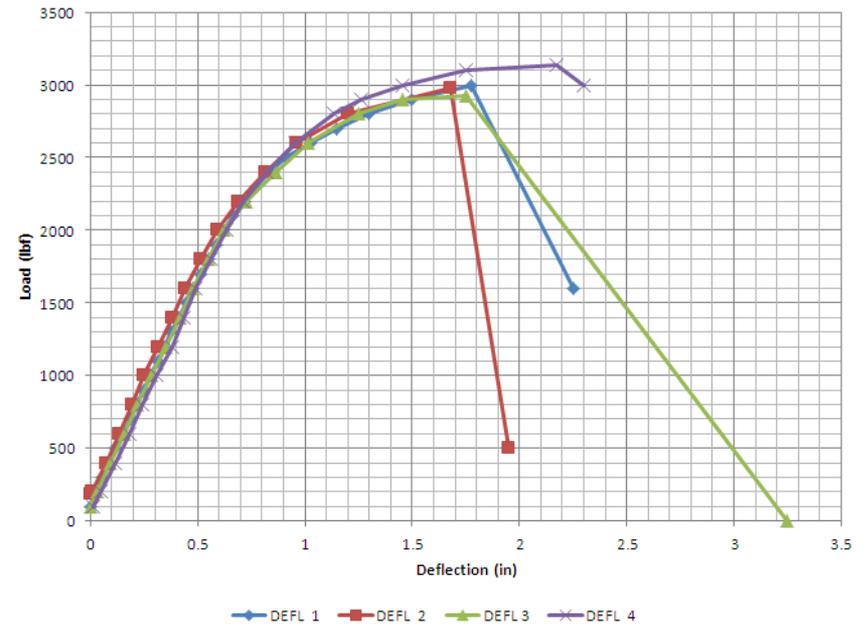
2" Sch. 40 Threaded Joints

The threaded fittings were ASME B16.3 malleable iron fittings, joining two 2 inch schedule 40 ASTM A 53 Grade B carbon steel pipes.

Three specimen failed by rupture of the first exposed pipe thread, and one specimen failed by stripping of the engaged threads.

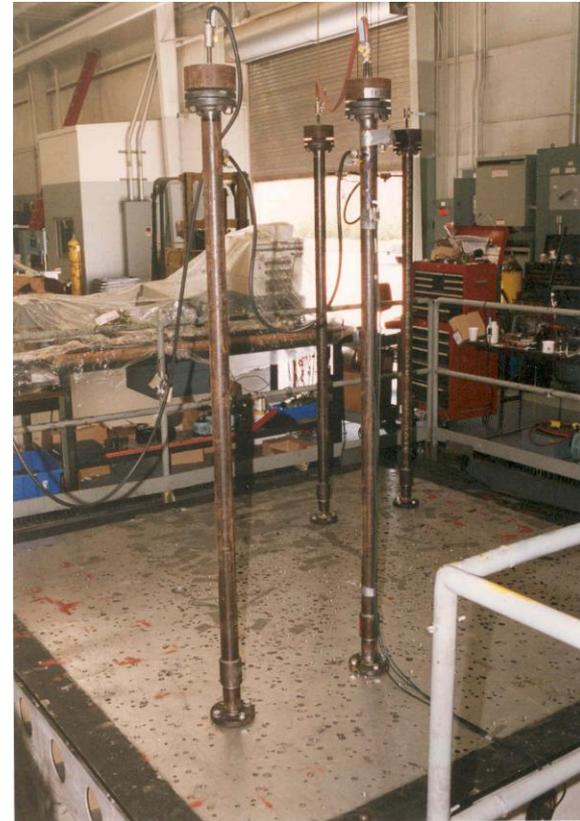
- 6' long pipe joined to 4" long spool welded to flange mounted on table
- Weight mounted on top of 6' long pipe to simulate moment loads of similar magnitude to bending moments in static tests
- Pressurized specimens to 150 psi
