# Stainless Steel Canister Challenges

**Steve Marschman**  
**Field Demonstration Lead**  
**Idaho National Laboratory**

**NEET ASI Review Meeting**  
**September 17, 2014**

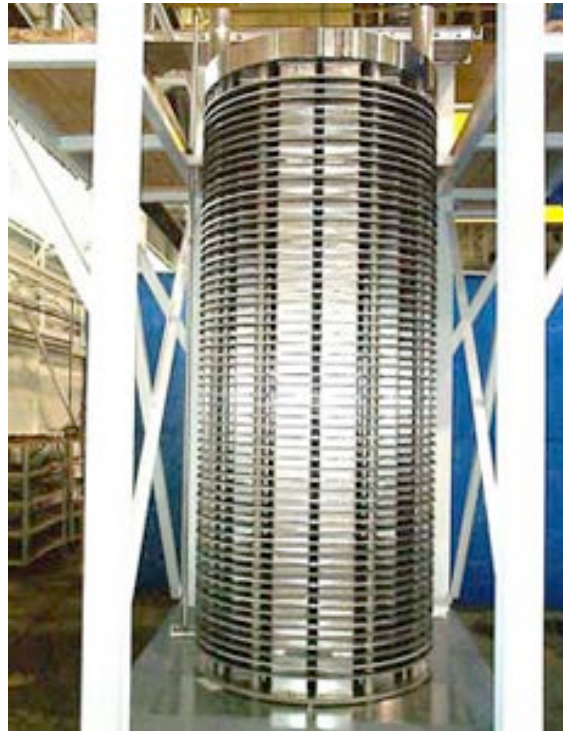
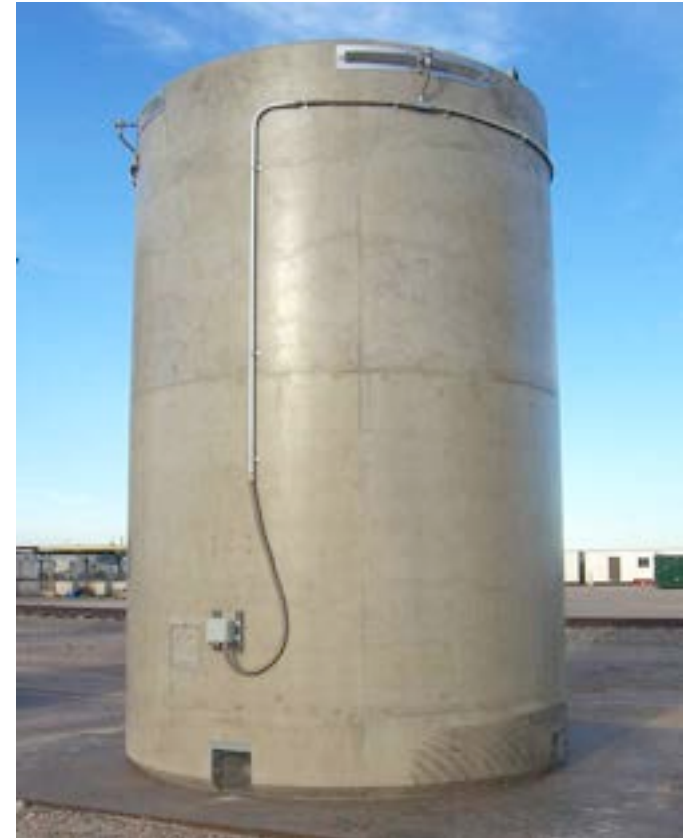
- NAC International, Inc.
- UMS (transportable canister in NAC-STC)
- 24 PWR or 56 BWR

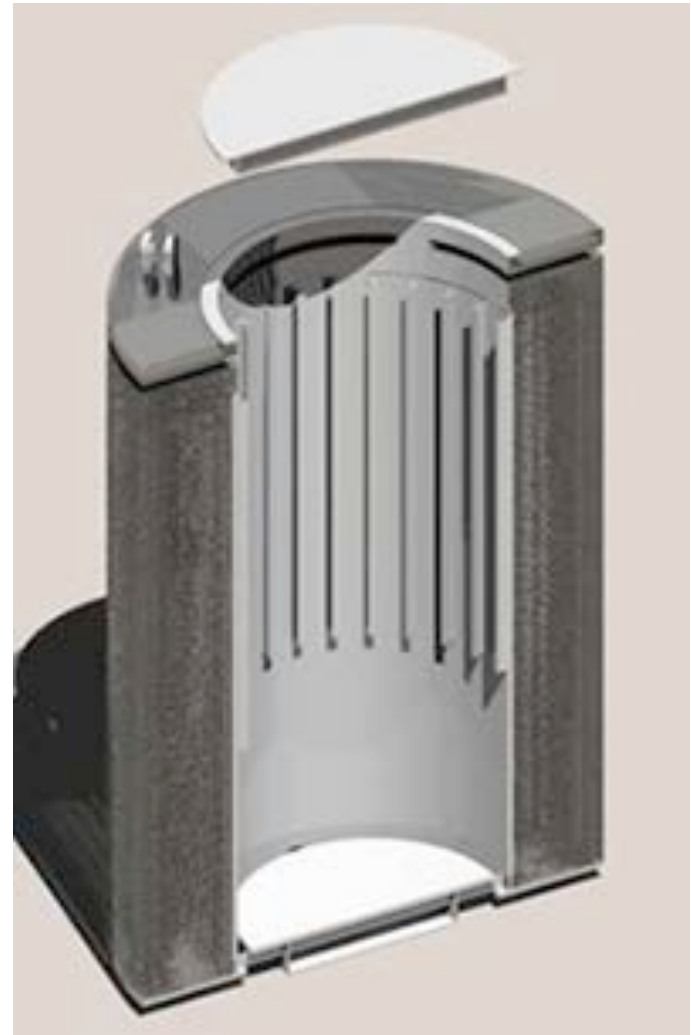
- **MagnaStor**
- **Newly in-service**
- **37 PWR or 87 BWR**

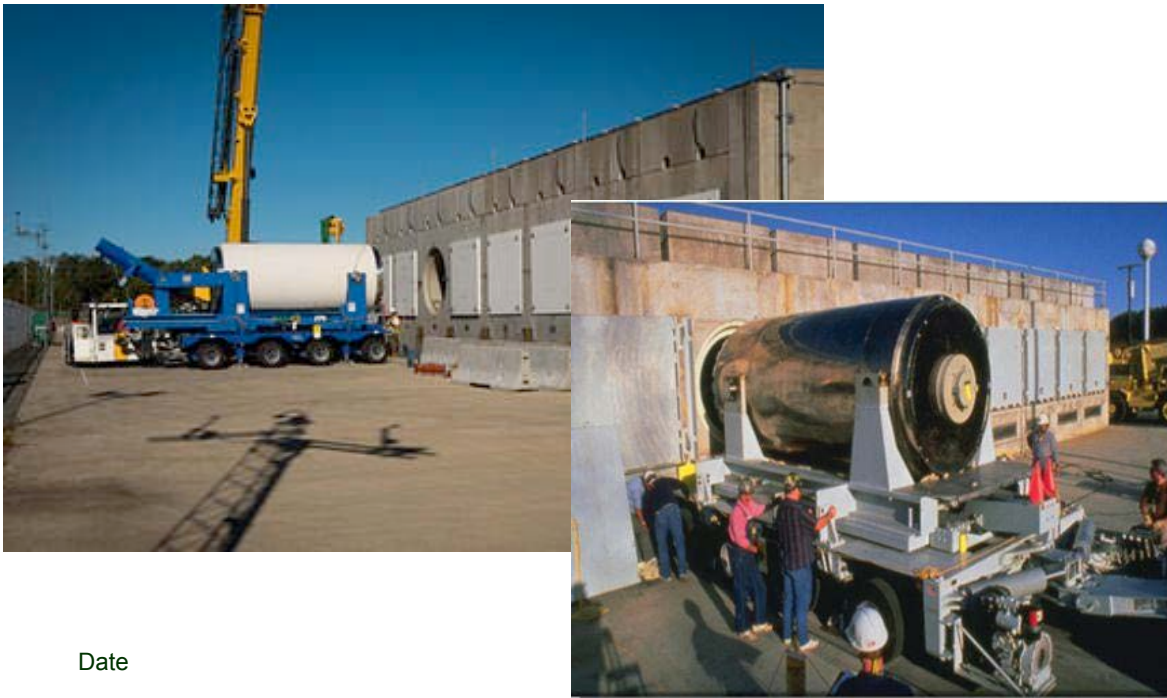
- AREVA-TN NUHOMS horizontal storage system
- 32-37 PWRs or 61-69 BWRs
- Canisters transferable using MP197HB transport cask

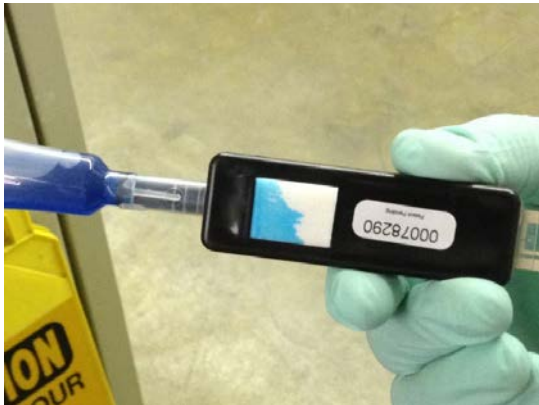
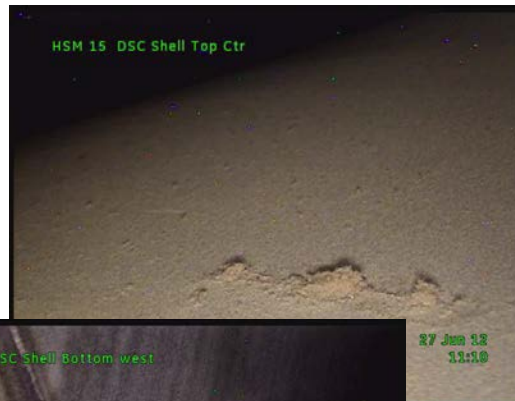
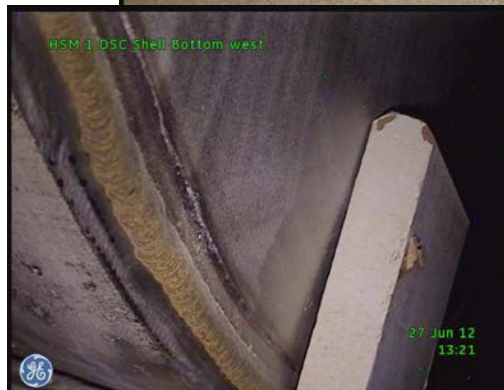
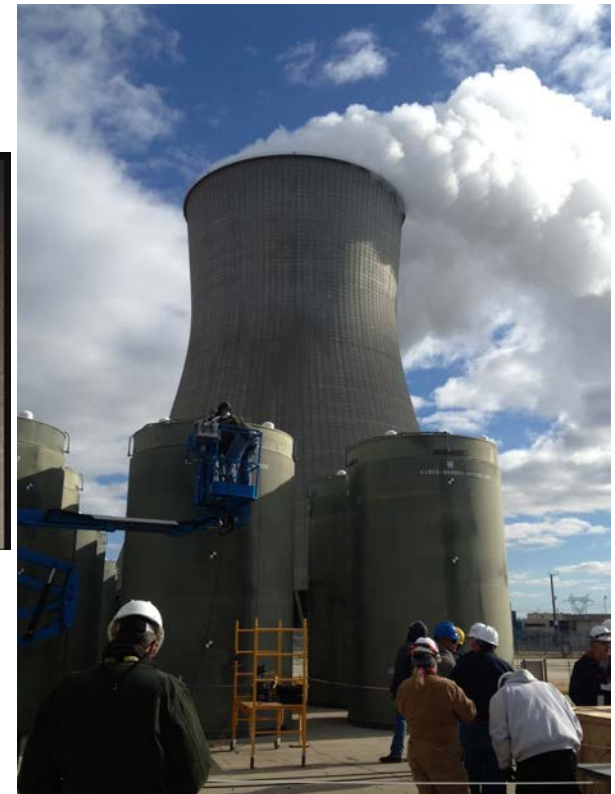
- EPRI led three examinations (partly funded by DOE); Calvert Cliffs, Hope Creek, Diablo Canyon
- Inspections generally consisted of:
  - Temperature measurements of cask at points inside the annulus between the cask and canister
  - SaltSmart™ measurements in similar locations
  - Dust collection from the cask lid
  - Visual inspection

- **Visual Inspection**
  - We did not see any evidence of cracking, but did we have good enough imaging capability?
    - Color could be misleading. If something appears orange-brown, is that really corrosion (on SS)?

- Very limited in surface area that could be covered (particularly for Holtec Hi-Storms)
    - Lighting inconsistent
- **Sampling for “Dust”**
  - Use of a spun nylon/alumina pad to collect samples was difficult.

- Hard to get pressure on the surface
    - Some sample falls off
    - Hot canisters partially melted the nylon substrate
  - “Salts” can degrade in handling and shipping; did we alter the sample through the sampling process?

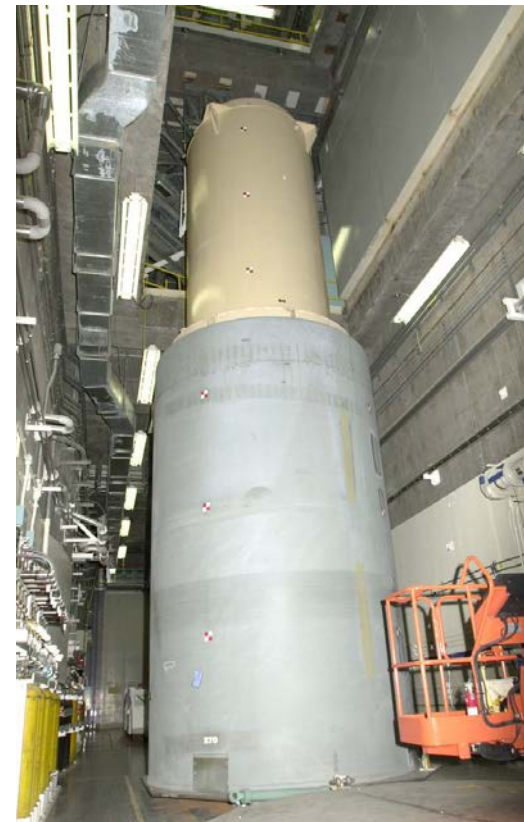
## ■ Some things we know:

- Canisters do not sit straight
- Canisters may not be centered
- Nothing is truly round
- Tolerances are fairly large
