Advanced Materials for Lightweight Valve Train Components

OVT Annual Merit Review
Final Program Review
February 26, 2008

PI: Nate Phillips (CAT)
Project Manager : Jeff Jensen (CAT)
Team Members: H. T. Lin (ORNL)
J. G. Sun (ANL)

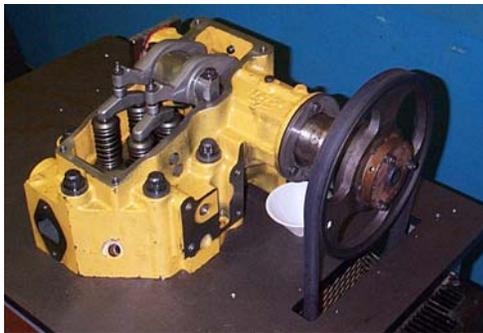
SCOTE impact test rig

Si₃N₄ valve

Early life “polish” wear

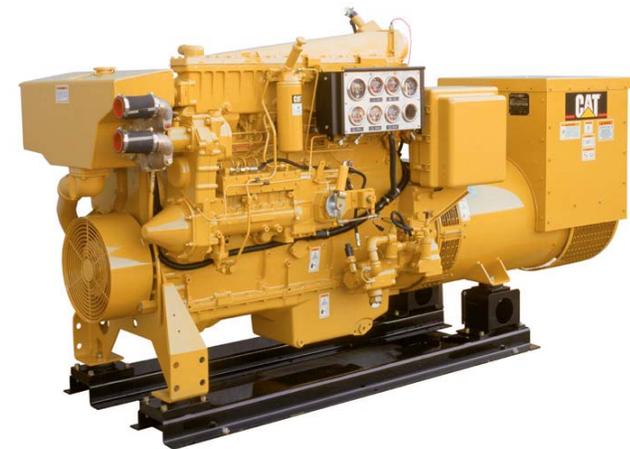
Caterpillar G3406 Engine

- Valves will accumulate 1000 hrs. on a G3406:
 - 1800 rpm, 12.77 bar bmep, $\lambda = 0.99-1.09$
 - Three Phases
 - Phase I: 100 hours
 - Phase II: 500 hours
 - Phase III: 1000hours
- Valves to be tested:
 - 8 Si3N4 intake valves
 - 8 Si3N4 exhaust valves
 - 8 TiAl exhaust valves
 - Balance: production valves

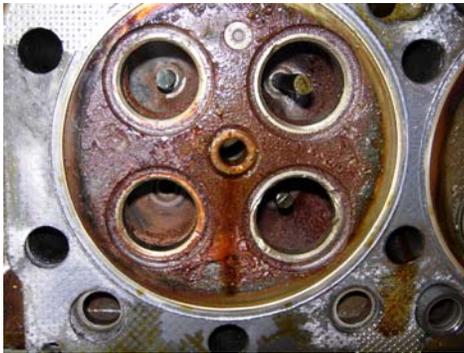
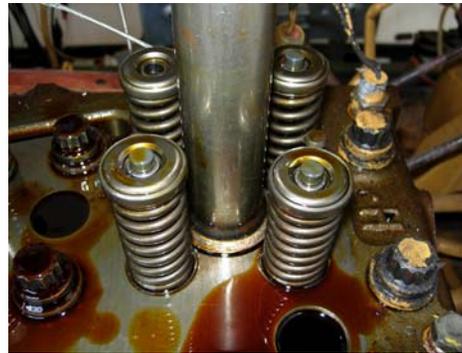
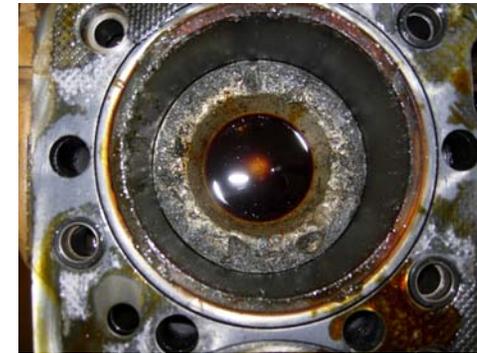
1. The keeper notch for intake valve #22 wore off or sheared, allowing the valve (composed of silicon nitride) to drop into the cylinder.
2. Once in the cylinder, the valve head was hit by the piston and shattered. Loose fragments from this valve destroyed the remaining three silicon nitride valve heads and well as damaging the piston and cylinder liner.

3. During the compression stroke a portion of the valve fragments entered the intake manifold. Since the intake valve heads for cylinder #6 were missing, an opening existed for the transport of these fragments into the intake manifold.

4. The silicon nitride fragments, which had entered the intake manifold, were subsequently sucked into the other five cylinders during the intake stroke.

5. Once inside the combustion chamber, the fragments destroyed the other valves, piston crowns, and liners via high velocity impact.
6. During the exhaust stroke, a portion of the silicon nitride fragments entered the exhaust and subsequently damaged the turbocharger.

- Si_3N_4 and TiAl valves showed significant wear improvements over production steel valves after 500 hours of engine testing
- The failure of the G3406 engine was caused by the failure of a steel keeper, not the durability and reliability of the Si_3N_4 valves
