***Results of Stainless
Steel Canister Corrosion
Studies and
Environmental Sample
Investigations***

***Prepared for
U.S. Department of Energy
Used Fuel Disposition Program***

***Charles Bryan and David Enos
Sandia National Laboratories
September 25, 2014***

**FCRD-UFD-2014-000055
SAND2014-20347 O**

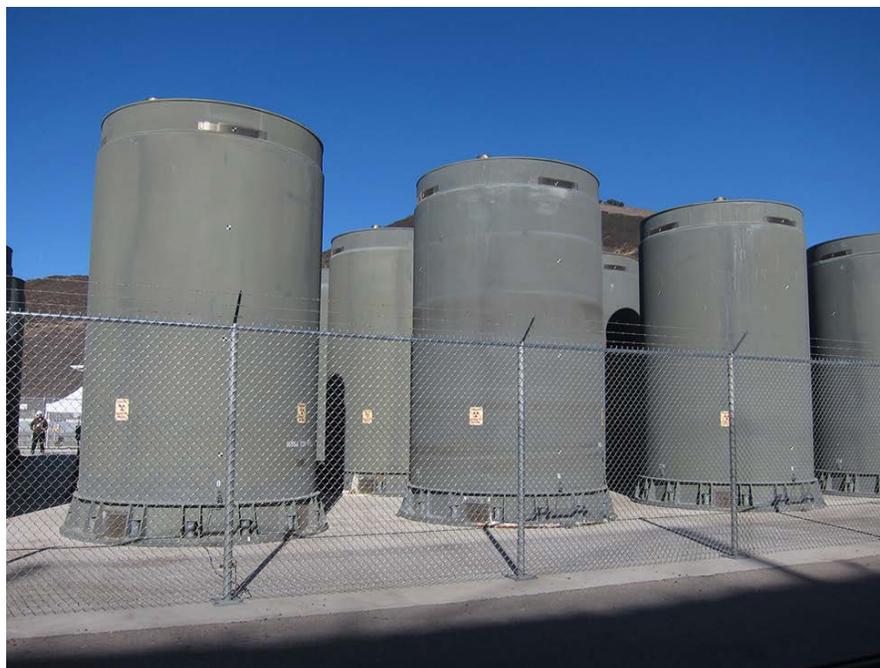
Figure 1. Holtec HI-STORM dry cask storage systems at Diablo Canyon.

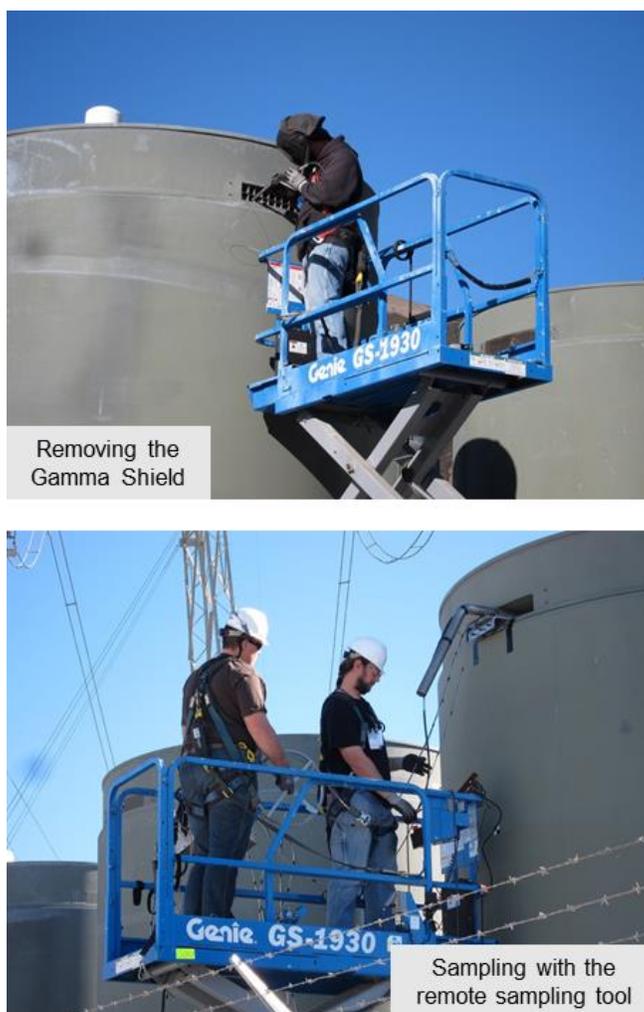
Figure 2. Sampling dust from the surface of interim storage canisters within their overpacks.

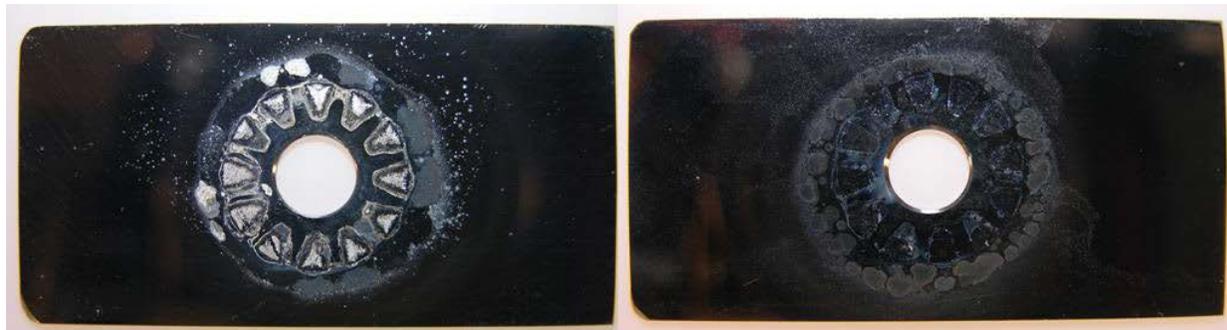
Figure 38. 304SS coupon with $200 \mu\text{g}/\text{cm}^2$ and 7 day exposure after crevice former removal (L) and rinsing (R).
