Center Hill Dam Safety Rehabilitation

Status Update – Team Cumberland

6 April 2016

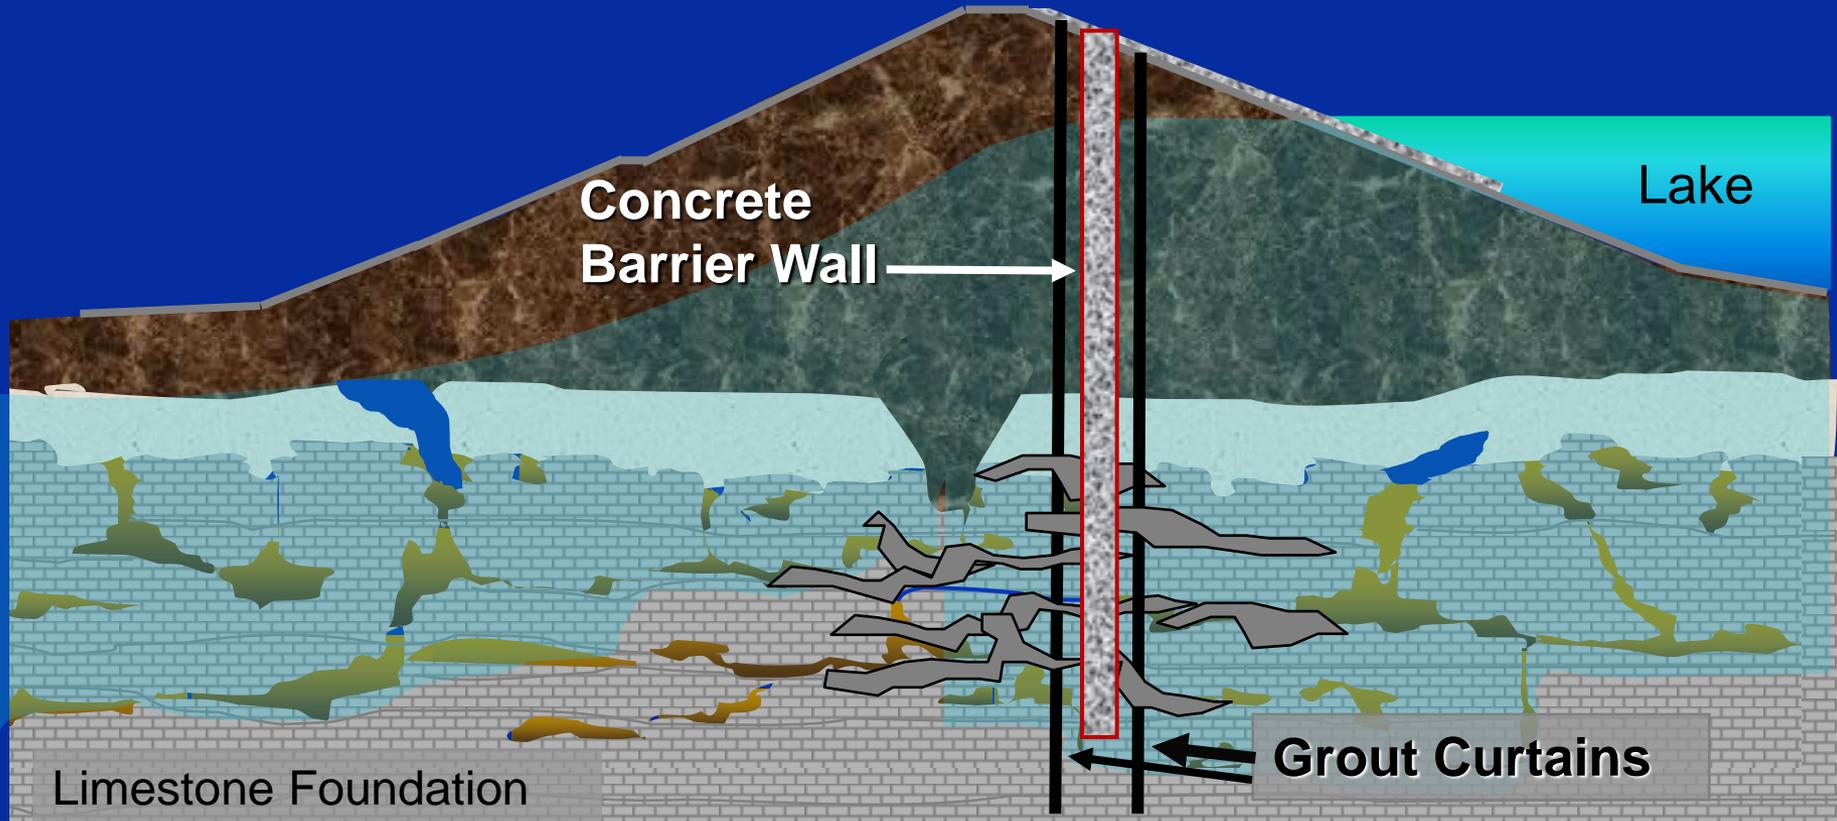
Grout Curtain and Barrier Wall

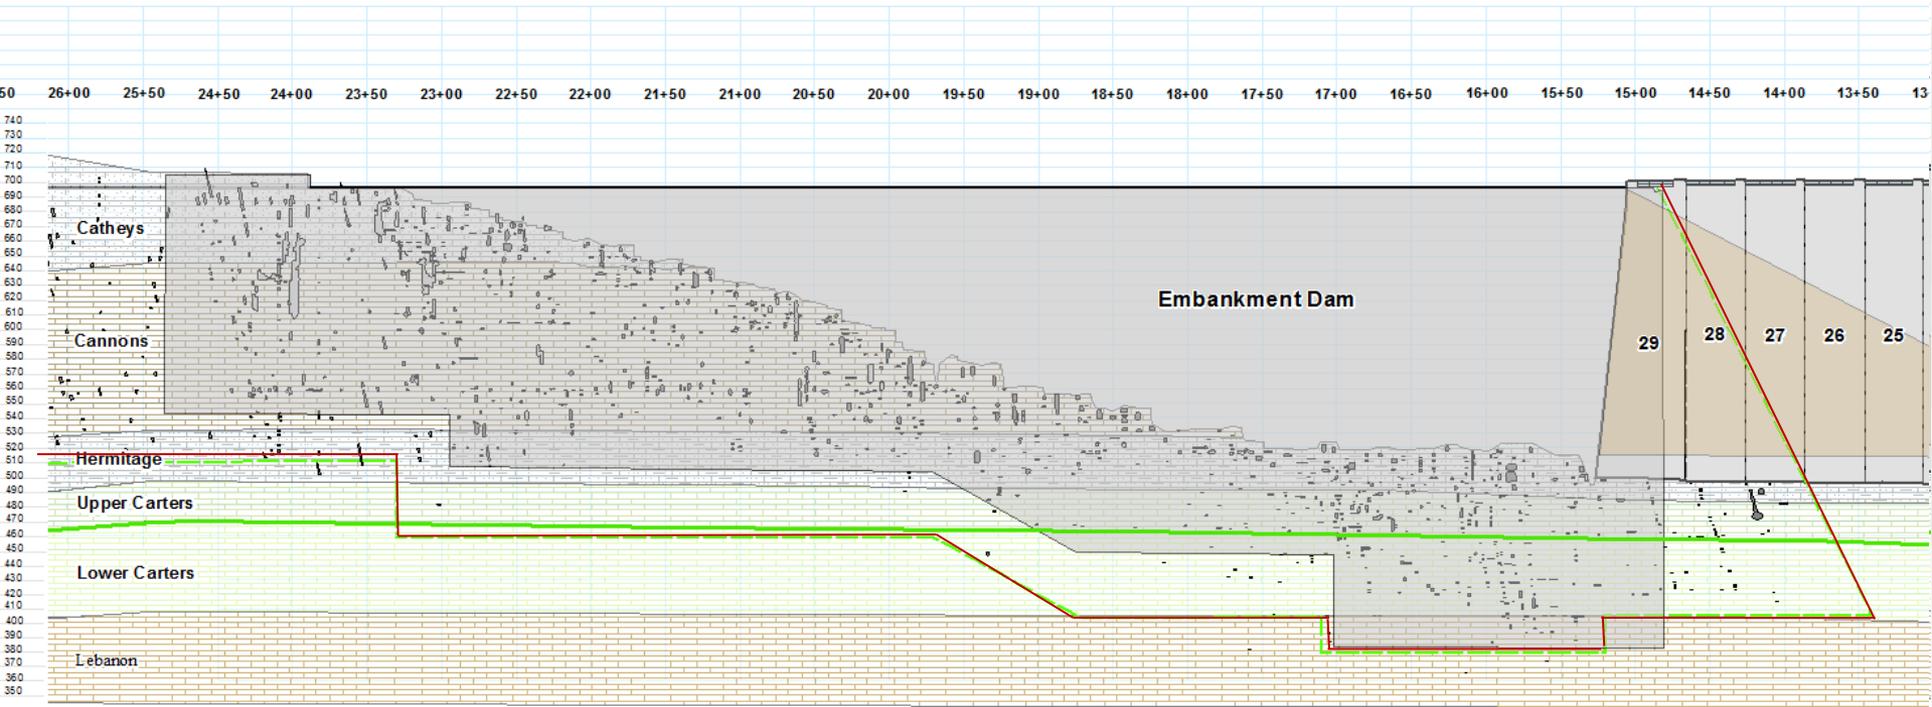
Grouting and Barrier Wall

Profile View – Looking DS

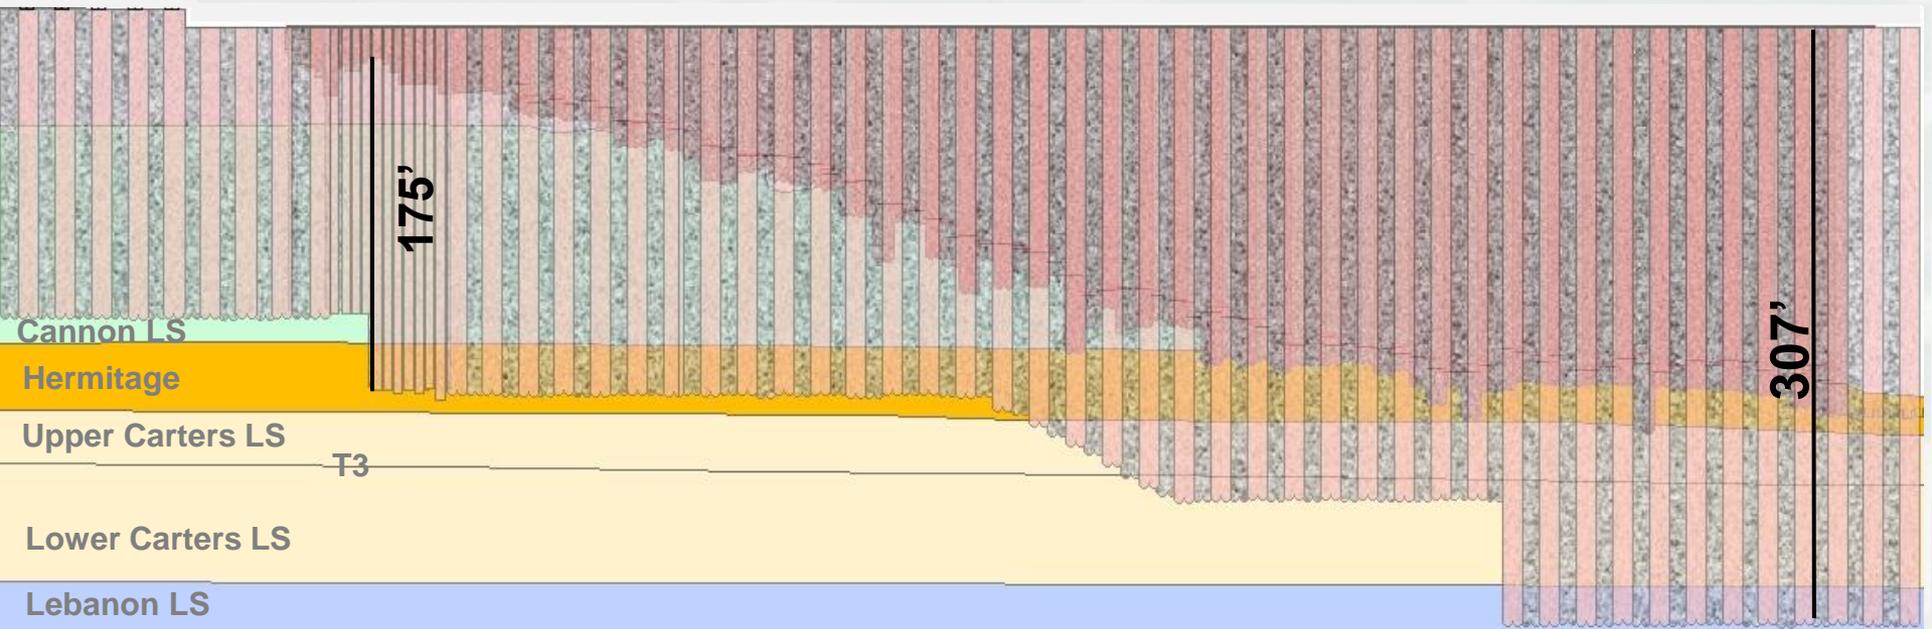
Barrier Wall Geometry

Profile View – Looking DS

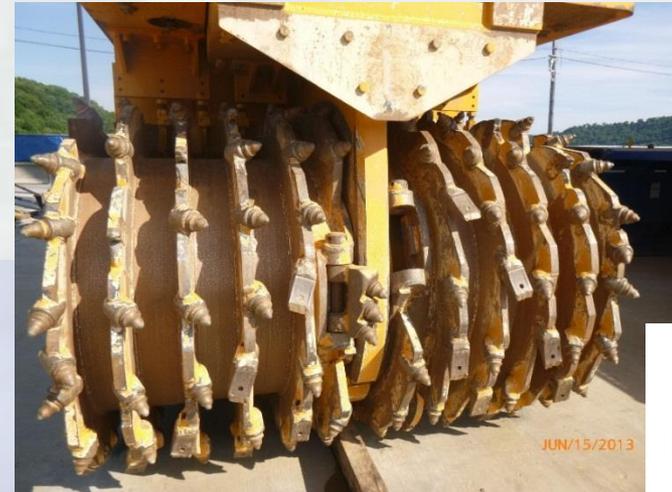
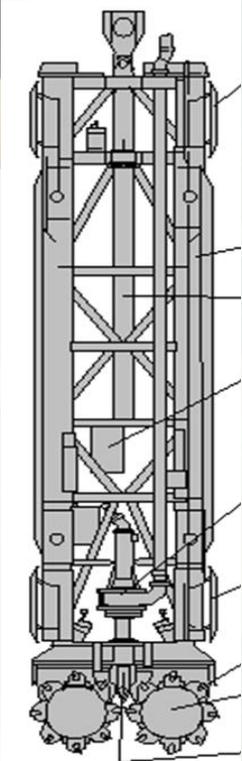
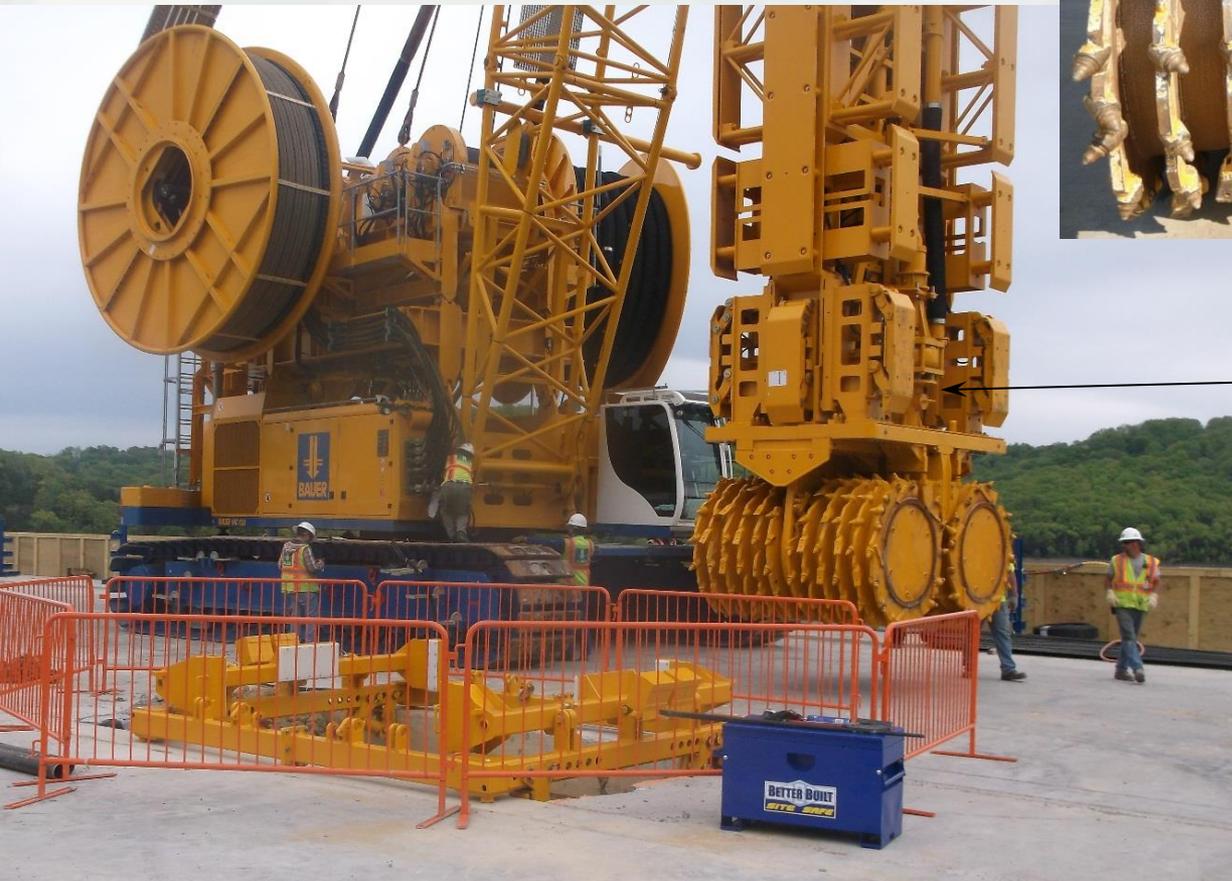
Wall Excavation-BC50 Cutter

Cutter head fitted with rock picks and soil cutters

Pump for slurry circulation and removal of cuttings

Onboard instrumentation (inclinometers) for monitoring orientation

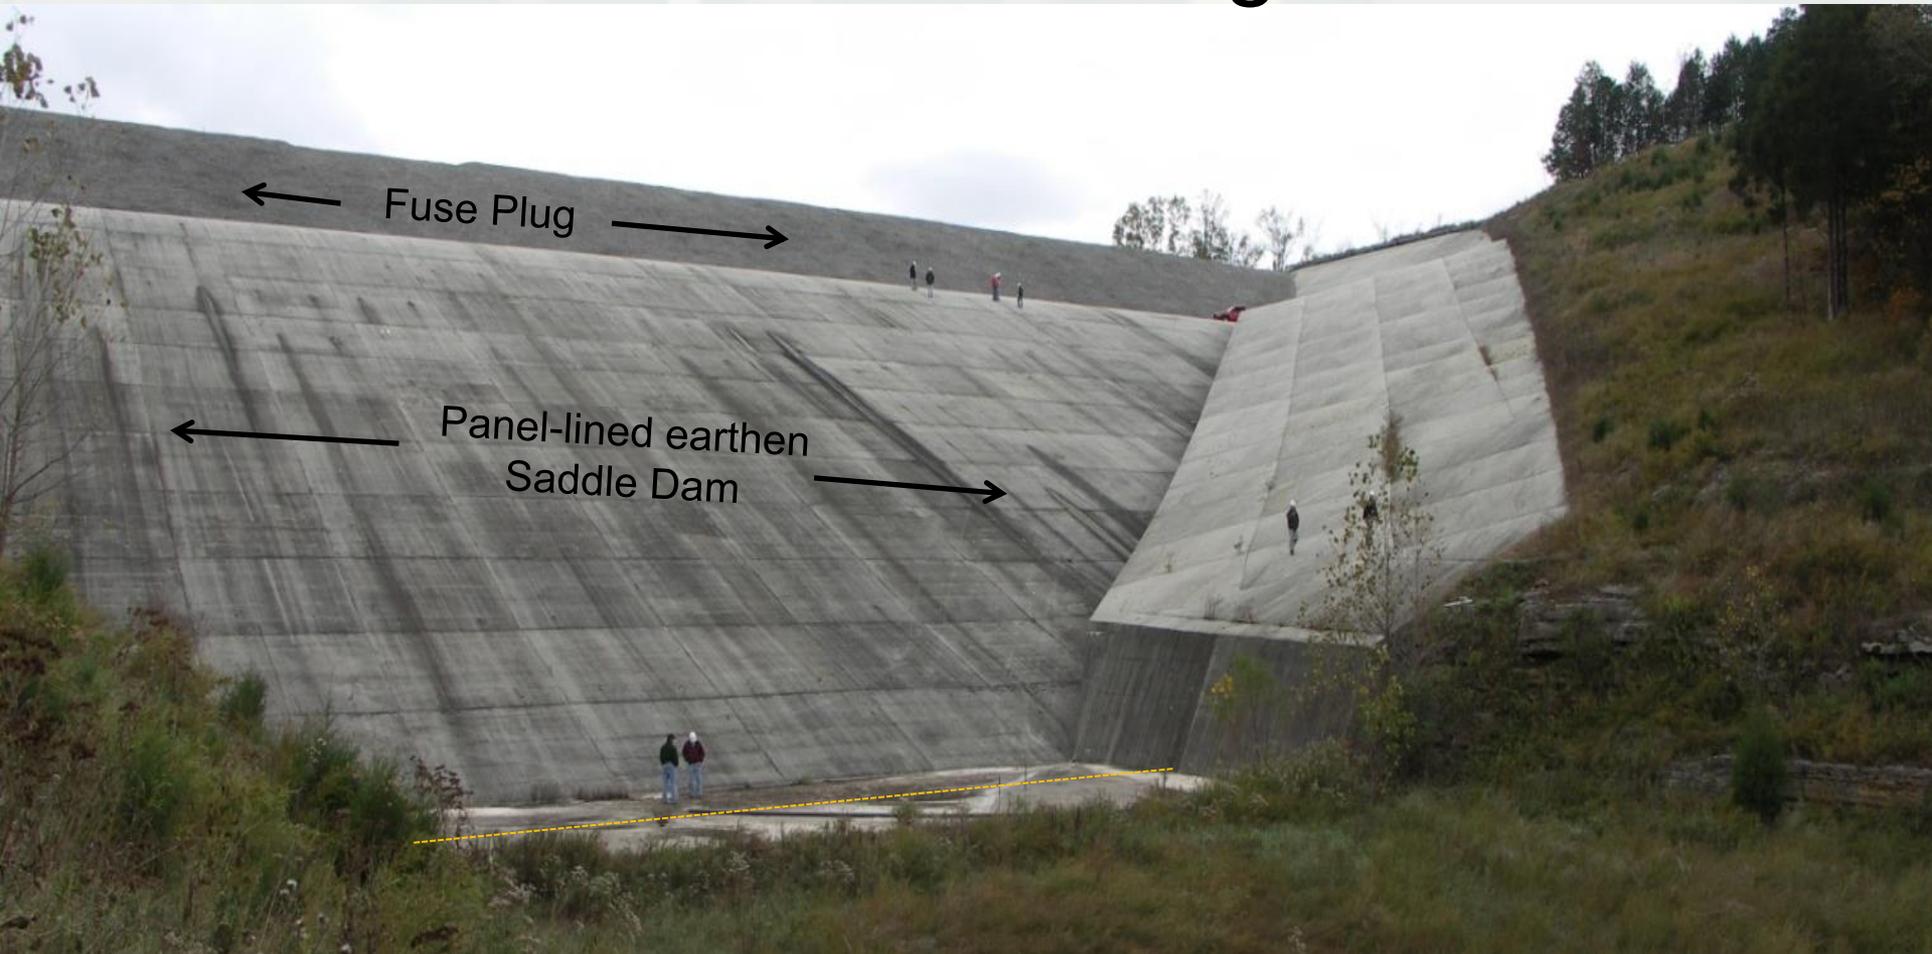
Existing Saddle Dam and Fuse Plug

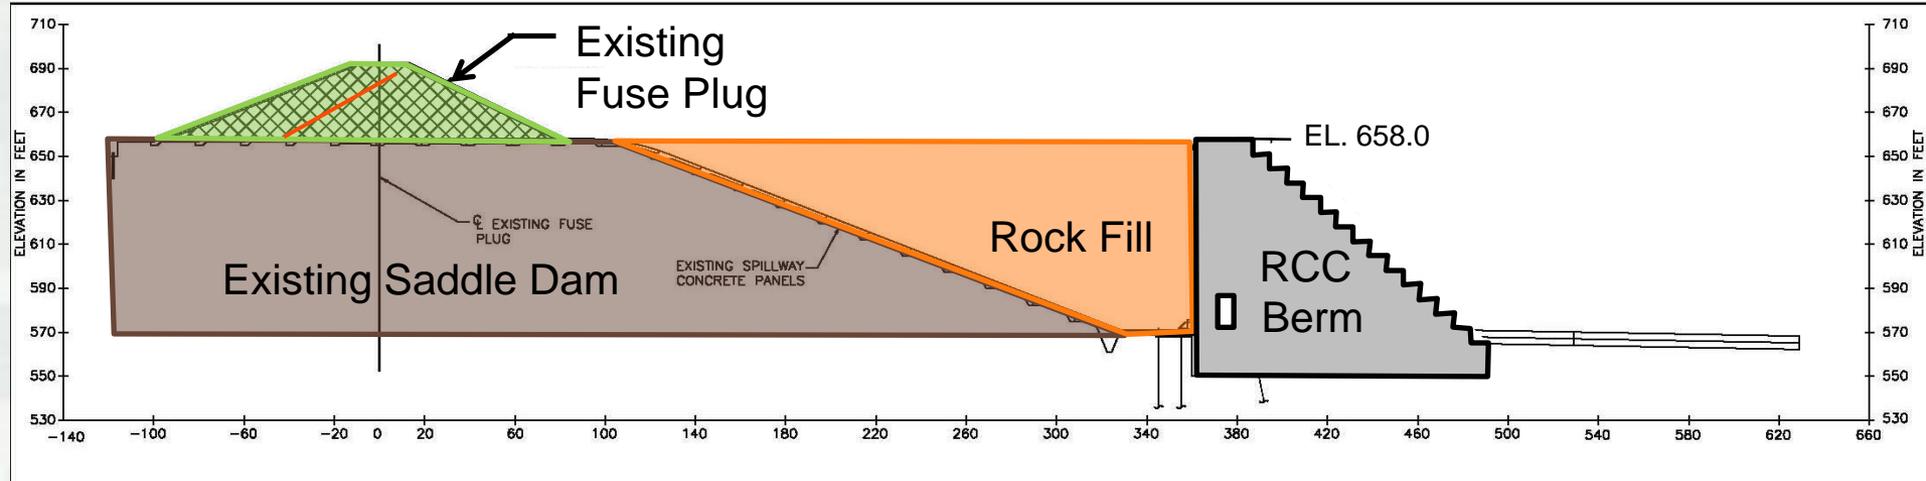
RCC Berm at Saddle Dam

Section View
