PROJECT ID: ES166

POST-TEST ANALYSIS OF LITHIUM-ION BATTERY MATERIALS

DOE Annual Merit Review
Washington, DC, June 8, 2016

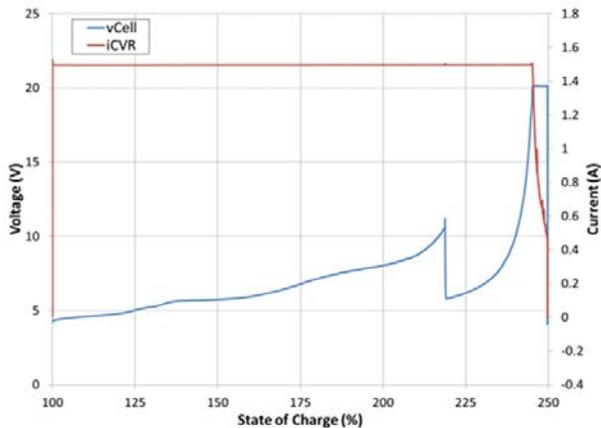
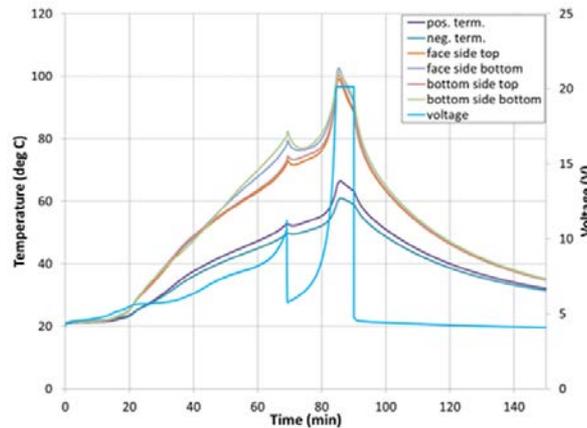
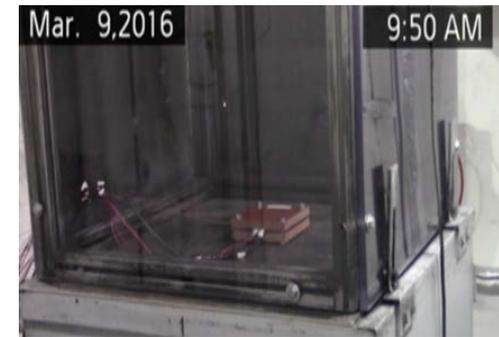
Cell runaway observed just below 250% SOC
No visual abuse response observed, only audible indication
Ensure safety for handling at SOC < 200% (Planned evaluations)

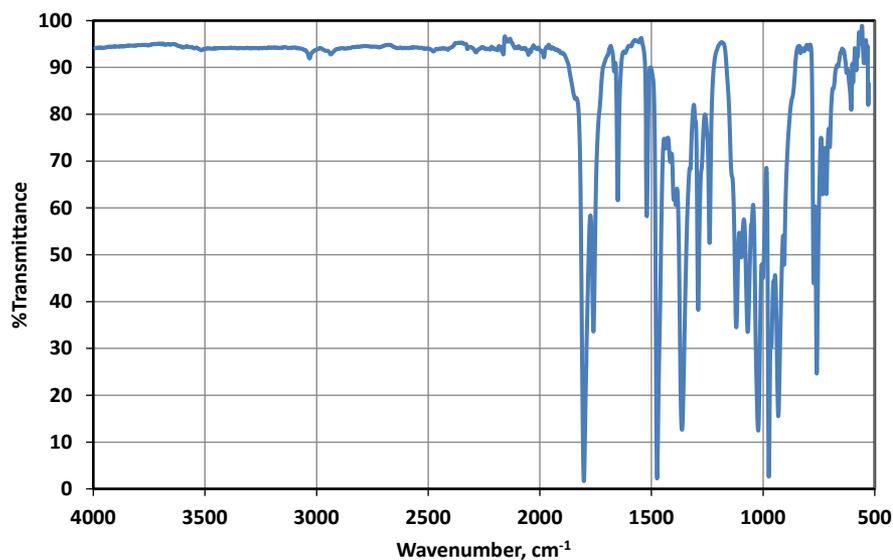
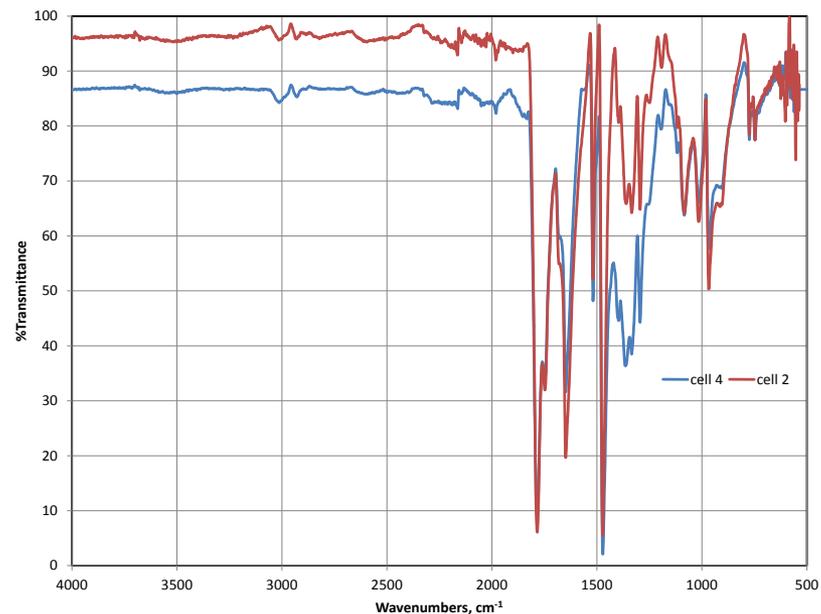
Example: FT-IR shows changes in thermally-abused cell

Salt before

cell anodes after thermal abuse

- Scoping experiments to determine what types of changes to expect and how to detect them
- Examine fate of $(C_6F_5)B(\text{oxalate})\text{-LiF}$ (ABA) containing cells. This additive has show promise to reduce thermal-abuse response and overall energetic output of a cell undergoing runaway

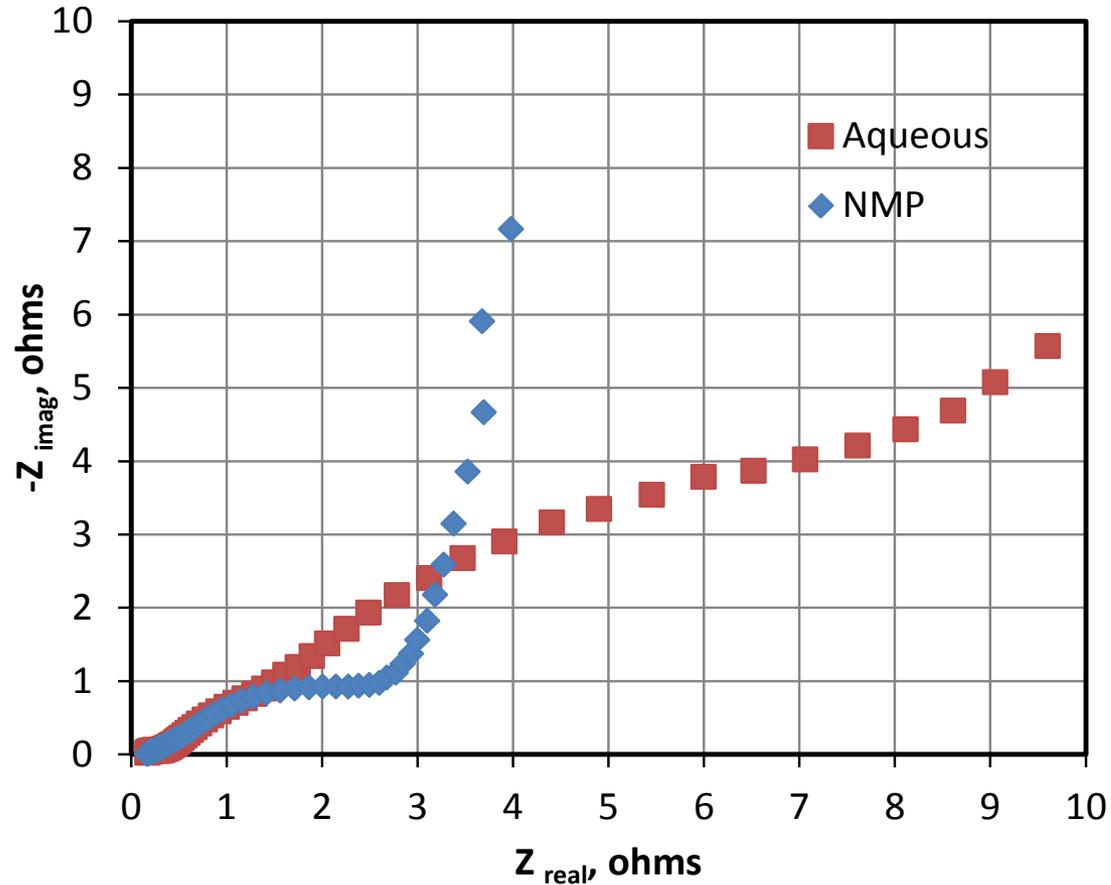
CELL IMPEDANCE (EIS) IS DEPENDENT ON BINDER

Aqueous process results in higher impedance

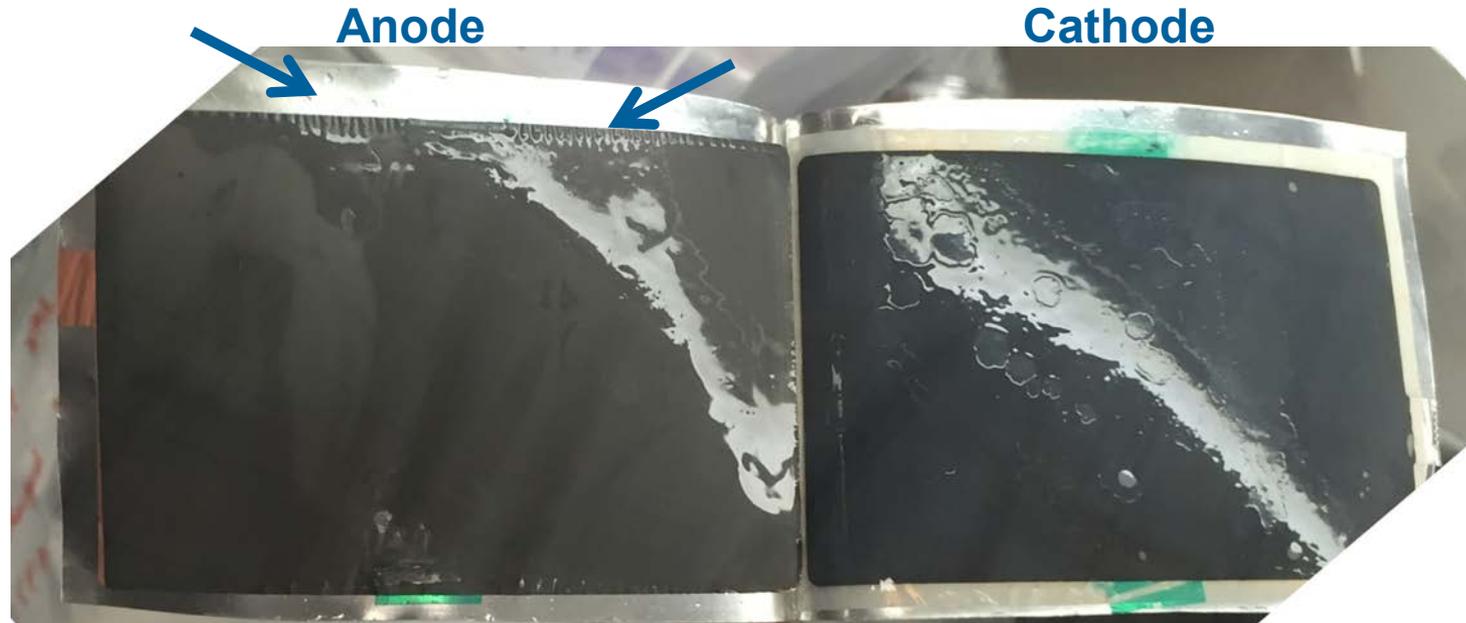
NMP-based

INITIAL INSPECTION SHOWS MANUFACTURING ISSUES (I)

- Electrodes appear fully wet. No signs of electrolyte exhaustion
- Signs of stress-induced delamination (rippling) on edges of anode

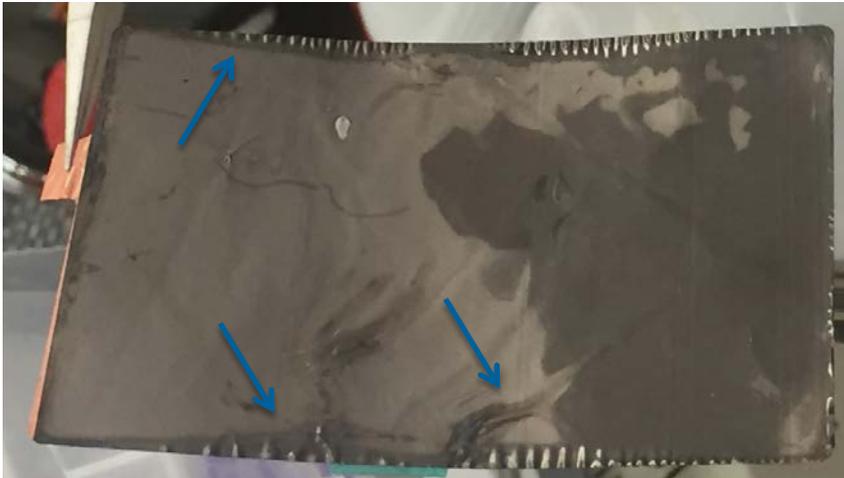
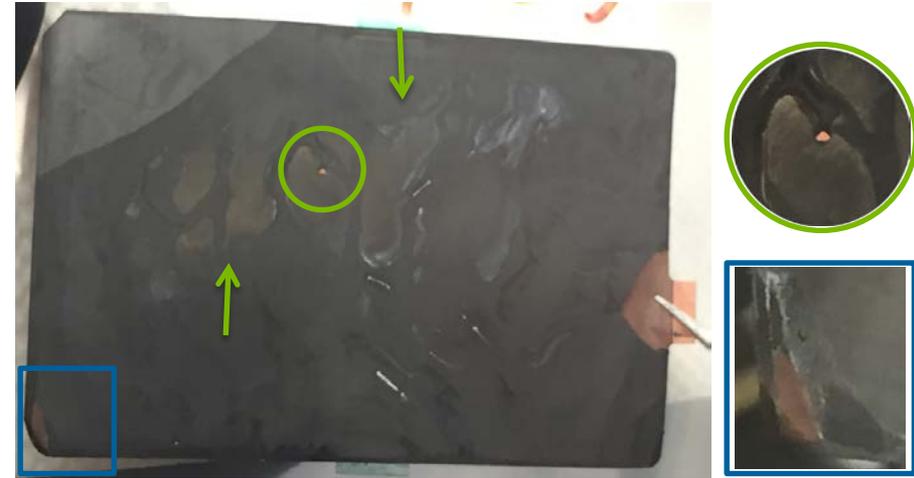
Anodes

NMP-based

Aqueous process

- Signs of stress-induced delamination (rippling) on edges of anode
- Possible pin hole formation during aqueous process

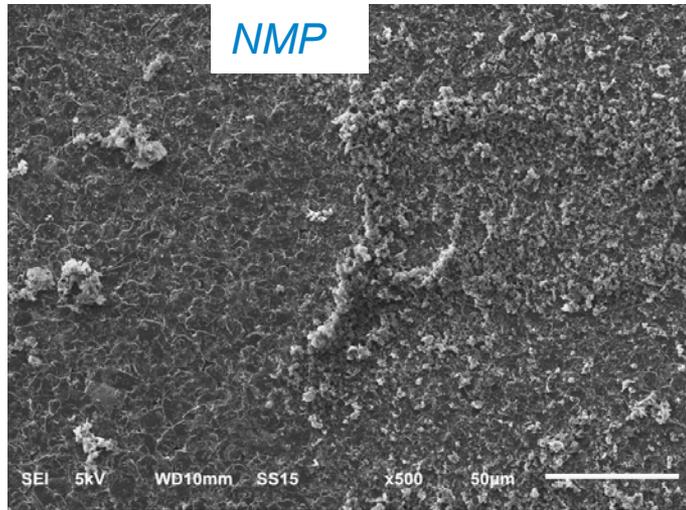
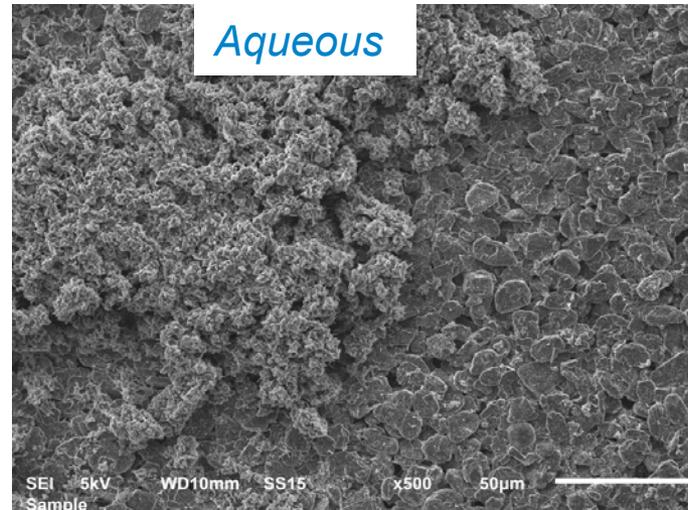
Anodes

Precipitates richer in F, and P than exposed particles

Composition differences more prominent in aqueous electrodes

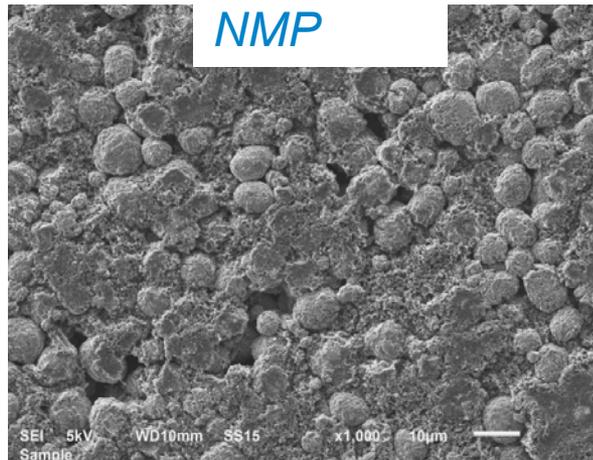
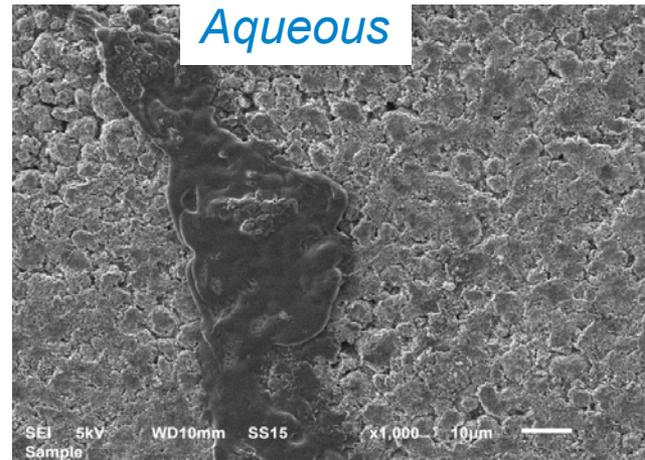
Cathodes

On NMP-based, F only at precipitates

Aqueous has more F. Concentrated at precipitates, but also present on particles

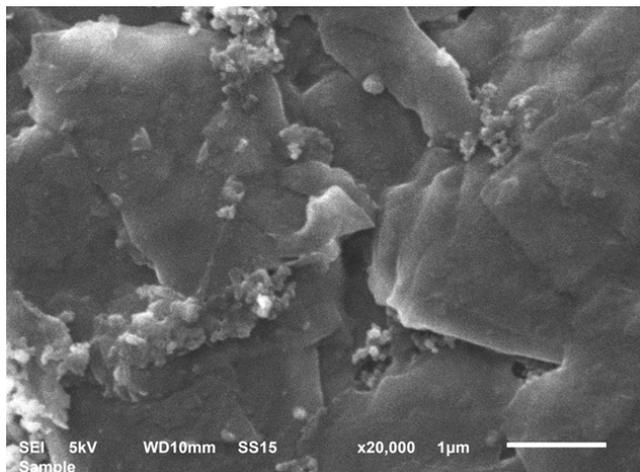
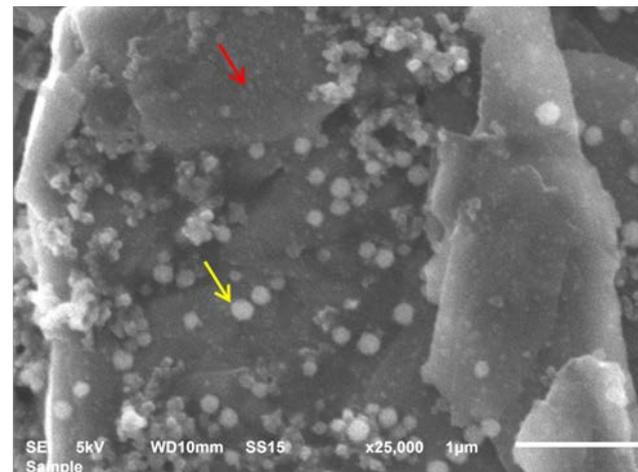
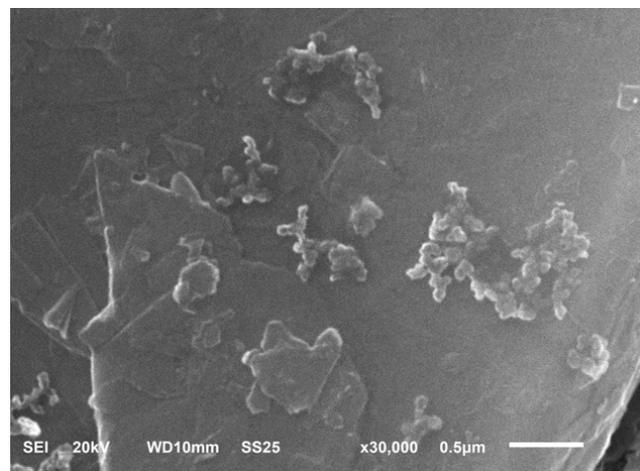
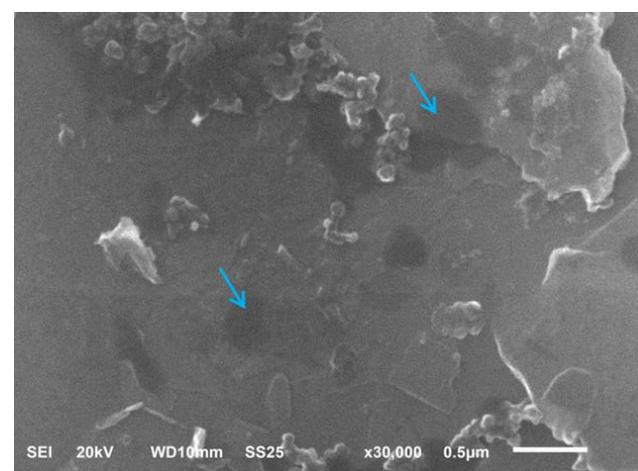
BINDER AFFECTS PRECIPITATES

Round precipitates and “stains” on aqueous processed anode

NMP

Aqueous

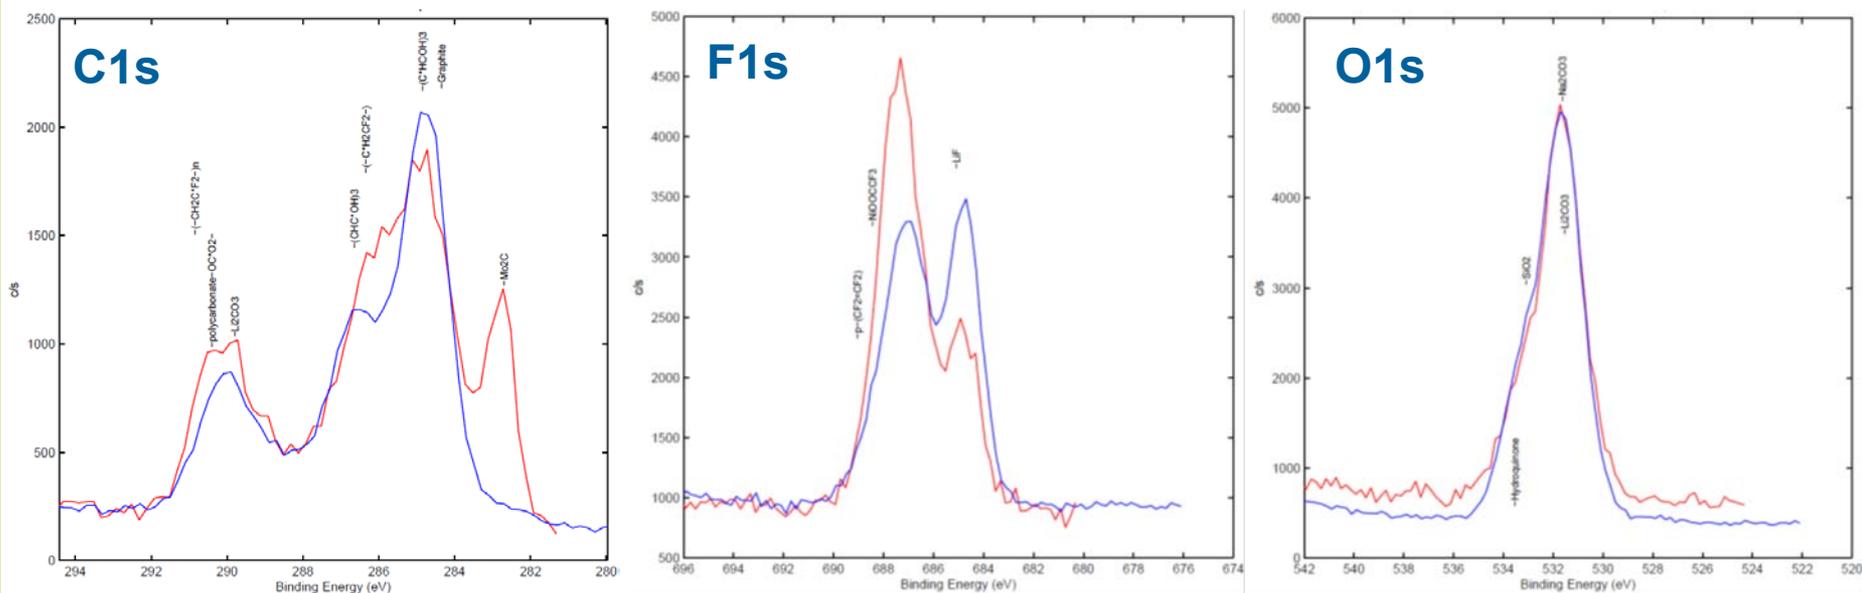
BINDER AFFECTS NATURE OF SEI

Differences in C and F structure between aqueous and NMP anodes

Aqueous anode

NMP-based anode

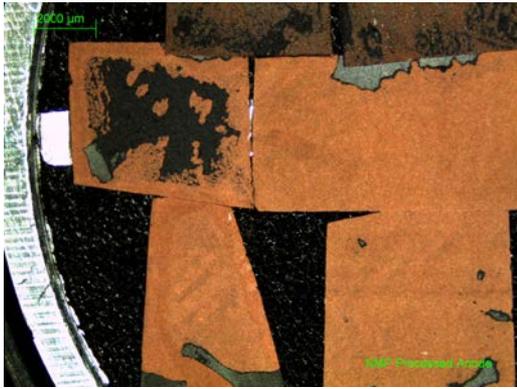
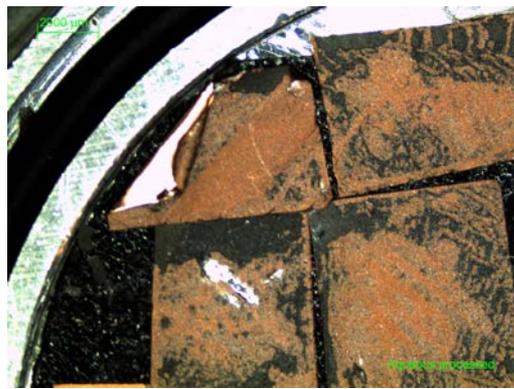
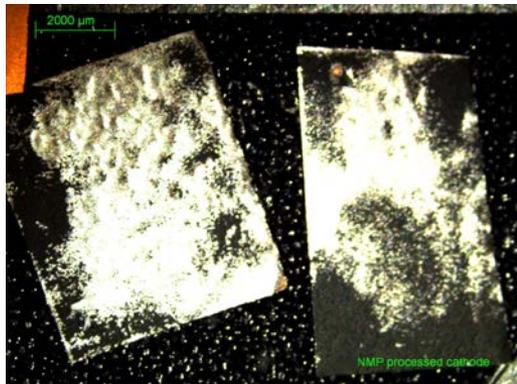
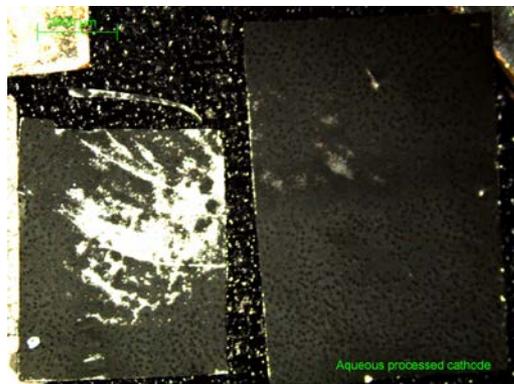
BINDERS DISPLAY DIFFERENT LEVELS OF ADHESION

- ‘Scotch’ tape used to test adhesion
- Aqueous processed coatings have better adherence to the collector than the NMP processed cell
- In the NMP processed anode, the coating was completely lifted with minimal effort
- In the aqueous processed anode, residual coating stuck to the collector after multiple strippings

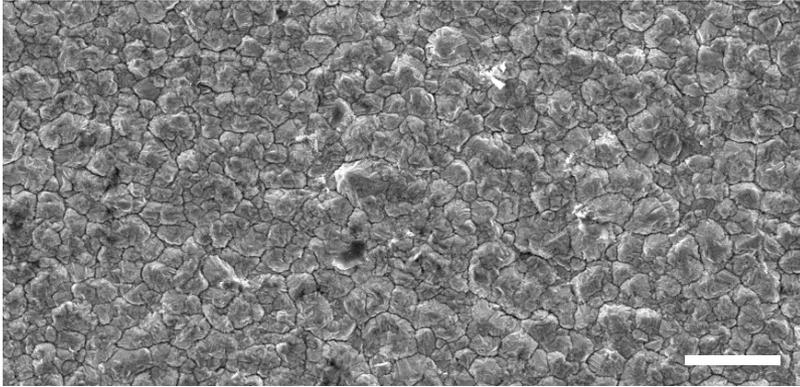
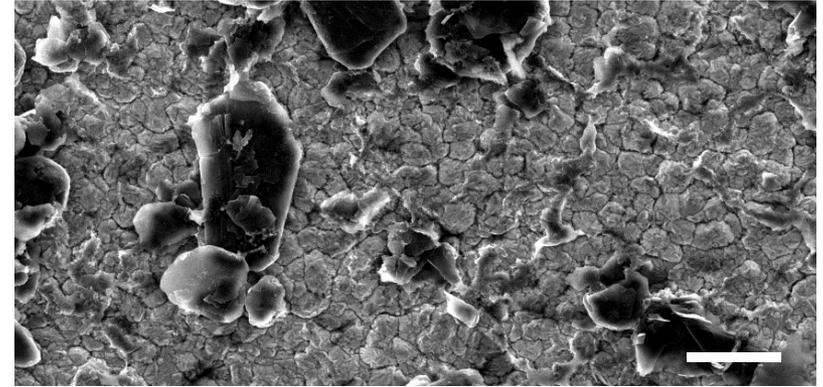
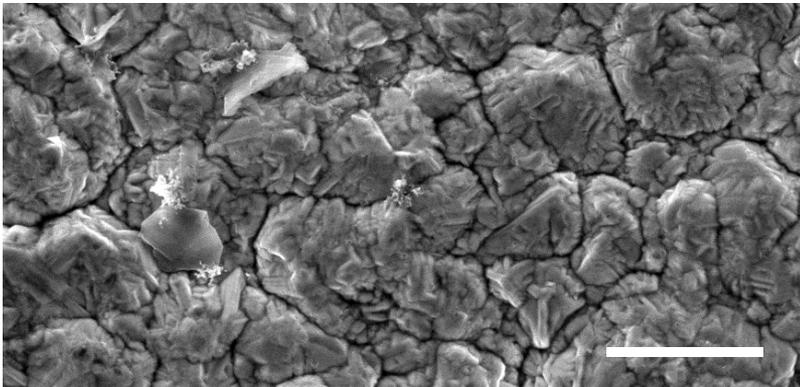
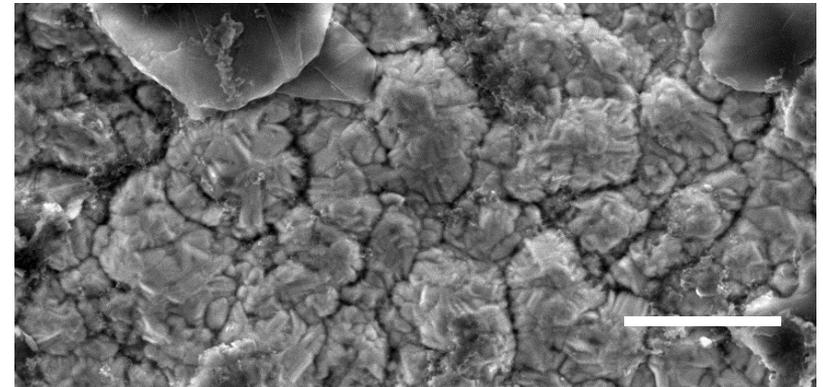
Extensive grain boundary corrosion in both electrodes (!)

NMP-based 10 μm scale bar

Aqueous process 10 μm scale bar

NMP-based 5 μm scale bar

Aqueous process 5 μm scale bar

- Grain boundary corrosion does not appear to be sensitive to binder type
- What caused corrosion in minimally-aged cells?
- Is some part of the fabrication process, common to both, the cause of the observation?
- Are the electrolyte/electrode interacting to cause the corrosion?
- To understand the underlying phenomenology, perform systematic experiments
- Fabricate and characterize Cu foil from --
 - Pristine anode (just fabricated)
 - Anode that has seen cell chemistry, but has not been cycled/formed
