# Materials Issues Associated with EGR Systems

Michael J. Lance

Oak Ridge National  
Laboratory

Project ID# PM009

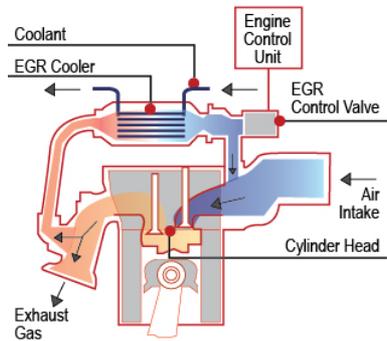
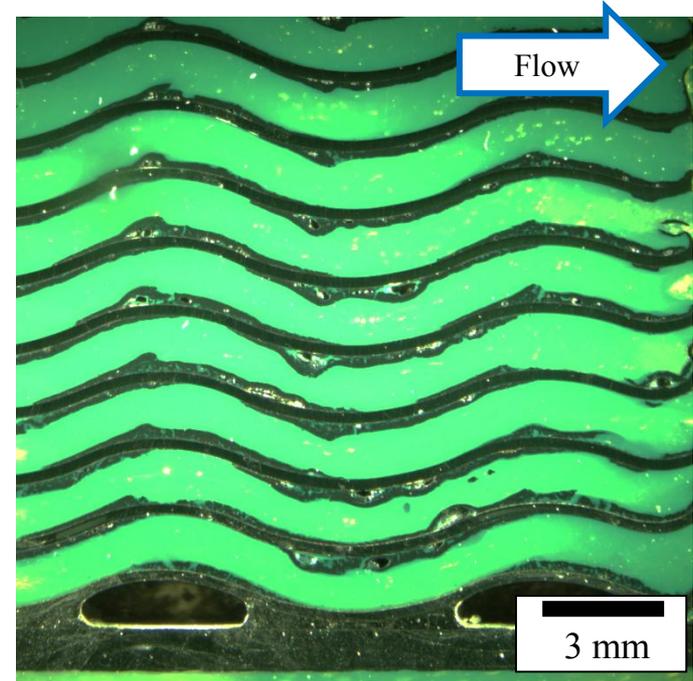
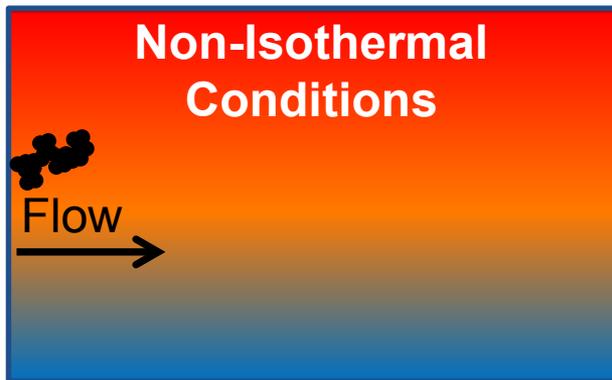
Industry-Provided Fouled EGR Cooler

- EGR cooler fouling occurs when the particulate matter (PM) and hydrocarbon (HC) in the exhaust gas deposits onto the walls of the EGR cooler through thermophoresis and condensation.
- The resulting deposit has a very low thermal conductivity which reduces the effectiveness of the EGR system.
- The deposit also narrows the channels which increases the back pressure.

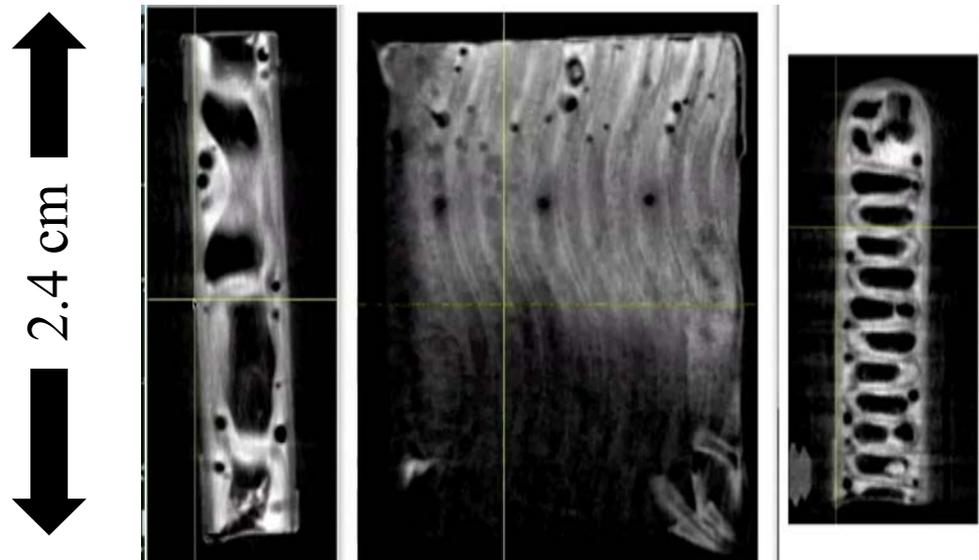
Lacquer-like Deposit

- Deposits that contained a lot of hydrocarbon could be imaged using neutron tomography but these deposits aren't affected much by the cooler geometry and are relatively rare.
- More common are deposits with low (<10 wt%) hydrocarbon which are greatly influenced by the cooler geometry but don't attenuate the neutron beam enough to be detected.
- Two new approaches for measuring deposit thickness have been developed in order to probe the interaction between deposition and cooler geometry.

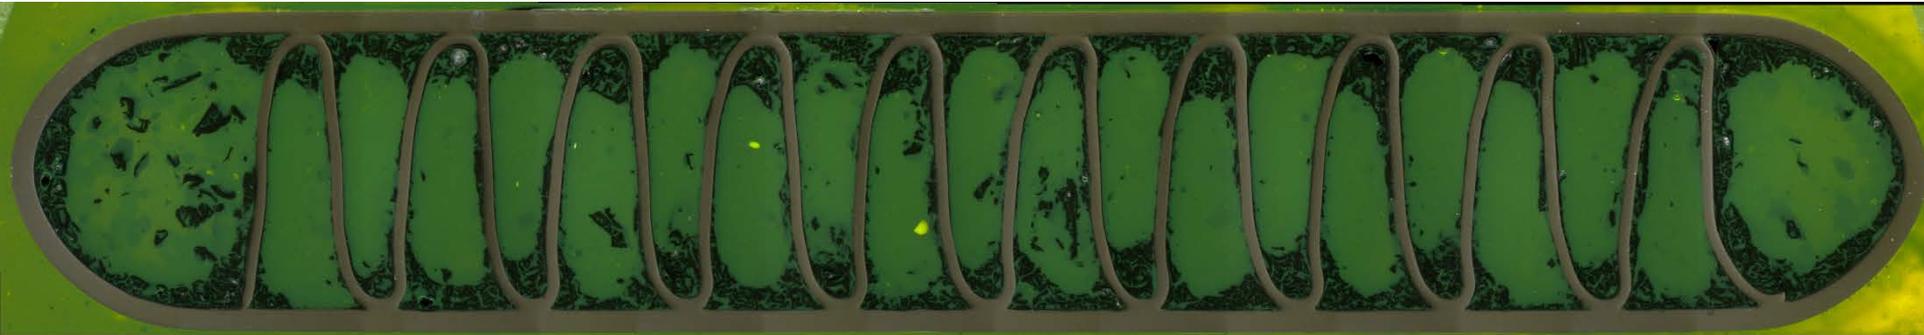
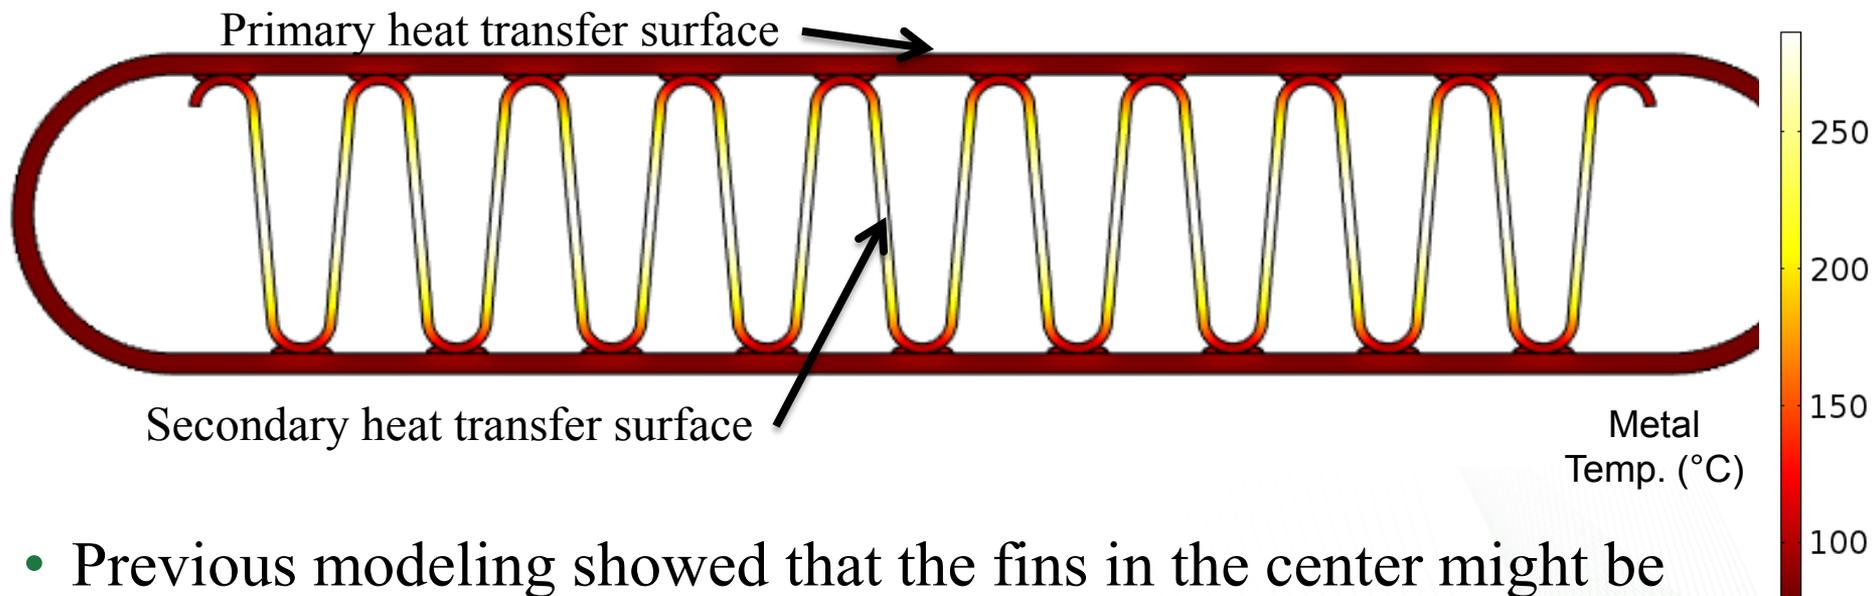
# Technical Accomplishment: Variations in the deposit thickness were observed across the tube width.

- Previous modeling showed that the fins in the center might be hotter than the outer surface which is in contact with the coolant.

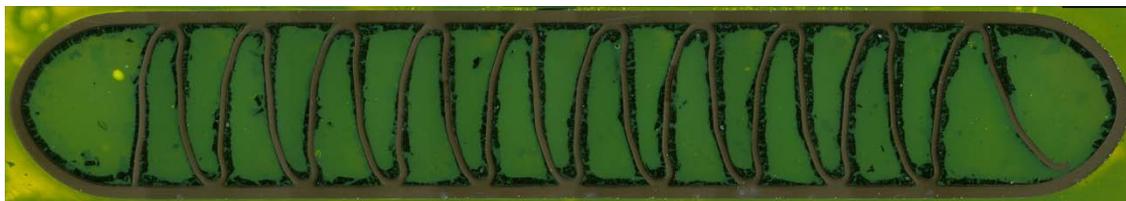
Samples were cut and mounted in epoxy to show the cross-section of the EGR tube. A fluorescent dye was added to the epoxy to enhance the contrast with the deposit.

Original image.

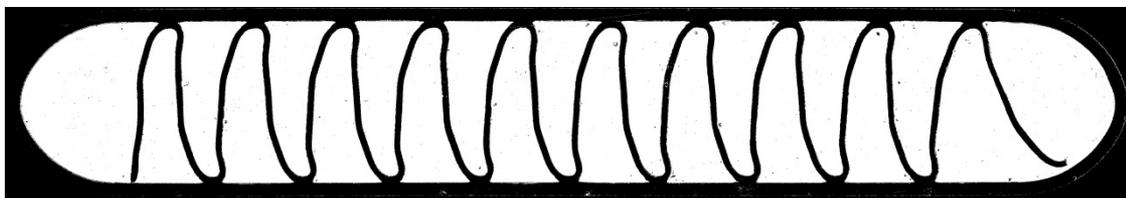
The image was thresholded to measure the areas of empty space and deposit for each sample.

Total empty space thresholded.

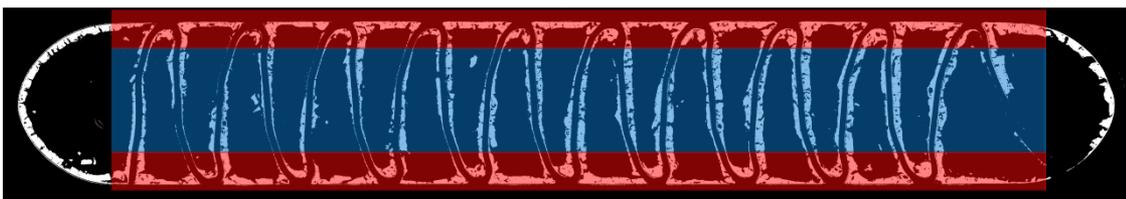
The deposit area on the primary surface (**outer tube**) was then separated from the deposit area on the secondary surface (**inner fins**).

Deposit thresholded.

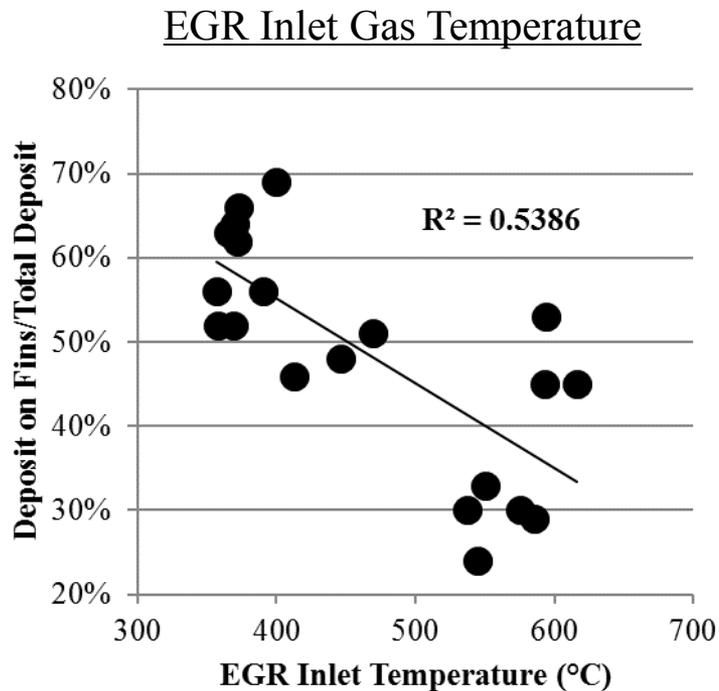
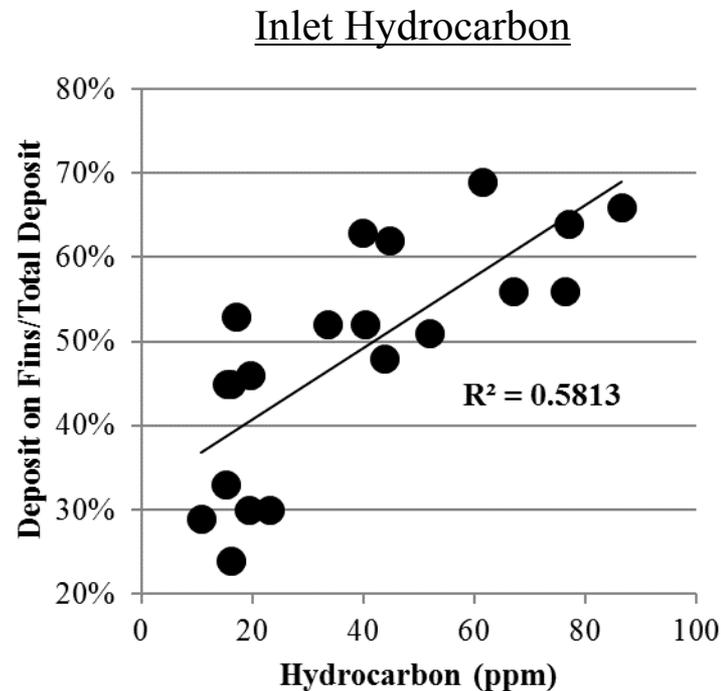
# Technical Accomplishment: Two engine operating conditions strongly influenced how much deposit formed on the fins.

- At low inlet gas temperatures, the deposit thickness was uniform throughout. At high inlet gas temperatures the deposit is thinner on the fins due to higher metal wall temperatures which reduces thermophoresis.
- Increasing the inlet hydrocarbon content may enhance the stickiness of the metal fin causing an increase in the deposit thickness.

As inlet gas temperatures increase, the fins become hotter than the coolant resulting in less heat transfer but also less deposit formation. Much of the EGR cooler surface area may be well above the coolant temperature.

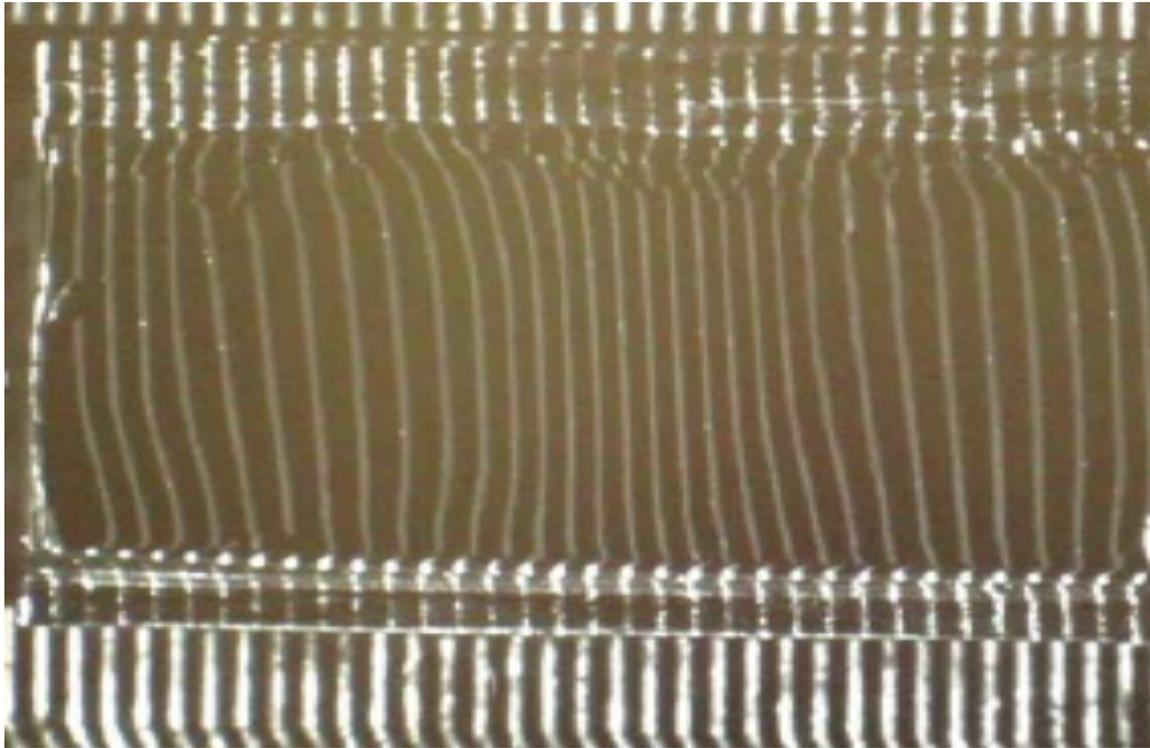
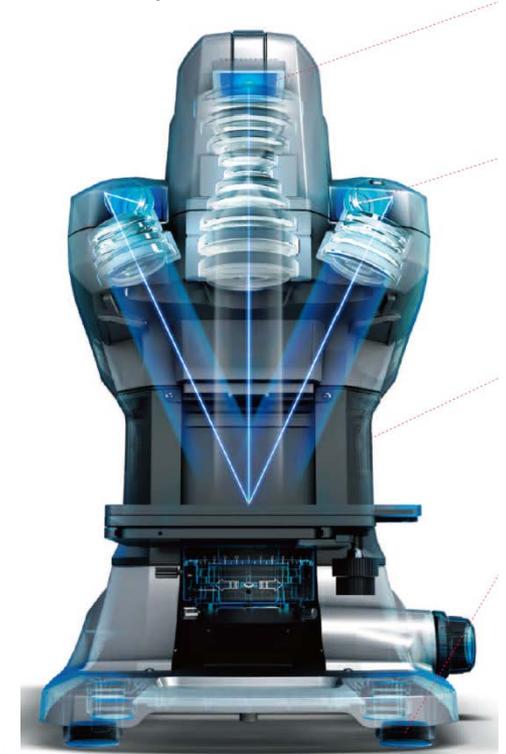
Keyence VR-3000

Technical Accomplishment: A new optical profilometer was used to collect 3D images of the undisturbed deposit surface.

- “Structured” light is illuminated on the surface and the microscope uses trigonometry to calculate surface height to a  $\sim 1 \mu\text{m}$  resolution.

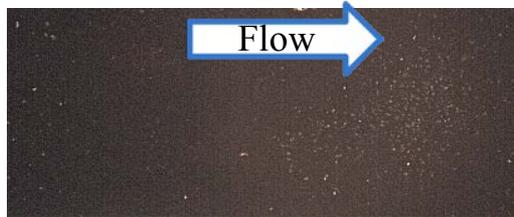
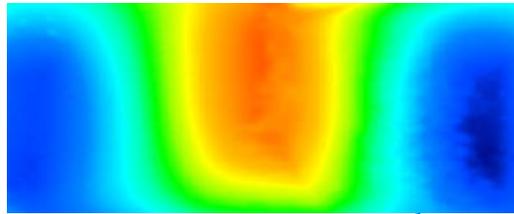
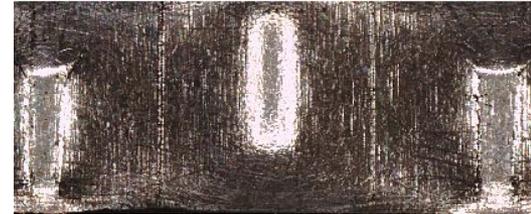
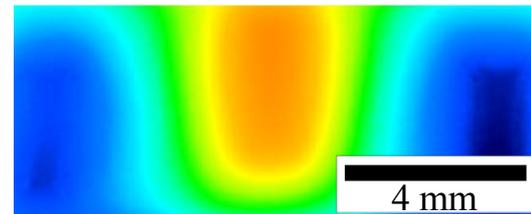
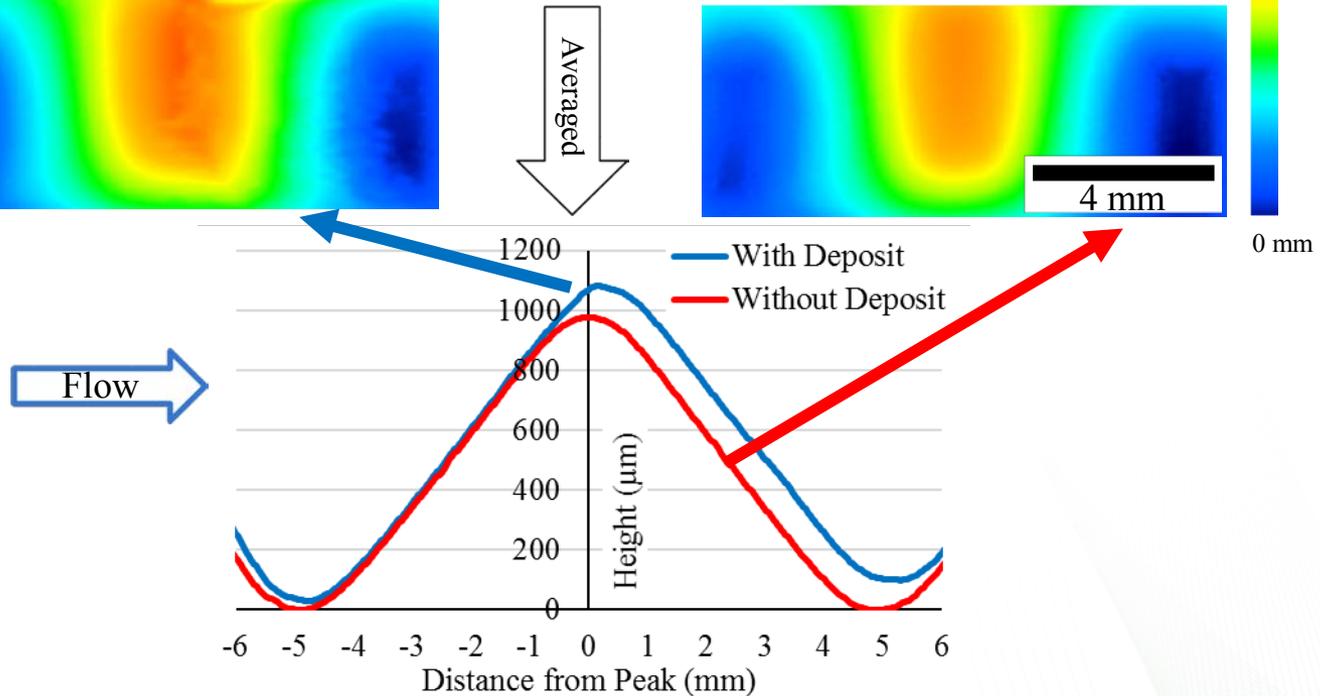
# Technical Accomplishment: Collecting 3-D images before and after the deposit is removed allowed for the measurement of thickness with respect to the fin geometry.

- The true deposit thickness is determined across one entire wavelength of the fin.

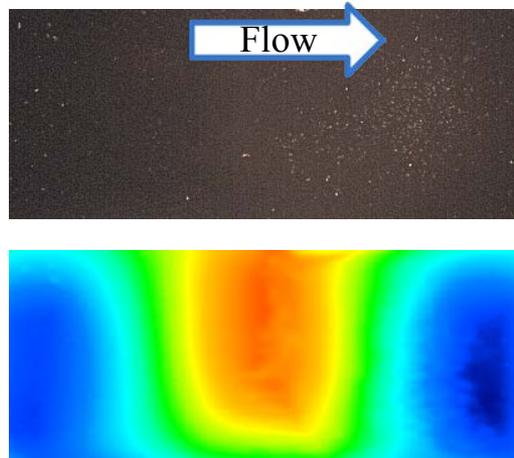
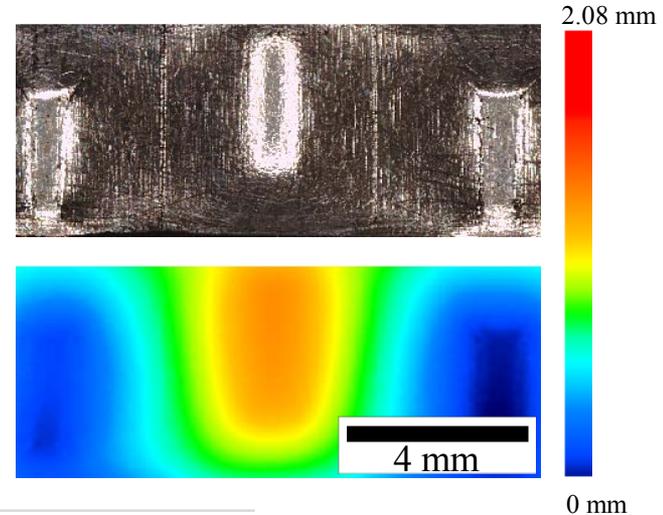
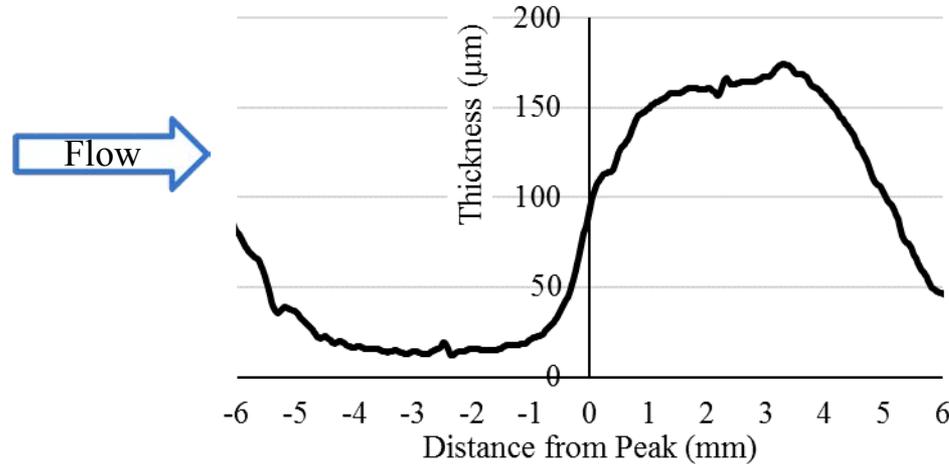
# Technical Accomplishment: Collecting 3-D images before and after the deposit is removed allowed for the measurement of thickness with respect to the fin geometry.

- The true deposit thickness is determined across one entire wavelength of the fin.

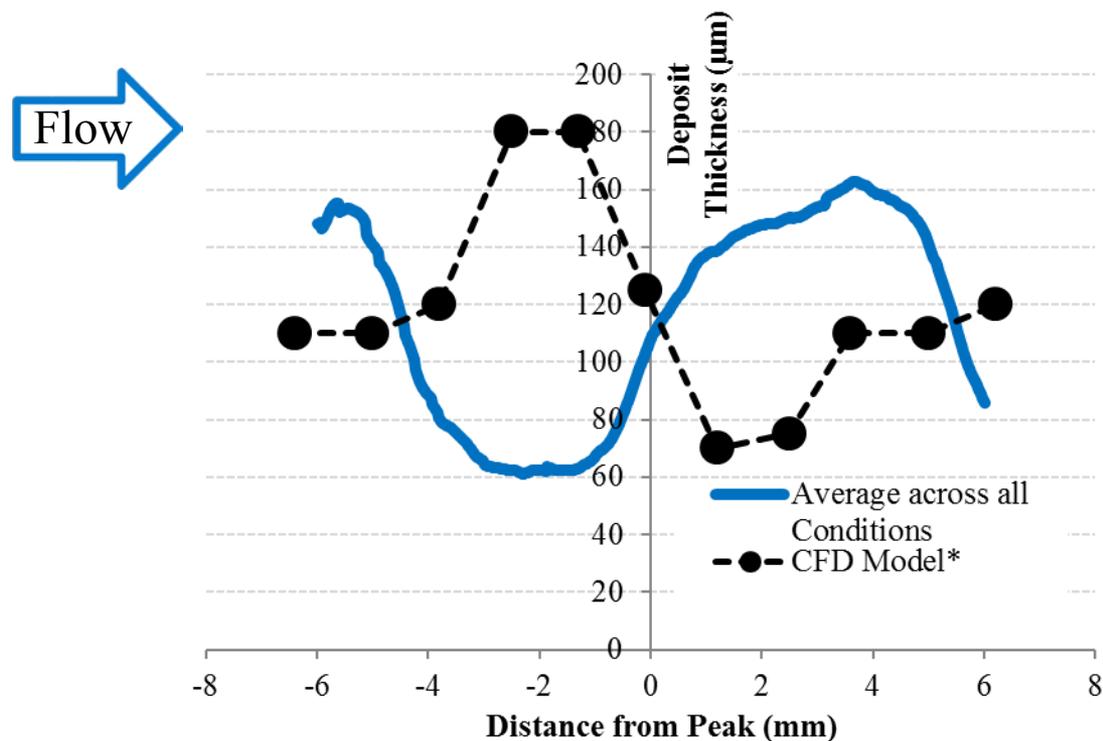
## Technical Accomplishment: Thickness measurements contradicted the predicted location of deposits based on CFD modeling.

- Modeling shows that the exhaust gas impacts the upstream side of the fin leading to a thin boundary layer which increases the temperature gradient and hence thermophoretic deposition of PM.
- However, the exhaust gas also creates shear forces on the upstream side of the fin which may lead to lower deposition rates and deposit removal. This was not considered in the CFD model.
- These first ever measurements of deposit thickness on real-world coolers show the importance of considering shear forces and their interaction with cooler geometry in EGR cooler fouling.

Deposit thickness measurements contradicted CFD modeling illustrating the central importance of shear forces and cooler geometry in fouling.

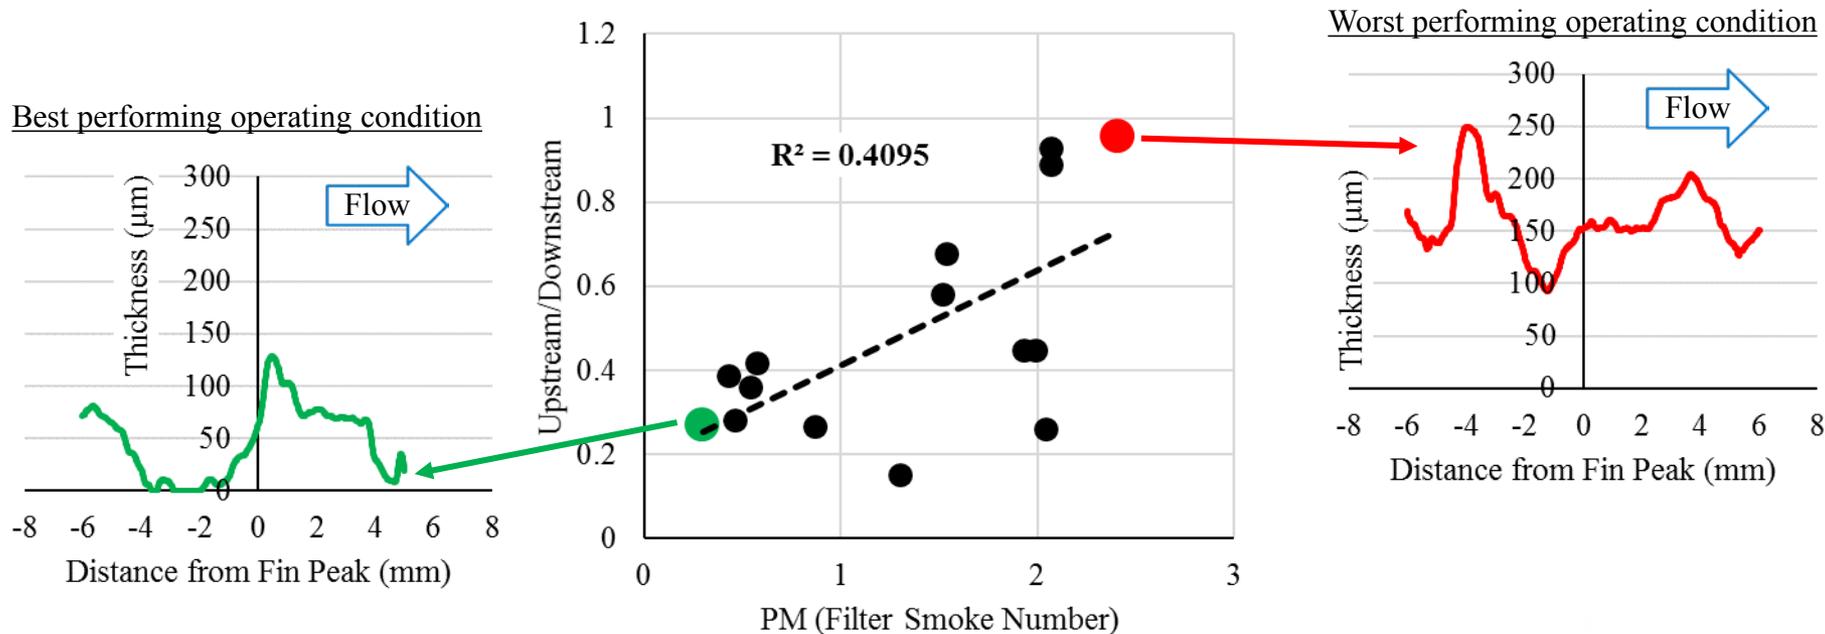
## Thickness on upstream side/thickness on downstream side

# Technical Accomplishment: The PM level was the only engine operating condition that significantly affected the deposit location along the flow direction

- The downstream migration of the deposit was determined by taking the ratio of the deposit thickness on the upstream side by the downstream side.
- The lowest PM condition had almost no deposit on the upstream side of the fin showing that fouling had hardly occurred there. This cooler also had the lowest pressure drop and highest heat transfer (best performing).
- The deposit that formed under the highest PM condition was uninfluenced by the sinusoidal wave of the fin which shows that with enough soot in the exhaust, the deposition rate exceeds the removal rate and fouling will proceed in an uncontrolled manner. This cooler had the highest pressure drop and lowest heat transfer (worst performing).

Operating conditions that generate high levels of PM will overwhelm beneficial effects the cooler geometry has on deposit removal.

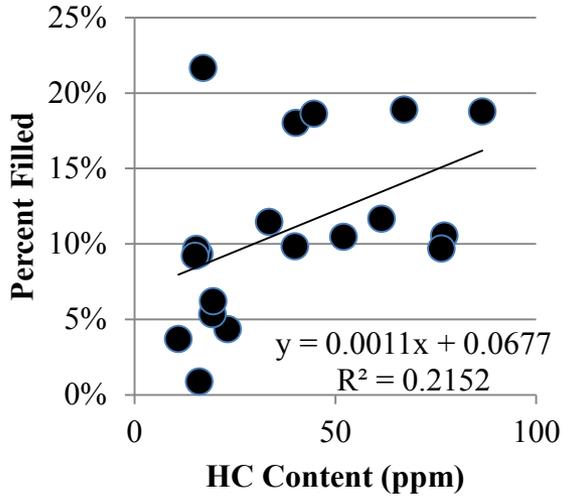
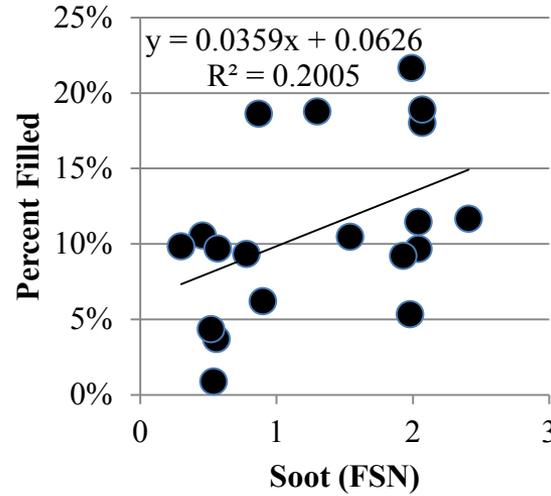
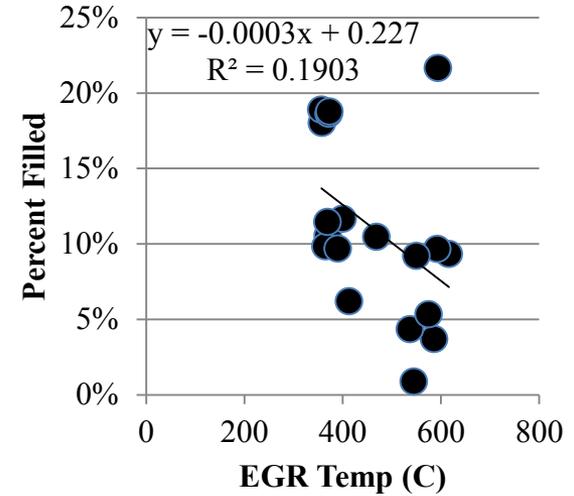
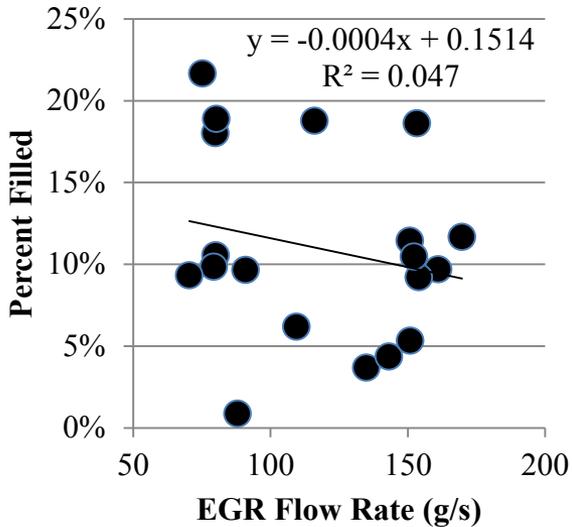
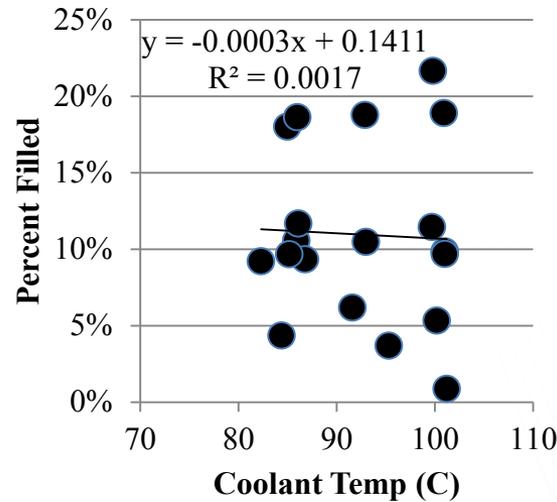
# Technical Accomplishment: Higher HC and Soot increased the total thickness of the deposit.

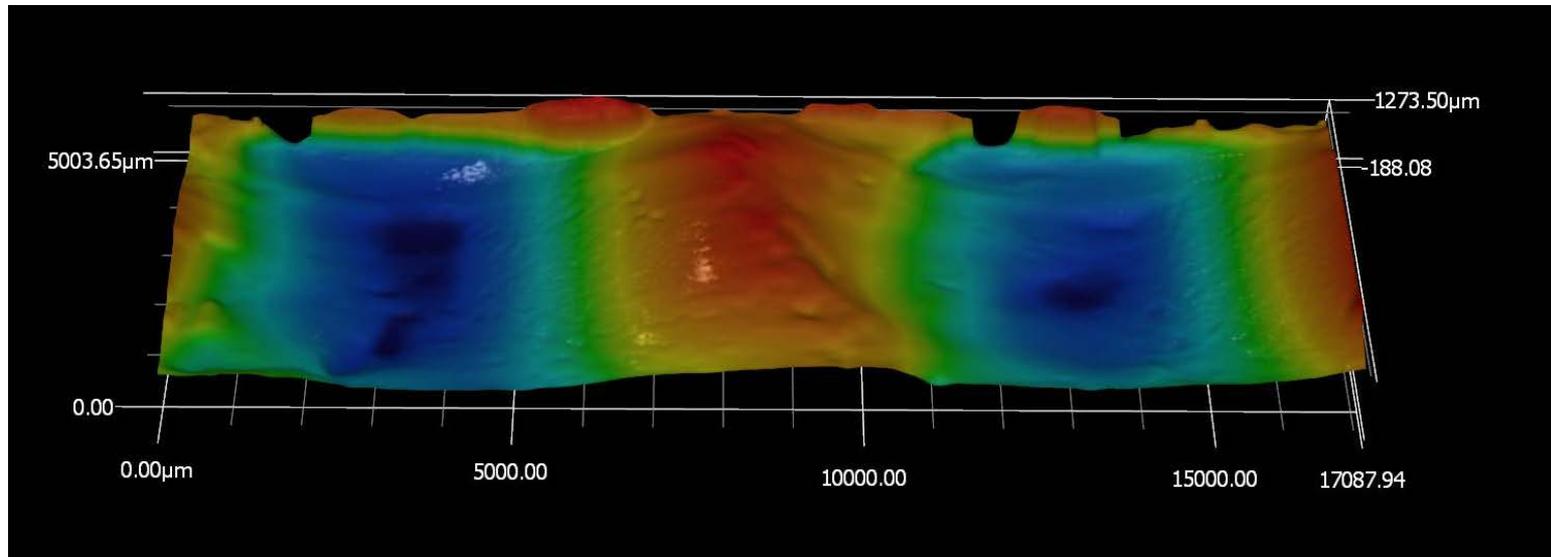
Technical Accomplishment: On the upstream side of the peak there are grooves in the deposit that indicate shear removal has occurred

- The highest heat transfer occurs at the upstream side of the peak where the boundary layer is the thinnest. The CFD model also predicted that the thin boundary layer will result in the most deposition.

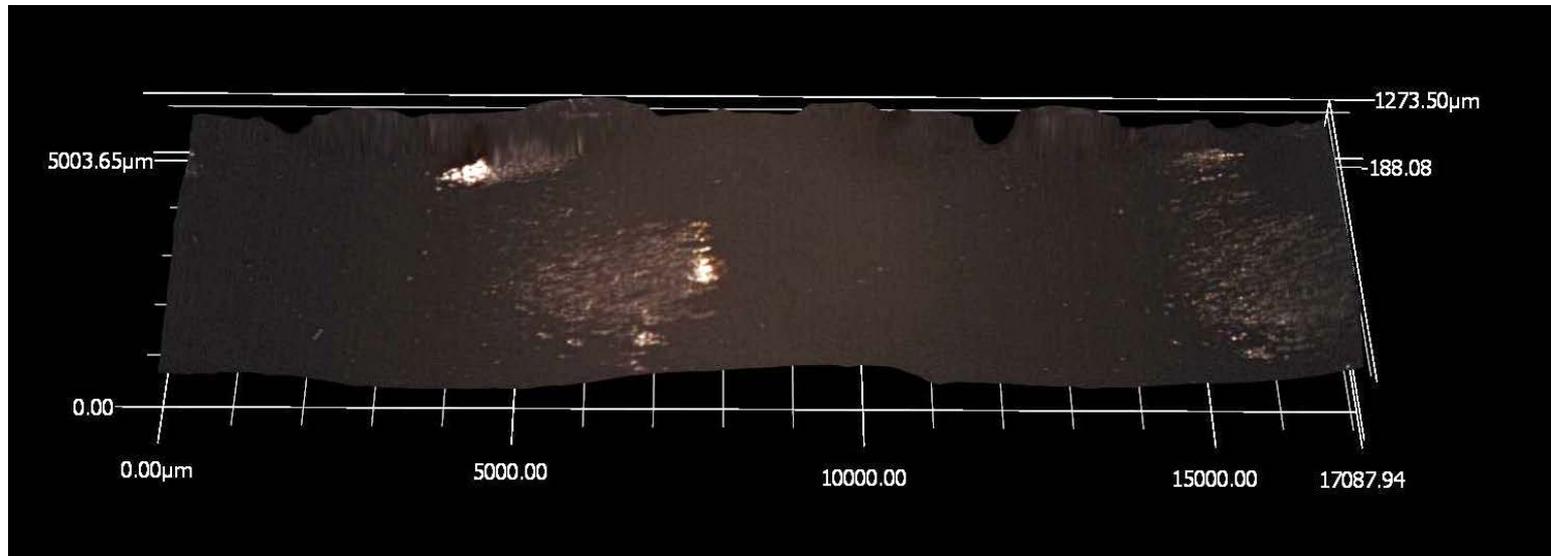
Technical Accomplishment: On the upstream side of the peak there are grooves in the deposit that indicate shear removal has occurred

- The highest heat transfer occurs at the upstream side of the peak where the boundary layer is the thinnest. The CFD model also predicted that the thin boundary layer will result in the most deposition.

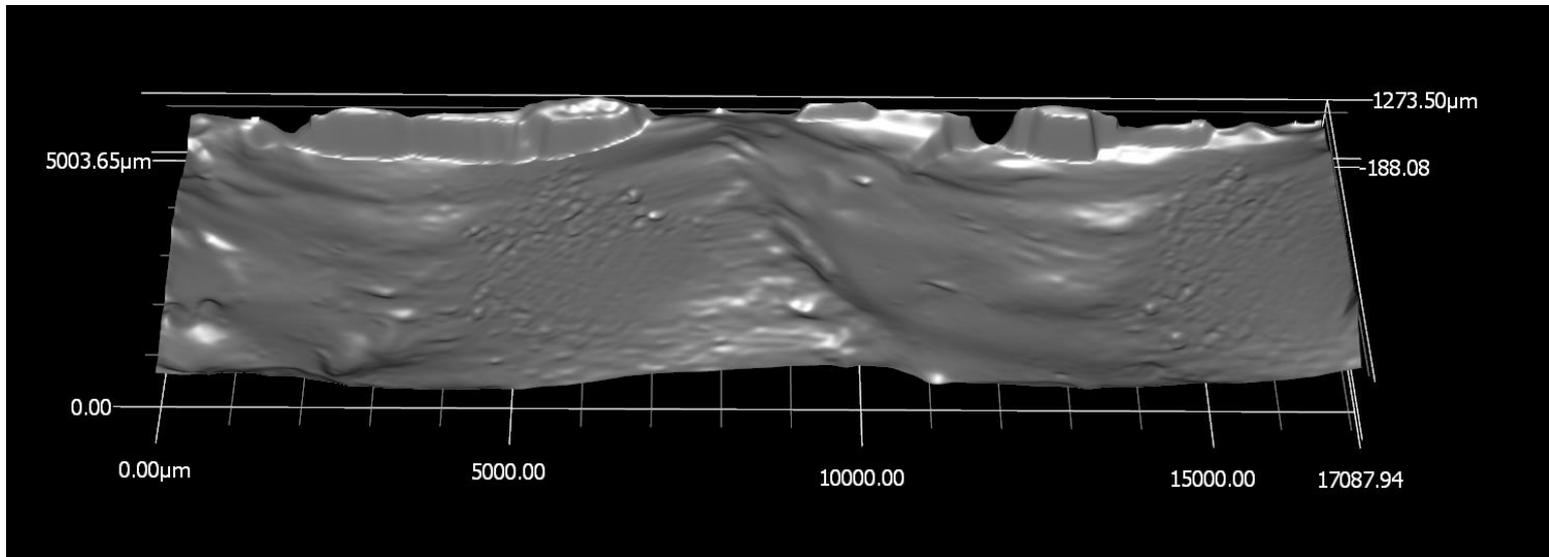
Technical Accomplishment: On the upstream side of the peak there are grooves in the deposit that indicate shear removal has occurred

- The highest heat transfer occurs at the upstream side of the peak where the boundary layer is the thinnest. The CFD model also predicted that the thin boundary layer will result in the most deposition.
