Type A Accident Investigation Report

**Vehicle Fatality Accident, July 1, 2008
59th Avenue NE and Highway 117
West of Cando, North Dakota**

August 2008

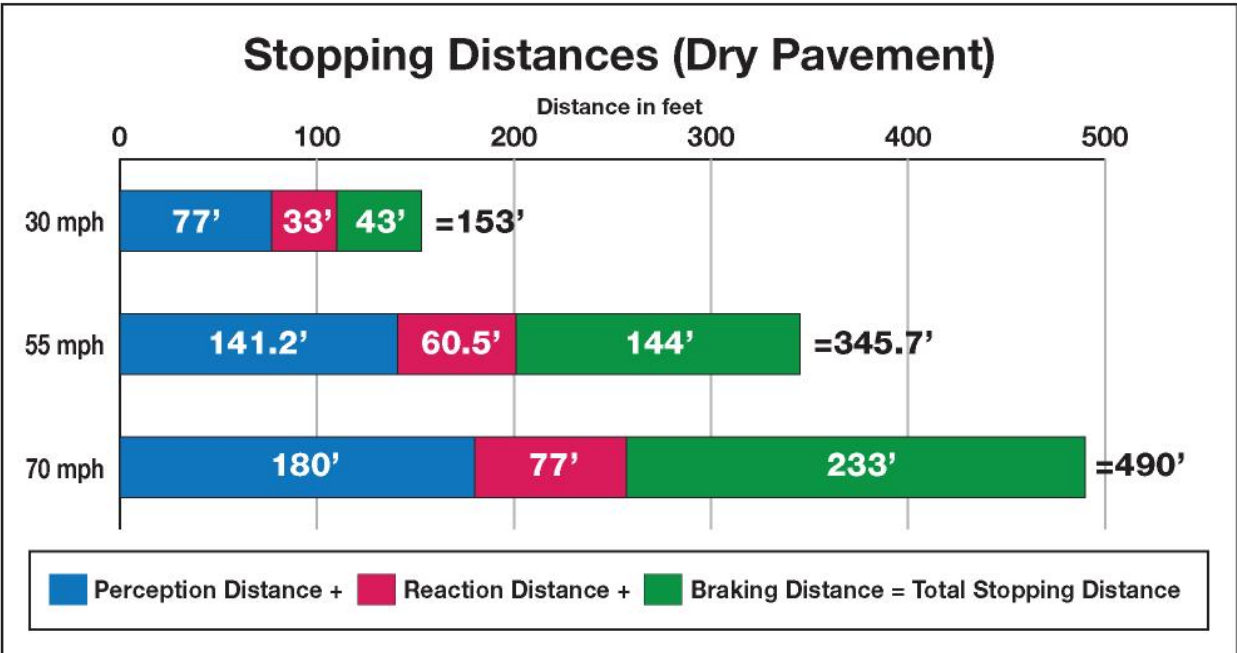
Each of the distances traveled are much less then the typical stopping distance required at 55 mph.

Several physical factors such as the dynamics of V2 slowing to a stop at the intersection and the unknown length of the dust cloud behind V2 prevent calculation of available stopping distance.
