Final Report

**Type B Accident
Investigation Board Report
August 5, 1998
Load Haul Dump Accident
at
U16b Tunnel
Nevada Test Site**

Nevada Operations Office

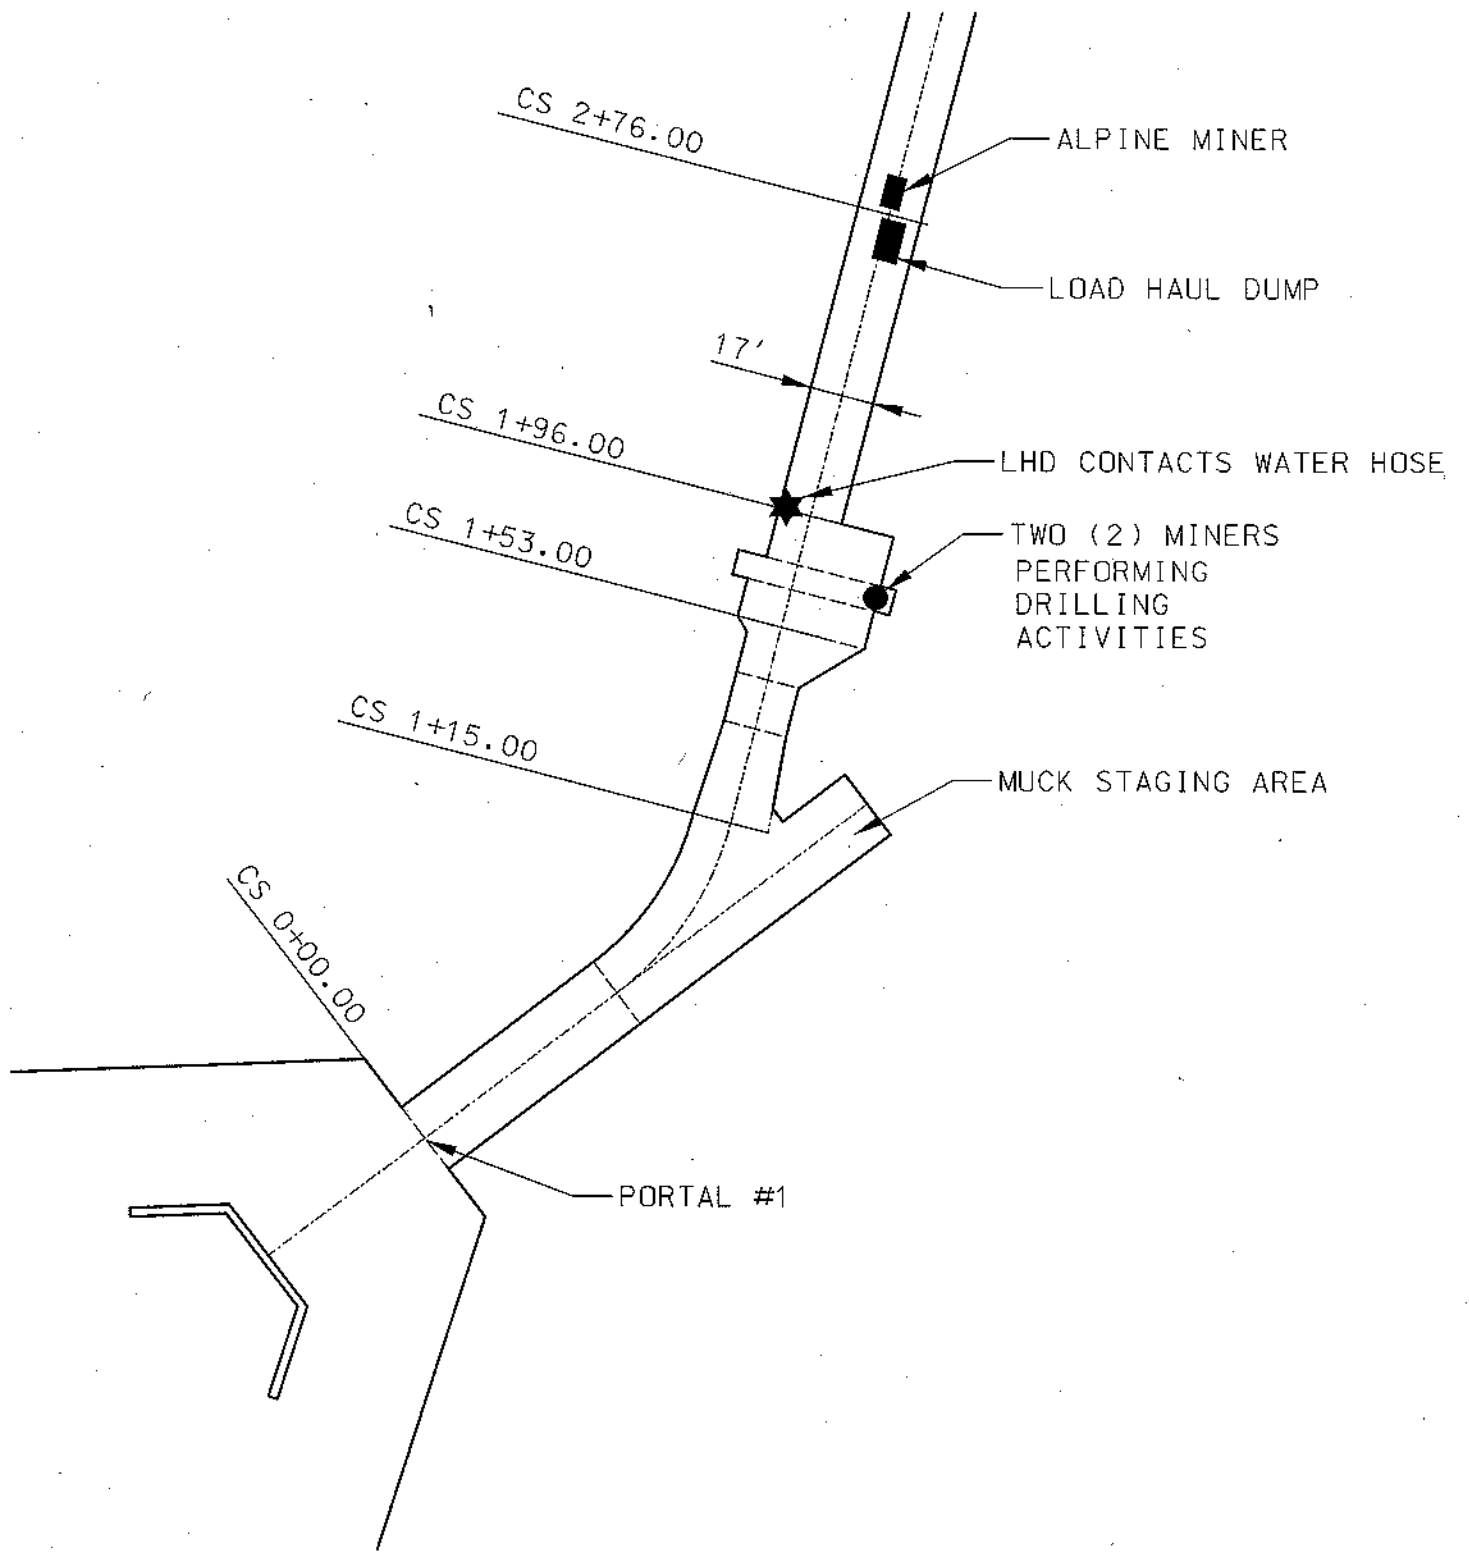
Figure 2 Plan of U16b Tunnel Portal 1

The U16b tunnel (figure 2) has been under construction since January, 1998. On the morning of August 5, 1998, a decision was made to begin construction of a keyway in an alcove on the right side of the tunnel at approximately Construction Station (CS) 1+75. A water and air hose connected to water and air lines on the left rib of the tunnel were hung up the left rib, across the back, and down the right rib. These hoses provided water and air to a jackleg drill and had initially been laid across the invert. However, the BN Shifter had directed the two miners operating the drill to string them overhead to prevent damage to the hoses from the LHD running over them as it passed while removing muck from behind Alpine Miner at CS 2+76. When the hoses were hung they were not held as tight to the ribs as reasonably possible. During the time the hoses were being hung, the LHD was removing muck from the tunnel's inside muck staging area at CS 1+15 to the outside muck pile. After the air and water hoses had been hung from the back, the LHD resumed mucking.

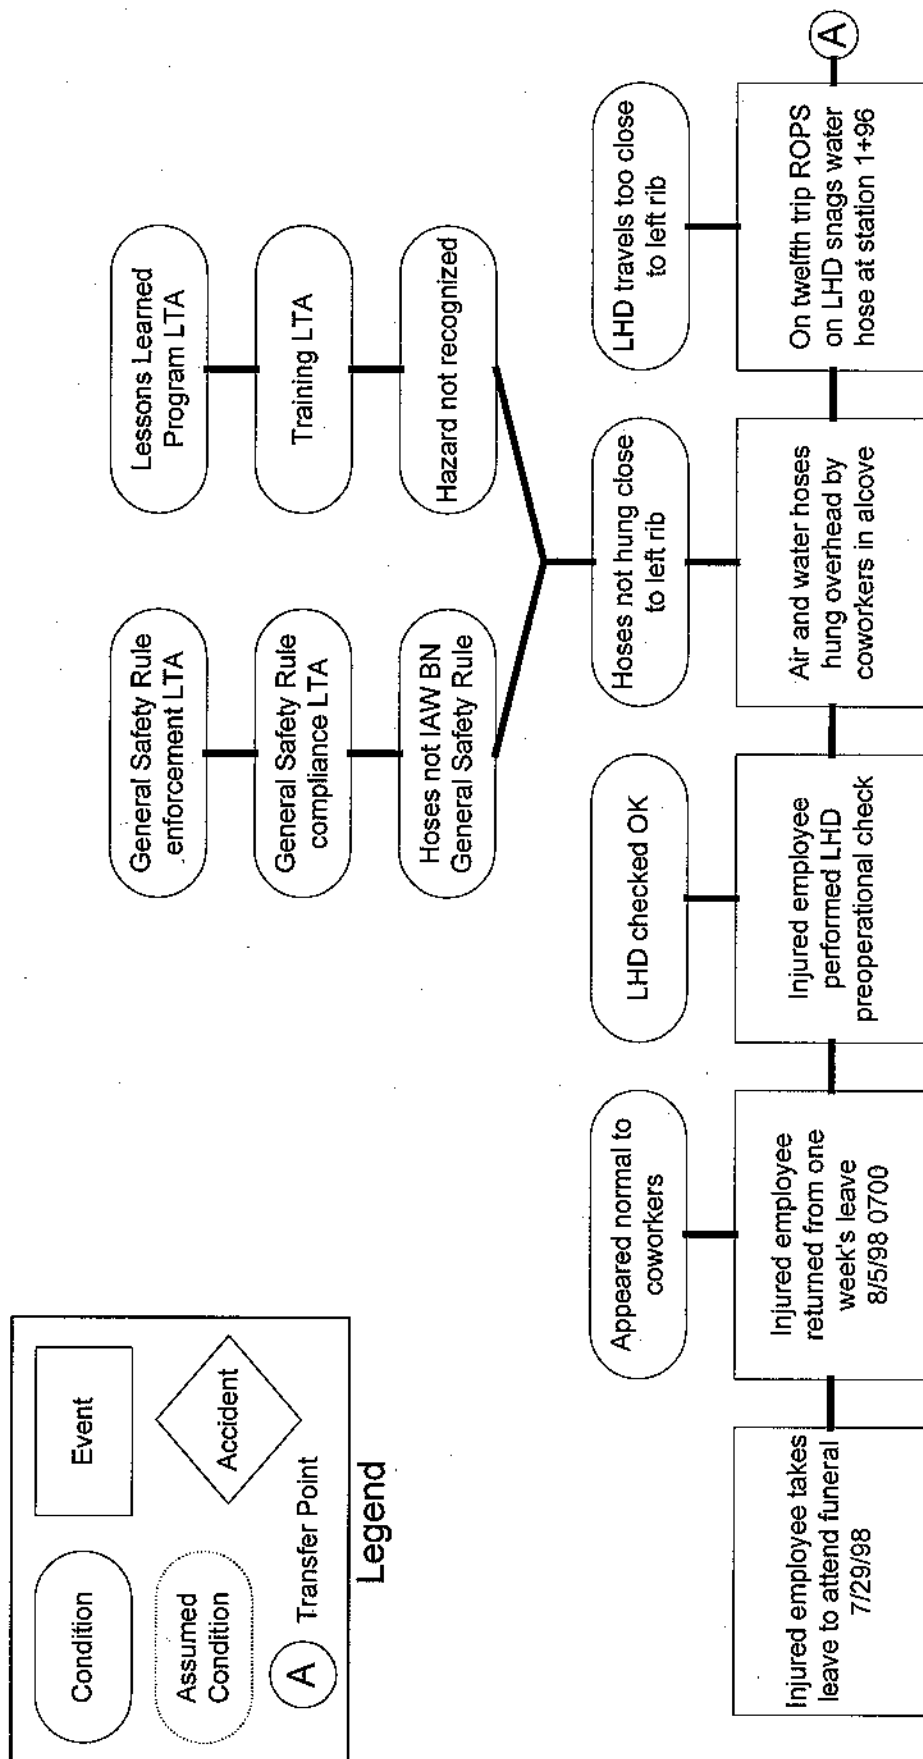
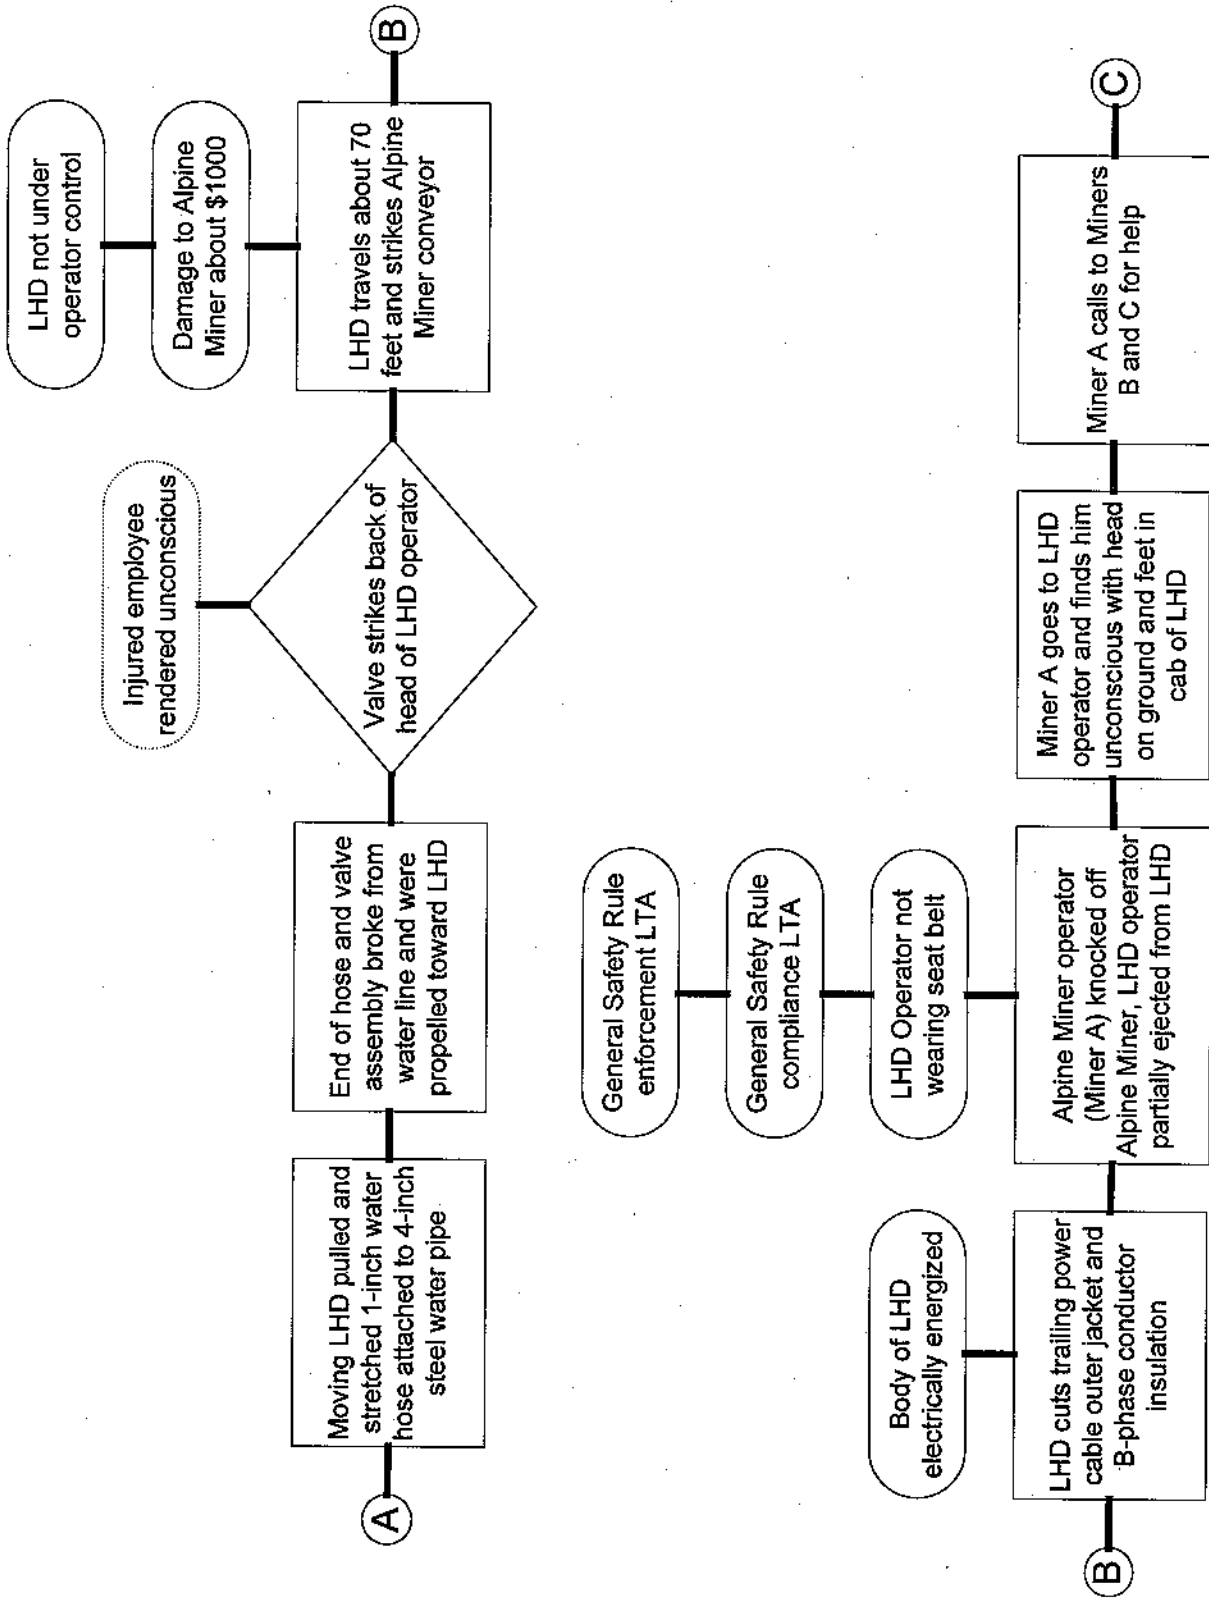
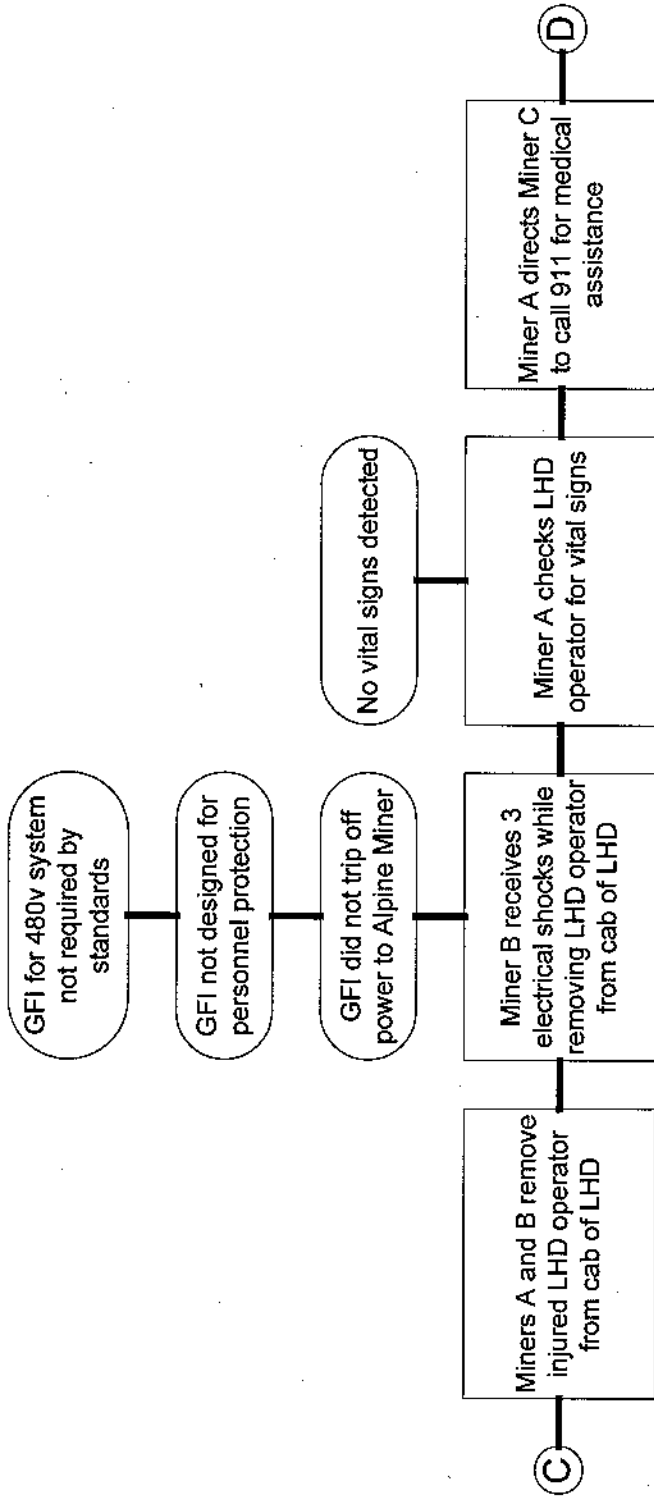
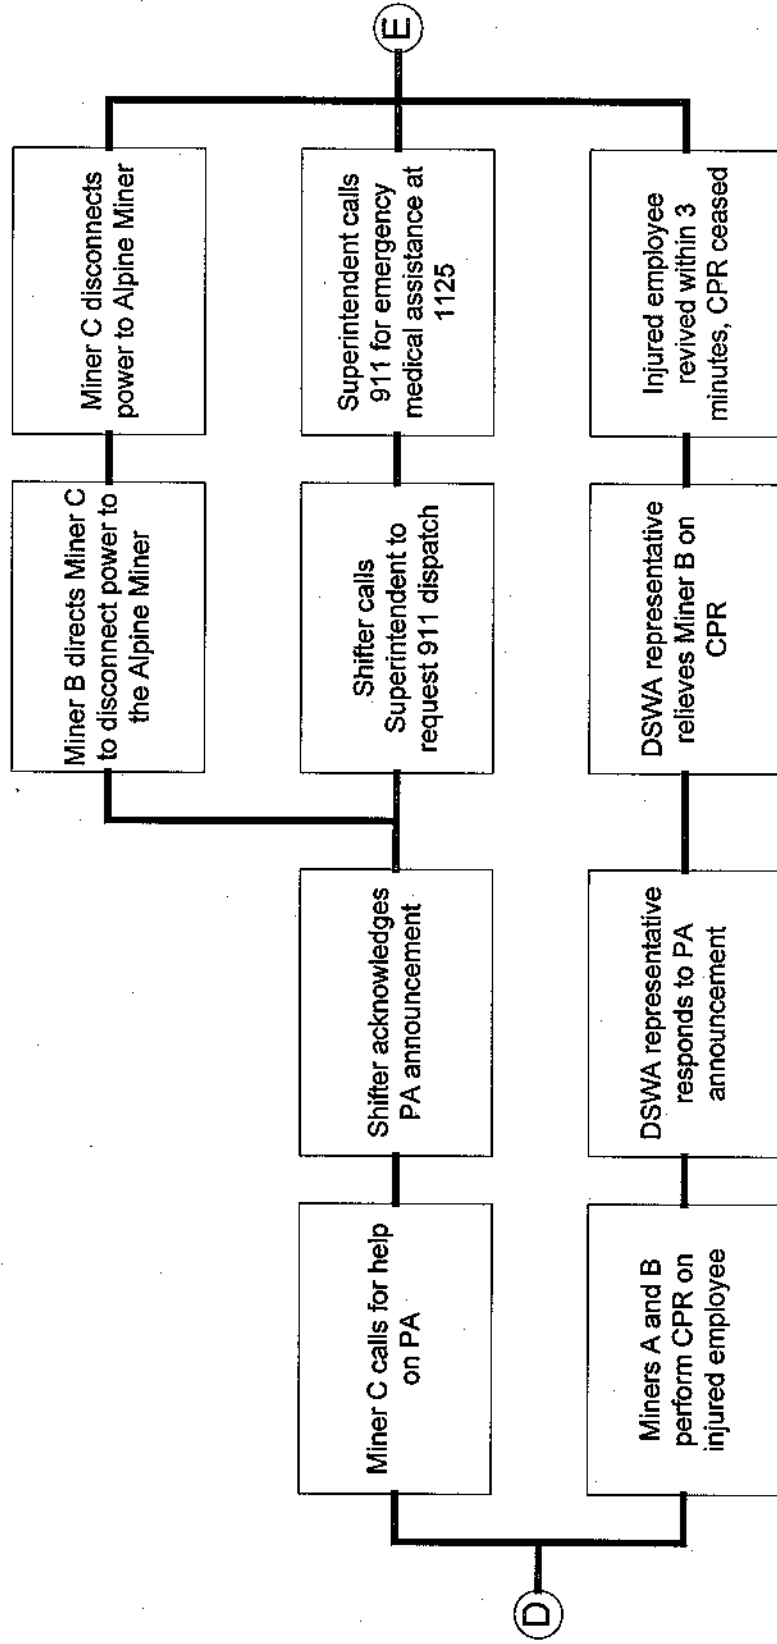
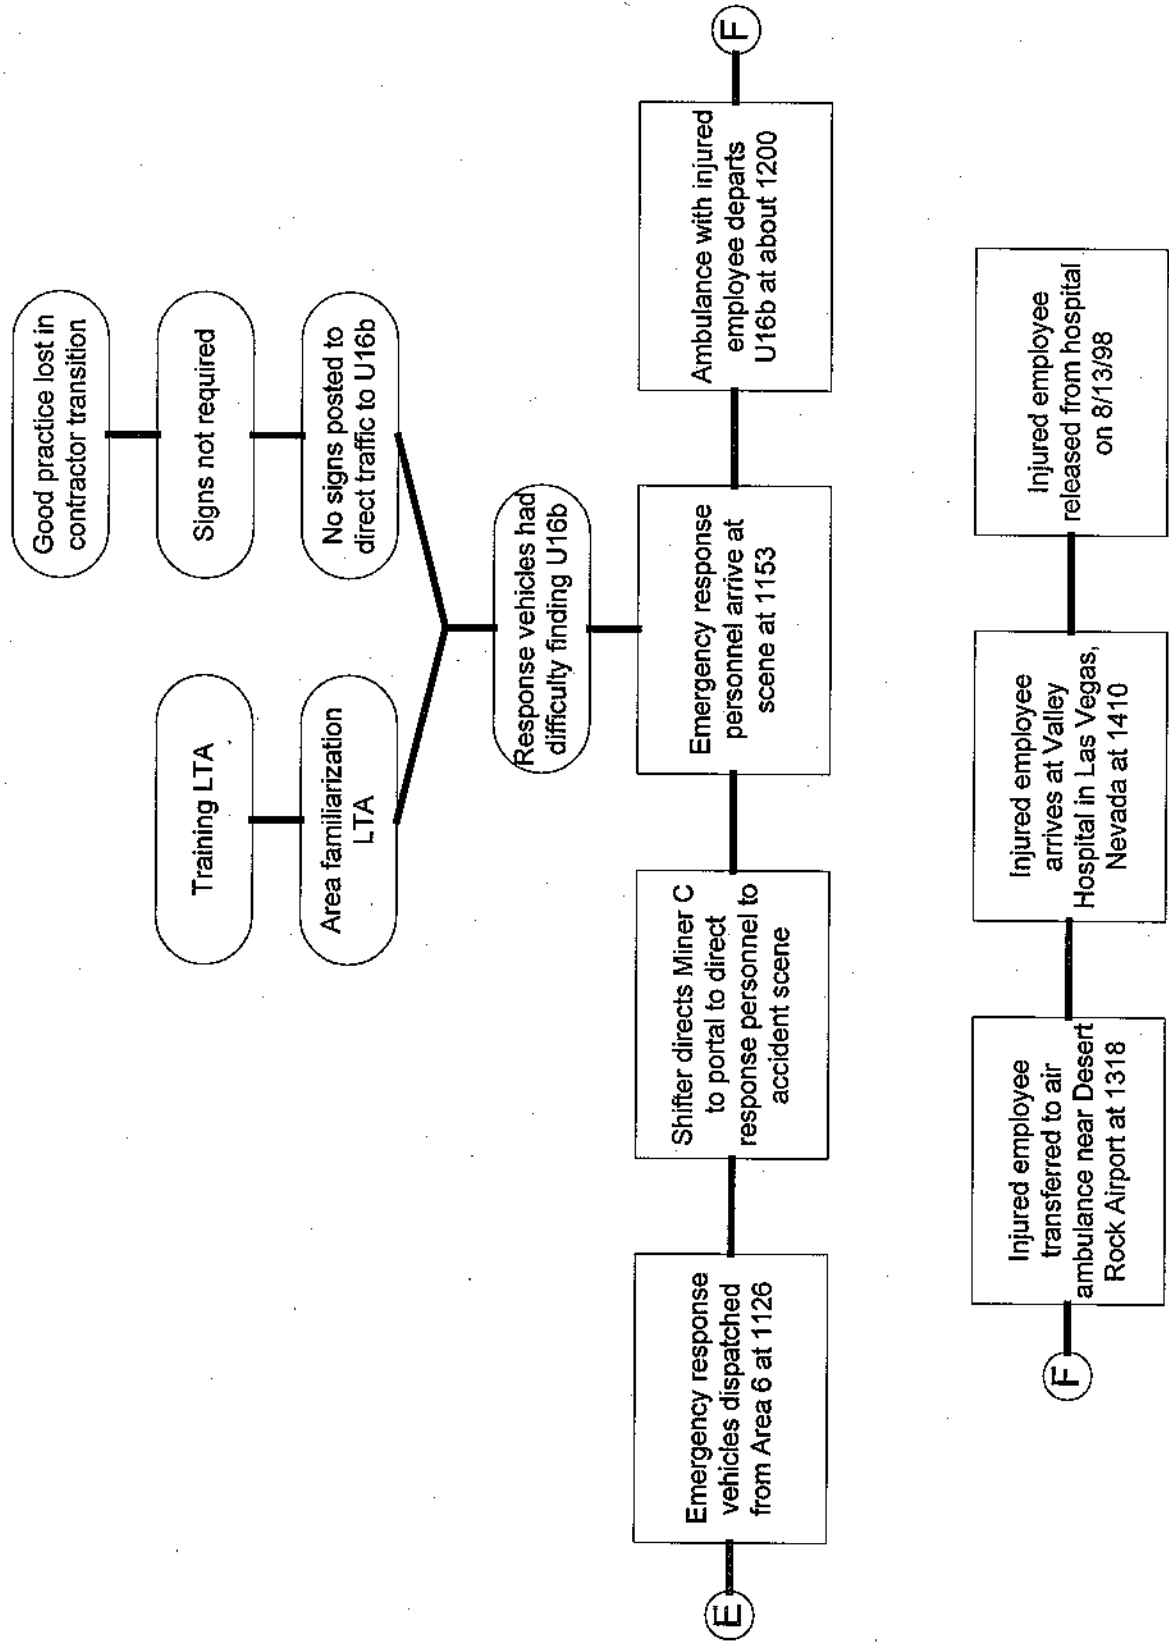
Figure 10, Events and Causal Factors Chart

Figure 10 is the Events and Causal Factors Chart used to analyze the causal factors in this accident. Table 3 presents causal factors in summary form.
