**Type B Accident Investigation Board
Report of the
September 1, 1999, Plutonium Intakes
at the
Savannah River Site FB-Line**

Type B Accident
Investigation Report of
the September 1, 1999,
Plutonium Intakes at the
Savannah River Site
FB-Line

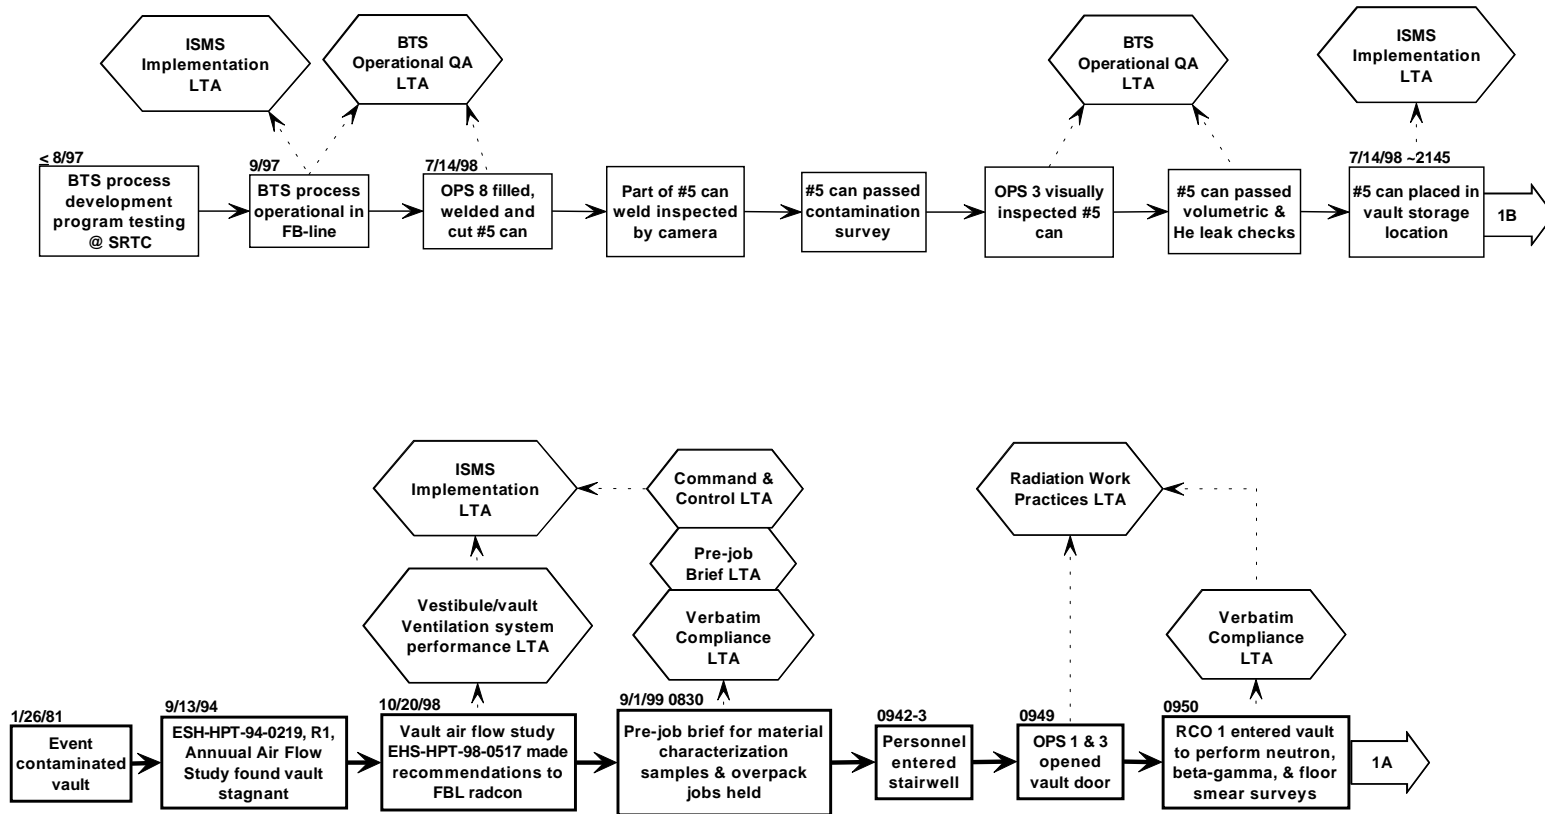
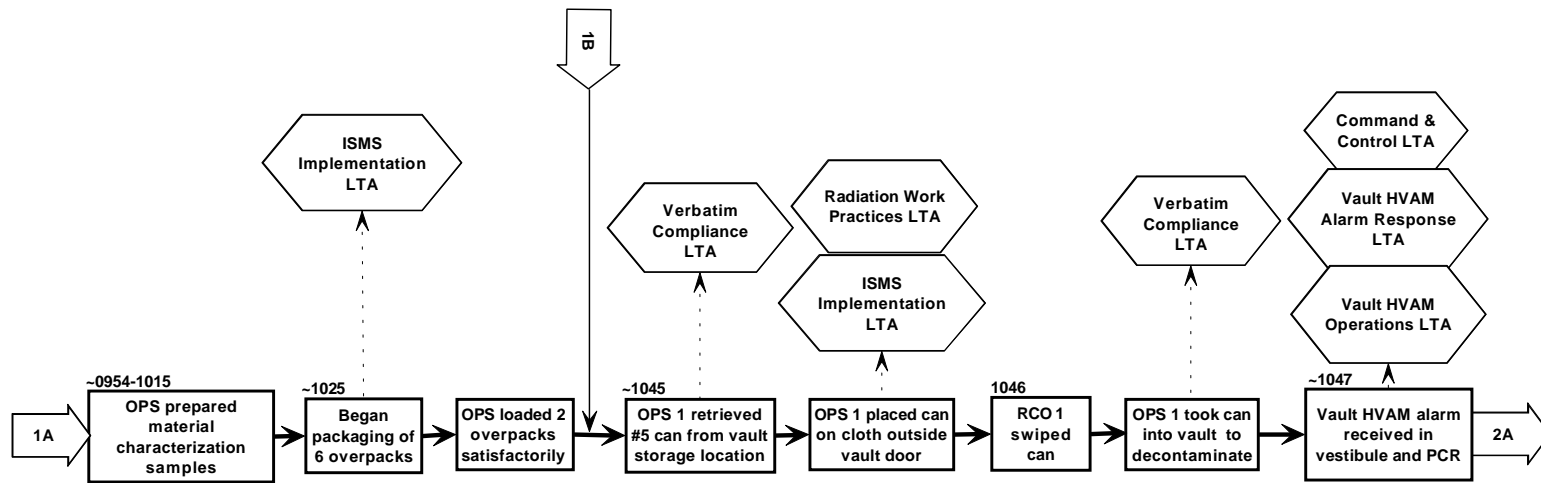
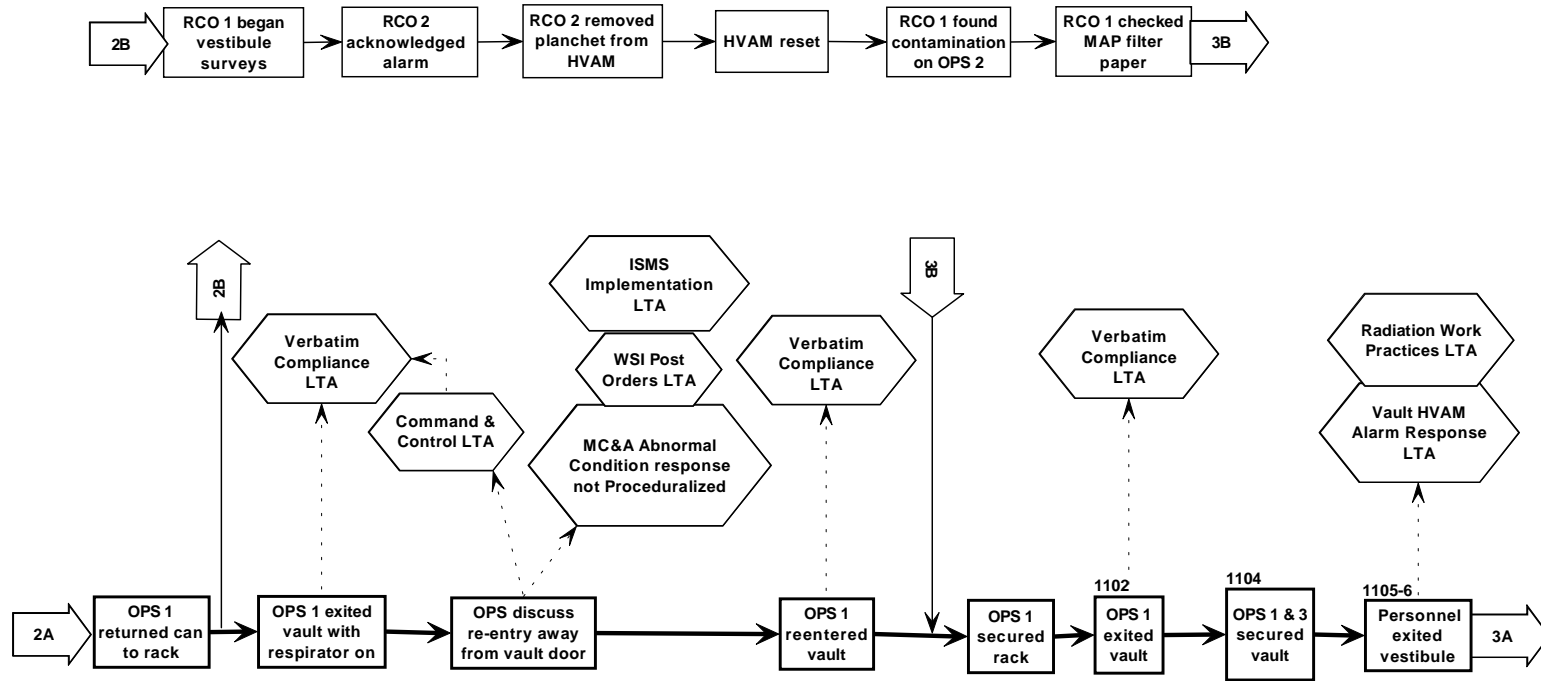
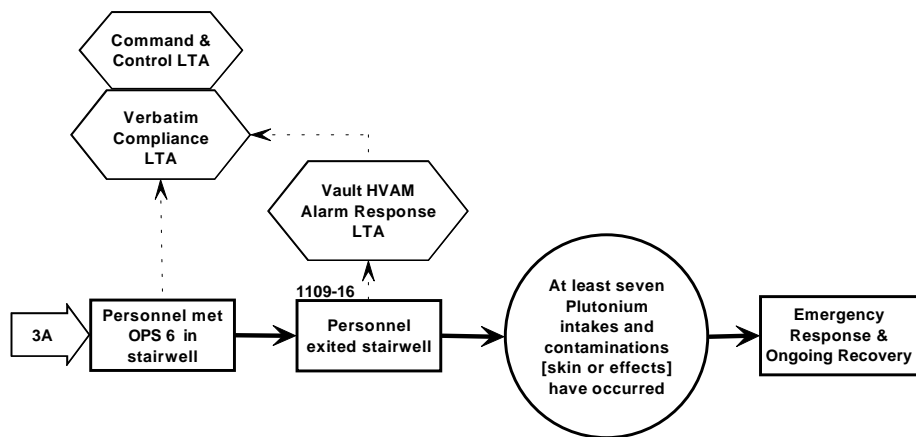
SUMMARY EVENTS & CAUSAL FACTORS CHART FOR
PLUTONIUM INTAKES AT FB-LINE SEPTEMBER 1, 1999

Causal factors are the events and conditions that produced or contributed to the accident. The direct cause is defined as the immediate event or condition causing the accident. The Board determined the direct cause of the accident was the release of plutonium from a defective bagless transfer can, resulting in inhalation of plutonium by FB-Line workers.

- Quality assurance on the bagless transfer system canister was not adequate to identify the weld defect.
- Implementation of integrated safety management for plutonium vault operations was inadequate to provide worker protection during interim plutonium storage and handling.
