OPERATING EXPERIENCE SUMMARY

OE Summary 2014-05

Fatality While Driving Gradall Material Handler on a Remote Forest Service Road

Lithium Fire at the Sandia National Laboratories' Plasma Material Test Facility Highlights Opportunities for Improvement in Work Planning and Hazards Analysis

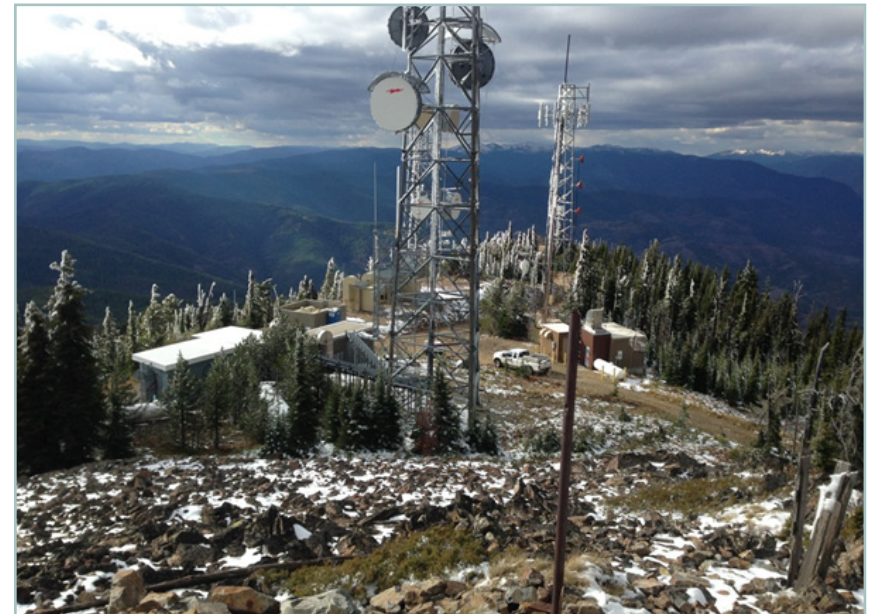
Figure 1-1. BPA's Patrick Knob Radio Station

BPA's Patrick's Knob Radio Station (Figures 1-1 and 1-2) was being upgraded with an EG replacement under a single project plan. The replacement was a high priority due to generator-set damage earlier in the year and station accessibility issues during the upcoming winter.

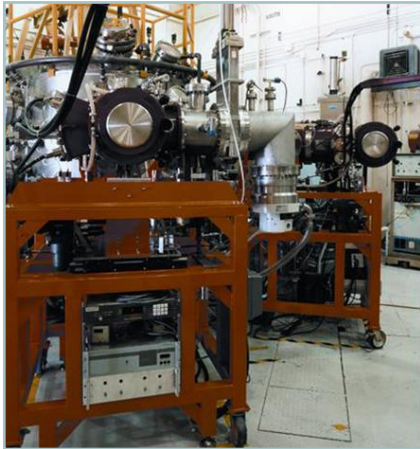
Figure 2-2. PMTF Electron Beam-1200-kW System¹

On August 26, 2011, an explosion and a lithium fire occurred at Sandia National Laboratories' (SNL) Plasma Materials Test Facility (PMTF) Electron Beam (EB) vacuum test chamber. (Figure 2-1 shows an aerial view of SNL; Figure 2-2 shows the PMTF Electron Beam 1200-kW System.) The accident significantly damaged the EB-1200 kilowatt (kW) equipment and resulted in damage to the facility. Two workers in the test chamber's immediate vicinity were not injured; fortunately, the worker closest to the chamber had moved away just prior to the event, but was knocked to the floor. Three of the five workers who were in the general vicinity of the explosion had ringing in their ears, but were returned to work without restrictions. (ORPS Report NA--SS-SNL-1000-2011-0007; final report issued September 21, 2012)

in the Test Plan). This resulted in rapid failure in the face of the lithium preheater panel. When the preheater failed, molten lithium sprayed from thin cracks in the preheater across the chamber into the beam line of the electron beam gun, where it struck and fractured an alumina ceramic liner. The ceramic liner separated coolant (which was used to cool this region of the chamber during operation of the high-power electron beam gun) from the vacuum environment in the chamber. The fracturing of the liner allowed the coolant (water and polypropylene glycol) to contact molten lithium, which resulted in an explosion and fire.

The *direct cause* was determined to be material failures in the lithium preheater and ceramic cooling annulus that allowed a reaction between molten lithium and the water. A metallographic analysis requested by Sandia's Investigation Team determined that thermal shock-induced liquid metal embrittlement, which can occur when parts are under stress, caused the failure of the lithium preheater.
