B O N N E V I L L E
P O W E R A D M I N I S T R A T I O N

Level I Accident Investigation Report

Wilson Construction Company Employee Fatality on the Bandon-Rogue No. 1 115kV Line

**Report Date:
September 2013**

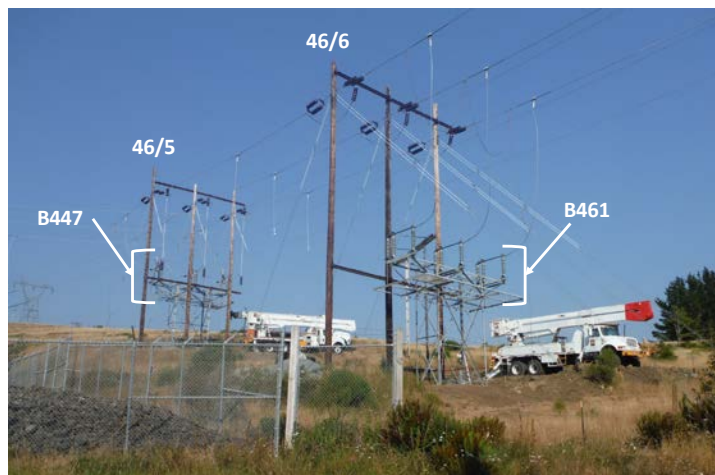
By about 0930, WCC Crew Foreman 2 (CF2) climbed up to the top of B447 switch stand to attach lift slings suspended from the crane. Once the lift slings were placed and pulled up snug, CF2 positioned himself to assist in the removal of the blade end sectionalizing jumper on B-phase.

At approximately 0945, CF2 made contact with a difference of potential across the blade end insulator stack of B447.

The Board concluded the **direct cause** of the accident was that CF2 made contact with a difference of potential across the blade end insulator stack of B447.

The Board concluded the **root cause** of the accident was Crew 2's failure to establish an equipotential zone (EPZ).

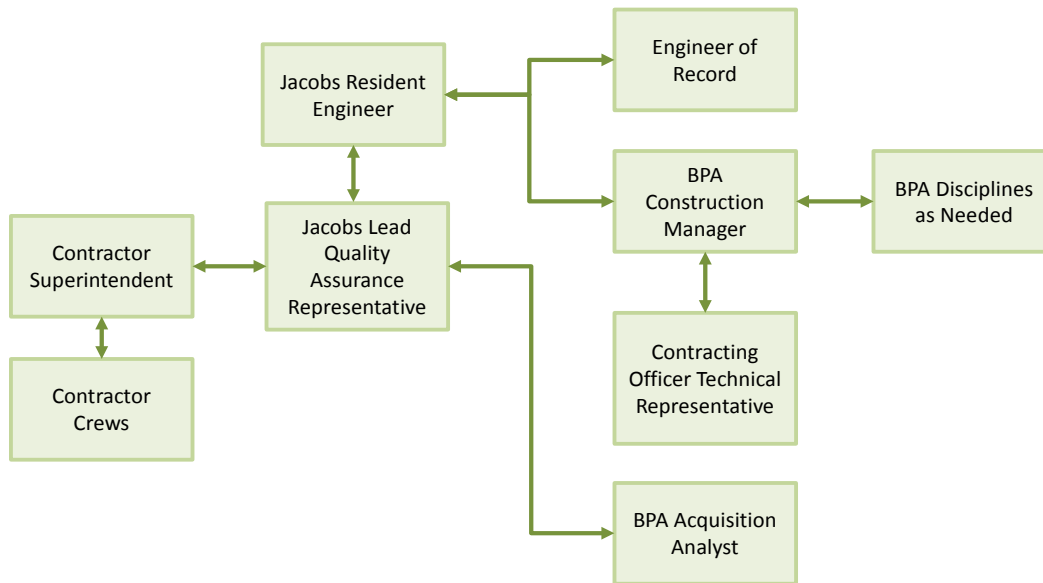
Figure 6: General Contractor Project Communication Diagram

The Superintendent is the first line for field questions on the project. If the answer to a question cannot be determined by the Superintendent, the question is passed on to the Quality Assurance Representative. Questions regarding field issues, safety, or material issues can often be resolved at this level.

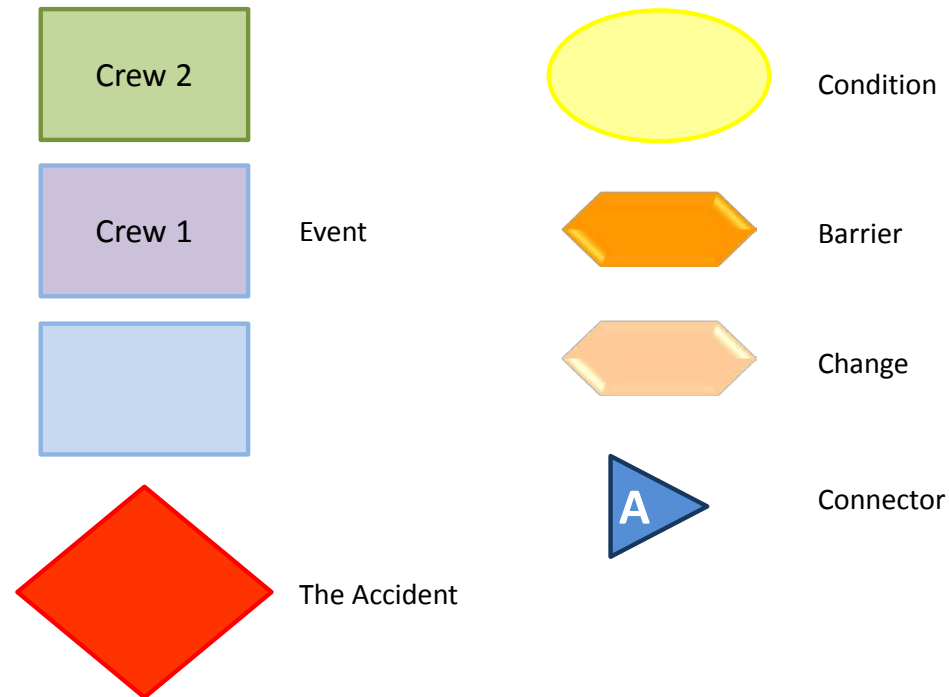
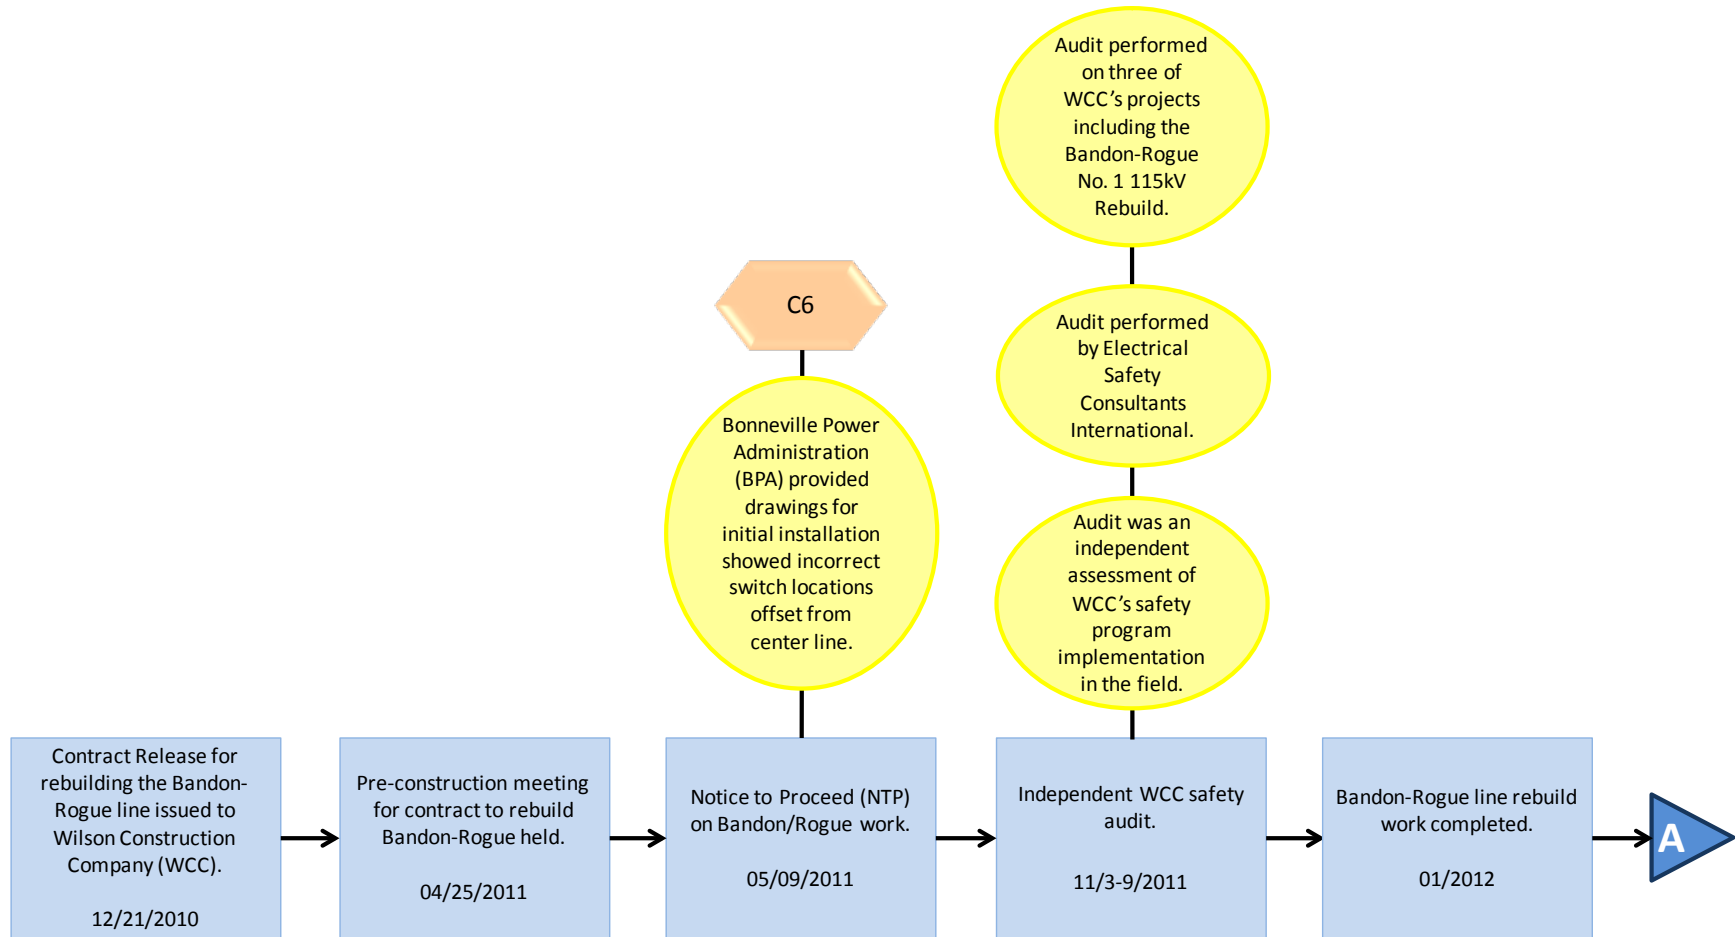
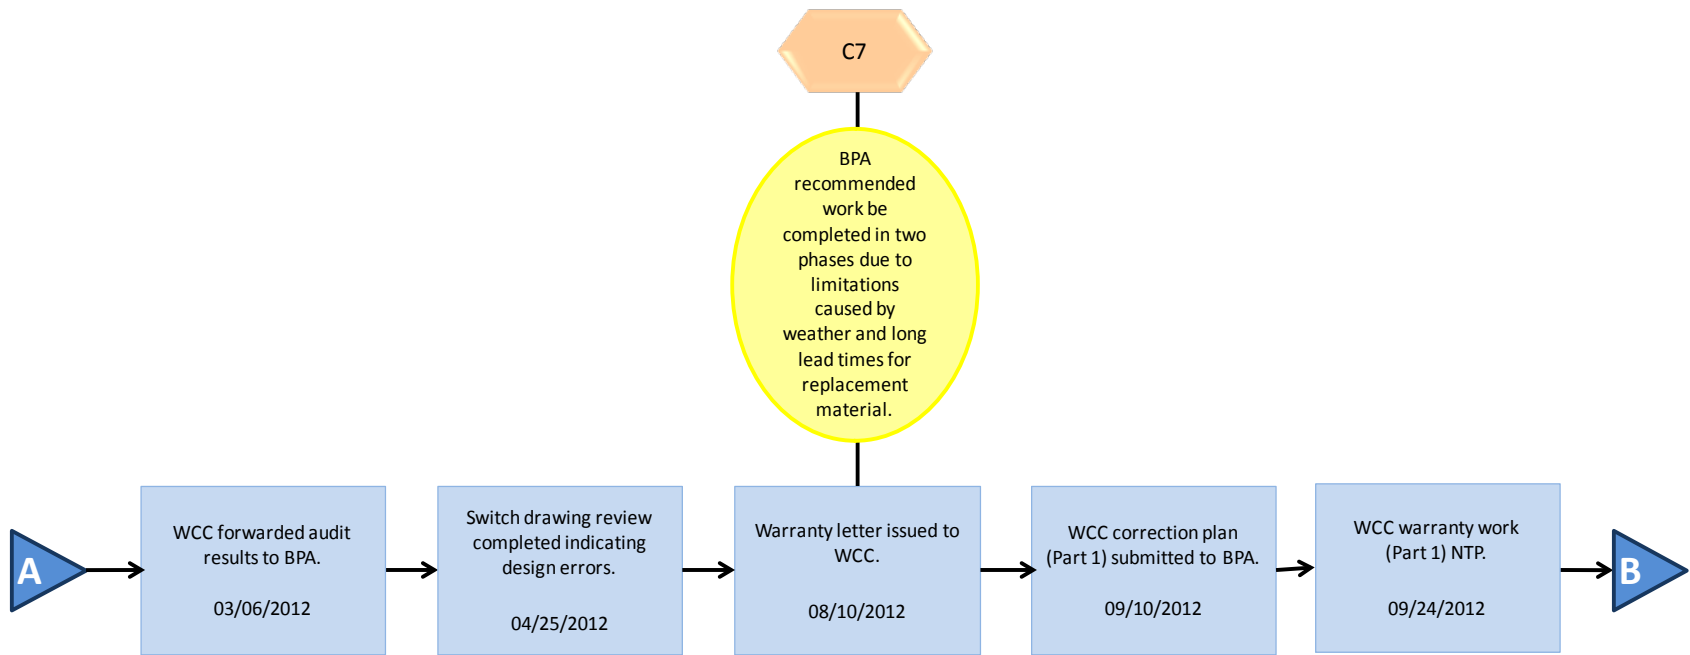
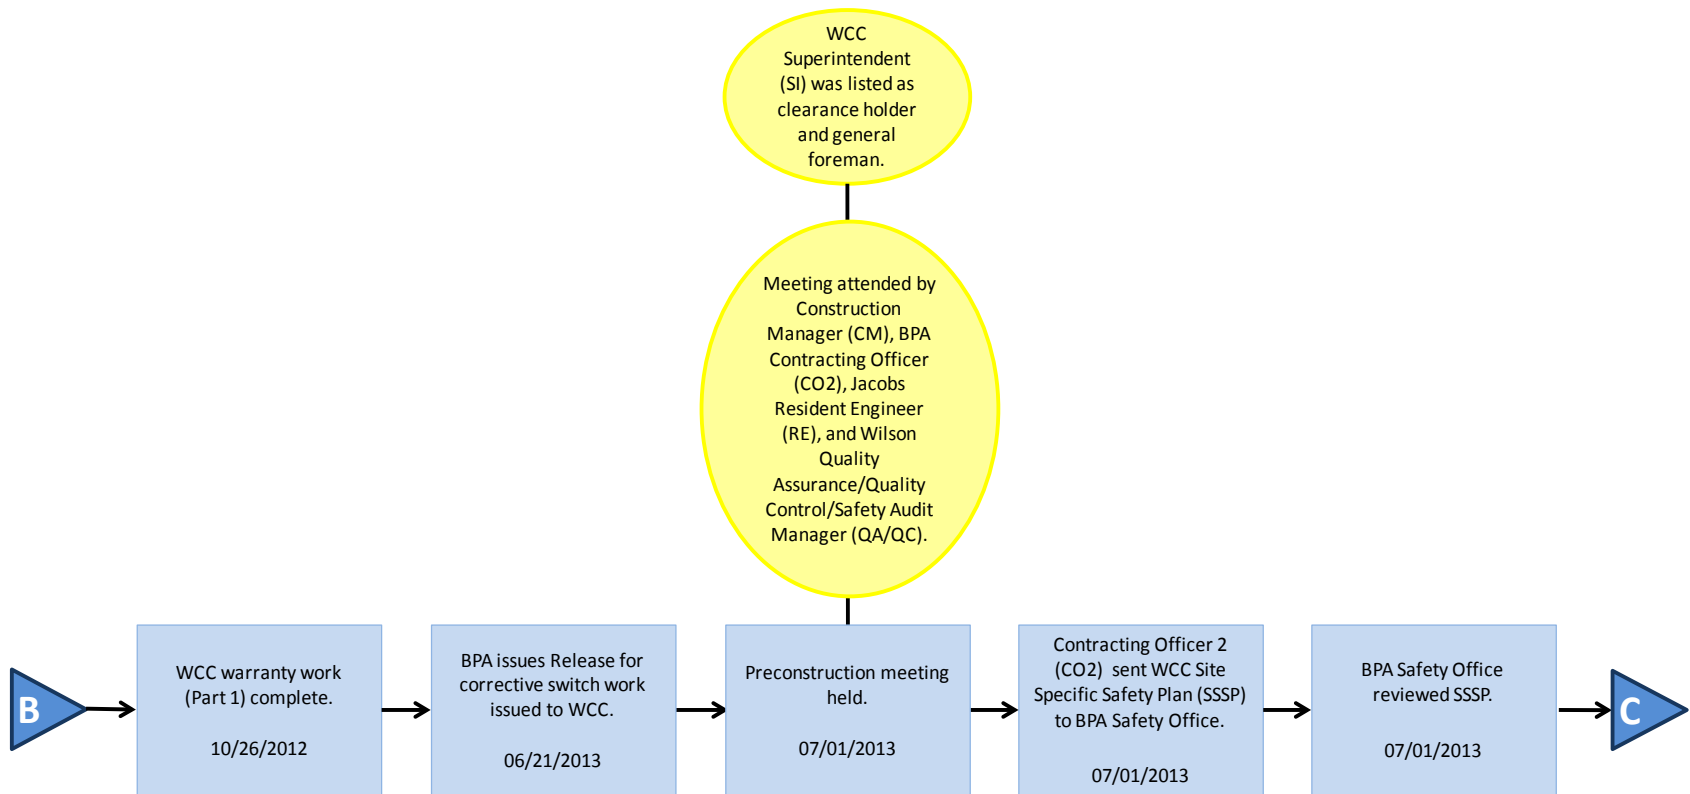
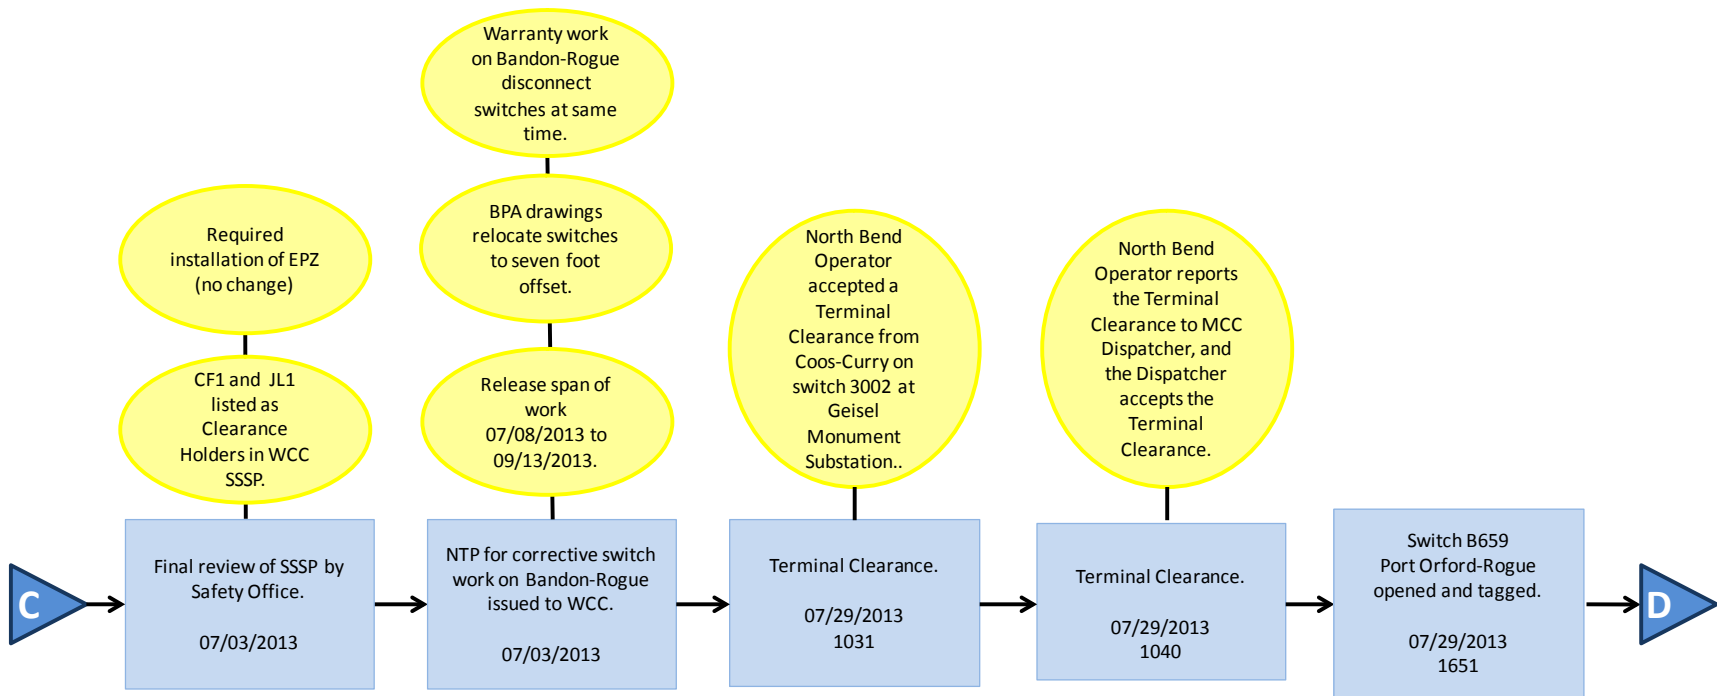
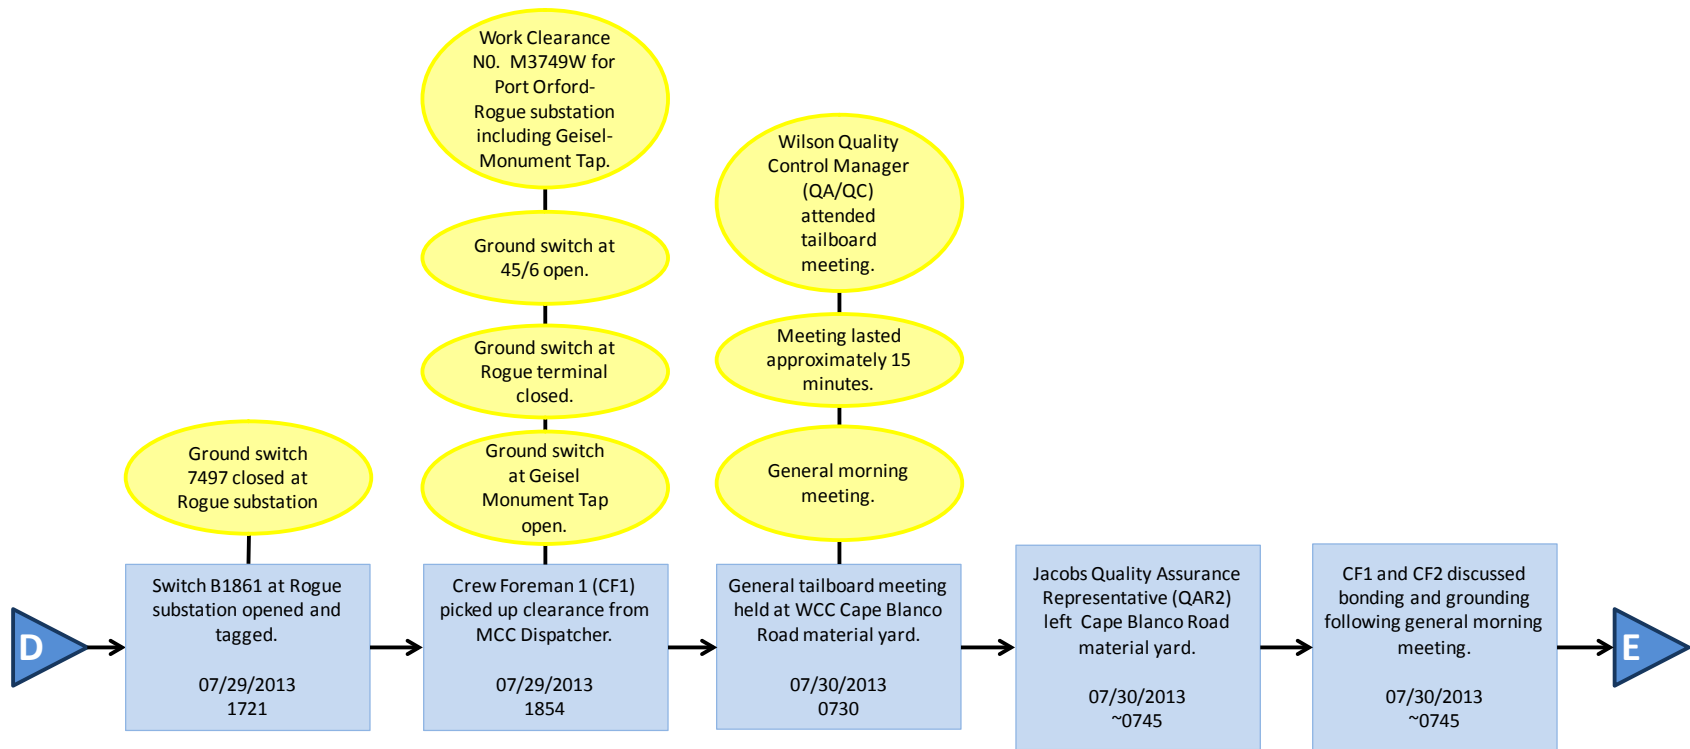
Table D-1: Events and Causal Factors Chart

An events and causal factors analysis was performed in accordance with the DOE workbook *Conducting Accident Investigations*. The events and causal factors analysis requires deductive reasoning to determine those events and/or conditions that contributed to the accident. Causal factors are the events or conditions that produced or contributed to the accident, and they consist of direct, contributing, and root causes. The direct cause is the immediate event(s) or condition(s) that caused the accident. The contributing causes are the events or conditions that, collectively with the other causes, increased the likelihood of the accident, but which did not solely cause the accident. Root causes are the events or conditions that, if corrected, would prevent recurrence of this and similar accidents. The causal factors are identified in Table D-1: Events and Causal Factors Analysis Chart.
