Lessons Learned from Practical Field Experience with High Pressure Gaseous Fuels

DOE – DOT
CNG – H₂ Workshop
December 10, 2009

Douglas Horne, PE – CVEF President

Rob Adams, P.Eng. – Marathon Technical Services

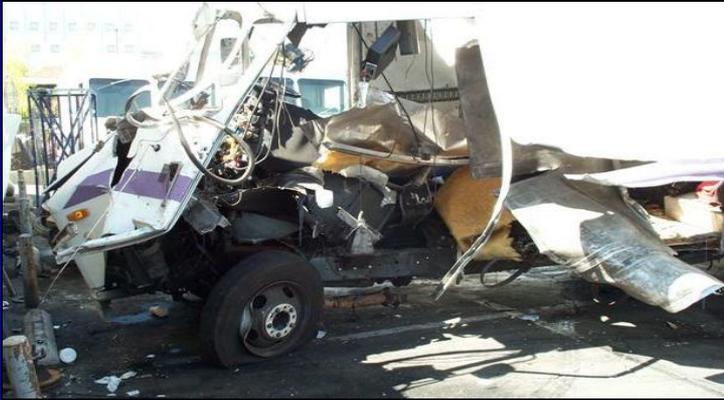
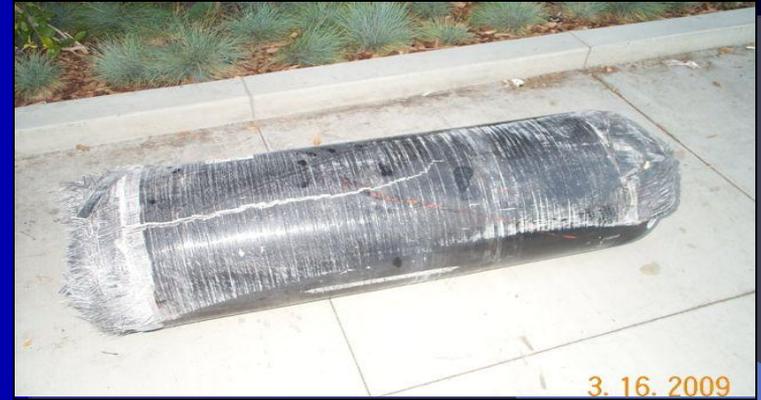
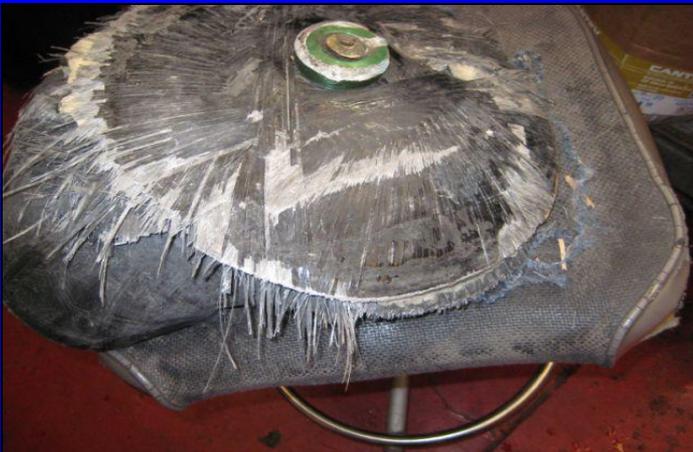
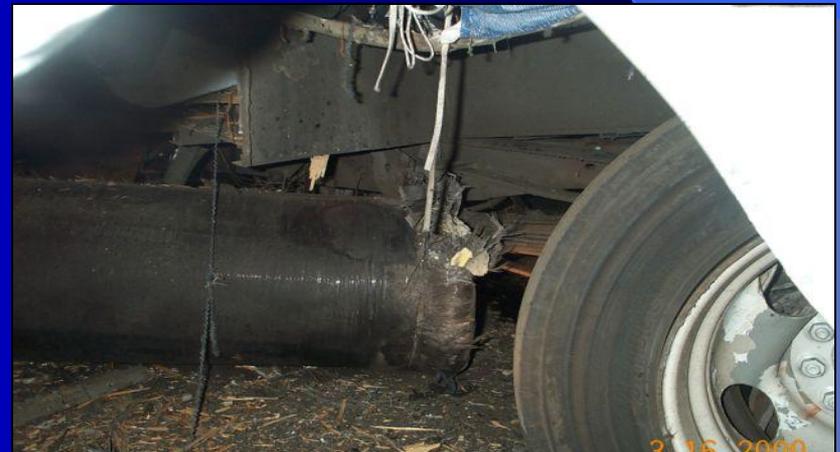
Type 4 Cylinder Incident Physical Damage

- Two Type 4 Brunswick cylinders failed during fueling
 - The cylinders were 14 years old with one mounted horizontally under the truck and the other mounted vertically inside the truck body directly above the horizontal cylinder
 - The vertical cylinder had the valve end dome mounted on a rubber padded steel ring with the valve and piping exposed under the vehicle
 - It is believed that the horizontal cylinder failed first due to unknown road damage and when it failed the floor of the truck was forced upward with the steel ring cutting into the dome of the vertical cylinder which then failed.
 - The initial report has been completed by CVEF and additional evaluation of the cylinders will be made by NASA (White Sands)

- No shielding of exposed cylinder under vehicle
- PRD on vertical cylinder isolated from cylinder exposure

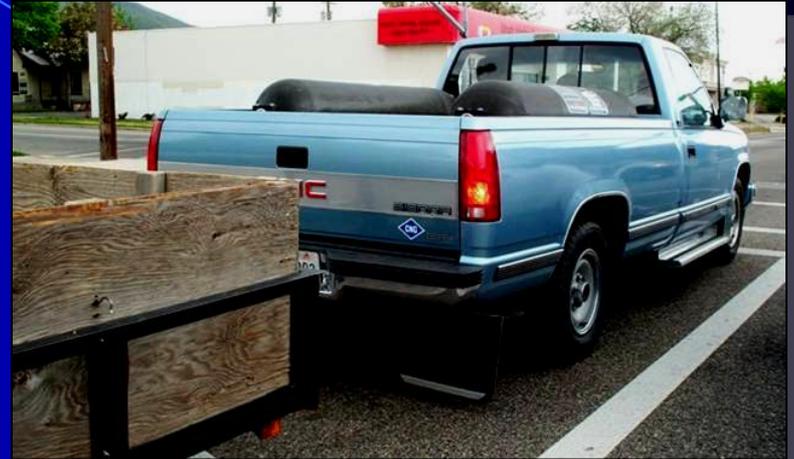
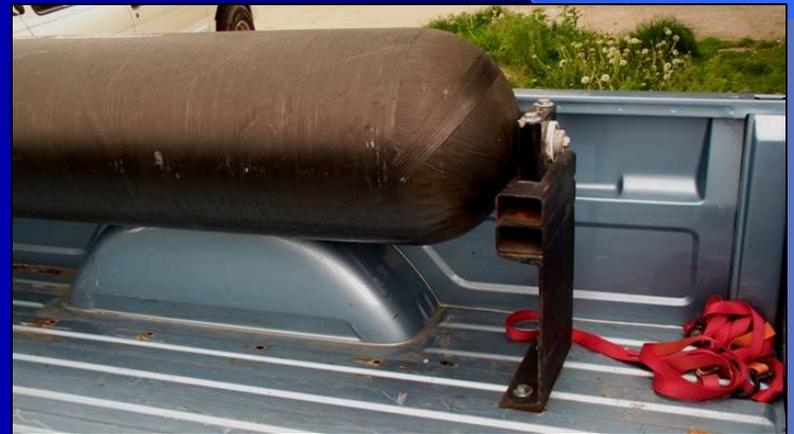
Installation Issues

- With NGV market growth and the significant saving in fuel cost, independent conversions of CNG vehicles by untrained mechanics have presented safety concerns
- While states recognized that use of conversion kits not certified by EPA or CARB was an issue, they failed to realize that EPA and CARB do not address safe installation practices
- The ASE (F1 test) certification program for technicians has been updated to cover installation as well as maintenance of CNG vehicles

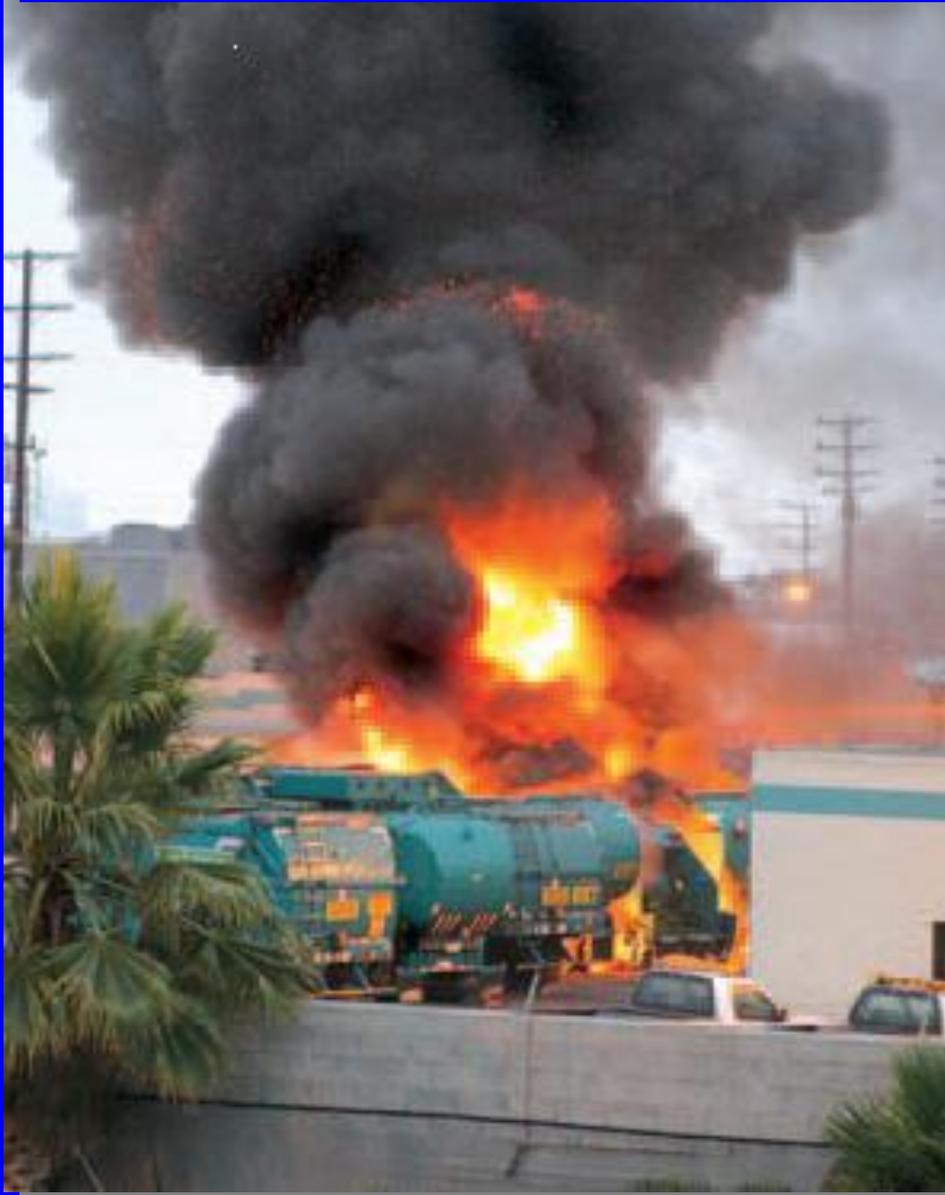
Refuse Hauler Fire

1. Fire destroyed or heavily damaged 5 CNG powered garbage trucks. Approx. \$1.5M in property damage.
2. The fire was believed to have originated in one truck and spread to others from there.
3. There were no injuries.

- Vehicles were fueling.
- Staff heard a loud “metallic bang—like a hand grenade.”
- Staff immediately investigated and found the fire.

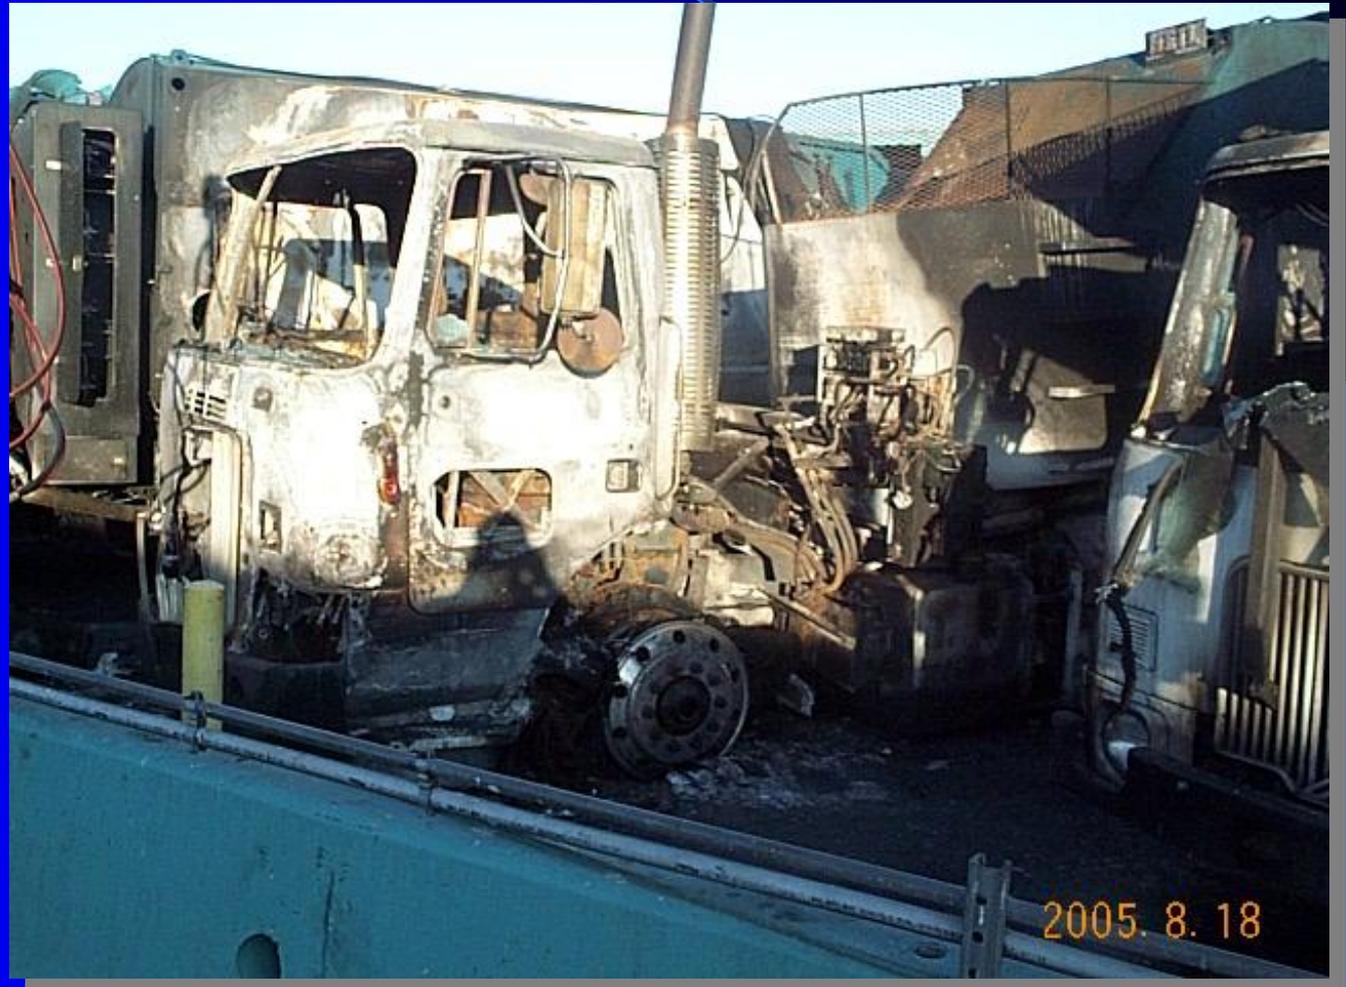
Refuse Hauler Fires

4 of the 5
trucks
involved
were
written off.
