Accident Investigation Report

Underground Salt Haul Truck Fire at the Waste Isolation Pilot Plant February 5, 2014

March 2014

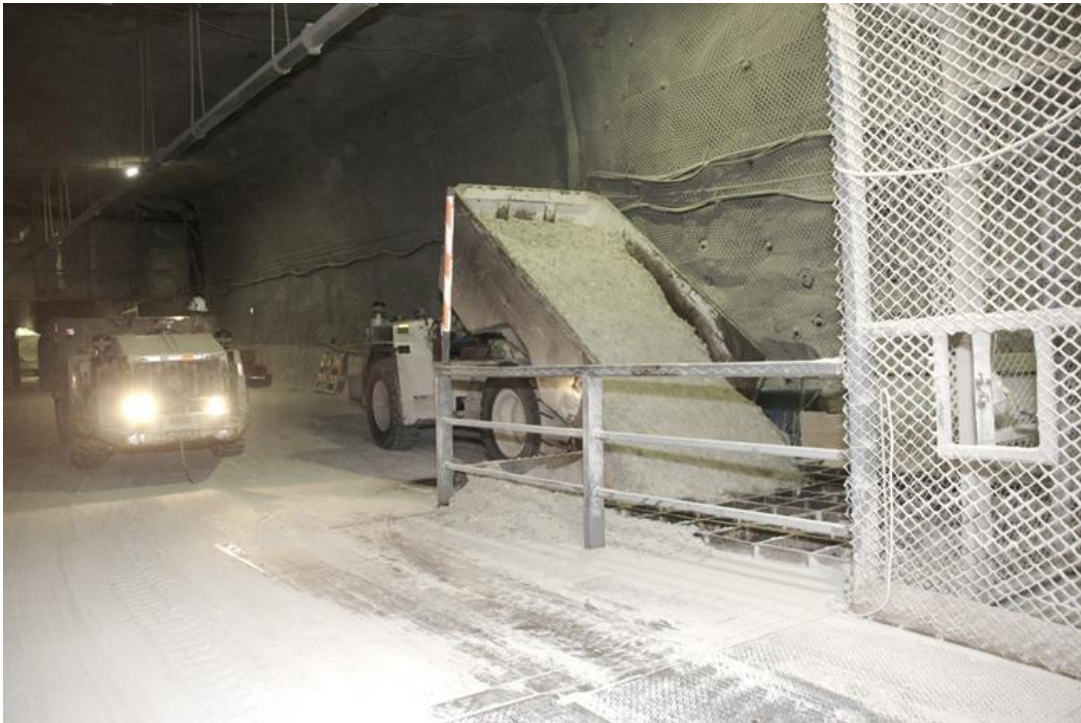
Figure 7: The Loading Pocket “The Grizzly”

An Operator picked up a load of salt using haul truck 74-U-006B at Panel 8 at approximately 1045 and headed north on W-170 toward the loading pocket (Figure 7) to dump the load. Figure 8 shows the Operator's route from Panel 8 to the scene of the fire. He turned right on S-90, left on E-0, dropped half of his load at the loading pocket, continued north in E-0, and passed N-150 to drop the rest of his load. The Operator pulled into N-300, backed up into E-0, and unloaded the rest of the truck. As the Operator lowered the bed, he looked back to see if it was clear of muck. It was at this point that he noticed an orange glow and then flames between the engine and the dump sections of the truck.

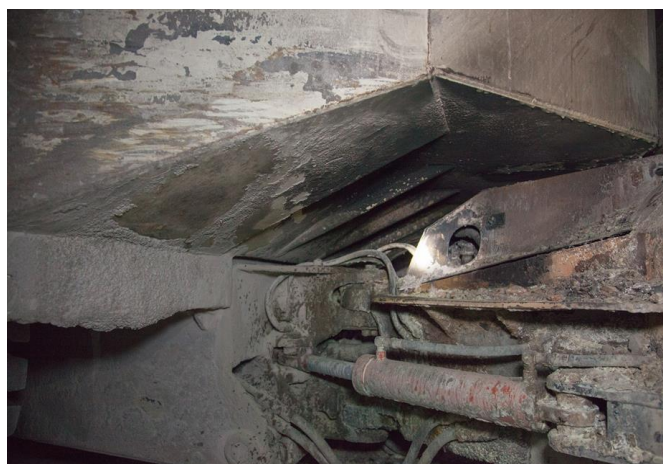
Figure 20: Transmission Fluid Stick Access

1043) and was recognized by the truck Operator at 1048. The Operator shut down the engine, exited the hauler on the left side, and moved to the right side. The Operator then discharged his hand-held fire extinguisher through the transmission access hole, which is forward of the pivot pin (see Figure 20) and under the haul truck. Because the fire was enclosed, using a handheld fire extinguisher was ineffective. The delay between initial ignition and activation of the engine compartment fire suppression system resulted in development of multiple leaks.

When the Operator had discharged the hand-held fire extinguisher, he returned to the left side of the haul truck to initiate release of the on-board fire suppression system. The effectiveness of suppression system is uncertain. At activation, the fire could have been too severe to control, or if initially controlled, a hot surface within the engine compartment might

have reignited the fire. When the engine was shut down, the cooling fan stopped. Because of the haul truck orientation, mine ventilation flow was opposed to the cooling system airflow. This prevented further propagation towards the rear of the haul truck and prevented ignition of the rear tires. The change in engine compartment airflow direction also created a V-shaped discoloration on the haul truck grill. This discoloration was created by the most intense flaming. Sooty deposits occurred on either side of this V where the flames were less intense.
