ACCIDENT INVESTIGATION

JULY 15, 2004

HANFORD 200 EAST AREA

FALL FATALITY

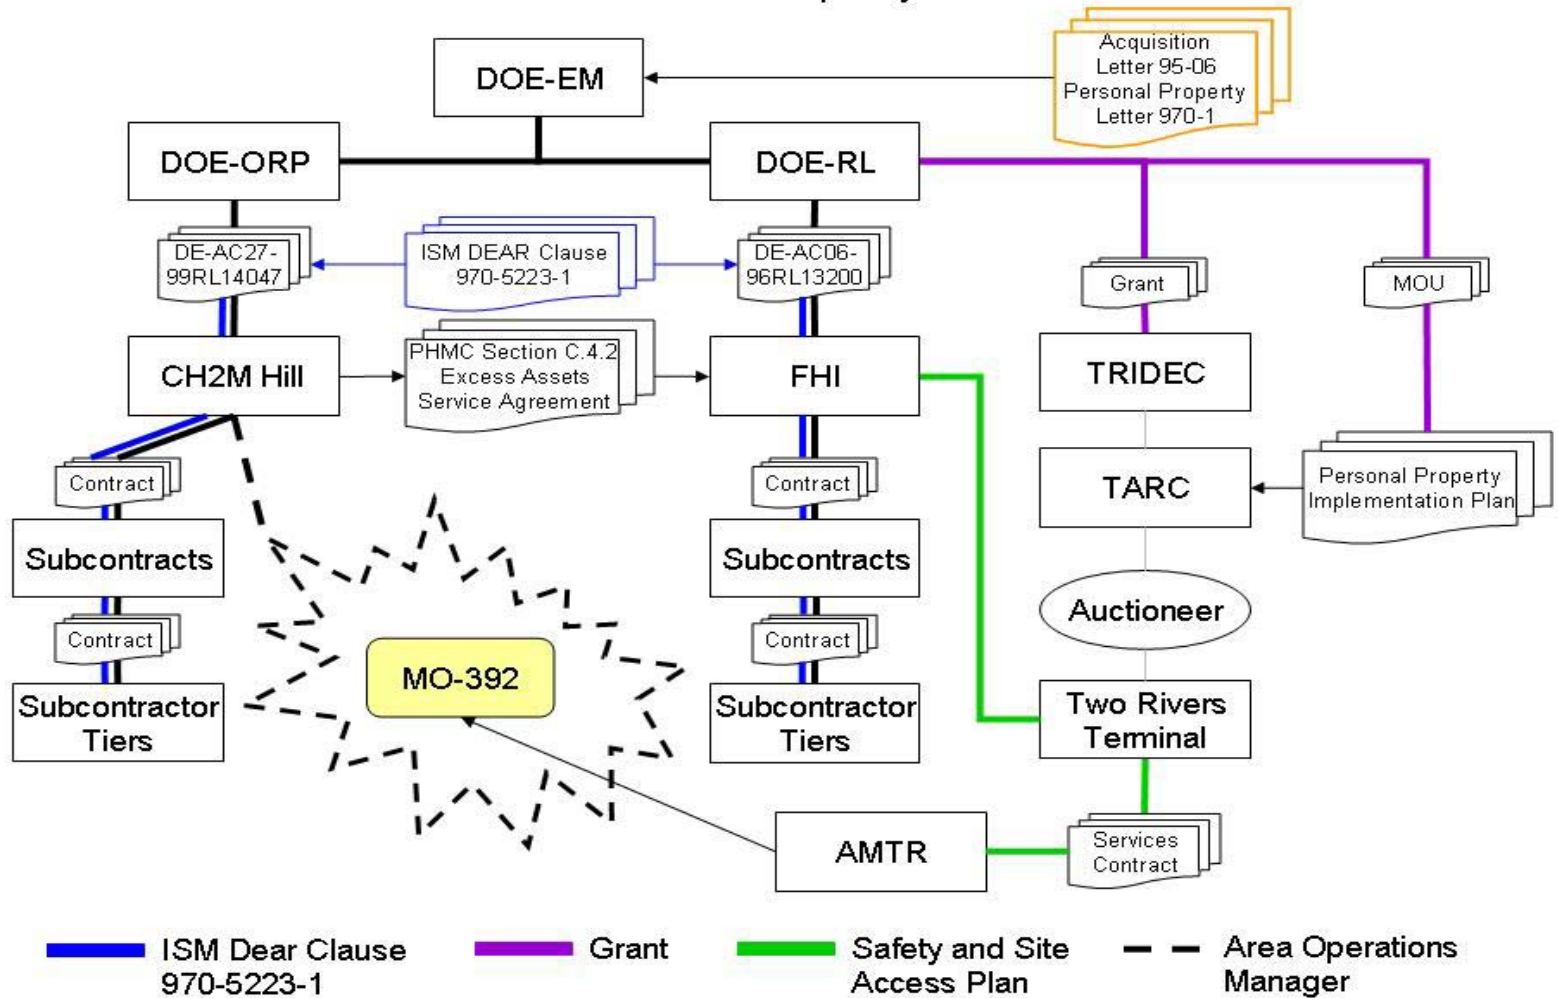
The relationships depicted in Figure 3-1 are discussed below. A DOE-RL grant established TRIDEC as the CRO in 1994. In 1999, DOE-RL and TARC (as the directed representative of the CRO [TRIDEC]), established a Personal Property Transfer Implementation Plan. The plan was set to expire in five years (June 2004) and was not renewed prior to that date. The Personal Property Transfer Implementation Plan implements the provisions in Personal Property Letter 970-1, which states DOE will transfer property to the CRO and move it to an area controlled by the CRO. As discussed in Section 3.1.1, all involved parties have been negotiating a revision to the Personal Property Transfer Implementation Plan. DOE-RL, FHI, and TARC were operating to the draft Personal Property Transfer Implementation Plan without formal procedures.

DOE-RL and FHI used informal procedures to establish and manage safety for CRO related work performed on site. DOE-RL and FHI accepted the performance of unstructured work on the Hanford Site.
