**TYPE A ACCIDENT INVESTIGATION
OF THE MARCH 16, 2000
PLUTONIUM-238 MULTIPLE INTAKE
EVENT AT THE PLUTONIUM
FACILITY LOS ALAMOS NATIONAL
LABORATORY
NEW MEXICO**

July 2000
Prepared by
Office of Oversight
Office of Environment, Safety and Health
U.S. Department of Energy

Executive Summary

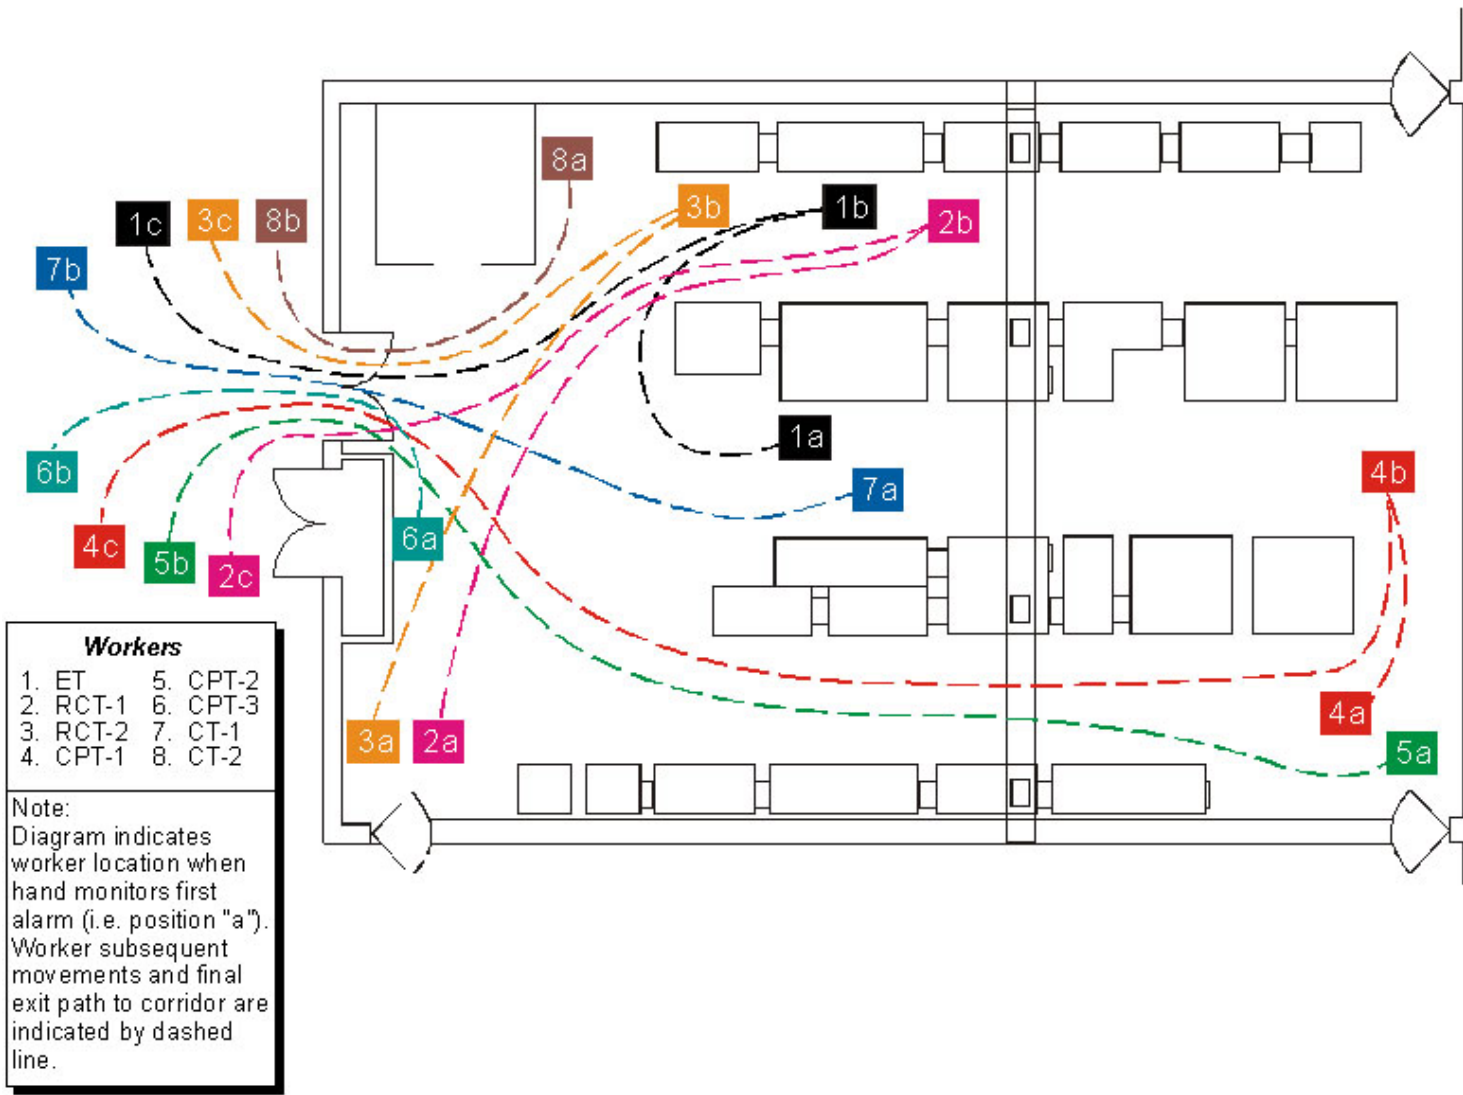
Figure 2-1. Locations and Exit Paths of Workers

- Two Chemical Technicians (CT-1 and CT-2) associated with the electrolytic decontamination of the glovebox being examined by ET; CT-1 was on the east side of the glovebox, and CT-2 was at the desk in the southwest corner.

[Figure 2-1](#) illustrates the room orientation with the location and paths taken by the eight workers, from just before the first hand monitor alarm until exiting to the corridor.

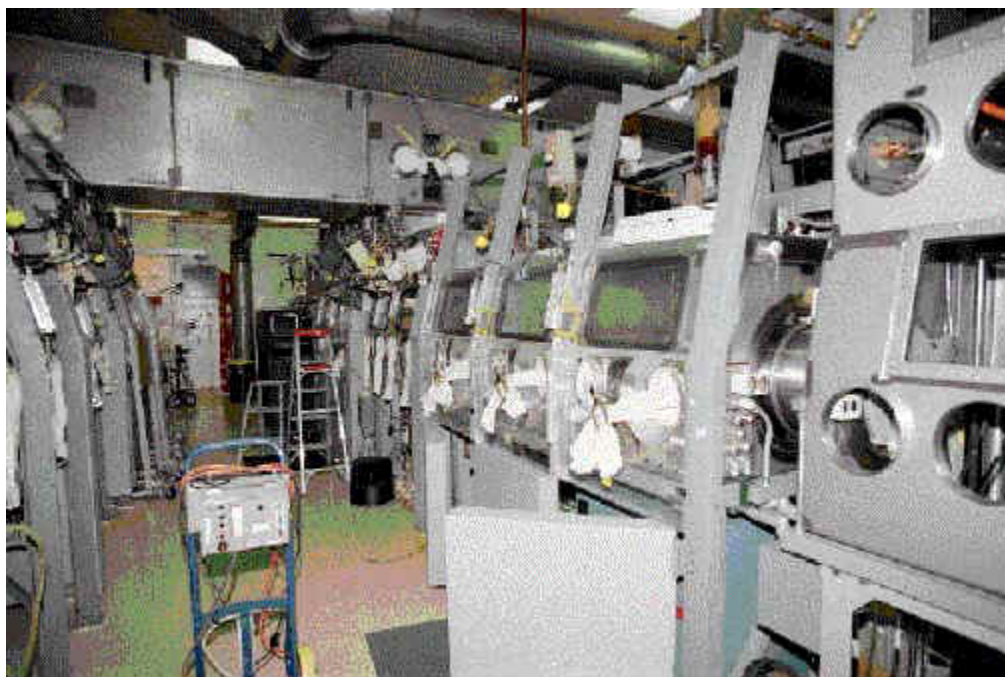
**Exhibit
2-1. Affected
Line of
Gloveboxes**

On March 16, 2000, a release of material containing Pu-238 occurred in one room of Building PF-4 in TA-55. Present in the room at the time were (refer to Figure 2-1):

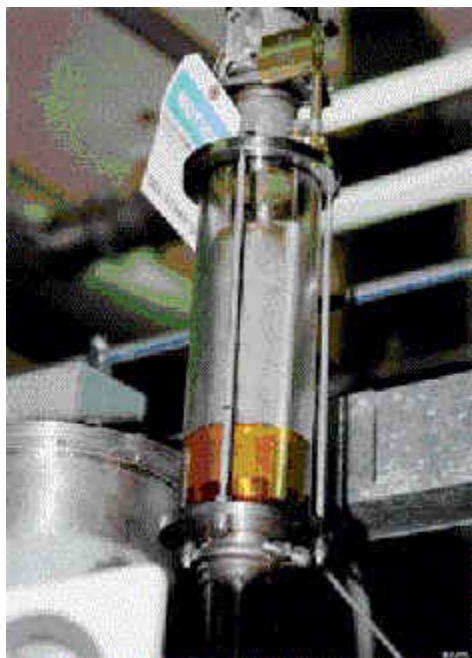
Exhibit 2-2. Glovebox Bubbler

On March 16, 2000, a supervisor, performing his morning walkdown of glovebox lines in TA-55, noted that one glovebox had no argon flow through its oil bubbler. This inert glovebox has an argon atmosphere, maintained by a system that provides argon to the glovebox when its pressure falls below a specific setpoint and by an oil bubbler that regulates the negative pressure in the glovebox.

ET was examining the argon purge line for an inert glovebox that is purged with argon and maintained at a negative pressure with respect to the room. To maintain an inert, dry, and specific negative pressure in this glovebox, argon is supplied through a solenoid valve that is actuated by a photohelic pressure sensor. When pressure in the glovebox decreases below the desired negative differential pressure, the photohelic sensor energizes the solenoid valve to admit argon to the glovebox. This argon supply system is on the east side under the glovebox. Argon flow is controlled by a rotometer with an integrated throttle valve. The argon is exhausted from the glovebox to the appropriate facility ventilation header through a high efficiency particulate air (HEPA) filter and an oil bubbler (see [Exhibit 2-2](#)). The oil bubbler maintains the glovebox at a negative differential pressure based on the height of oil and the pressure in the ventilation header.
