OPERATING EXPERIENCE SUMMARY

OE Summary 2014-04

August 5, 2014

Scissor Lift Falls Over Inside Tank at Strategic Petroleum Reserve's West Hackberry Storage Site Resulting in Serious Injuries

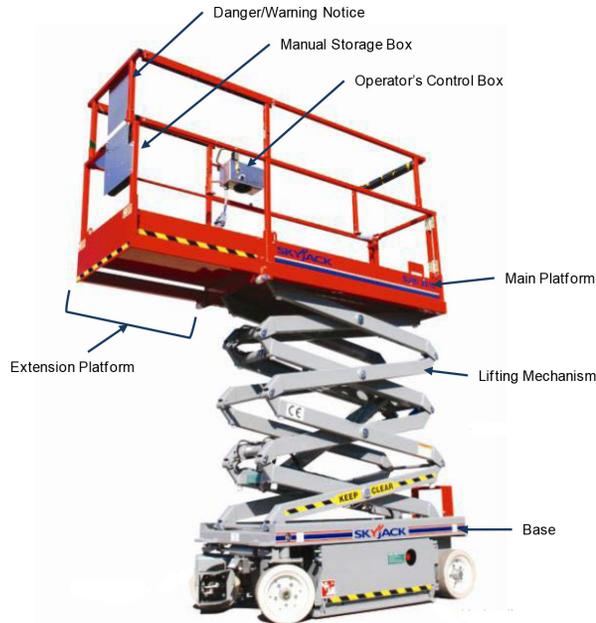
Figure 1-3. Skyjack SJIII 3226 Scissor Lift

Two rented scissor lifts were inside the tank. Blaster 1 was assigned to work from the smaller Skyjack Model SJIII 3226 (similar to the one pictured in Figure 1-3), and Blaster 2 was assigned to work from the larger JLG Model 2646ES. Both scissor lifts were designed to be raised to heights up to 26 feet. Blaster 1 completed the PBC *Aerial Man Lift Preventive Maintenance Checklist* for his assigned Skyjack and did not note any unsatisfactory conditions.
