OPERATING EXPERIENCE SUMMARY

OE Summary 2014-06

December 16, 2014

Truck Fire Underground at the Waste Isolation Pilot Plant

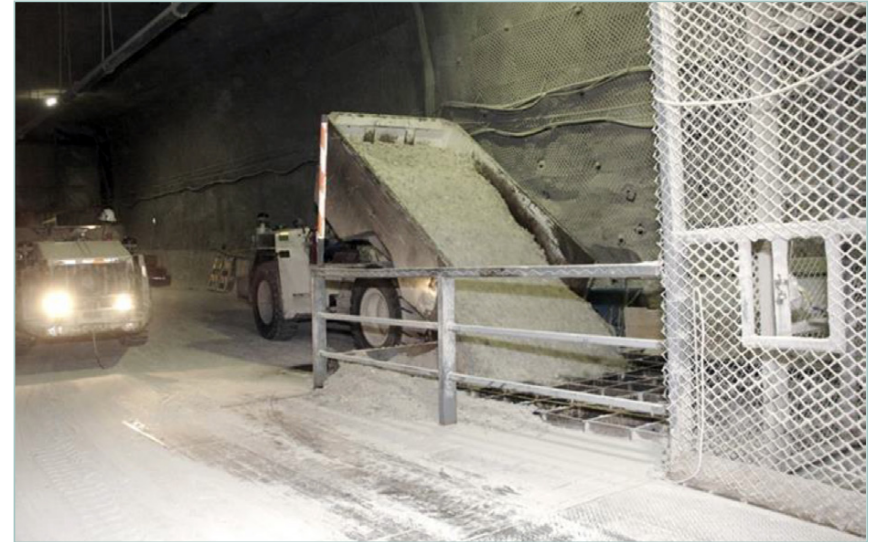
Figure 1-2. Mined salt is dumped at the loading pocket

The principal waste operations performed at WIPP involve (1) mining of underground rooms to provide space for waste emplacement and (2) receipt and disposal/storage of TRU waste. Salt is mined out of the ground to create the large rooms is loaded onto salt haul trucks and hauled to the loading pocket at the salt handling shaft, where it is dumped and then taken to the surface via the salt hoist (Figure 1-2). It was during one of these unloading operations that the truck caught fire, leading to the evacuation of the underground.
