U.S. Department of Energy Office of Environmental Management

Accident Investigation Report

Phase 1 Radiological Release Event at the Waste Isolation Pilot Plant on February 14, 2014

April 2014

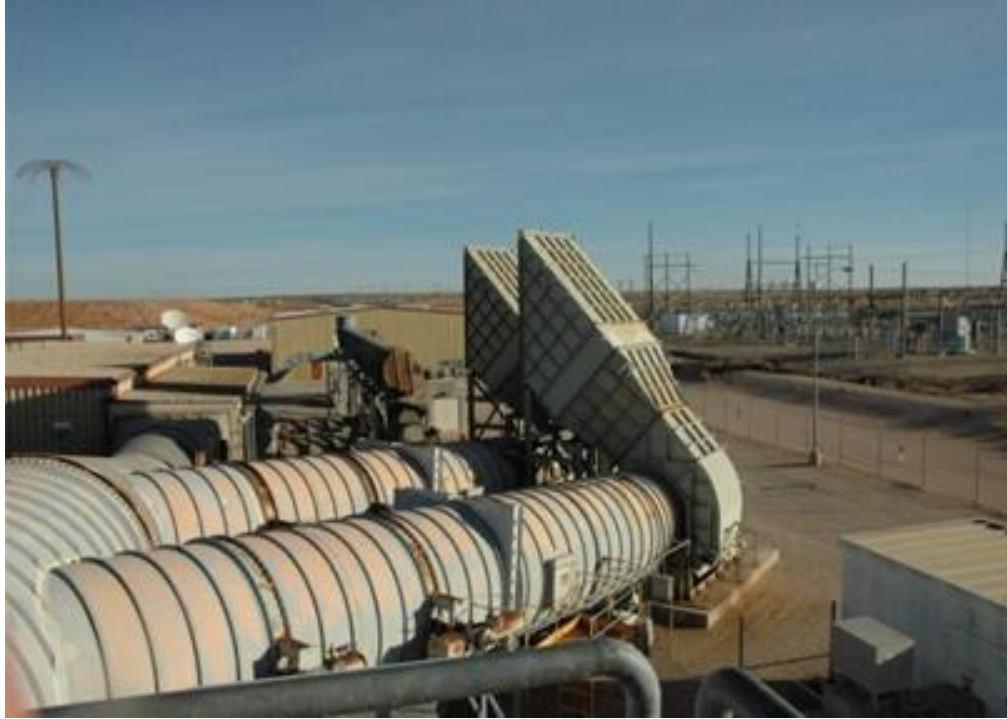
Figure 19: Ventilation Fans 700A and 700B

The exhaust fans serving the underground ventilation are located on the surface. A combination of six fans provides airflow for the U/G ventilation system. Three large main (700) fans rated nominally at 260,000 cfm discharge directly to the atmosphere. Three smaller 860 fans, rated nominally at 60,000 cfm, draw ventilation through HEPA filtration and discharge to a small stack monitored for radiological release. The 860 fans can also exhaust the underground directly through a filtration bypass duct. (Figure 18 and Figure 19)
