U.S. Department of Energy Office of Environmental Management

Accident Investigation Report

Phase 2 Radiological Release Event at the Waste Isolation Pilot Plant, February 14, 2014

April 2015

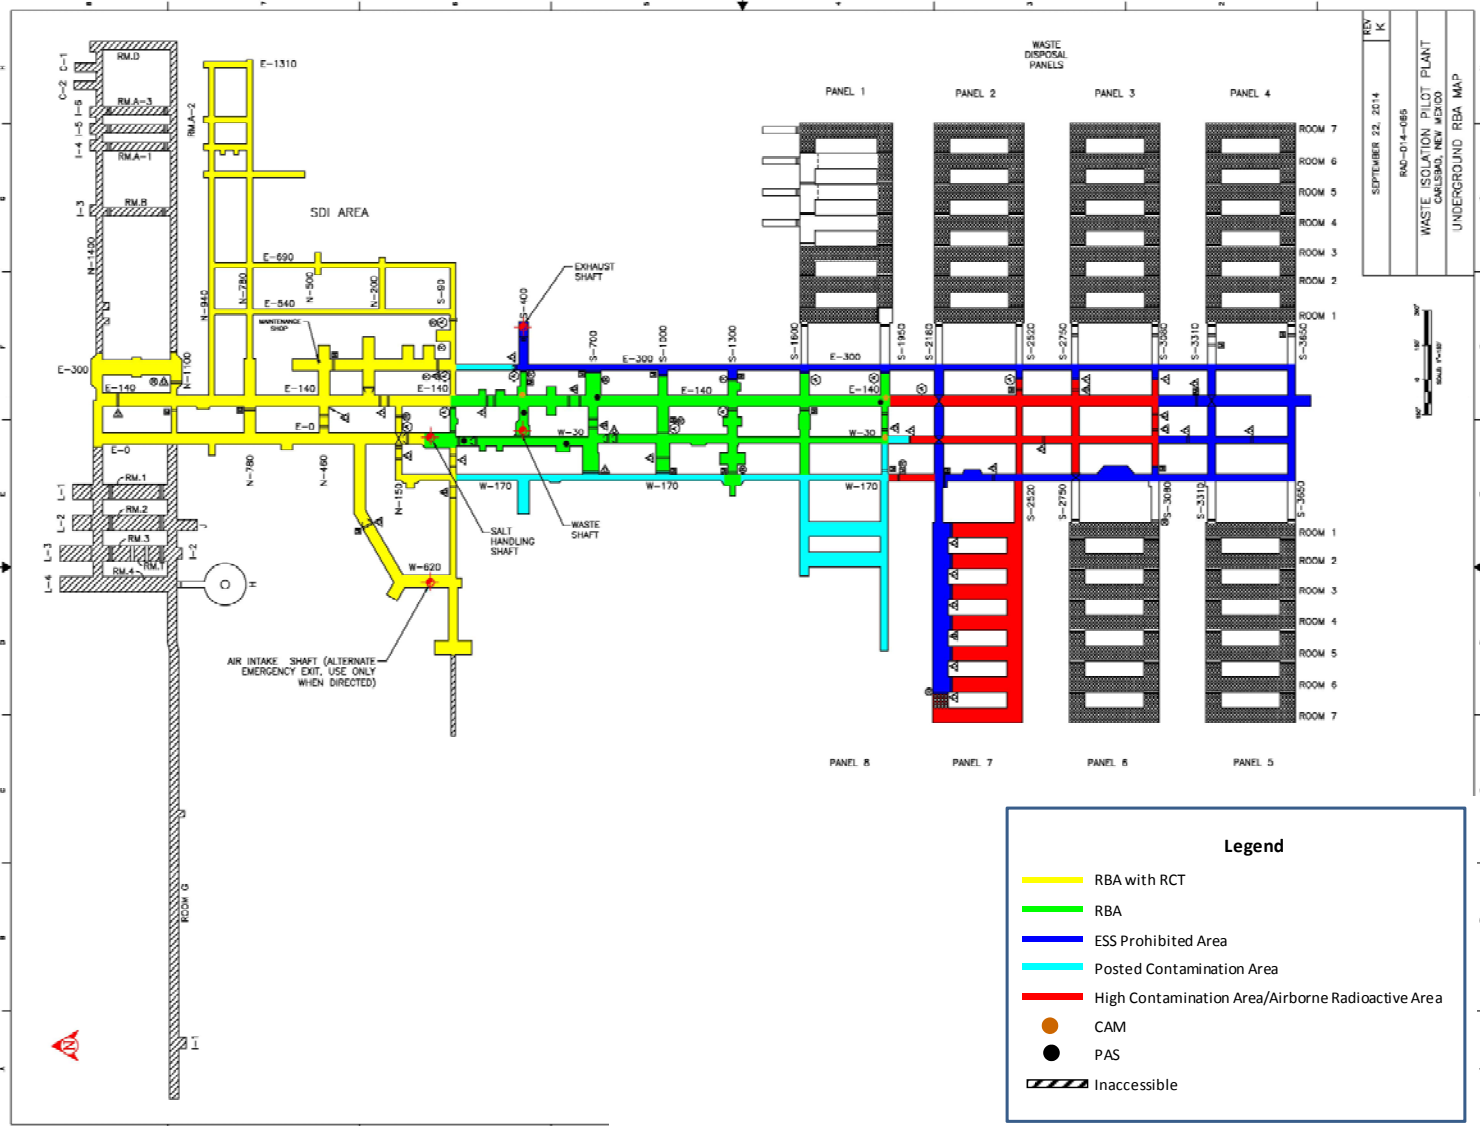
Figure 2-1: WIPP Underground RBA Map

activity contamination levels, with no beta or dose rate information collected. Radiological survey results of Panel 7 indicated that the general surface alpha contamination levels in Room 7 of 8,000 – 40,000 dpm, Room 6 of 10,000 – 20,000 dpm, and Room 1 of 6,000 – 28,000 dpm. More specific details are provided in Section 6.3, Radiological Forensics (Figure 2-1).

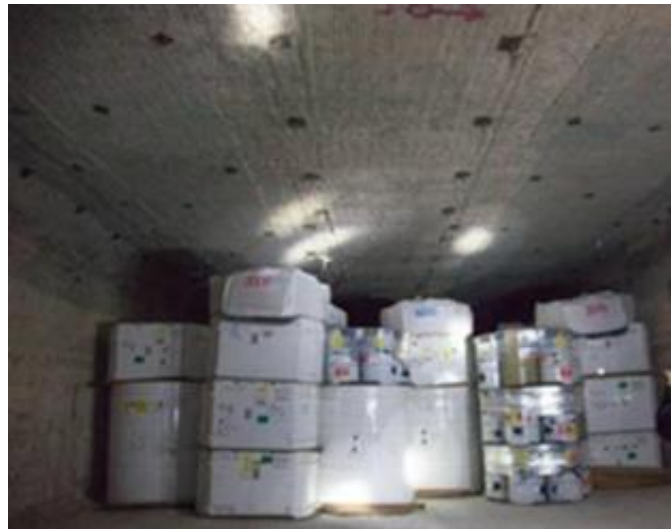
Figure 2-5: Panel 7 Room 7 Waste Face

On January 31, 2014, drum 68660 was emplaced at Panel 7 Room 7, Row 16, Column 4 (R16: C4) in the WIPP underground (Figure 2-5).

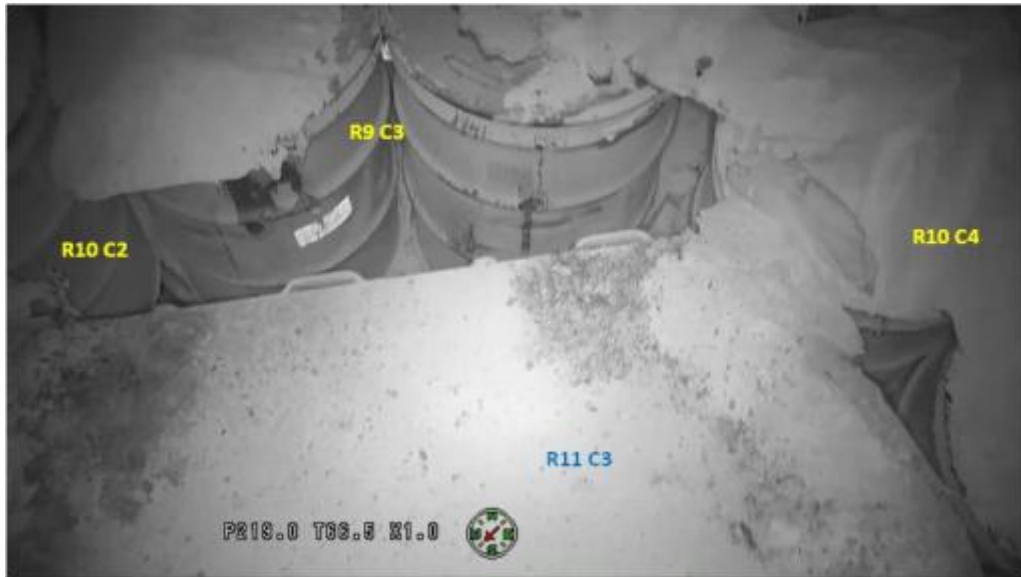
Figure 6-21: R9:C3 West Side

had no observable fire damage, stretch wrap at each of the other five stacks was damaged or missing. The 55GD assembly reinforcement plates at R9:C3 and R9:C5 melted, mixed with MgO, solidified on the drum lids, and cracked into pieces (Figure 6-19, Figure 6-20, Figure 6-21, Figure 6-22, Figure 6-23 and Figure 6-24). There was no evidence of reinforcement plate remaining between the drums. In some instances melting polyethylene formed streaks on the on the side of these drums. In addition, MgO slumped onto some of the drums in both locations.

The MgO super sacks in Row 10 were damaged, with most of the fabric melted or gone (Figure 6-21, Figure 6-22, Figure 6-24, Figure 6-25, and Figure 6-26). The residual MgO formed conical piles consistent with the outline of the waste containers on the top tier at each stack. At R10:C6 the 100GD assembly slip sheet, the middle tier reinforcement plate and slip sheet, were partially damaged and conformed to the outline of the drums (Figure 6-27). Many locations had

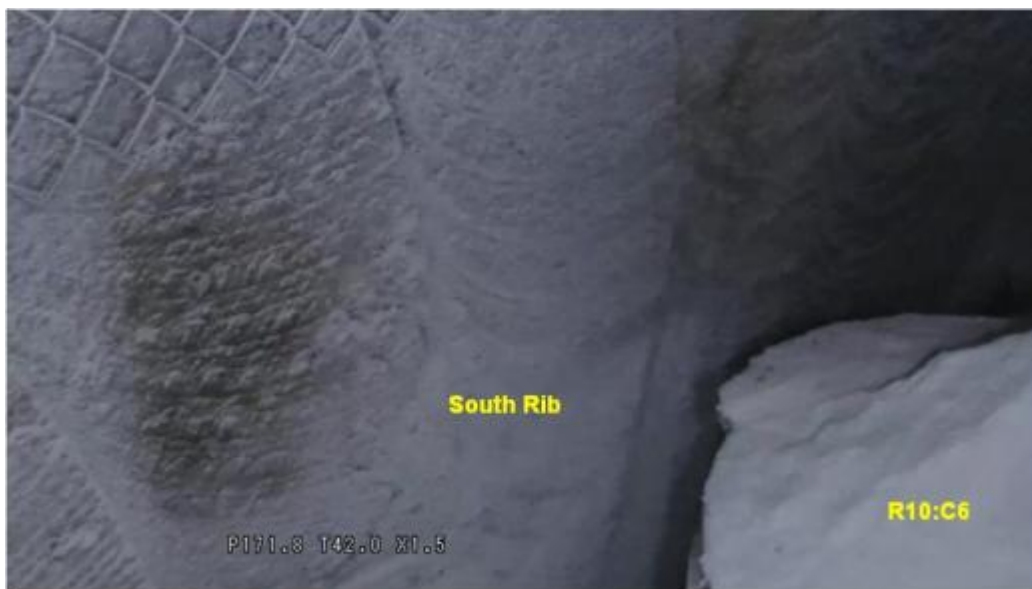
evidences of black discolorations on the sides of the waste drums. There was also evidence of flame impingement on the south rib (Figure 6-28).

Figure 6-28: Flame Impingement Evidence on South Rib near Row 10

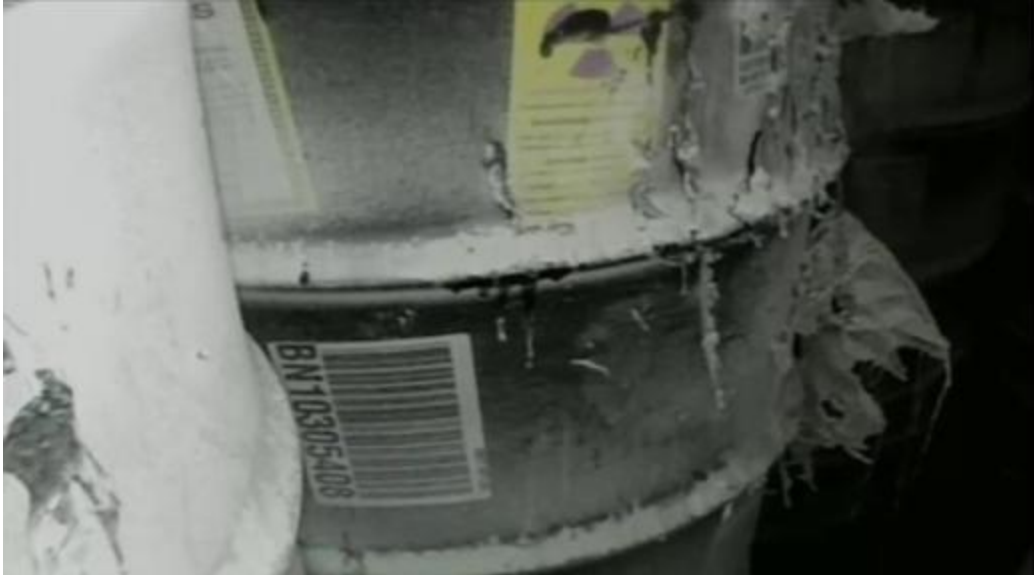
Figure 6-34: Drum in R15:C3 on Bulkhead Side Looking Southeast

The reinforcement plate at R15:C3 was damaged. The missing plate material conformed to the outline of the seven drums, including the spaces between the drums (Figure 6-33). There was residual stretch wrap visible on some portions of the assembly and some of the drum labels were undamaged (Figure 6-34). The TDOP below the 55GD assembly was undamaged.

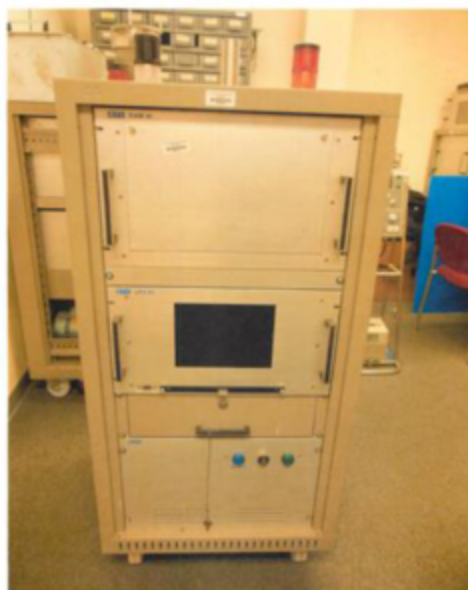
On Friday, February 14, 2014, at approximately 2314, a "HI HI" radiation alarm was received in the Central Monitoring Room (CMR) at the DOE WIPP facility approximately 27 miles east of Carlsbad, New Mexico. The alarm was triggered from a CAM (Figure ES-1) in the U/G which was monitoring airborne radioactivity levels in air exhausting from Panel 7, an active waste panel where TRU waste was being emplaced for disposal.

Figure ES-1: RADOS Continuous Air Monitor
