Accident Investigation Report

Underground Salt Haul Truck Fire at the Waste Isolation Pilot Plant February 5, 2014

March 2014

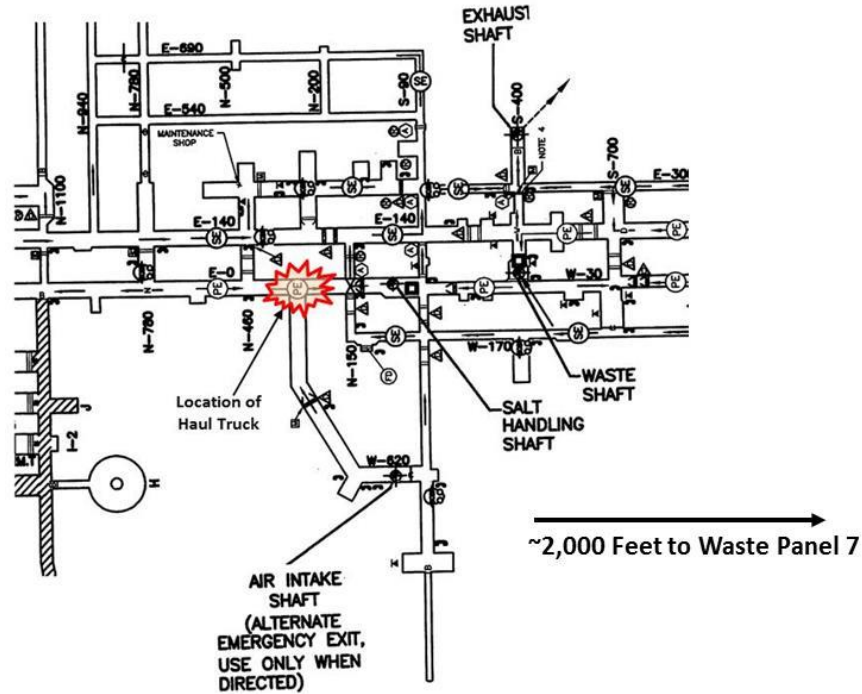
Figure 3: Location of the Haul Truck during the Fire

The WIPP underground consists of the waste disposal area, construction area, north area, and Waste Shaft station area. The location of the accident is shown in Figure 3.
