# U.S. Department of Energy Office of Environmental Management

## Accident Investigation Report

## Phase 2 Radiological Release Event at the Waste Isolation Pilot Plant, February 14, 2014

April 2015

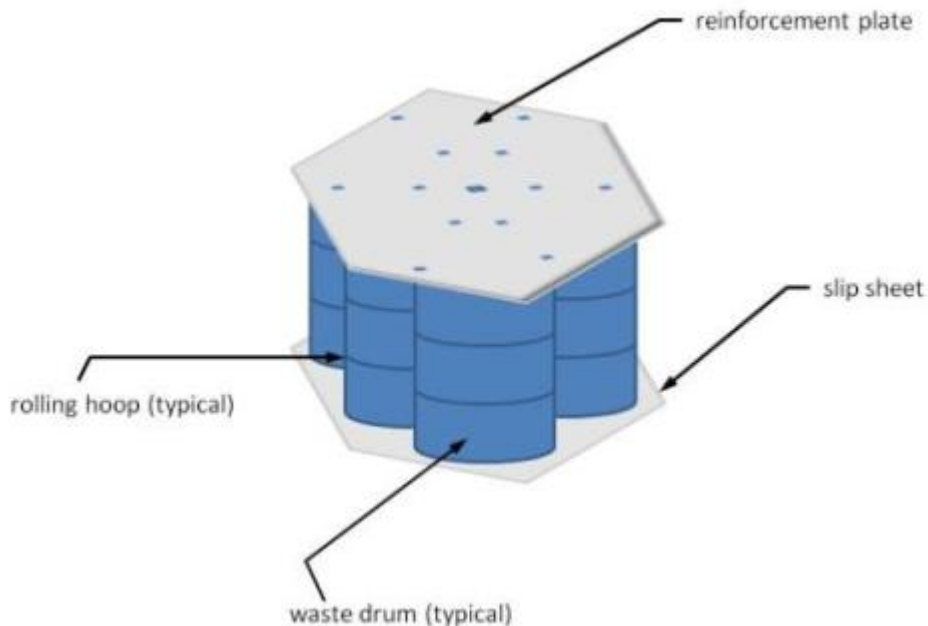
**Figure 6-3: Drum Waste Assembly with Slip Sheet and Reinforcement Plate**

Visual damage within the waste array was most severe at, or near, locations with 55GD and 100GD. These were locations with higher quantities of combustibles external to the waste containers such as fiberboard and polyethylene slip sheets, reinforcement plates, stretch wrap, cardboard stiffeners and polypropylene super sack fabric (Figure 6-3). Evidence of both melting and ignition were identified at these locations. Polyethylene is categorized as an easy-to-ignite material and has a melting temperature range of 122 – 135°C (NFPA 921, pp 51) and the observed damage was consistent with this information.

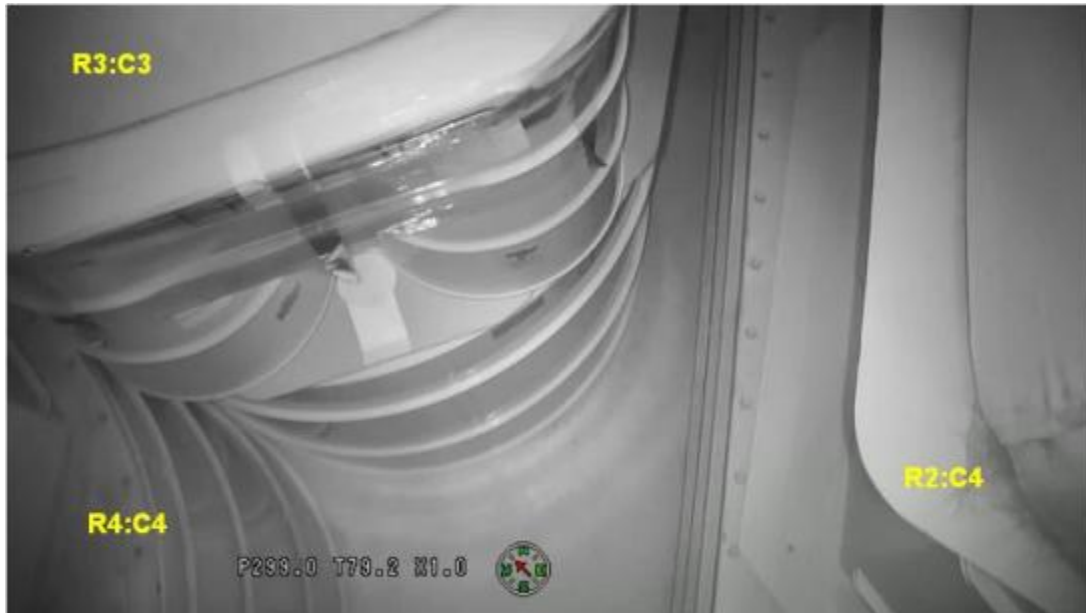
**Figure 6-8: Undamaged Stretch Wrap at R3:C5**

Rows 2 through 7 contained a mix of TDOPs, SWBs, 55GD assemblies, 100GD assemblies, and Standard Large Box Type 2s. These rows were closest to the bulkhead. The inspection identified no fire-related damage to the polyethylene stretch wrap or the polypropylene super sacks in these rows. The lack of damage to the polyethylene stretch wrap in these rows establishes that the bulk air temperature passing over the array was low, nominally below 135°C, which is the upper value of the melting temperature range of the polyethylene stretch wrap<sup>12</sup> (Figure 6-7, Figure 6-8 and Figure 6-9).

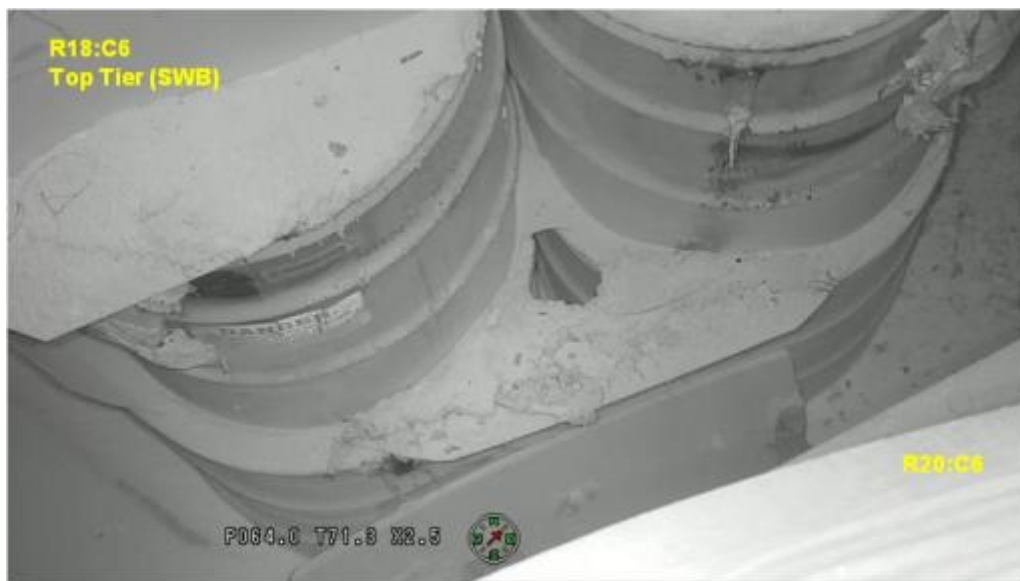
**Figure 6-12: Face Side (west) of R18:C6 Middle Tier**

Based on the orientation of the stack, the stack damage, and the ventilation direction, a hot or flaming ember is considered a plausible means of fire propagation to R18:C6. This ember landed on the fiberboard slip sheet that was below this SWB and caused ignition of the fiberboard. The fire consumed the exposed fiberboard above the two west drums (the drums on the face-side of the array, Figure 6-11). The reinforcement plate below the fiberboard burned and melted with the remaining material following the contour of the two west drums (Figure 6-12). The middle-tier stretch wrap on the west side was also damaged. There are streaks of polyethylene on the sides of the waste drums. The slip sheet and reinforcement plate between

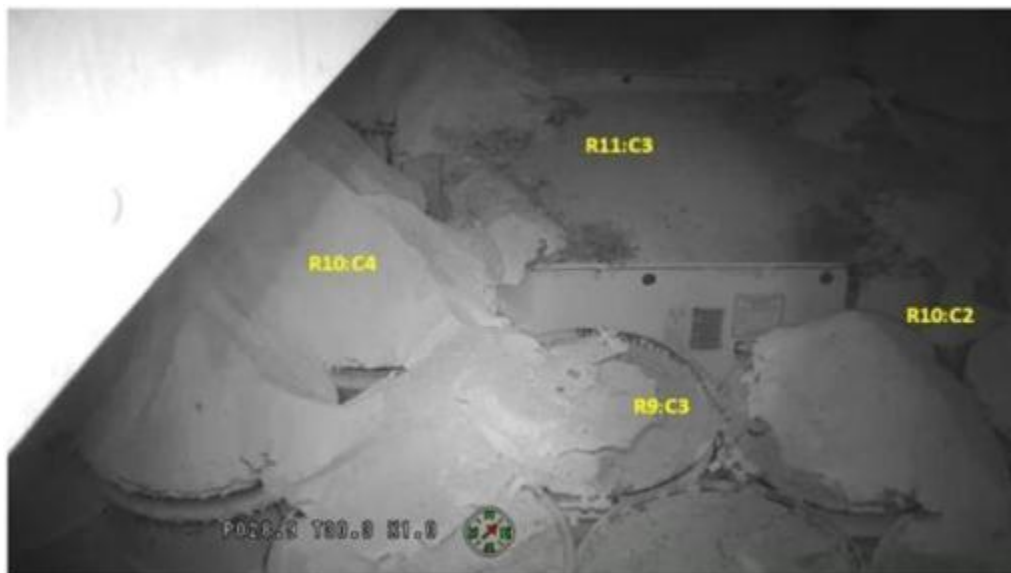
**Figure 6-24: R10:C2, R9:C3 and R10:C4 East (Bulkhead) View**

The MgO super sacks in Row 10 were damaged, with most of the fabric melted or gone (Figure 6-21, Figure 6-22, Figure 6-24, Figure 6-25, and Figure 6-26). The residual MgO formed conical piles consistent with the outline of the waste containers on the top tier at each stack. At R10:C6 the 100GD assembly slip sheet, the middle tier reinforcement plate and slip sheet, were partially damaged and conformed to the outline of the drums (Figure 6-27). Many locations had

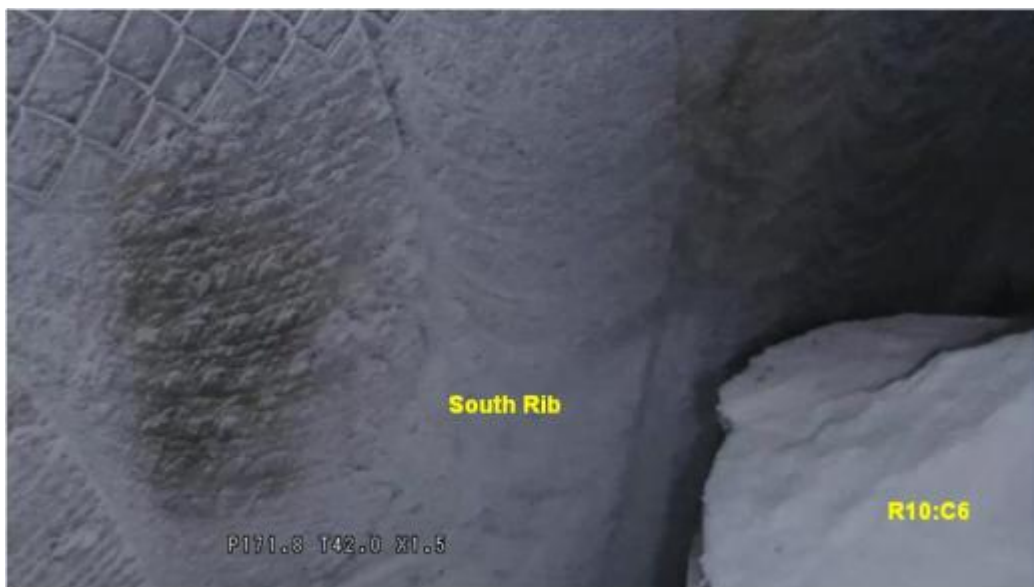
evidences of black discolorations on the sides of the waste drums. There was also evidence of flame impingement on the south rib (Figure 6-28).

**Figure 6-28: Flame Impingement Evidence on South Rib near Row 10**

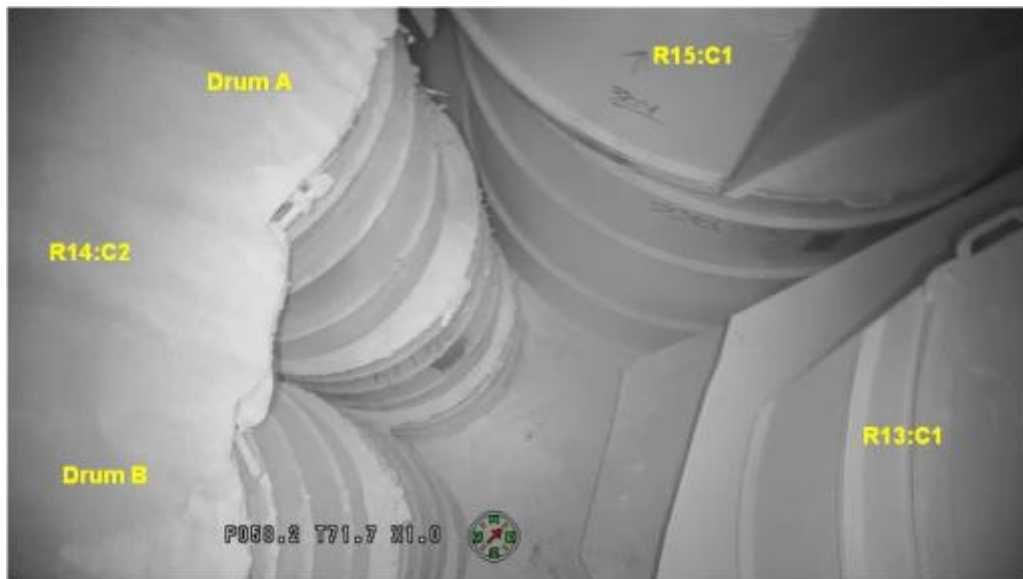
**Figure 6-29: North View**

The exposed plastics (fiberboard and polyethylene slip sheets, reinforcement plates, stretch wrap, cardboard stiffeners and polypropylene super sack fabric) in stack R14:C2 were severely damaged. The polyethylene plastic burned and melted to the outline of the waste drums (Figure 6-29 and Figure 6-30). The MgO formed three conical piles on the three top-tier drums (Figure 6-31). The 100GDs were originally a glossy black, but were covered with a coating of fine white powder (Figure 6-32).

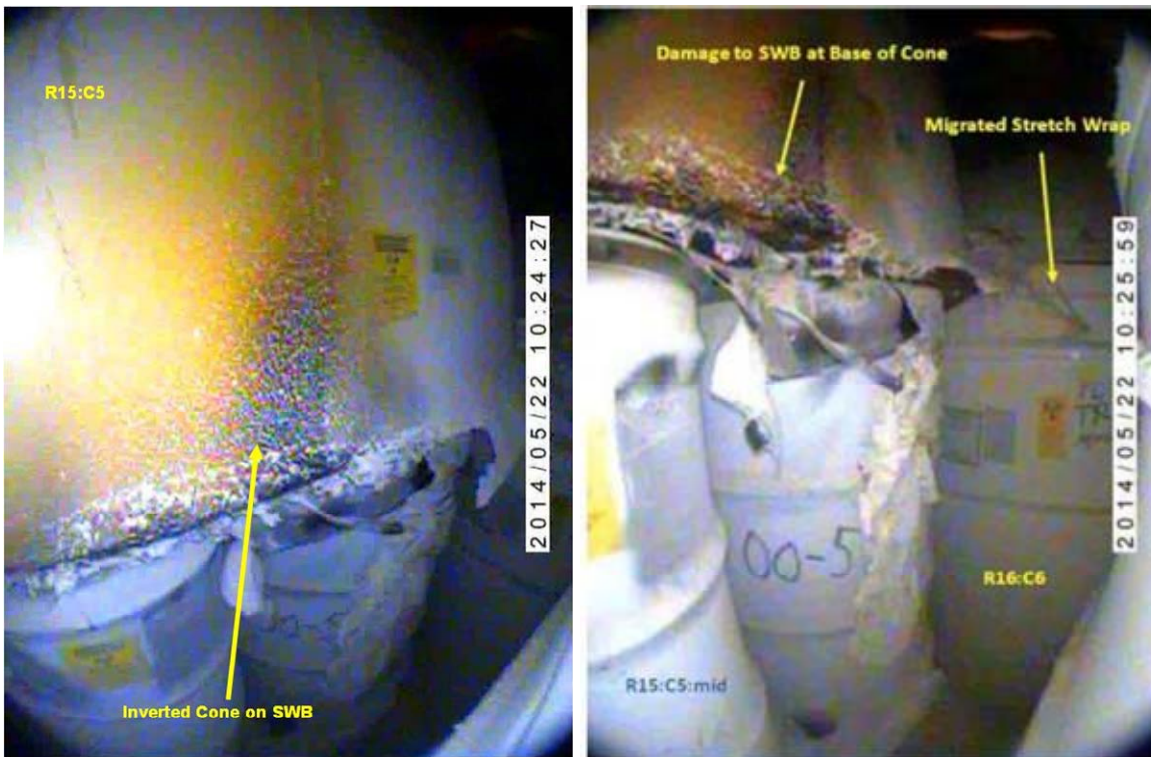
Figure 6-36: Side of SWB at R15:C5:top

The reinforcement plate and fiberboard slip sheet between the middle and top tiers of R15:C5 was severely damaged and partly burned on the west (face) and north sides. Much of the polyethylene stretch wrap was missing from these locations. There was discoloration indicative of overheating on the west side of the SWB near the seal (Figure 6-35). There was an inverted-cone pattern on the SWB centered between the two west-most middle-tier drums (Figure 6-36). The fiberboard slip sheet had a U-shaped damage pattern (Figure 6-37). This is indicative of flame exposure to the fiberboard from below. When the flame exposure ceased, combustion of the horizontal fiberboard likely stopped. The fiberboard slip sheet and reinforcement plate were badly damaged below the north end of the SWB (Figure 6-38). Char from the slip sheet conformed to the middle tier 55GDs.

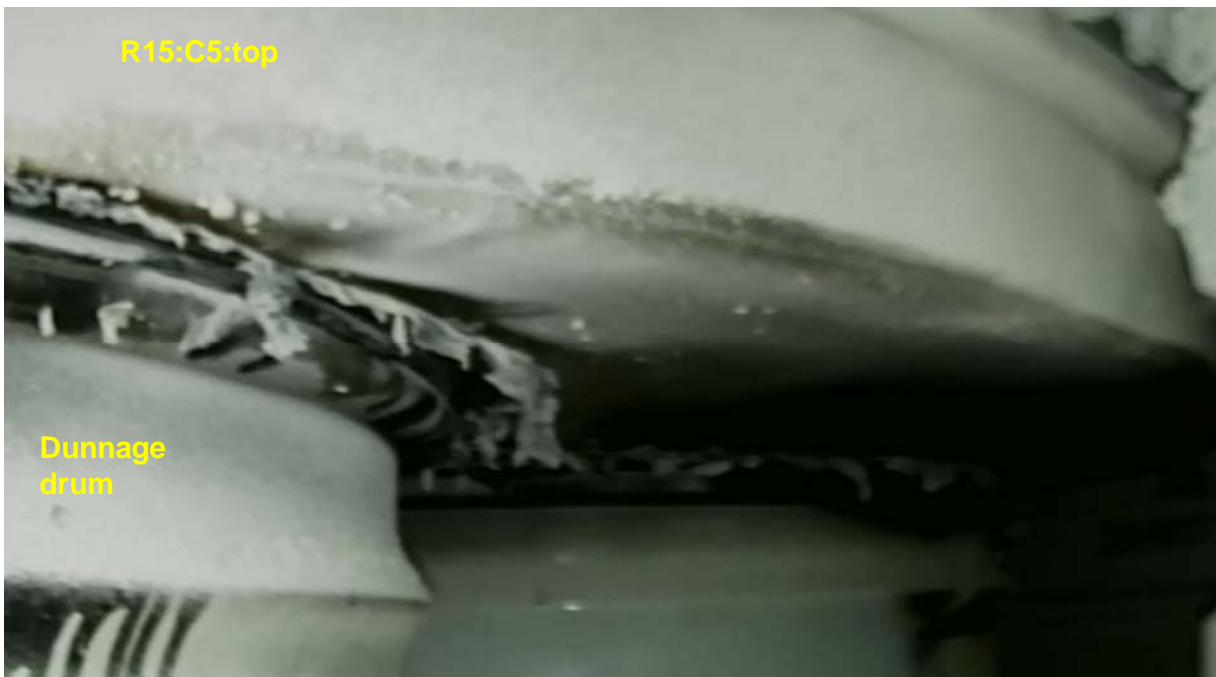
**Figure 6-38: North View of R15:C5, Bottom of SWB on Top Tier**

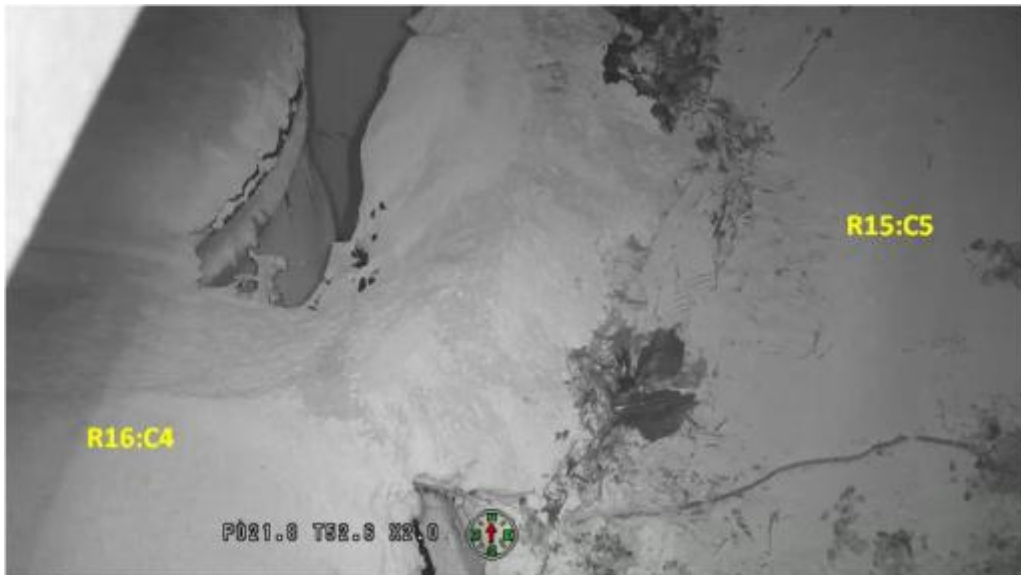
There was a moderate quantity of clumped material and MgO spillover on the SWB lid at R15:C5 (Figure 6-41). The depth of this material was greatest on the northwest corner where the stack is in close proximity to R16:C4 (Figure 6-42). The north end of the lid had evidence of combusted cardboard stiffener material from the MgO bag that was placed on top of R16:C4. Additionally, there was a fallen cardboard stiffener lying on the north end of the lid. There were two spots on the southeast and southwest corners of the lid where white MgO was seen on top of the discolored material spread across the remainder of the lid. This suggests that the MgO sacks on R16:C6 and R14:C6 spilled their contents sometime after the clumped material dispersed across the lid surface.

**Figure 6-42: Bridge between the R15:C5 SWB Lid and R16:C4**

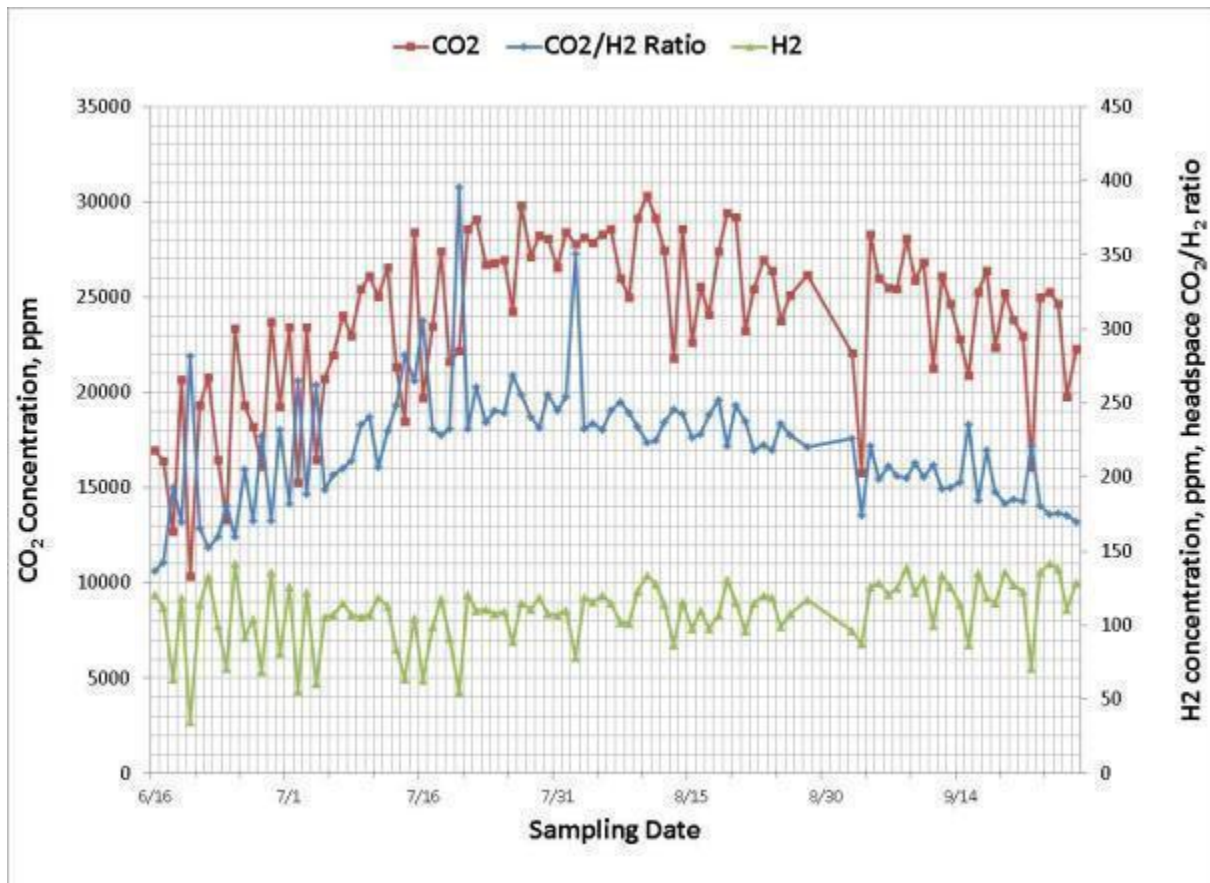
Figure 6-46: Headspace Sampling Results of CO<sub>2</sub> and H<sub>2</sub>

LANL conducted headspace gas sampling and thermography monitoring for the SWB containing drum 68685, the sibling drum of drum 68660. In addition, headspace gas sampling and thermography was performed for other remediated waste drums at LANL. The purpose of the gas sample analysis is to determine the presence and/or concentration of potential reaction products. The sampling was conducted via the vent port on the waste box, and thus is not able to directly sample the gases within the suspect drum, nor within any waste bags within the drum. The gases detected in the headspace gas sampling are consistent with oxidation. The headspace gas monitoring results are shown in Figure 6-46. The trend suggests that there is a chemical oxidation reaction occurring.

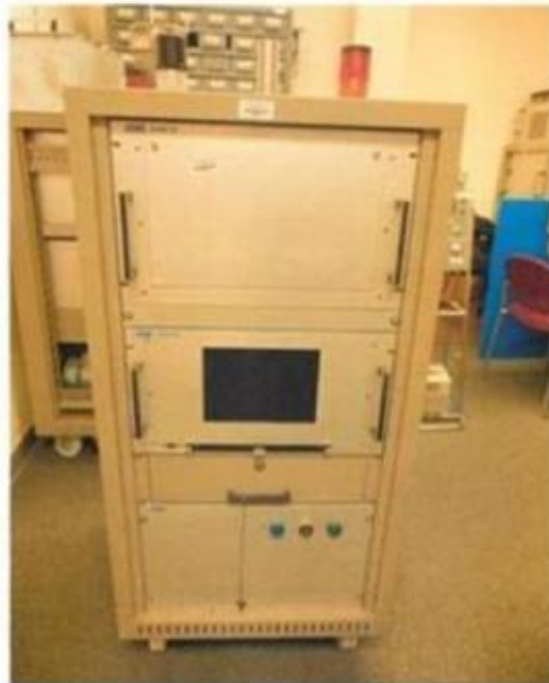
**Figure 6-47: RADOS Continuous Air Monitor**

Following the event, the CAM (Figure 6-47) filter housing was disassembled at SRNL. Each filter was assigned a specific number based on the order in which the filters were removed from the CAM cartridge, visually examined, and recorded. Each CAM filter was then screened by gamma pulse height analysis. The first six CAM filters were white and had low levels of activity; three of these are from routine monitoring before the event took place. The following 10 sample filters had various shades of black and brown, and had high levels of activity. Table 6-5 summarizes sampling start and stop time for each CAM filter and the DAC-hr value as recorded by the CAM, as well as total gamma emitting activity as measured by gamma pulse height analysis. CAM 151 filter papers are numbered and described in the order in which the filter paper was removed from the cartridge. The CAM 151 cartridge is loaded with filter papers with the earliest filters first. This means that the first filter used by the cartridge is the last filter paper to be removed. The CAM cache records indicate filter labeling as December 27, 2013 - 6 Filter 01 (Figure 6-48) through December 27, 2013 - 6 Filter 13 (Figure 6-49) during the period starting from February 12, 2014, 0304:43 through February 15, 2014, 0005:34 when the CAM shut down after the radiological event.

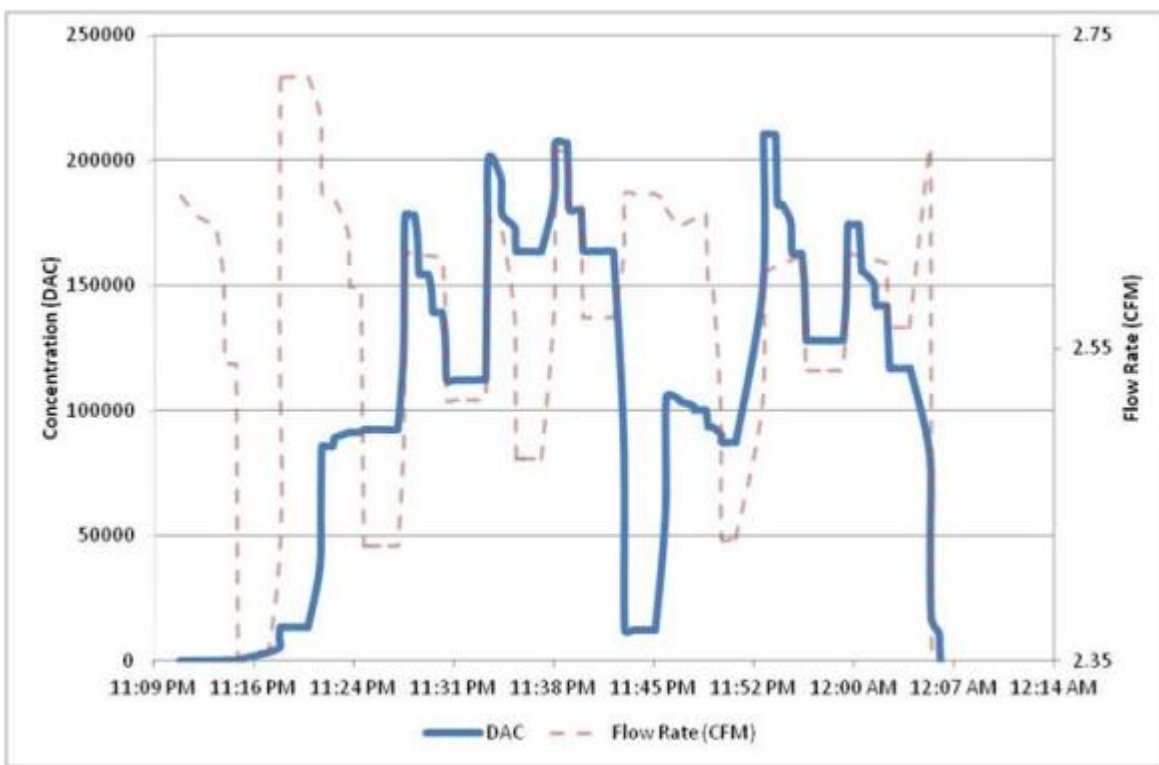
**Figure 6-50: Real-Time Air Concentrations Measured By CAM 151 with the CAM Flow Rate**

The total activity on each filter, expressed as DAC-hours, is related to the average air concentration over the entire period the filter was in use, and does not provide information about the fluctuation of real-time airborne concentrations during the time each filter is in use. As indicated in CAM log messages, the filter was rapidly clogging during the event, and required frequent filter changes at irregular intervals. However, as a filter is in use, the CAM is measuring the radioactivity on the filter at approximately 4-second intervals, and reporting the corresponding real-time concentration, which is then relayed to the CMS. The real-time DAC results are limited in their accuracy for quantitative results as the event progressed to later stages due to filter loading with ash/soot and potential alpha particle burial loss introducing measurement uncertainties; however the data are still appropriate for evaluating changes, trends, patterns, and timelines of the progression of airborne radioactivity concentrations. These real-time air concentrations as measured by CAM 151, along with the CAM flow rate, are presented in Figure 6-50.

CAM airborne radioactivity data correlates with the timeline for the event initiation, progression, and termination. The data indicated rapid increases/decreases in airborne radioactivity concentration over the duration. Three CAM filters (2, 7, and 11) were selected for extended gamma assays and chemical analyses. Extended gamma assays on those three CAM filters measured an actinide signature similar to what was found on the FAS. Table 6-6 is summary of the results of the three selected CAM filters.

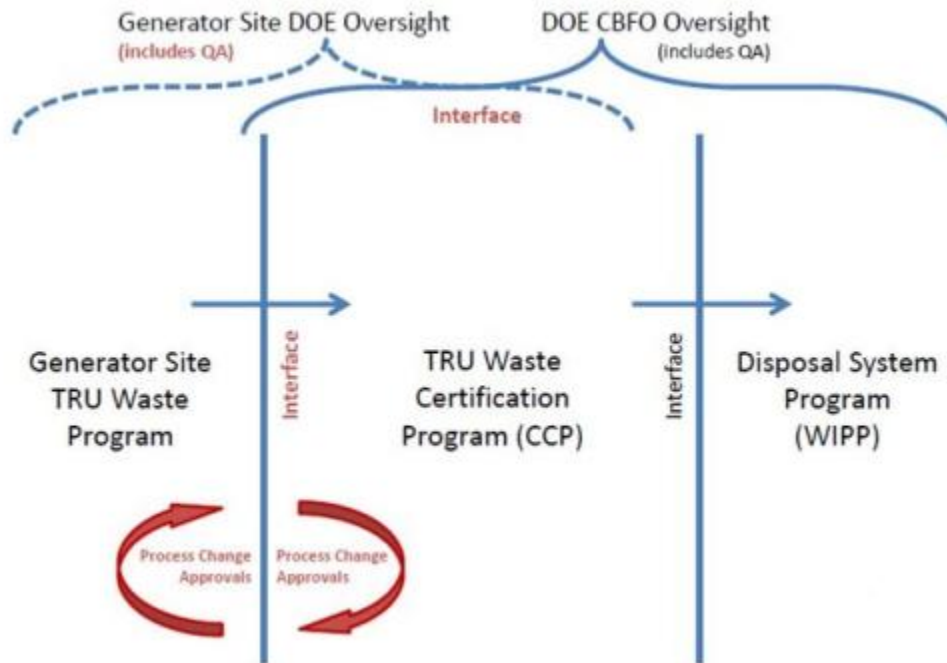
**Figure 9-1: Waste Characterization Program Interfaces and Oversight**

The Board also noted a lack of clearly defined Federal interface roles and responsibilities, and expectations between the LANL/generator site TRU waste program and the TRU waste certification program (CCP) as illustrated in Figure 9-1. Additionally, the Board identified inadequate CCP review and approval of waste management operating procedures/process changes, e.g., WCRRF glovebox operating procedure and inadequate Federal oversight of those processes.

- Inadequate separation of oversight and line management responsibilities within the CBFO National TRU Program was acknowledged by CBFO during the investigation.
- Lack of external/Headquarters oversight of all three key segments illustrated in Figure 9-1 of the National TRU Program including the generator site (LANL) TRU waste program, TRU waste certification program (CCP), and the disposal system program (WIPP).

**CON 18:** The Federal roles, responsibilities and execution for oversight of the activities between the generator site transuranic (TRU) waste program (LANL) and the TRU Waste Central Characterization Program (CCP) were inadequate.

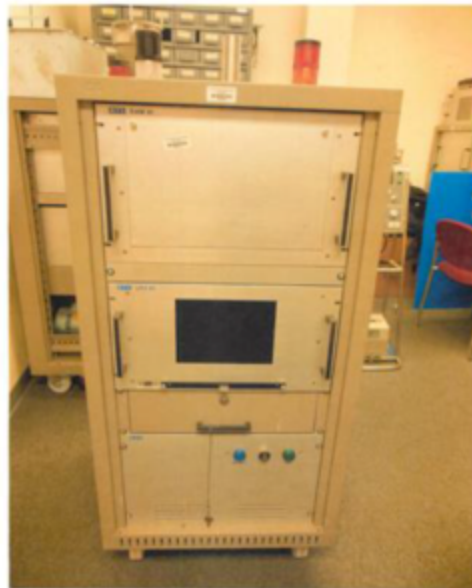
**Figure ES-1: RADOS Continuous Air Monitor**

On Friday, February 14, 2014, at approximately 2314, a "HI HI" radiation alarm was received in the Central Monitoring Room (CMR) at the DOE WIPP facility approximately 27 miles east of Carlsbad, New Mexico. The alarm was triggered from a CAM (Figure ES-1) in the U/G which was monitoring airborne radioactivity levels in air exhausting from Panel 7, an active waste panel where TRU waste was being emplaced for disposal.

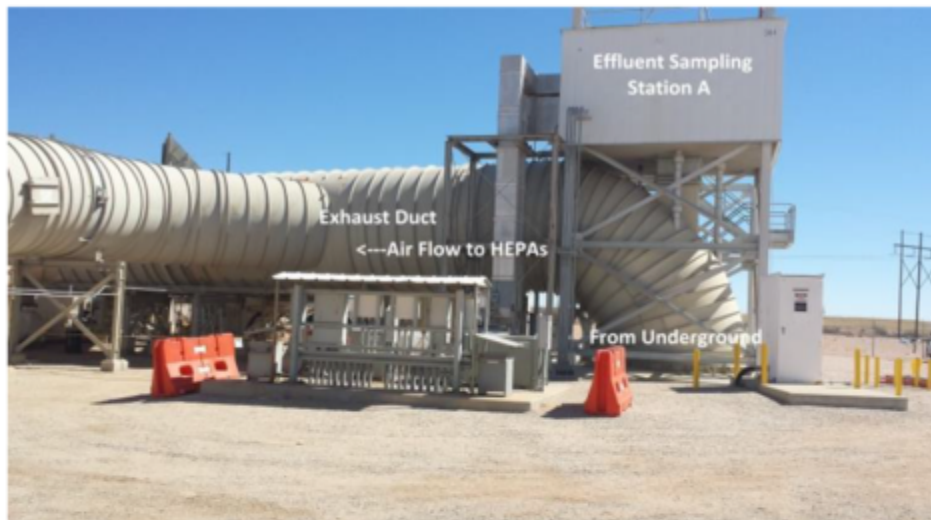
**Figure ES-2: Exhaust Air Shaft and Effluent Sample Station A**

On Saturday, February 15, 2014, the filters were counted at 0715; the RCM reported 4.4 million disintegrations per minute (dpm) alpha contamination on the filters from the effluent sample station upstream from the HEPA filters (Station A) (Figure ES-2). Preliminary data indicated the presence of TRU materials.

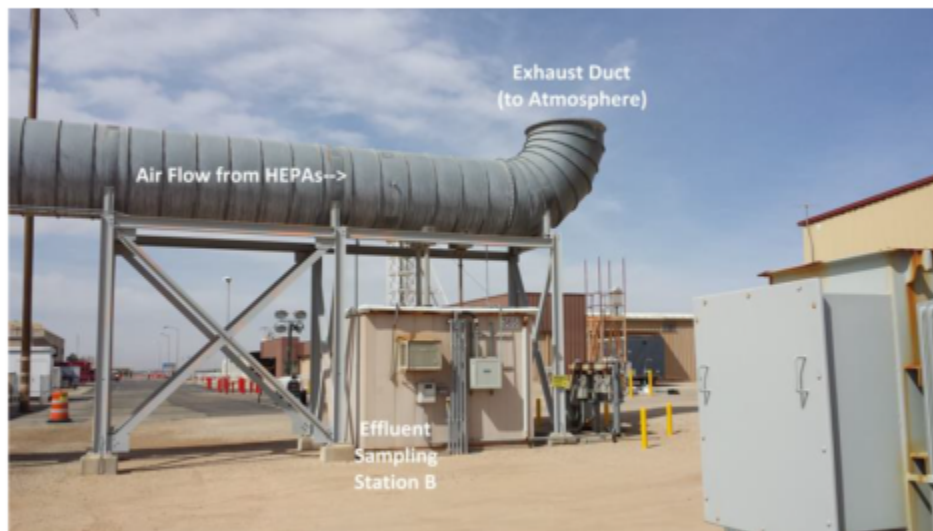
**Figure ES-3: Station B and Exhaust Duct**

Results from analysis of filters from the effluent sample station downstream of the HEPA filters (Station B) and at the discharge point to the atmosphere (Figure ES-3) were reported at 0915 and indicated 28,000 dpm alpha and 5,900 dpm beta contamination. This was the first indication that there was a release of contamination downstream of the HEPA filters to the environment.
