U.S. DEPARTMENT OF
ENERGY

Legacy
Management

2013 Annual Site Inspection and Monitoring Report for Uranium Mill Tailings Radiation Control Act Title II Disposal Sites

November 2013

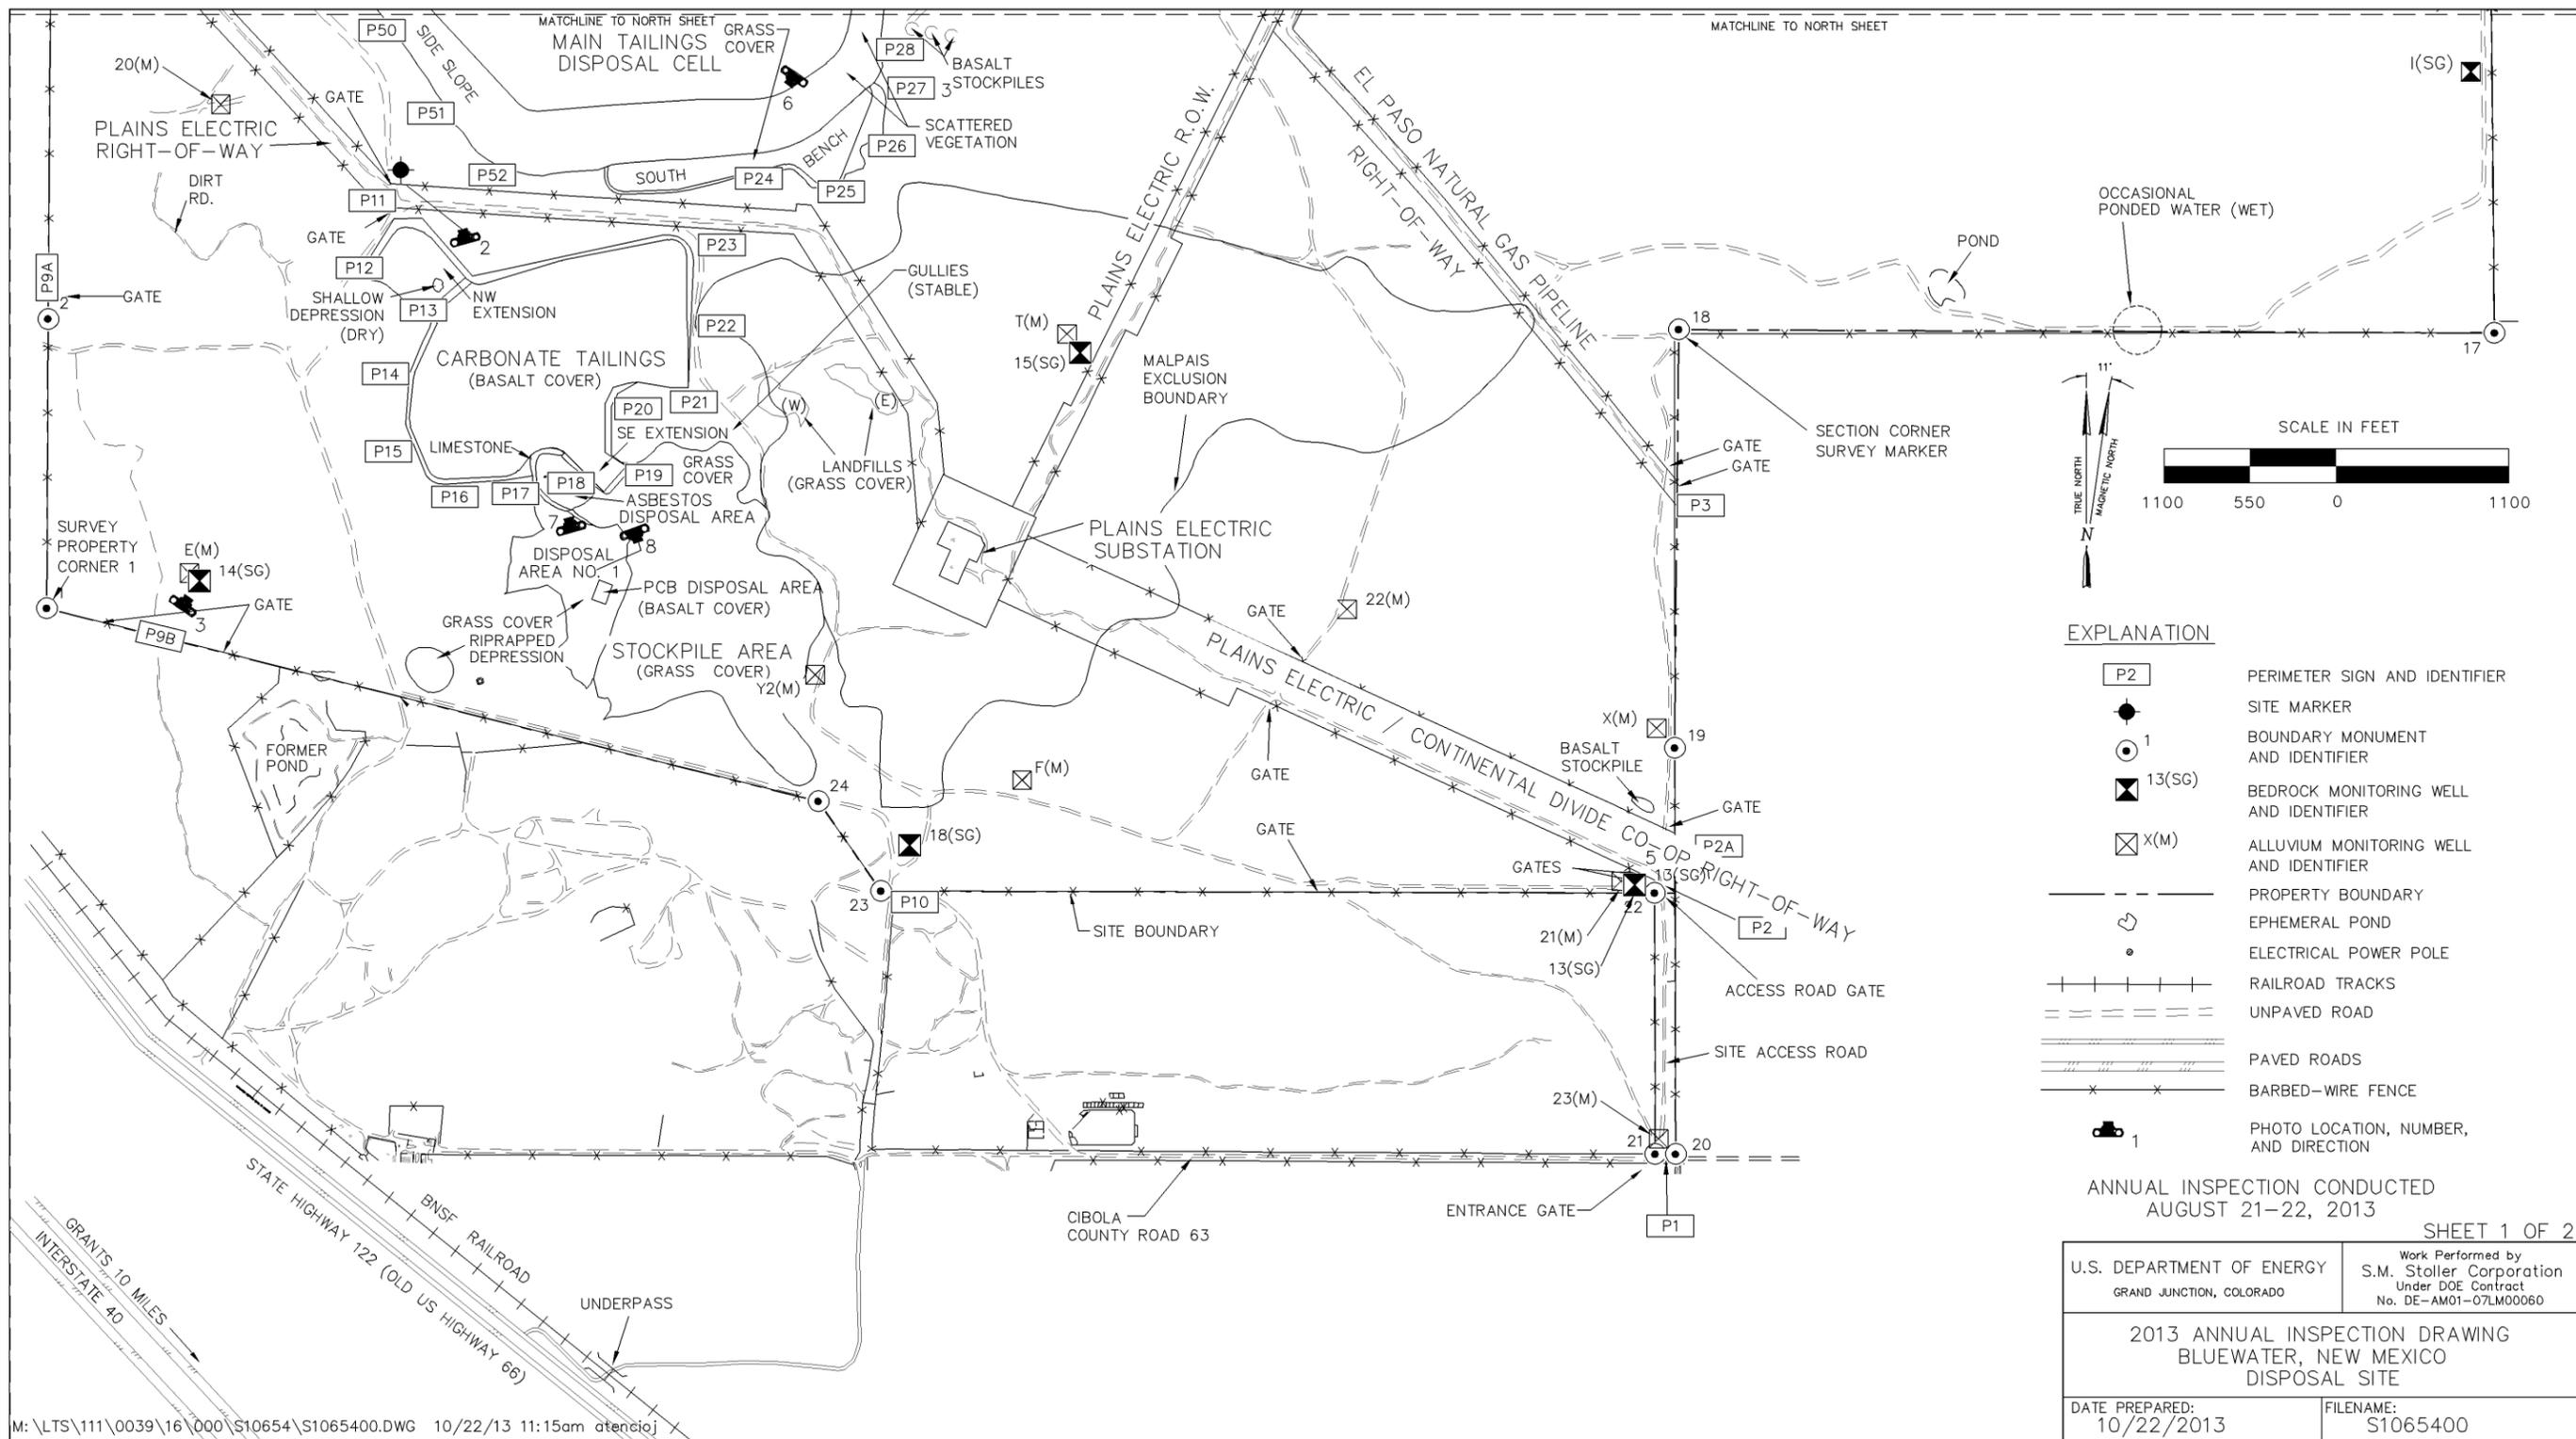
Figure 1-1. 2013 Annual Compliance Drawing for the Bluewater, New Mexico, Disposal Site (South Area)

The locations of site surveillance features are shown on Figure 1-1 (south area) and Figure 1-2 (north area). Inspection results and recommended maintenance activities associated with site surveillance features are included in the following subsections. Photographs to support specific observations are identified in the text and on the figures by photograph location (PL) numbers.

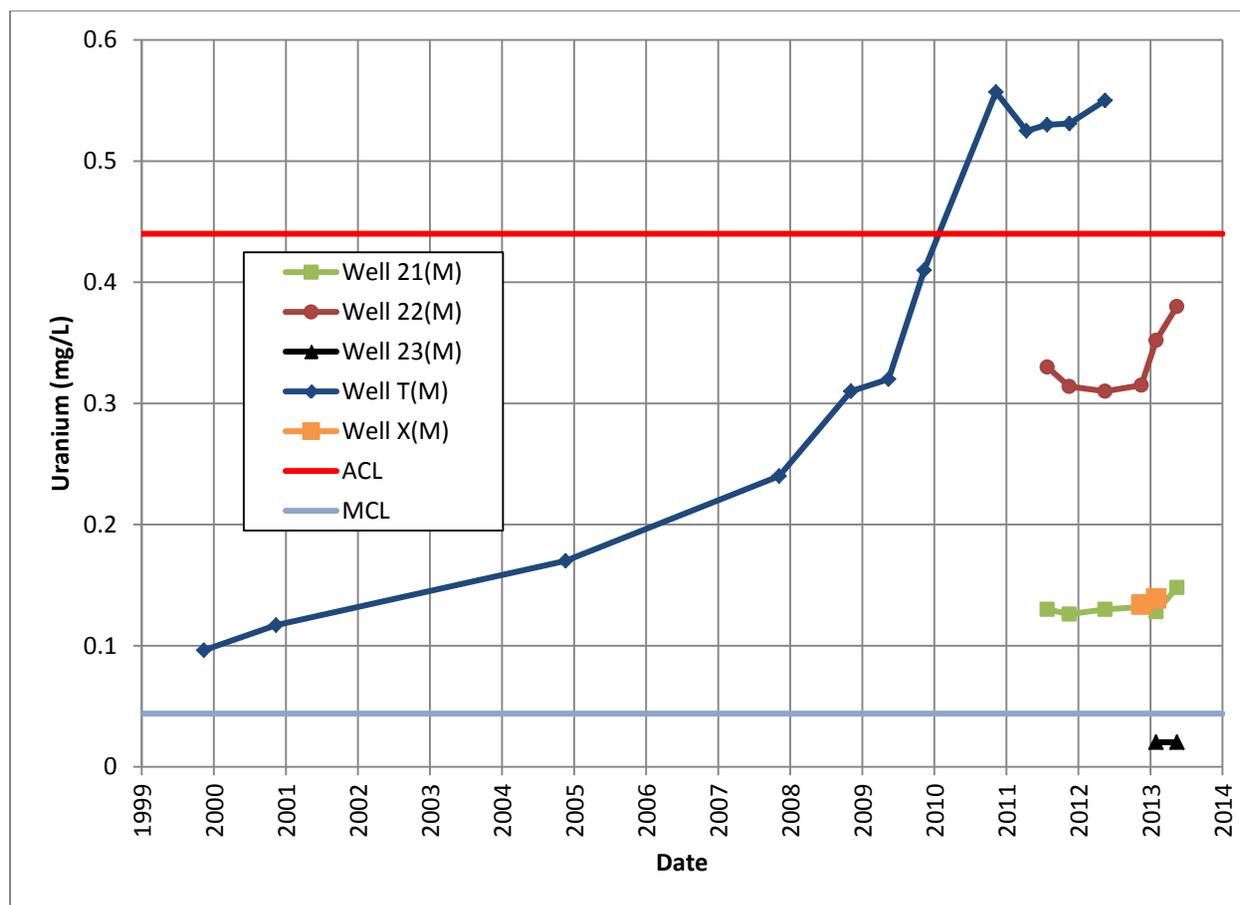
Figure 1-3. Uranium Concentrations in Alluvium POC Well T(M) and Downgradient Wells

- 1C However, the uranium concentrations in both wells, shown in Figure 1-3, continue to exceed the UMTRCA maximum concentration limit (MCL) of 0.044 mg/L (40 CFR 192, Table 1). Based on the elevated uranium concentration in well 21(M), alluvial groundwater with elevated uranium is leaving the site. The extent of contamination in the alluvial aquifer is not known at this time. However, the uranium concentration in well 23(M), located about 1,600 feet downgradient of well 21(M), was 0.020 mg/L.

- 1D NRC requested DOE to evaluate the performance of the main tailings disposal cell to see if there is a correlation between cell performance and the elevated uranium concentrations in the alluvium wells. DOE conducted radon flux measurements in July 2013 on top of the radon barrier in the area of depressions on the cell cover. All radon results were below the detection limit, indicating that the radon barrier in that portion of the disposal cell is performing as designed. Additionally, DOE is evaluating the water balance of the disposal cell to see if elevated uranium concentrations can be attributed to continued leakage from the cell. Preliminary observations suggest that the uranium concentrations in the site groundwater

monitoring network are the result of seepage of tailings fluids during milling operations and do not reflect a change in performance of the disposal cell.

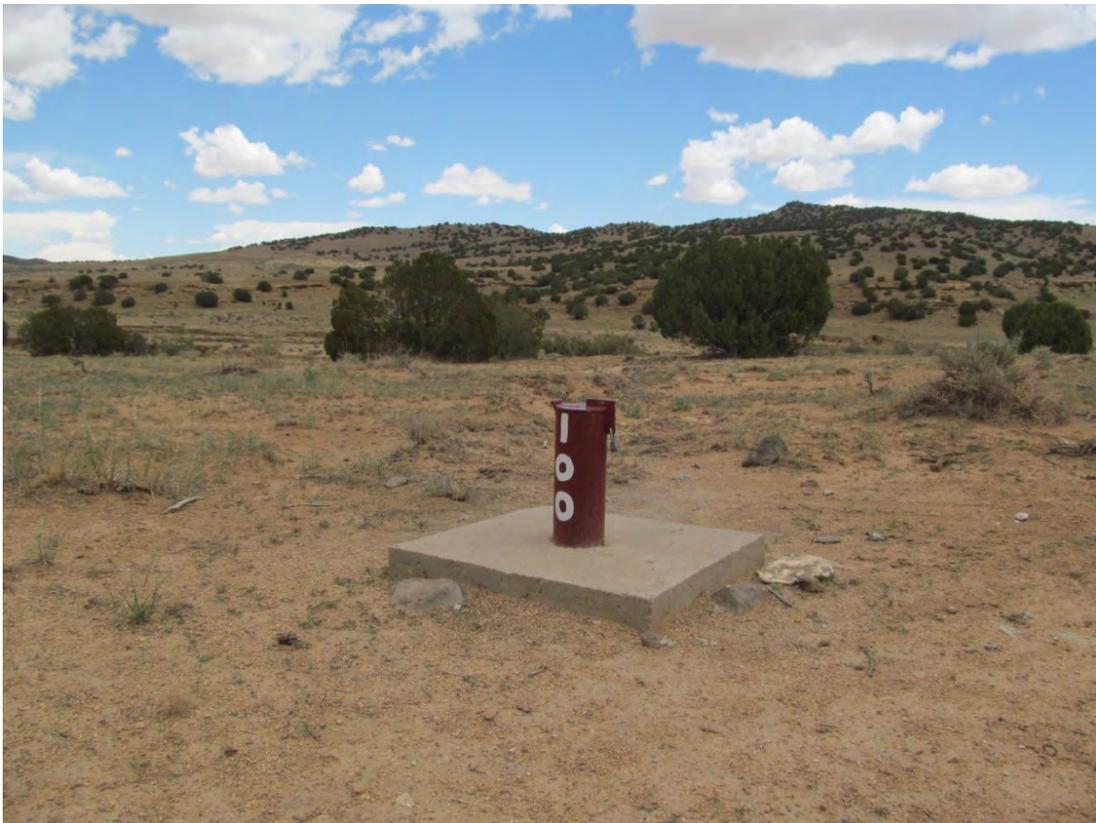
The site groundwater-monitoring network consists of 10 wells. Nine of the wells are located on DOE property; monitoring well 29A is located outside the northeast corner of the site. All of the wells were locked and in good condition (PL-4). Some well locations do not have established access roads or tracks but are accessible by 4-wheel drive vehicle as long as the ground is dry.

BAR 8/2013. PL-4. Monitoring well 100.

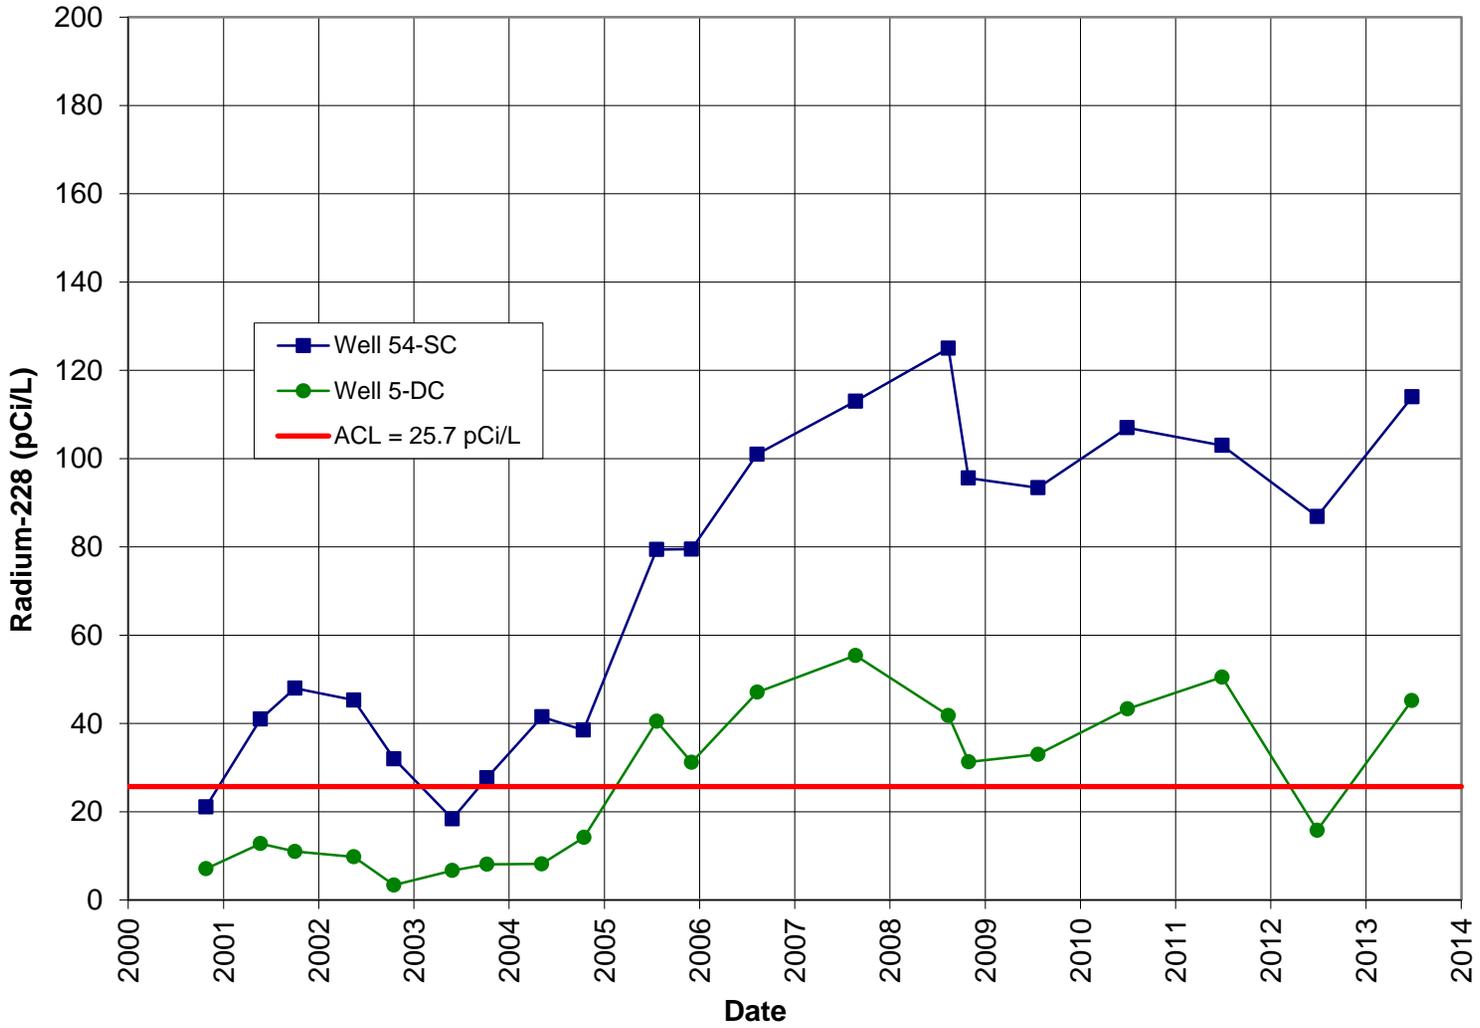
Figure 6-2. Radium-228 Concentrations in Wells 5-DC and 54-SC Since Completion of the Disposal Cell

The concentration for cadmium in well 5-SC remained below the ACL and has since 2005. However, radium-228 continued to exceed the ACL in wells 5-DC and 54-SC (Figure 6-2).

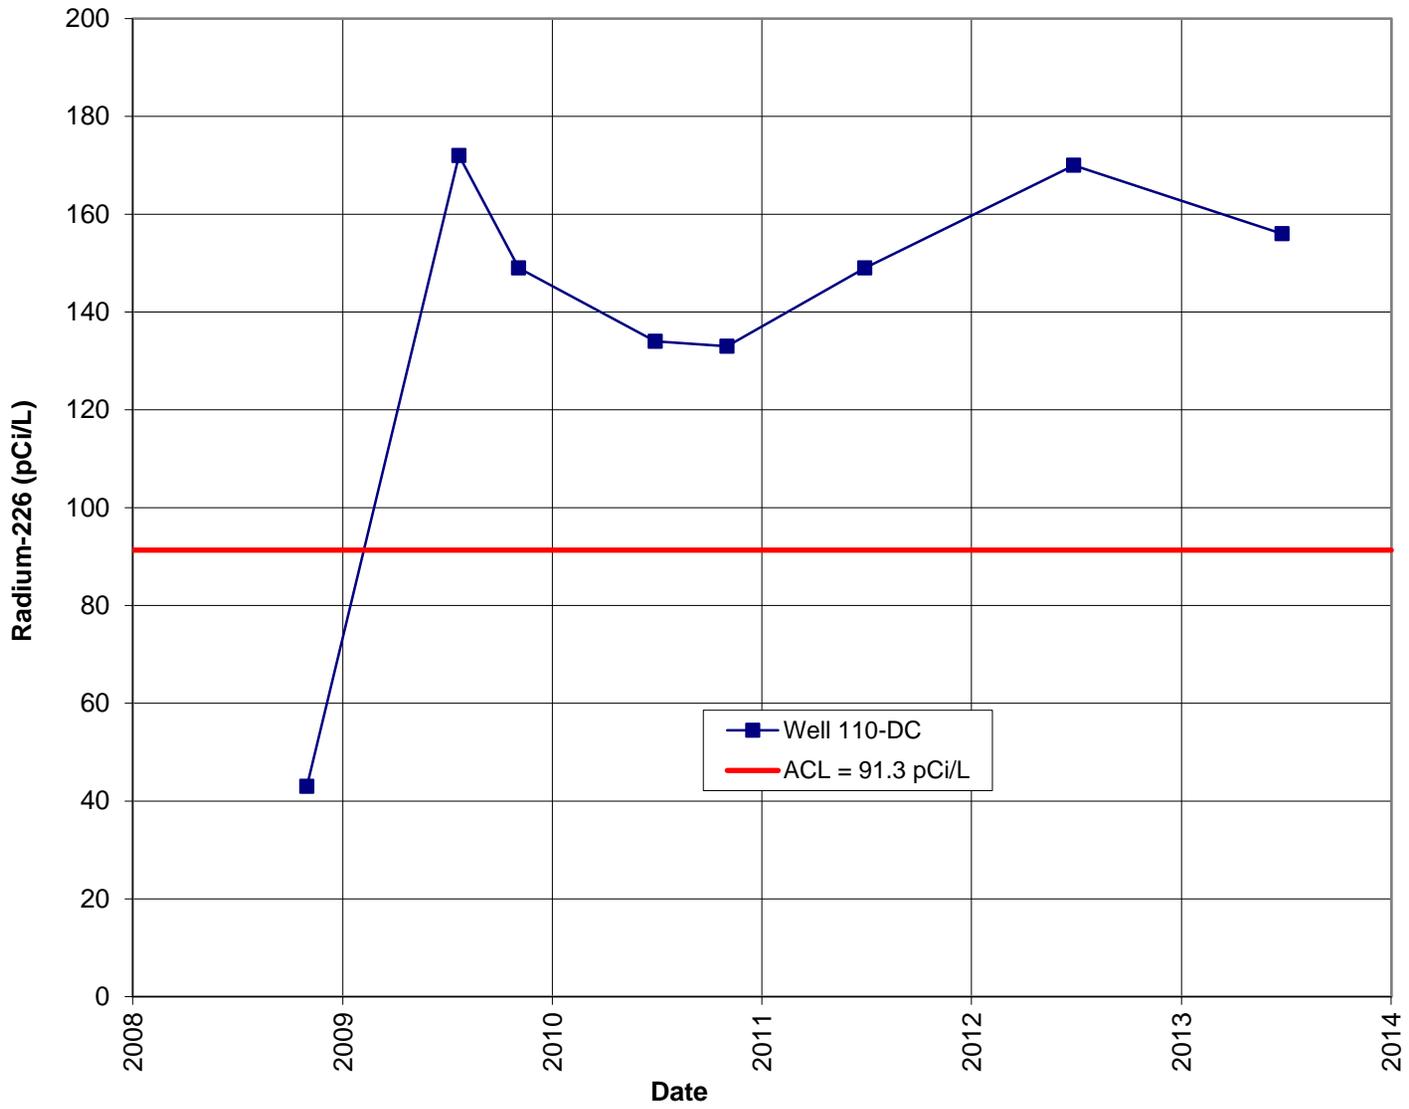
Figure 6-3. Radium-226 Concentrations in Well 110-DC

6B Additionally, the ACL for radium-226 continues to be exceeded in well 110-DC (Figure 6-3).

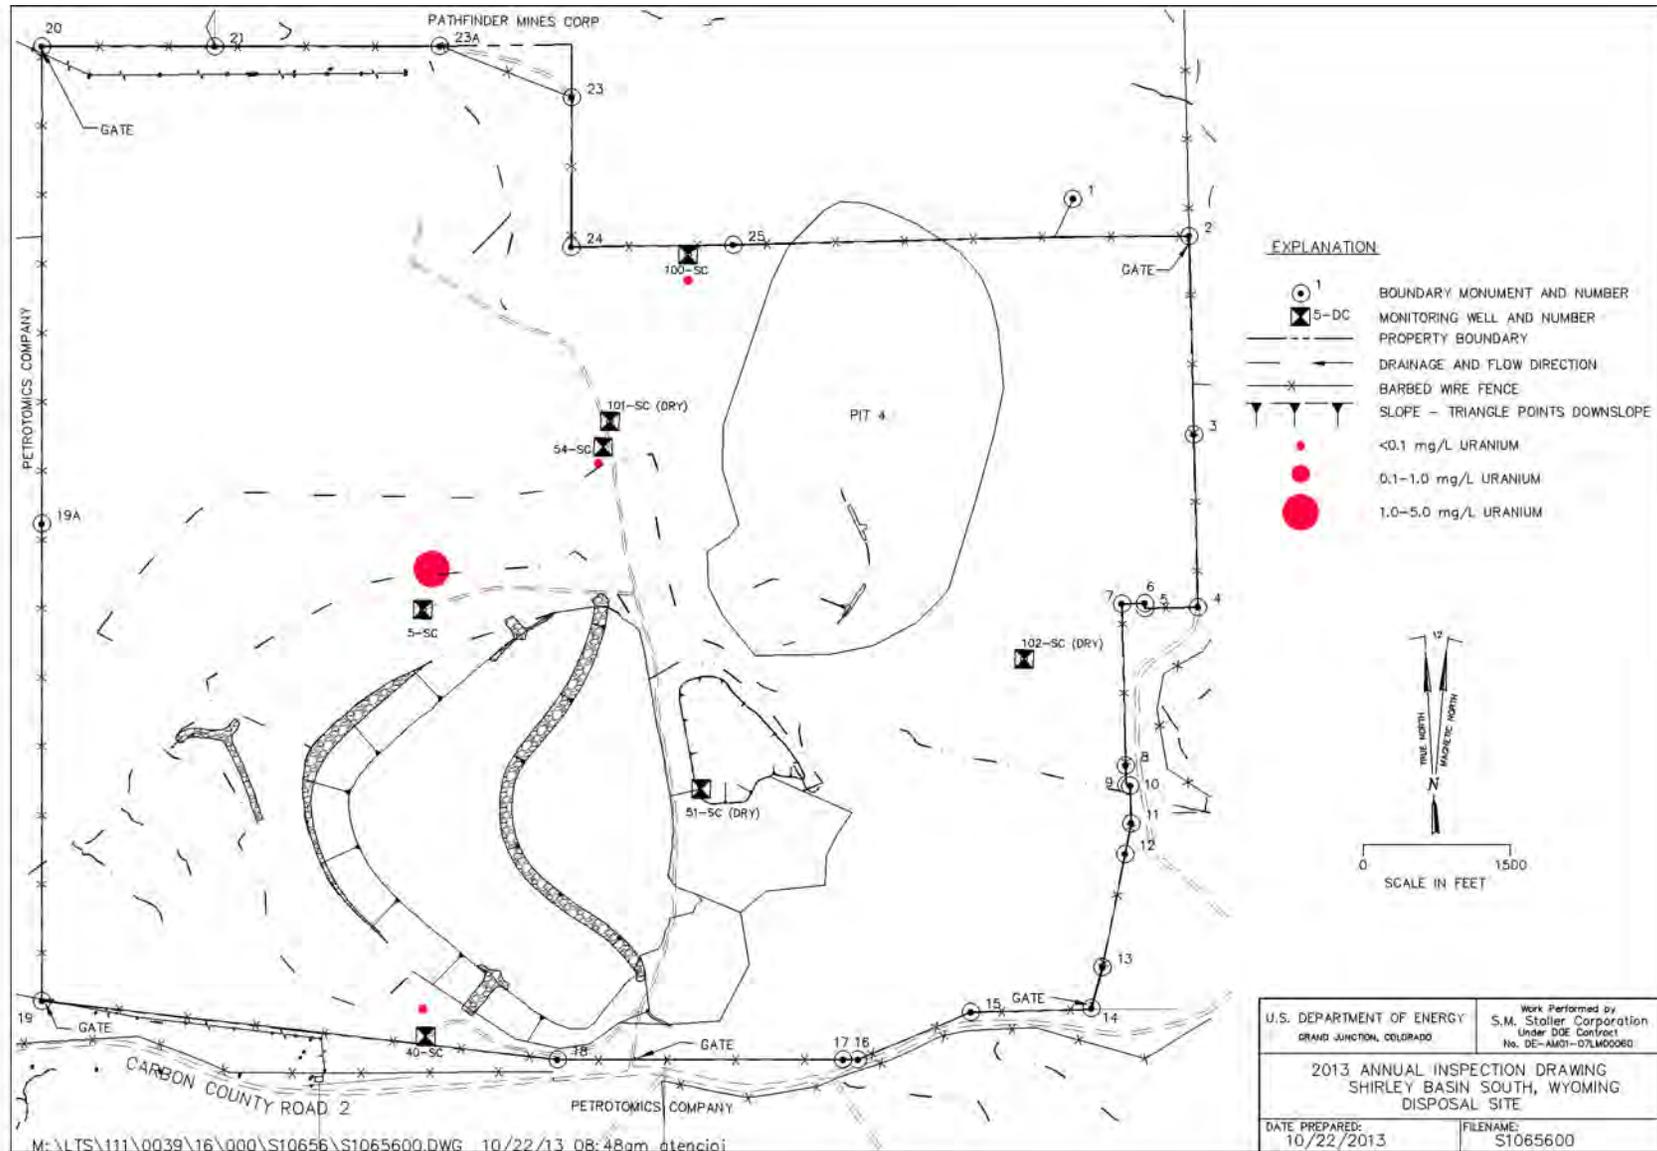
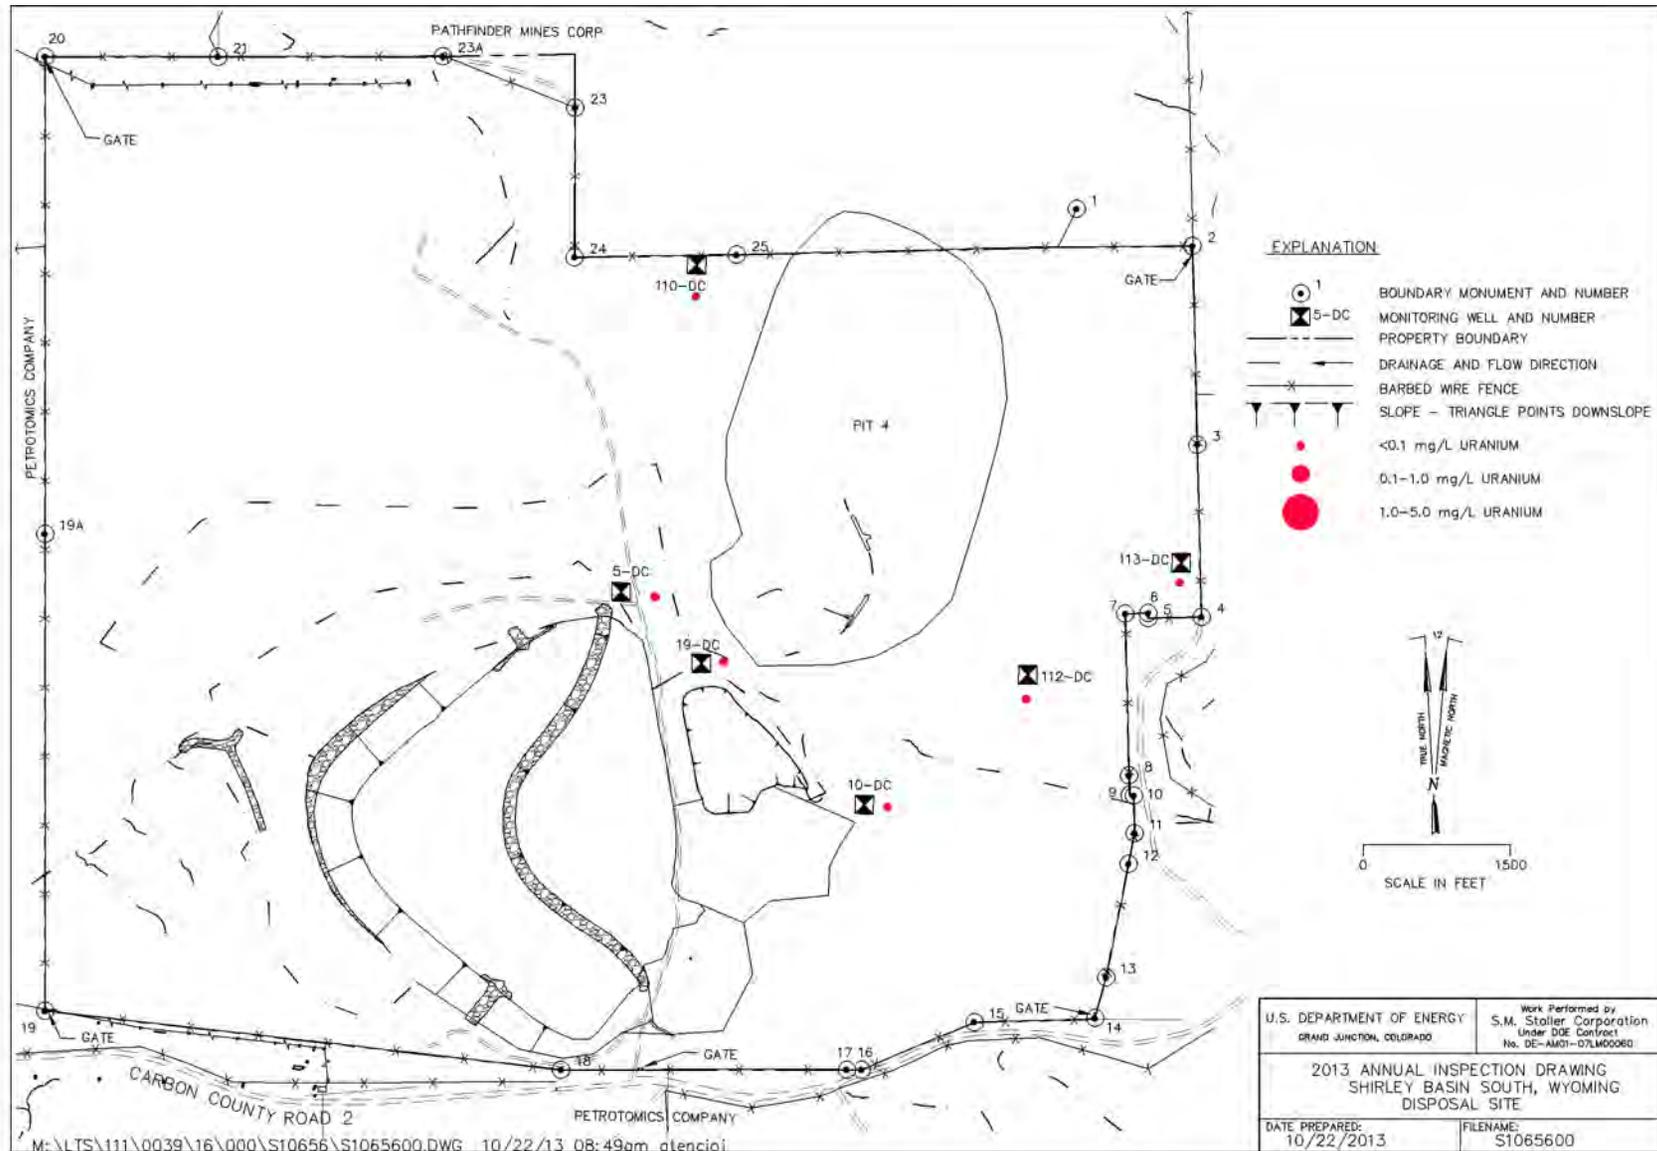
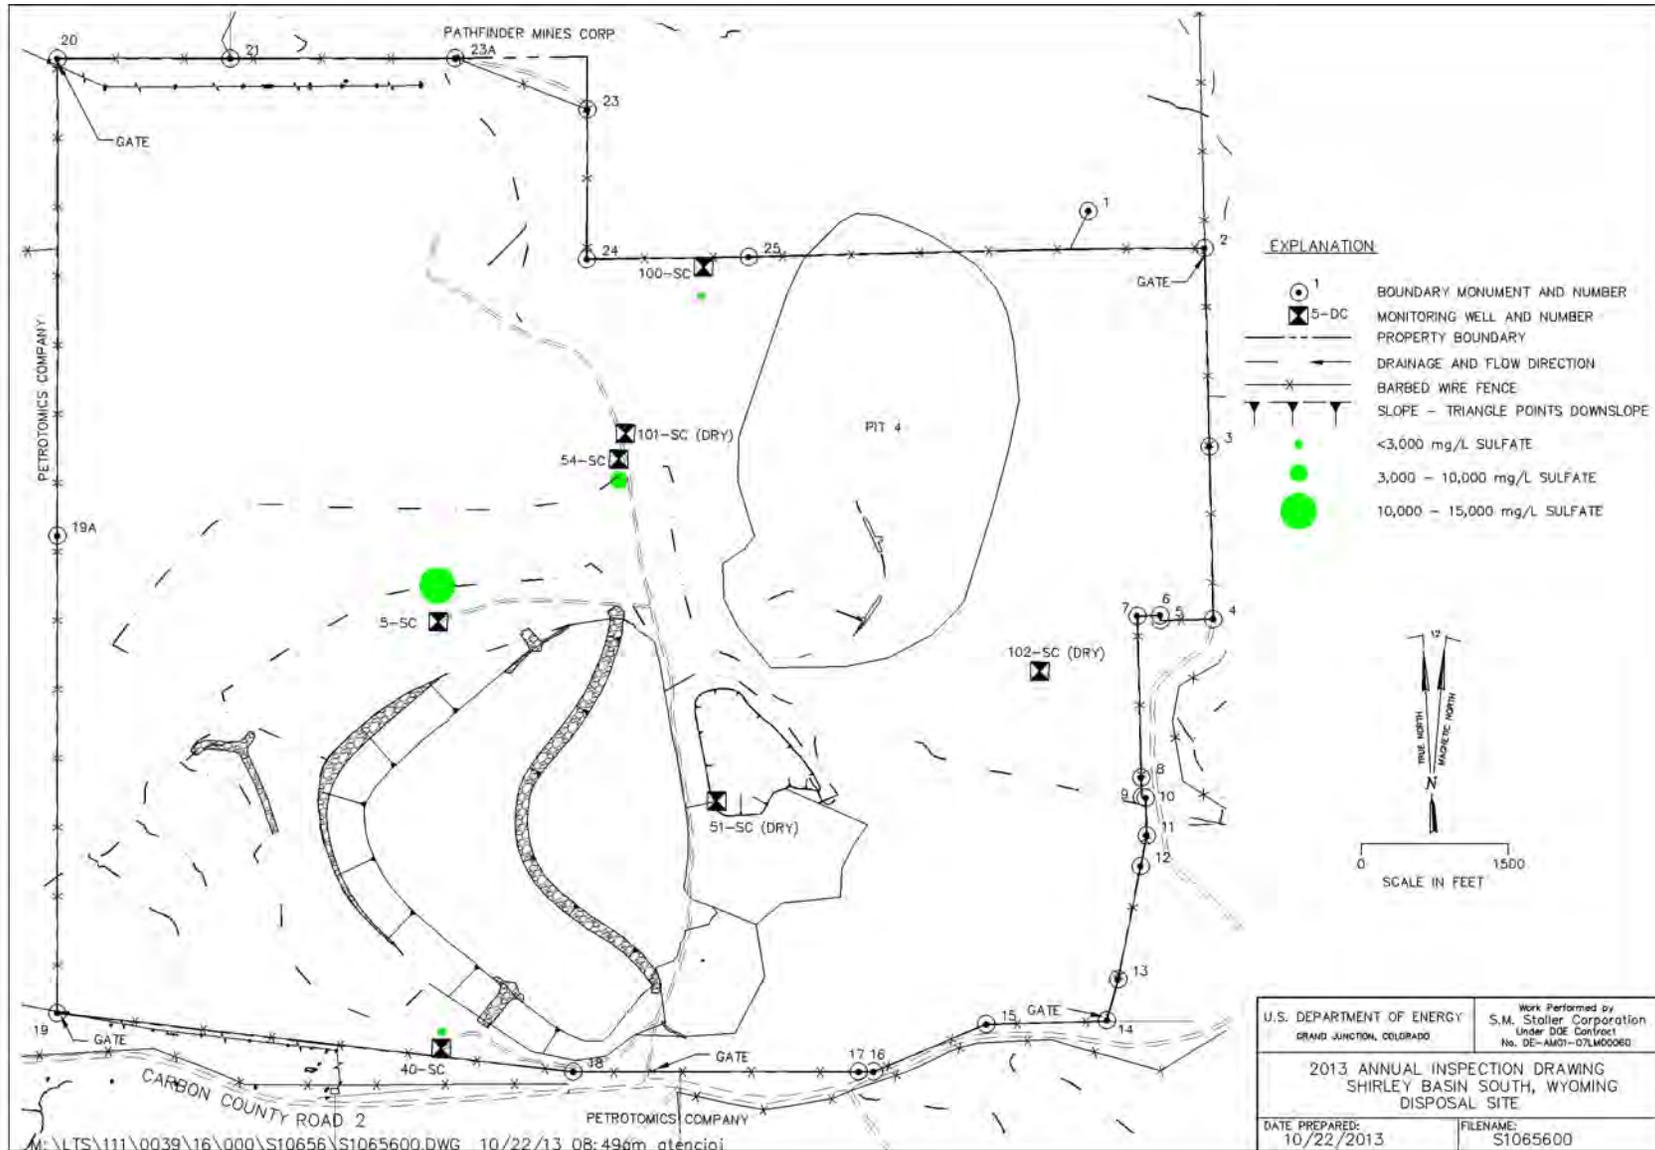
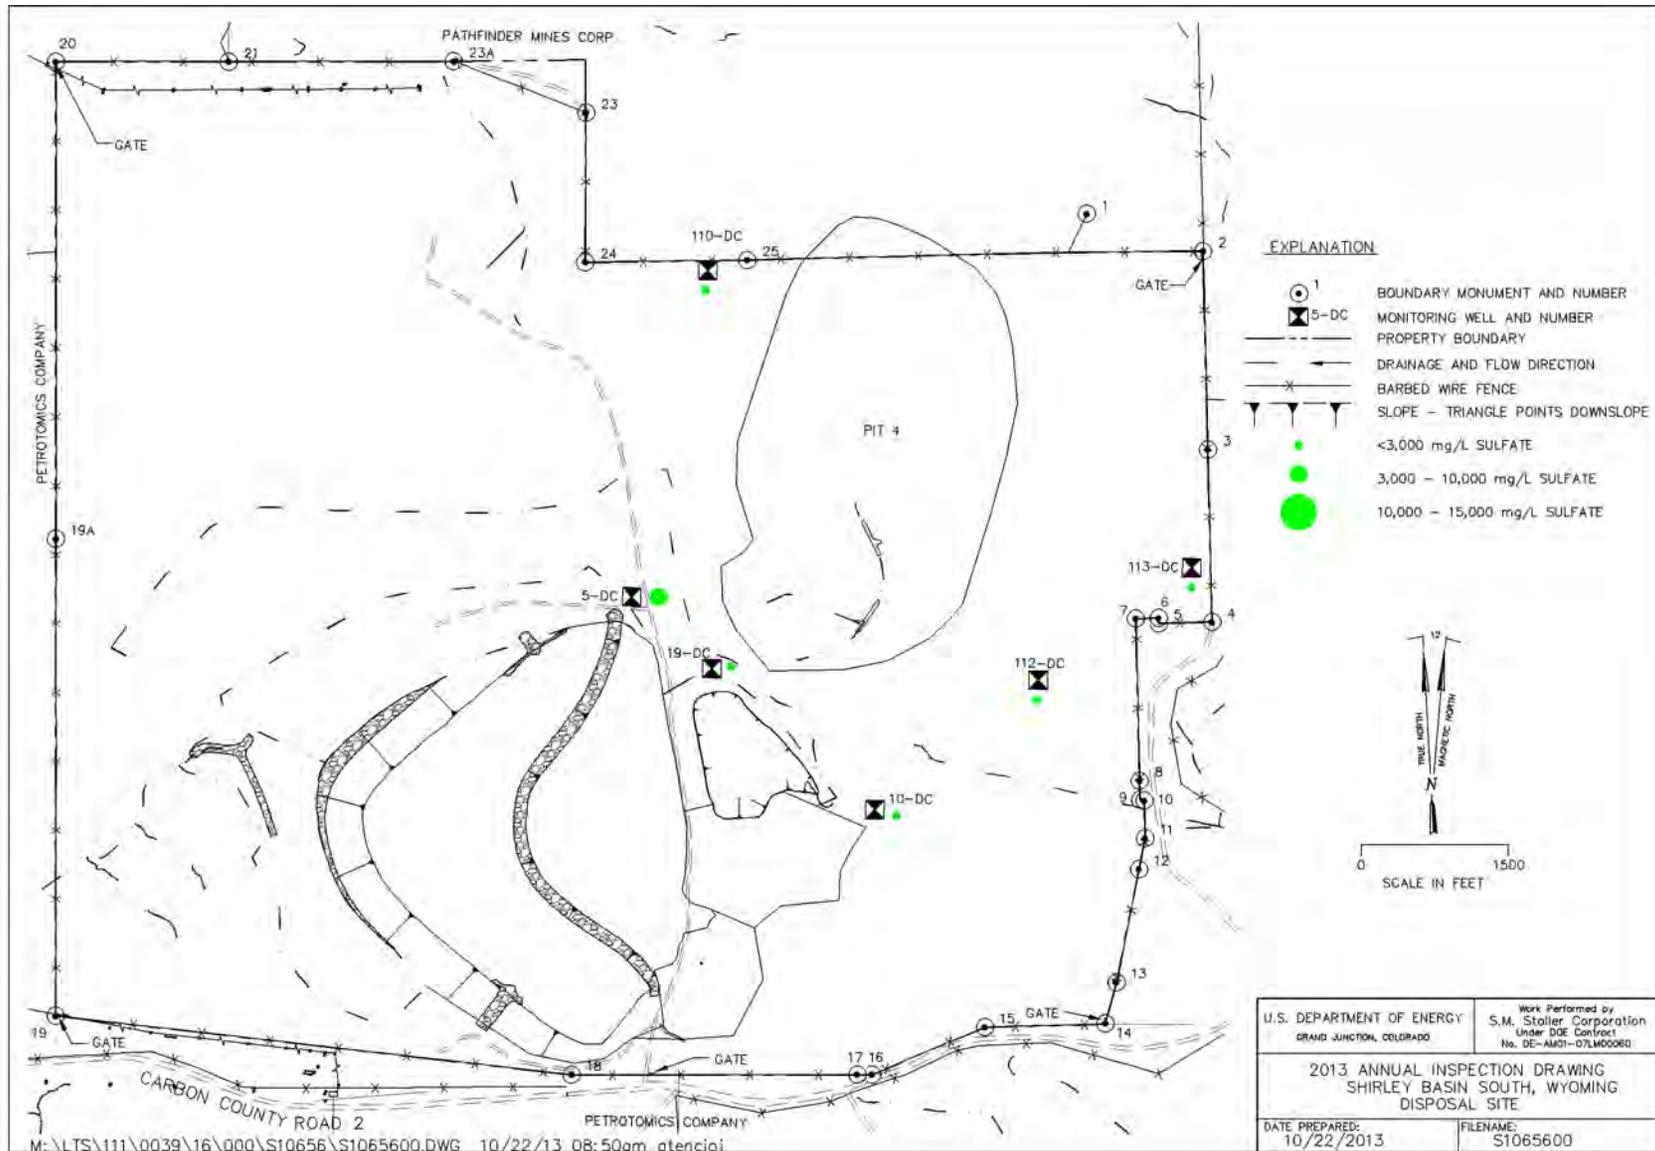
The LTSP specifies that this report provide iso-concentration maps for uranium and sulfate in each aquifer. However, the well network does not provide sufficient data points to develop contour maps of the contaminant plumes. Instead, 2013 concentrations for uranium in the two aquifers are shown on Figures 6-4 and 6-5, and concentrations for sulfate are shown on Figures 6-6 and 6-7. Uranium and sulfate concentrations remain lower than concentrations predicted by the former licensee.

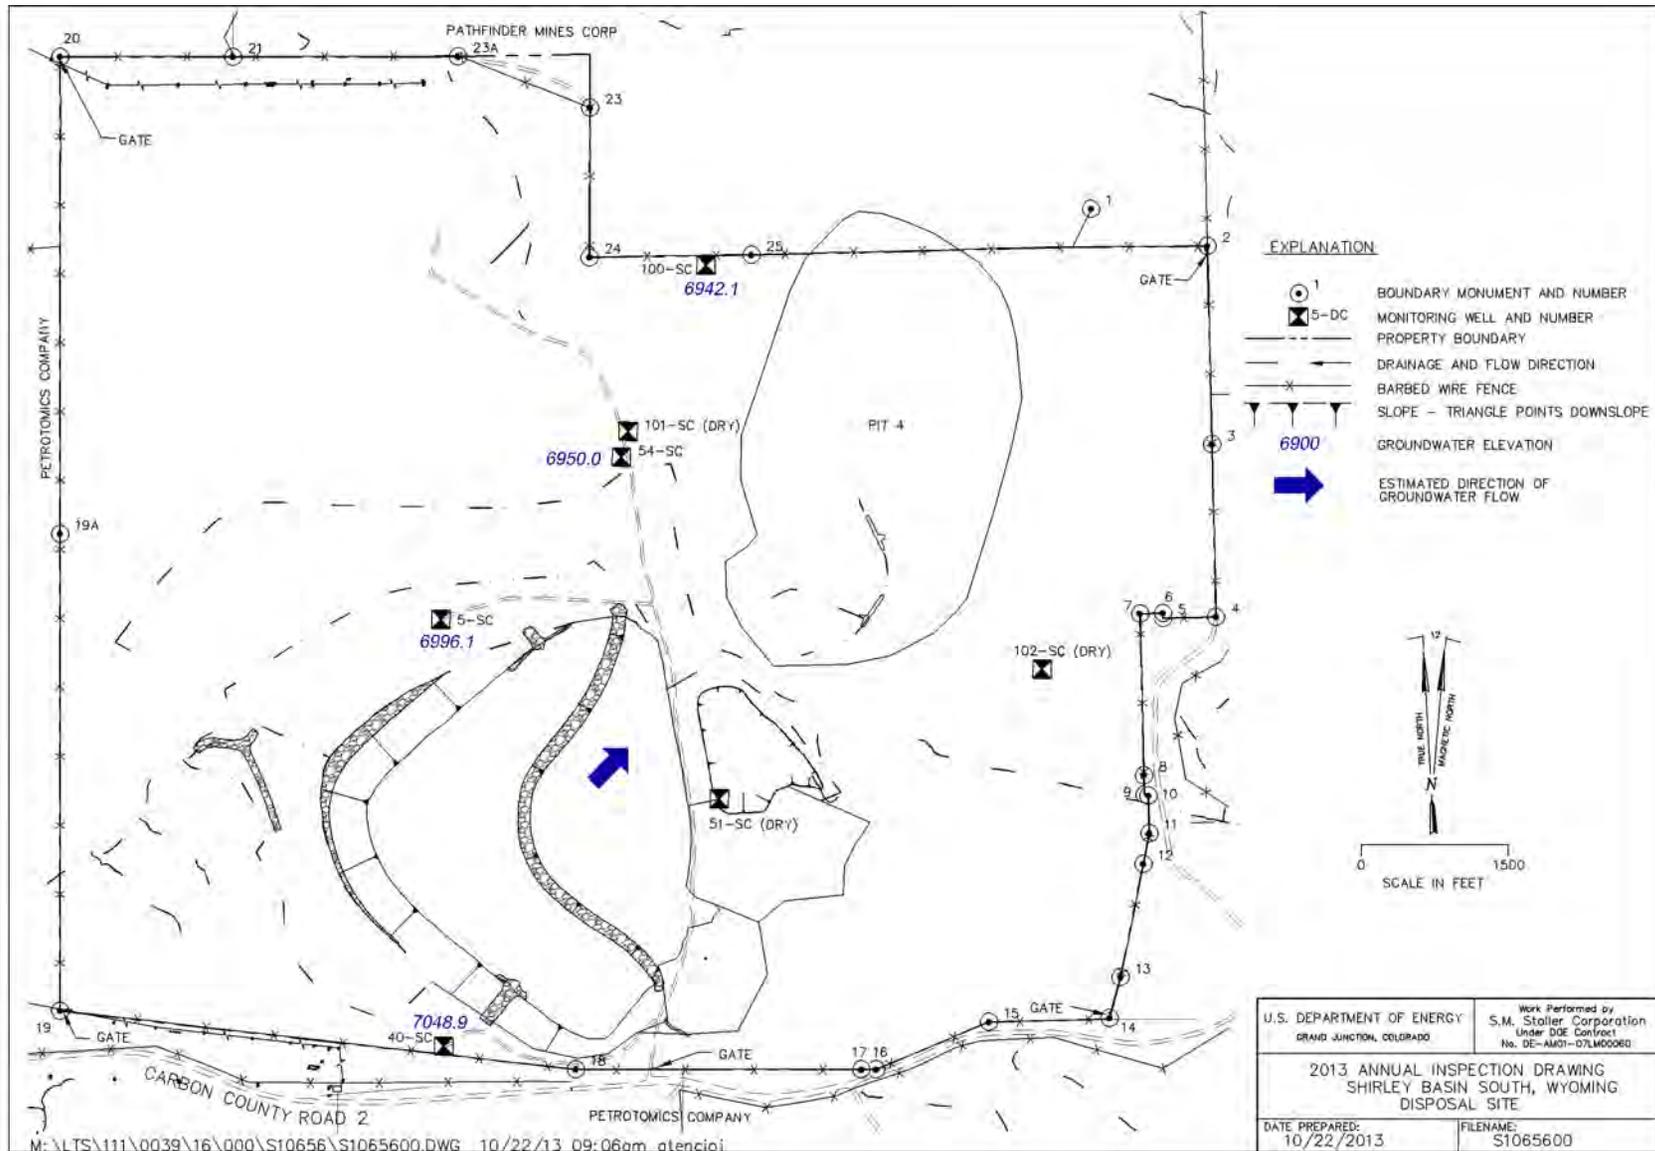
Figure 6-8. June 2013 Groundwater Elevations in the Upper Sand Aquifer at the Shirley Basin South, Wyoming, Disposal Site

Water level elevations for the upper sand aquifer are shown on Figure 6-8. The apparent flow direction is to the northeast, along the formation dip and toward Pit 4. The dry wells (51-SC, 101-SC, and 102-SC) indicate that the upper sand aquifer has not recovered in the vicinity of Pit 4. Because the aquifer is no longer confined at the Pit 4 location, it may never recover to its pre-mining elevations.

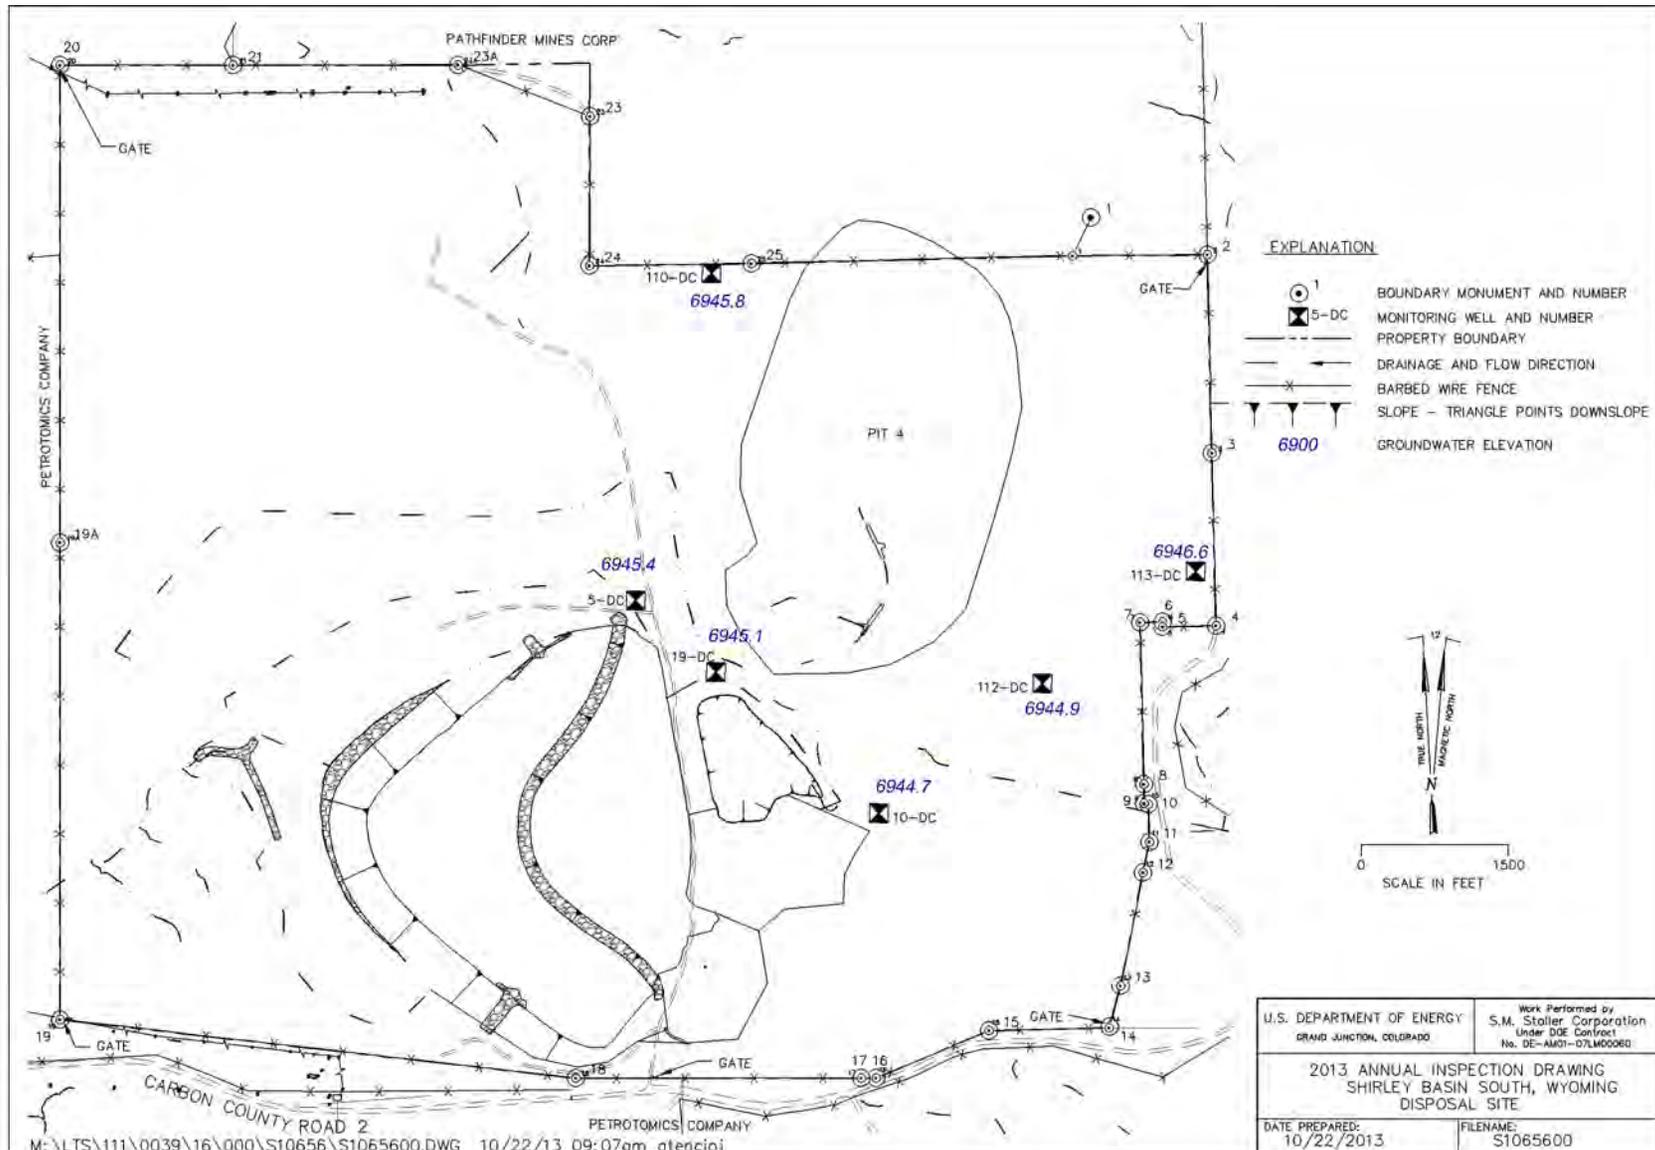
Figure 6-9. June 2013 Groundwater Elevations in the Main Sand Aquifer at the Shirley Basin South, Wyoming, Disposal Site

Main sand aquifer water elevations, shown on Figure 6-9, have been gradually rising at all wells since 2000, with an average rate of approximately 0.7 foot per year since DOE began monitoring water levels in 2005 (Figure 6-10). The rising levels indicate a gradual recovery of the aquifer. However, the altered conditions at Pit 4 may prevent a return to pre-mining elevations. Flow direction cannot be determined at this time because water level measurements indicate an essentially flat potentiometric surface at the site.

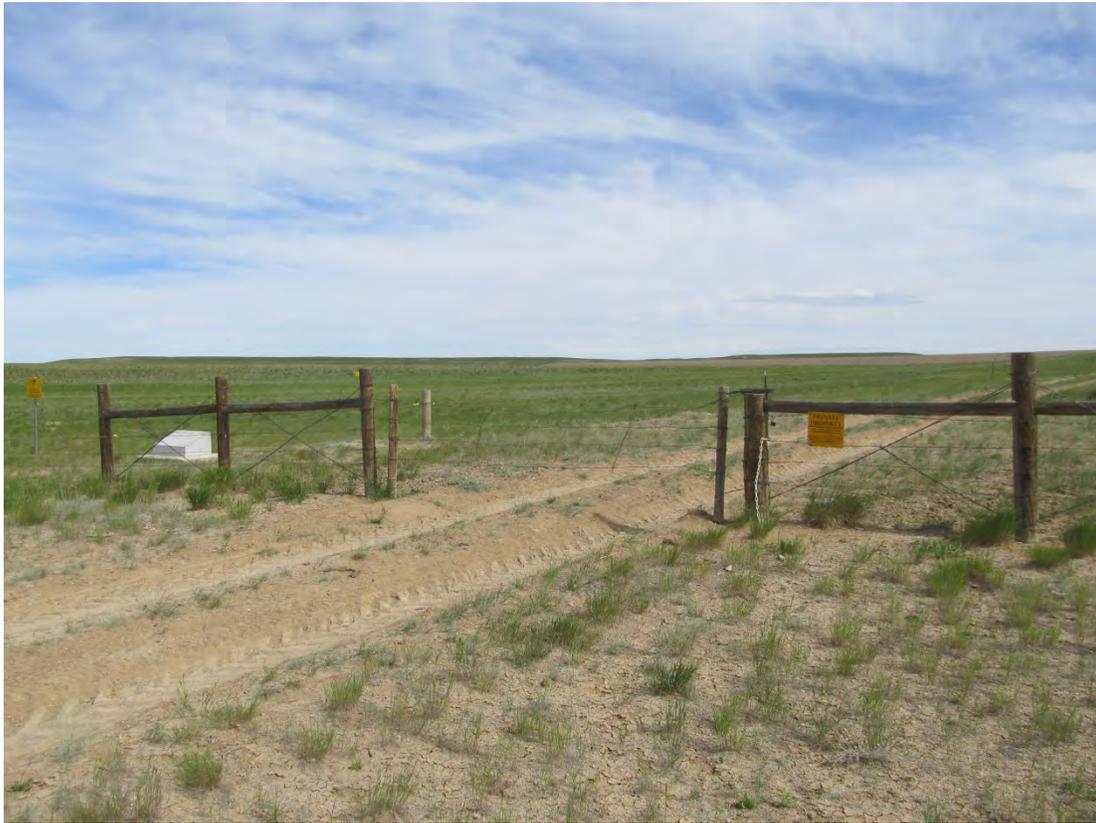
SBS 6/2013. PL-1. Site entrance gate.
