U.S. DEPARTMENT OF
ENERGY

Legacy
Management

2013 Annual Site Inspection and Monitoring Report for Uranium Mill Tailings Radiation Control Act Title II Disposal Sites

November 2013

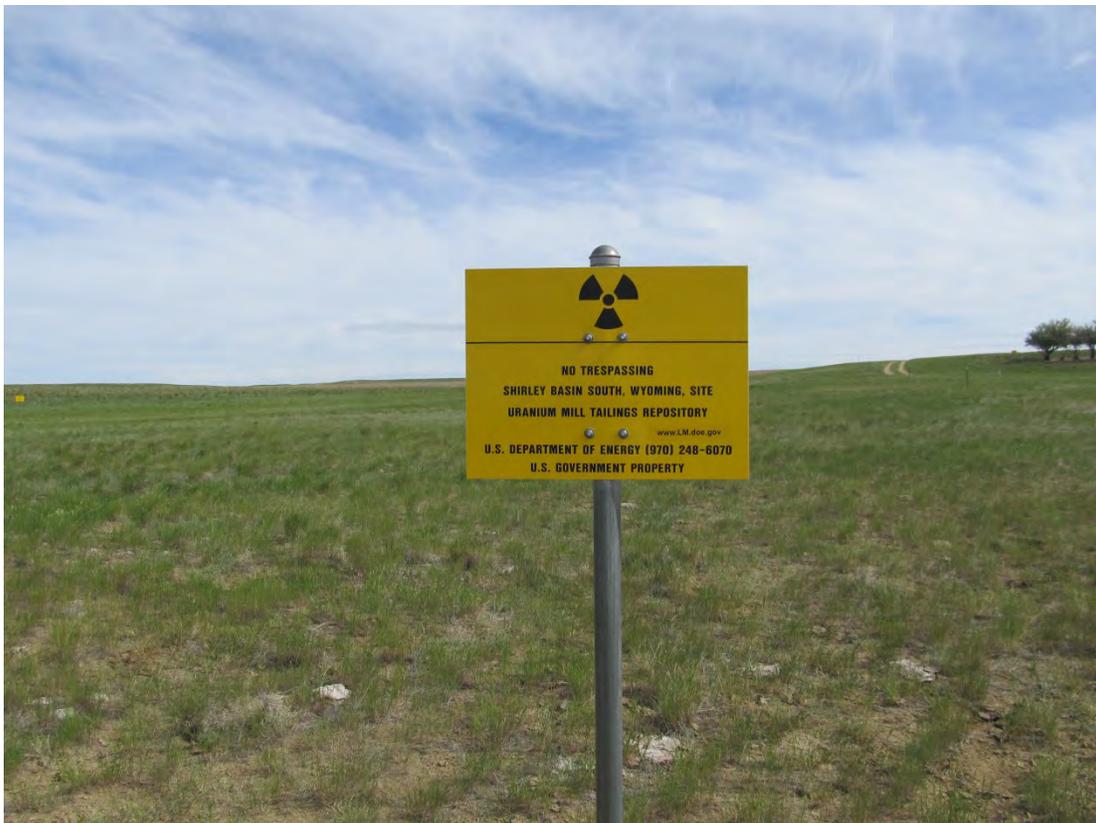
SBS 6/2013. PL-2. Perimeter sign P26 at site entrance.

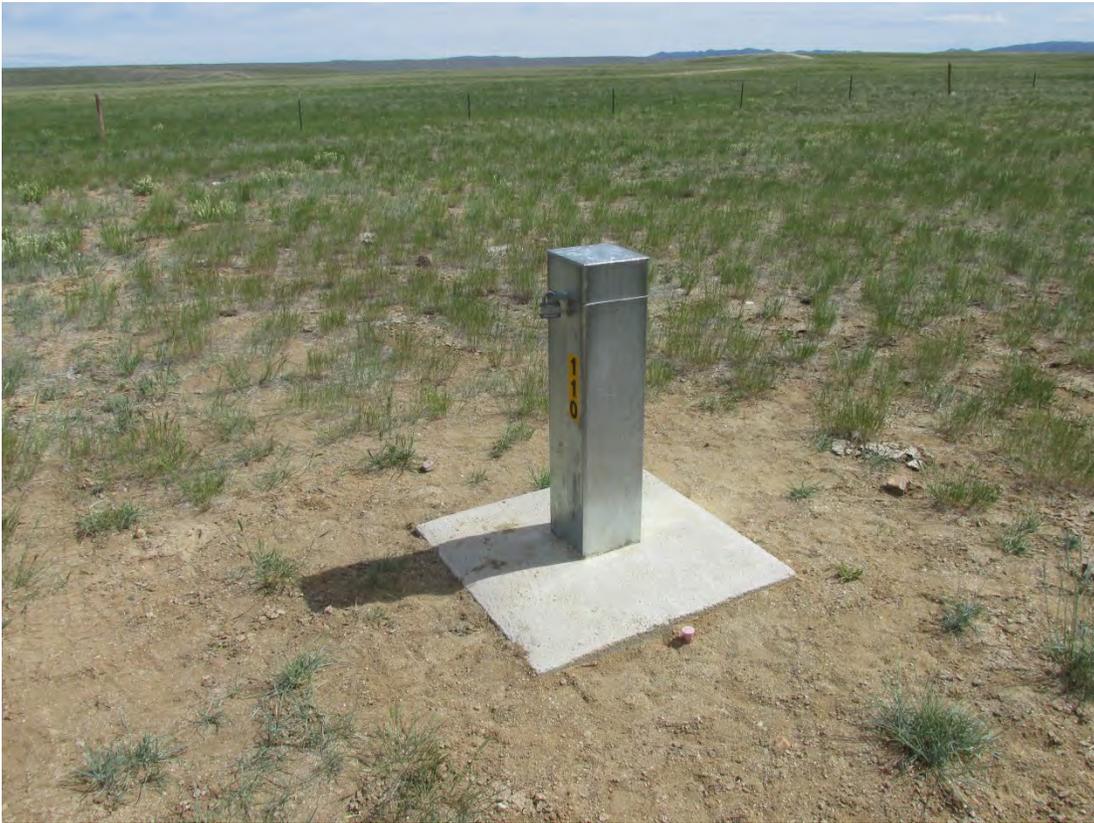
The second sampling event after installation of the new wells was conducted in July 2009 and indicated that radium-226 exceeded the ACL in new well 110-DC. NRC and WDEQ were notified of the exceedance, and DOE began to evaluate the cause of the exceedance.

SBS 6/2013. PL-5. Monitoring well 110-DC.

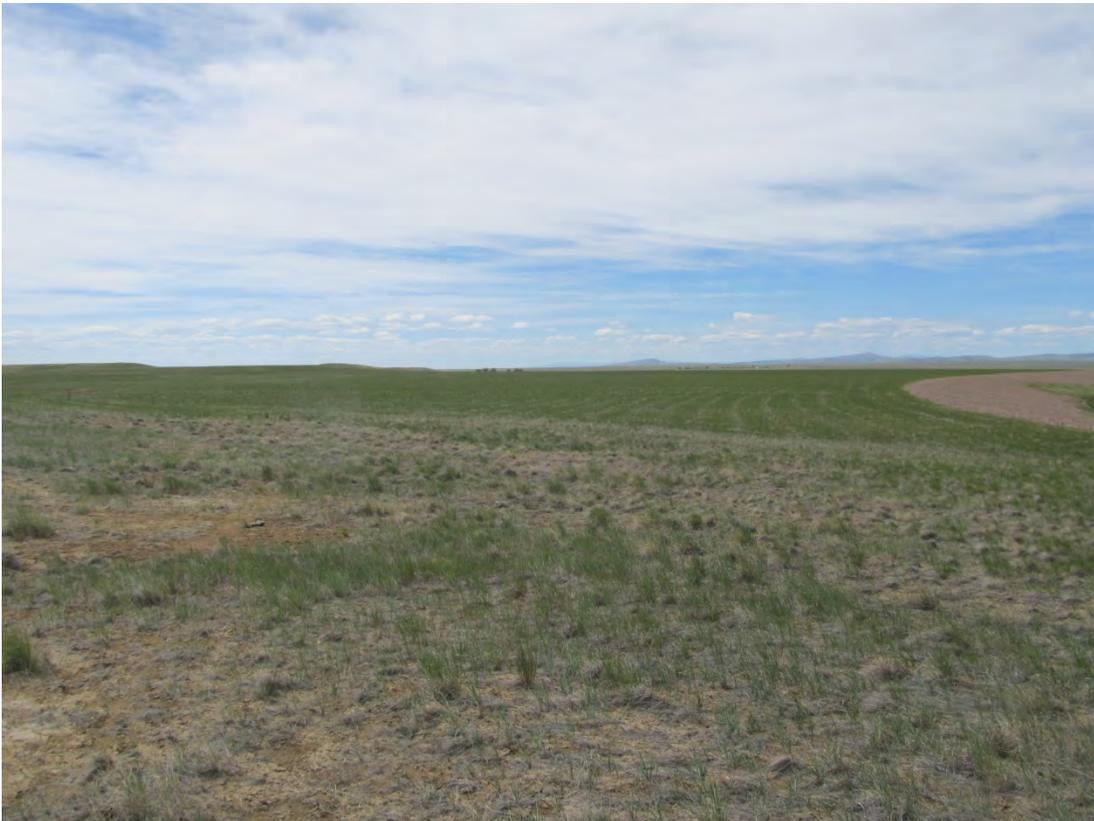
The tailings impoundment (disposal cell), completed in 2000, occupies approximately 142 acres. It has a soil cover and was revegetated primarily with native grasses. Although stressed due to dry conditions, the vegetation on the disposal cell and throughout the site was in good condition and is managed through a grazing license with a local rancher. The disposal cell surface is constructed at two elevations—the upper surface (PL-6) and the lower surface (PL-7)—separated by a riprap-armored slope. These features were in excellent condition; there were no indications of erosion, settlement, or other modifying processes on the disposal cell cover or side slopes that might affect the integrity of the cell.

The eastern (upper) surface is contoured to drain into a basin east of the cell and west over the riprap-protected slope to the western (lower) surface. The lower surface drains to the north and south at riprap-armored discharge points; the discharge structures were in excellent condition (PL-8). The riprap dissipation basins of the discharge points usually hold snowmelt runoff water in spring and early summer but were essentially dry at the time of the inspection.

SBS 6/2013. PL-6. Upper surface of disposal cell.

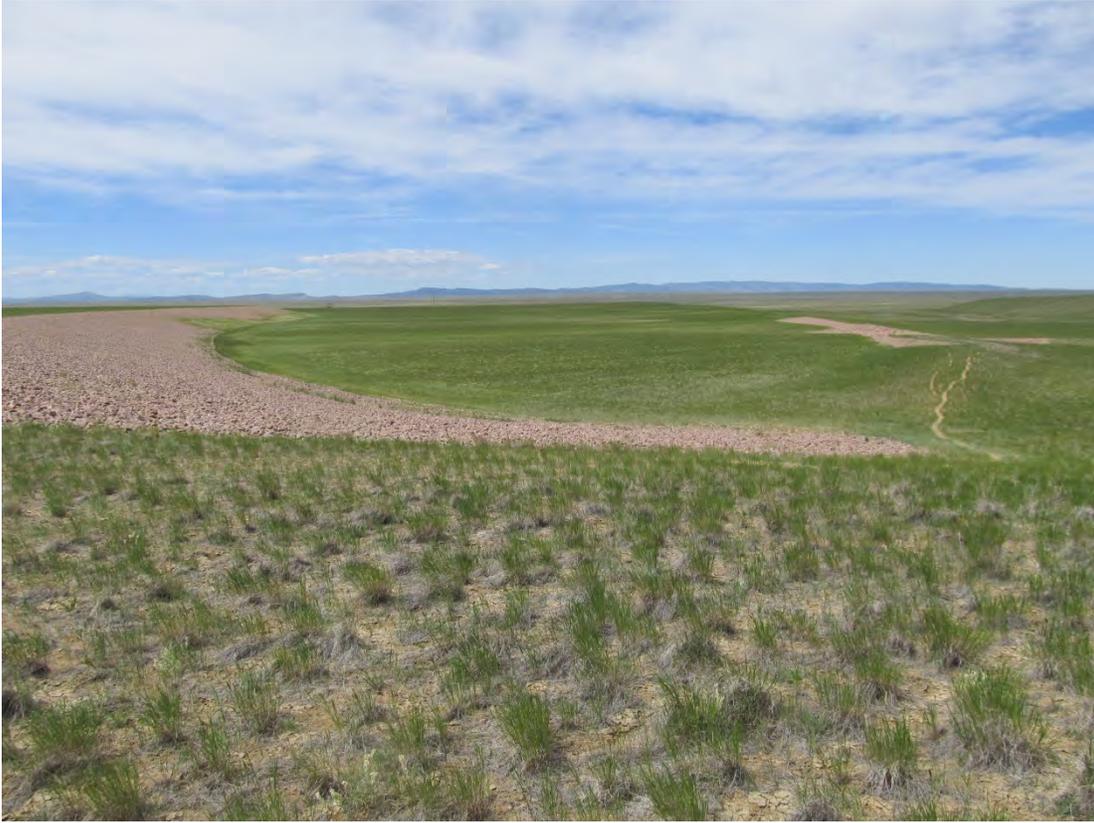
SBS 6/2013. PL-7. Lower surface of disposal cell.

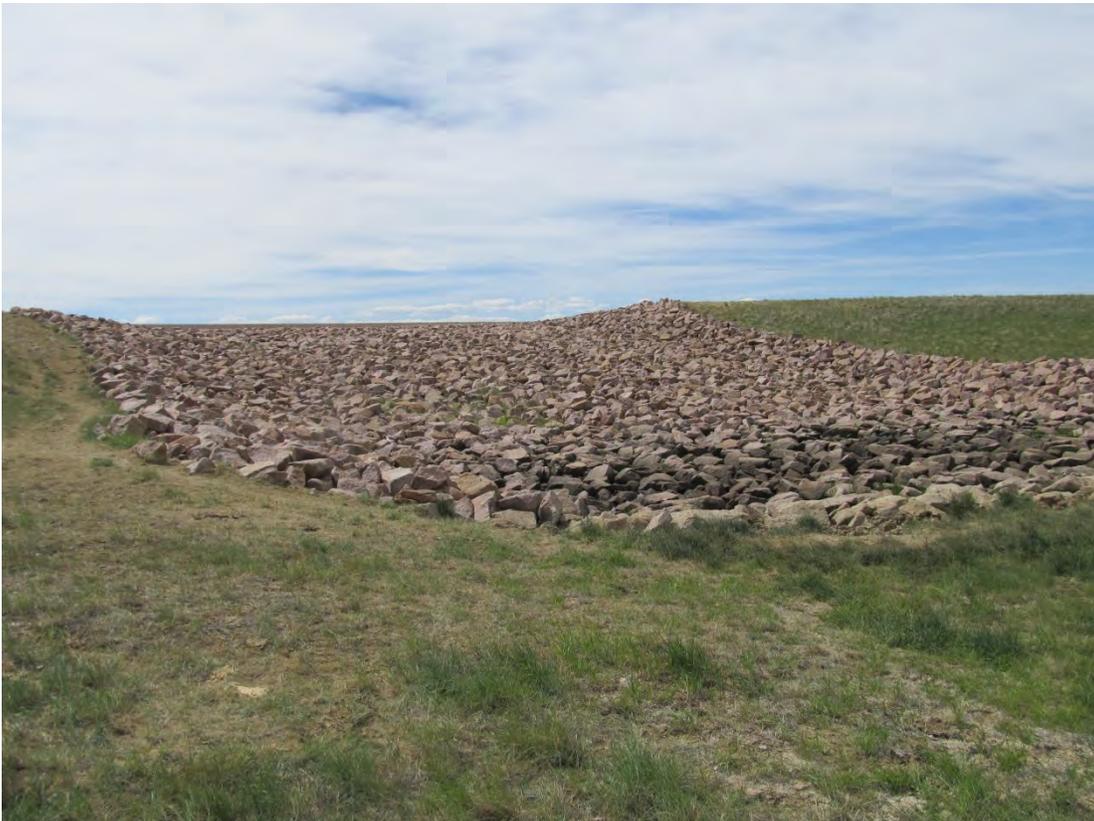
SBS 6/2013. PL-8. North swale discharge structure.

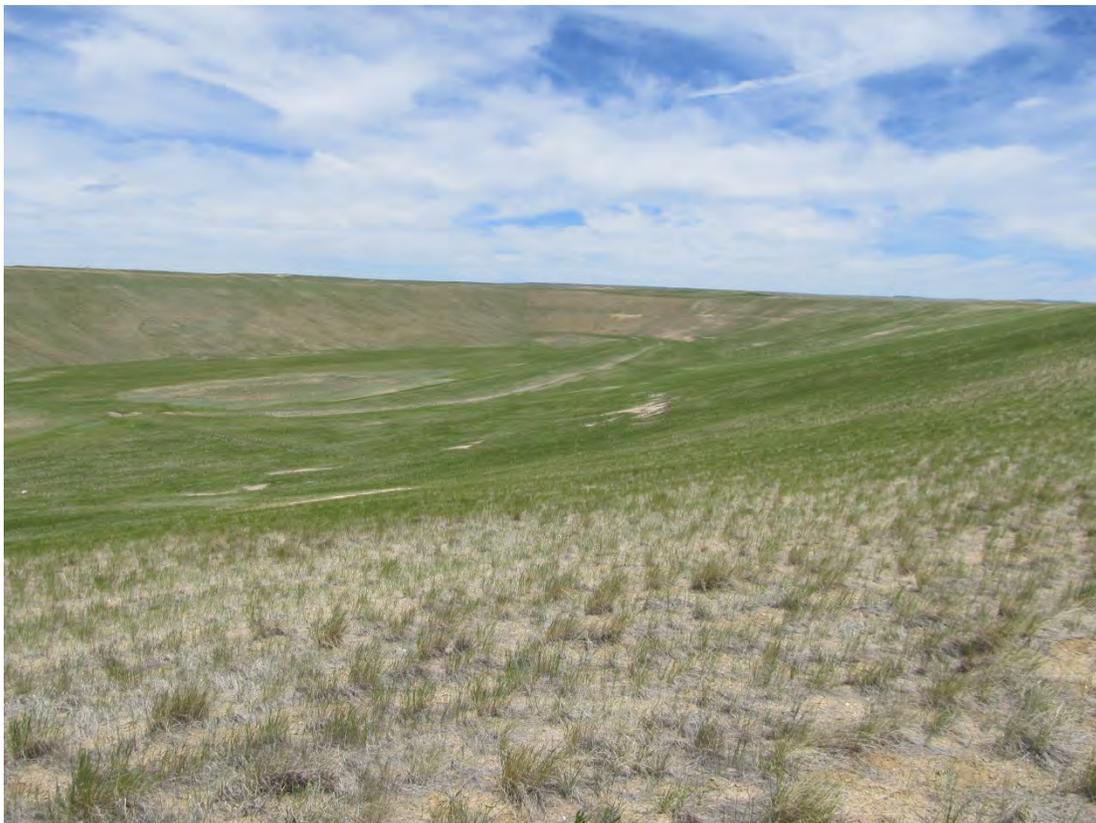
SBS 6/2013. PL-10. North and east portions of Pit 4.
