# OPERATING EXPERIENCE SUMMARY

OE Summary 2015-02

## Radiological Release Event at the Waste Isolation Pilot Plant (WIPP)

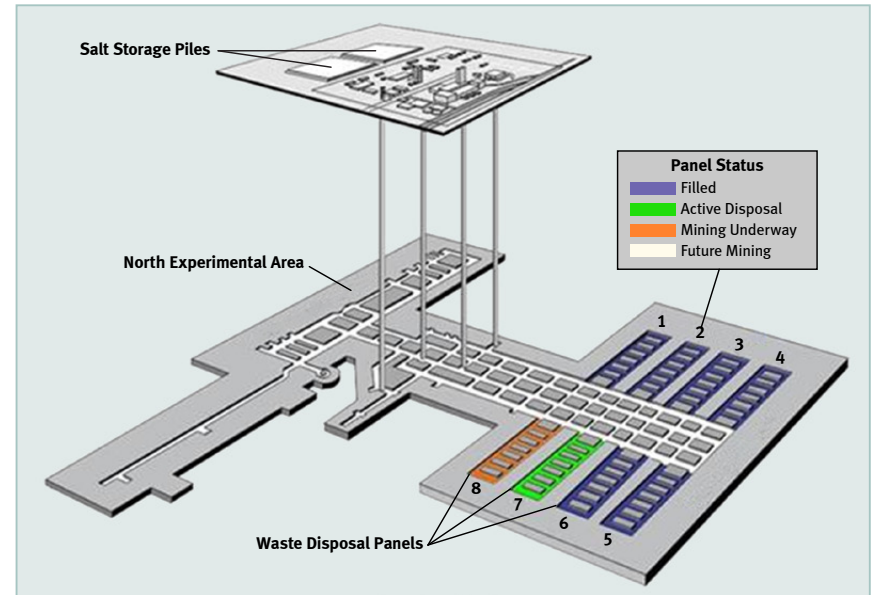
The principal contact-handled (CH) waste operations performed at WIPP involve: (1) mining of underground rooms to provide space for waste emplacement; and (2) receipt and disposal/storage of TRU waste. The facility is designed for excavation of eight panels branching off the main drifts, or halls, using "just-in-time" excavation. Each panel contains storage rooms that are filled, back to front. Figure 1-1 shows the layout. This means that when a new room is needed for disposal, a new panel is excavated, so that the excavation-fill-closure process is performed in a time frame to minimize the potential for developing hazardous ground conditions. Excavation is performed by a mining machine with a rotary head. The mined-out salt is loaded onto trucks and hauled to a loading area, where a hoist

**Figure 1-1. Panel and room layout in the underground**

takes it to the surface. CH waste containers are then moved into the newly-created disposal rooms, and remote-handled (RH) waste is placed in boreholes in the walls (ribs) of the rooms. After limited access to the underground was reestablished, it was determined that the radiological release occurred in Panel 7, Room 7. CH and RH wastes were being placed into Panel 7 during January and February 2014 when the event occurred.
