Thermal Cycling Combined with Dynamic Mechanical Load: Preliminary Report

Tadanori Tanahashi
ESPEC CORP.

Feb. 26, 2013
2013 PV Module Reliability Workshop

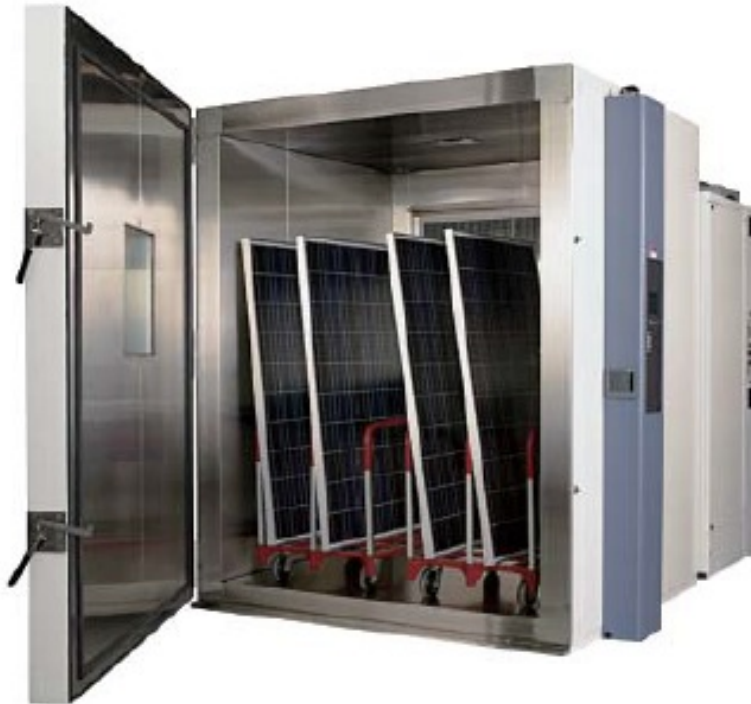
**Solar Panel
Large Walk-in Chambers**

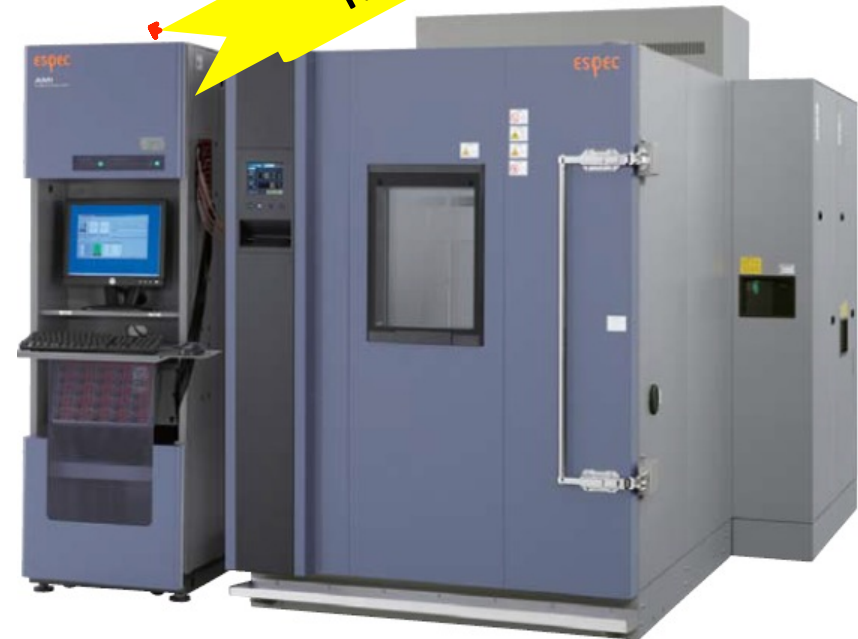
**PID Evaluation System
(Chamber with Insulation Rack &
Leakage Current Meas.
System)**

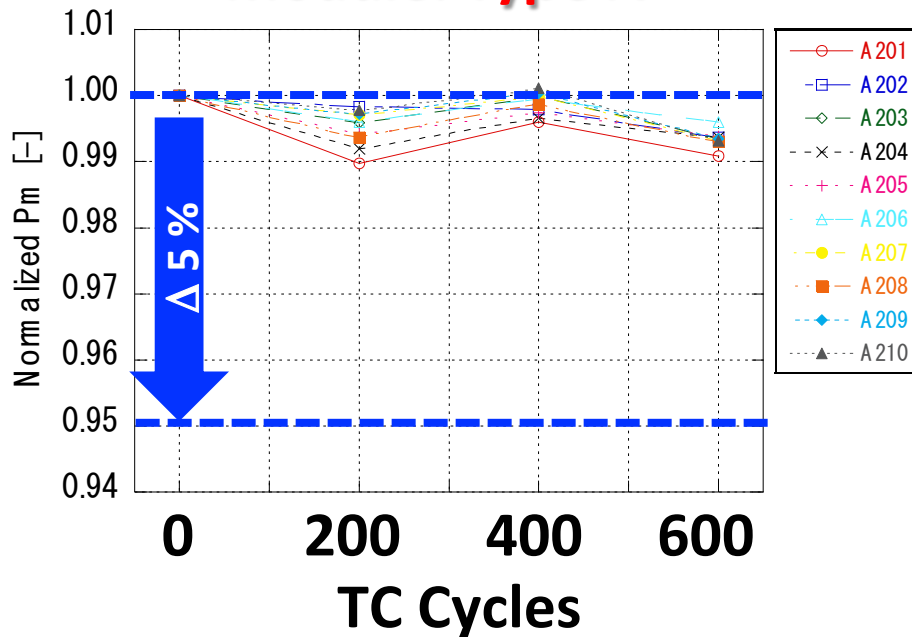
Module: Type A

- Increase in R_s was observed in both modules (A: 2% , B: 6% in average).
- The changes of other I-V Parameters were little (almost stable).
- **The asymmetrical dark area along bus-bar did not appeared in EL images.**

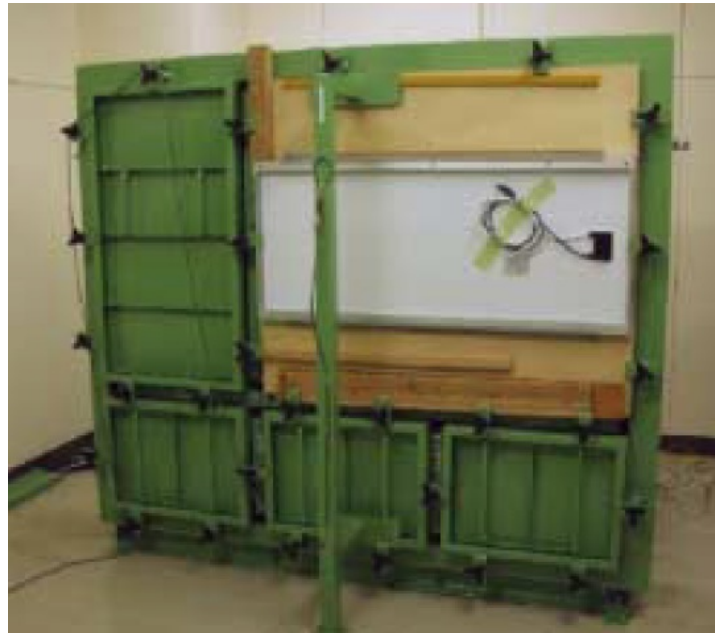
DML

IEC 62782

+ / - 1,000 Pa
1,000 Cycles
3 cycle/min
at RT

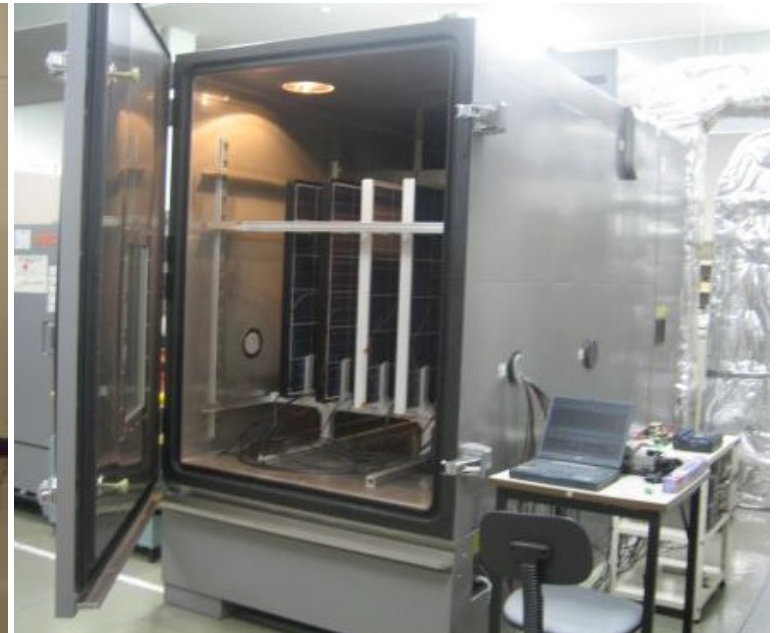
IEC 61215:2008

10.11 Thermal Cycling Test
-40 / 85 °C
200 Cycles
w/ Current (Ipm,
at > 25 °C)

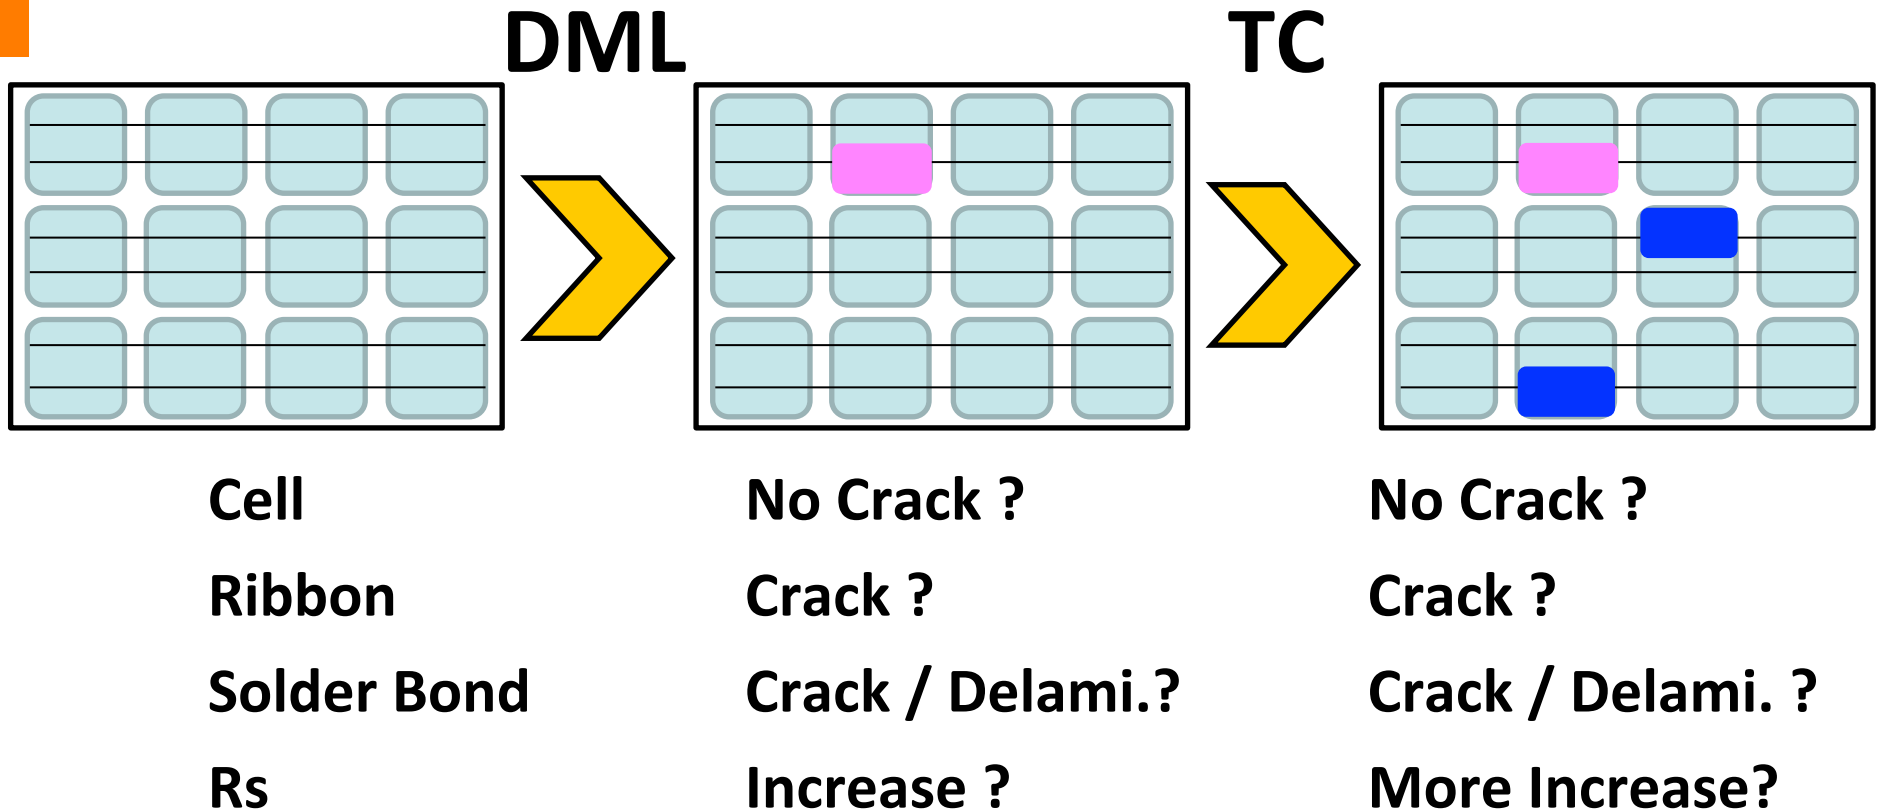
Putative Results (Ideal)

Focus:
Ribbon / Solder Crack, but not Cell Crack

Asymmetric Dark Area along bus-bar in EL Image

“No Cell Crack” was inspected by Laser Imaging

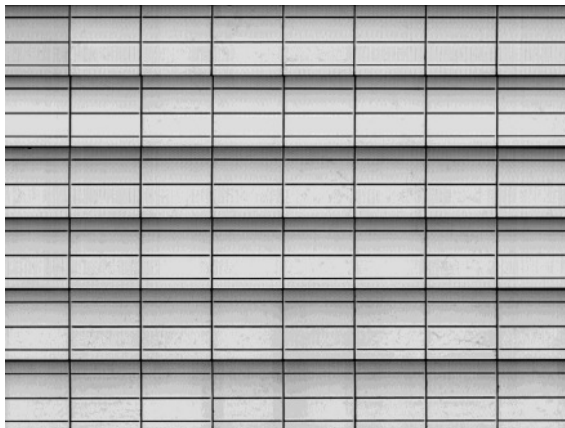
NPC Incorporated : “Module Laser Inspection Machine (NLS-M)”

- Laser scanning (narrow spot) with optimized bias current
 - > Reconstitution of Jsc Image
- SEMI PV Group (JP): Proposed a Standard as “Cell Crack Inspection Method’

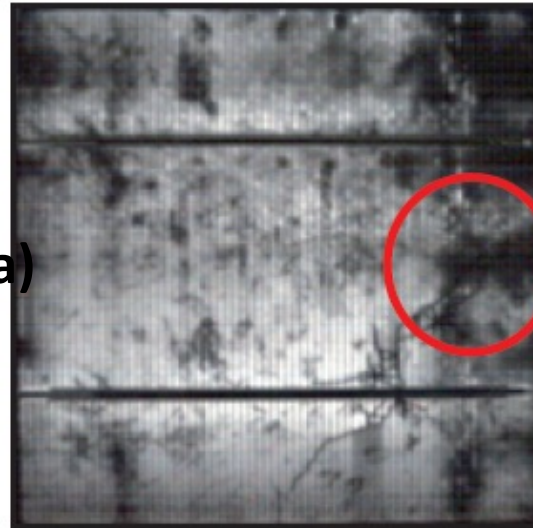
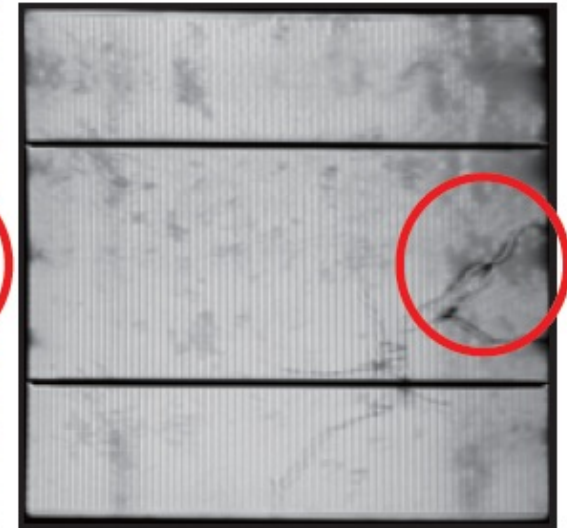
Cell Crack

EL: Pseudo-Negative
(Not Clear in Dark Area)

LS: Positive
(Clear)

EL Image

Laser Scanning

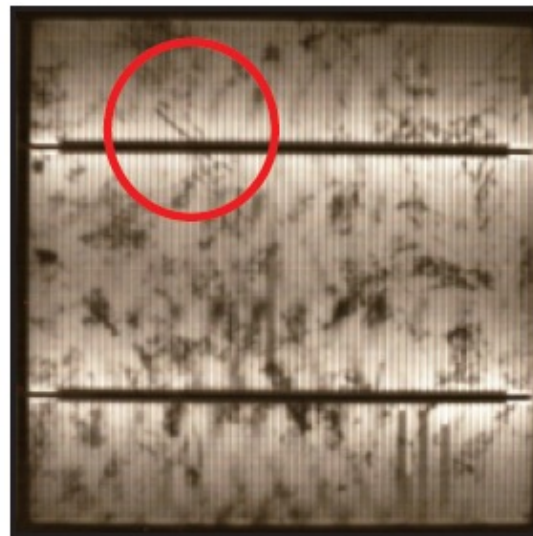
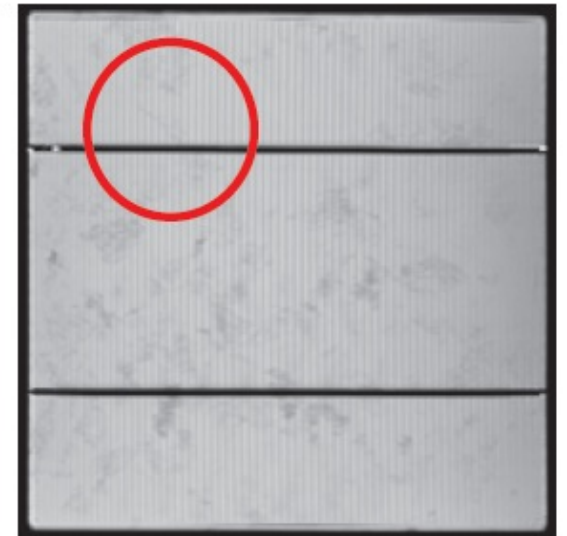
Cell Crack

EL: Pseudo-Positive

LS: Negative

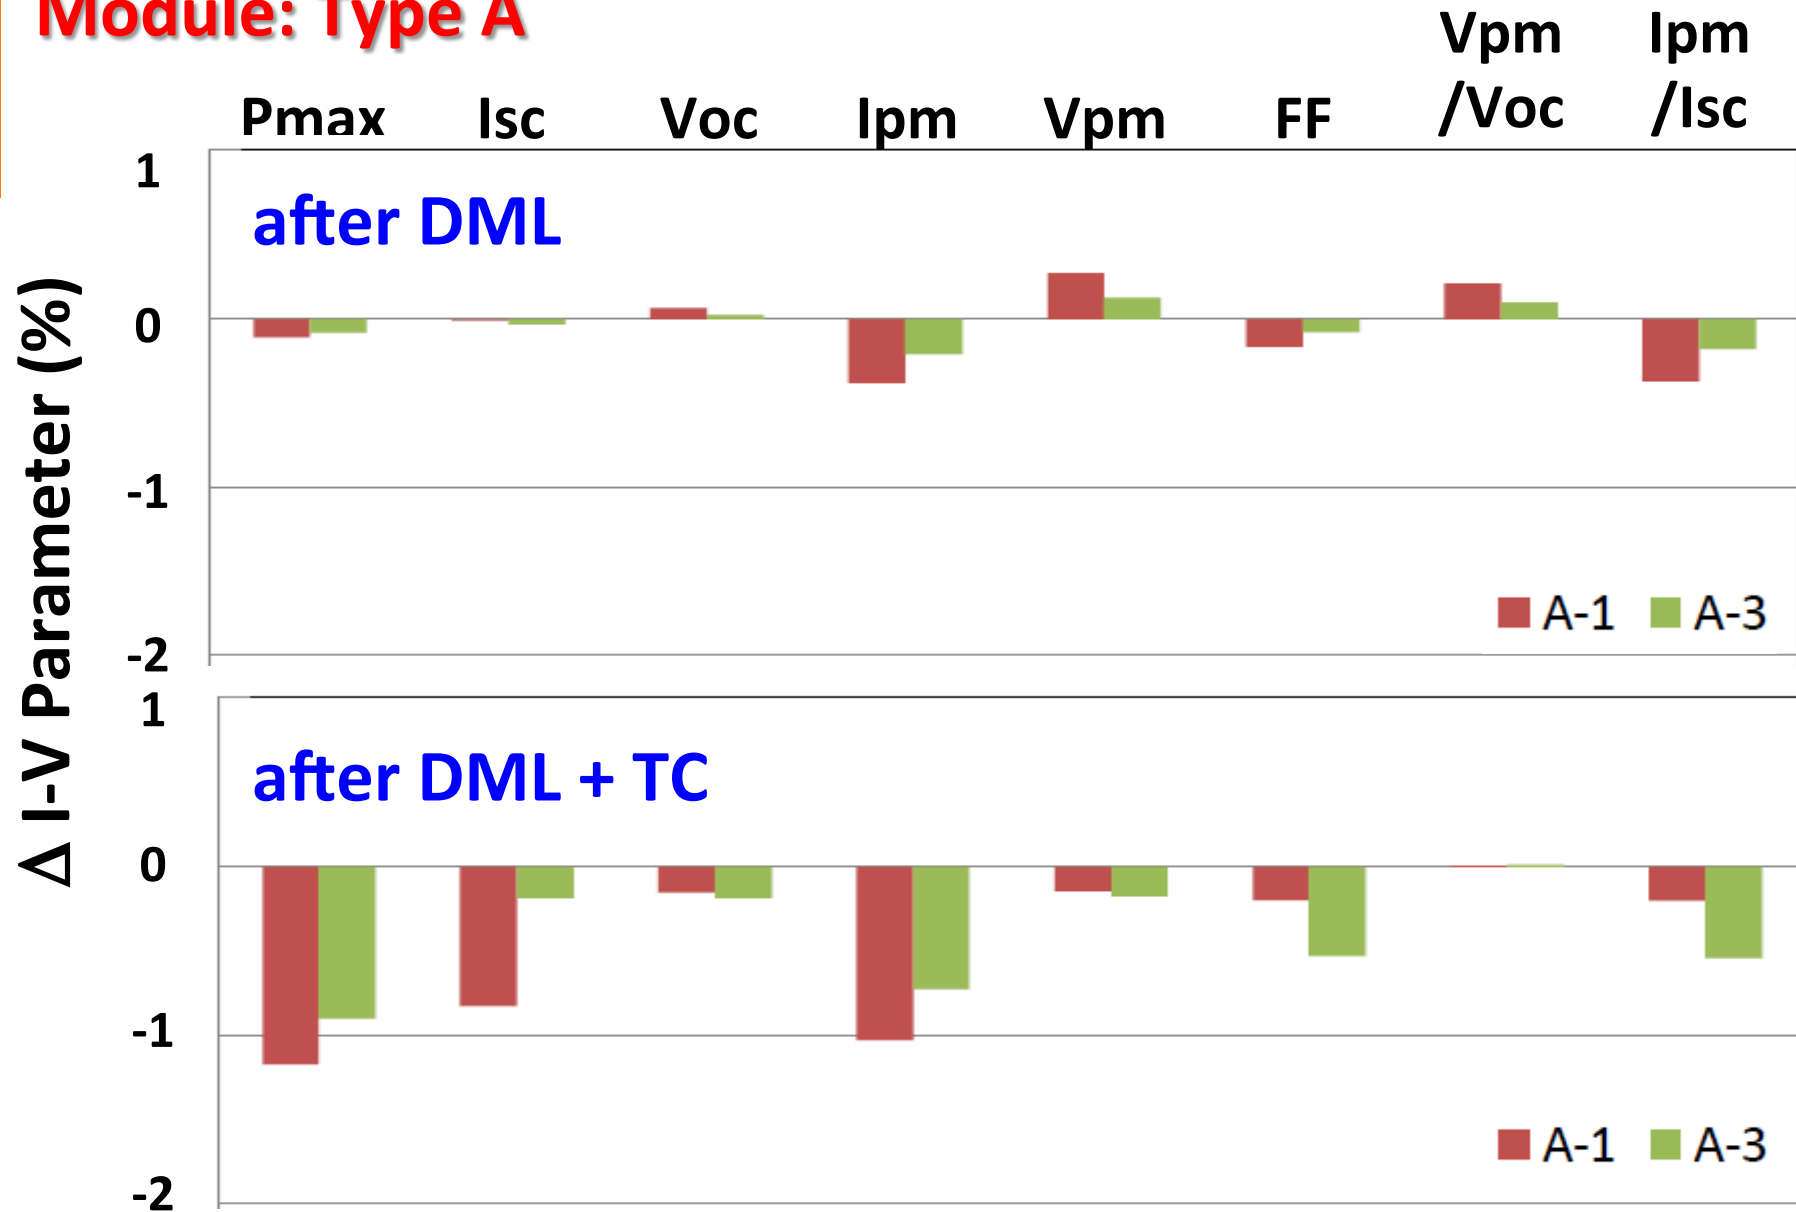
Module: Type A

Changes of I-V Parameters after DML/TC Testing

- The changes of I-V parameters is relatively-little.
- The asymmetrical dark area along bus-bar did not appeared in EL.
- A little cells are cracked by DML defined in IEC 62782.

- Power-loss (ca. 1%) was observed in each type of module with the reduction of FF.
- The asymmetrical dark area along bus-bar appeared in EL images (1 module / 4 modules).
- For the cell cracks, the inspection is carrying out now.

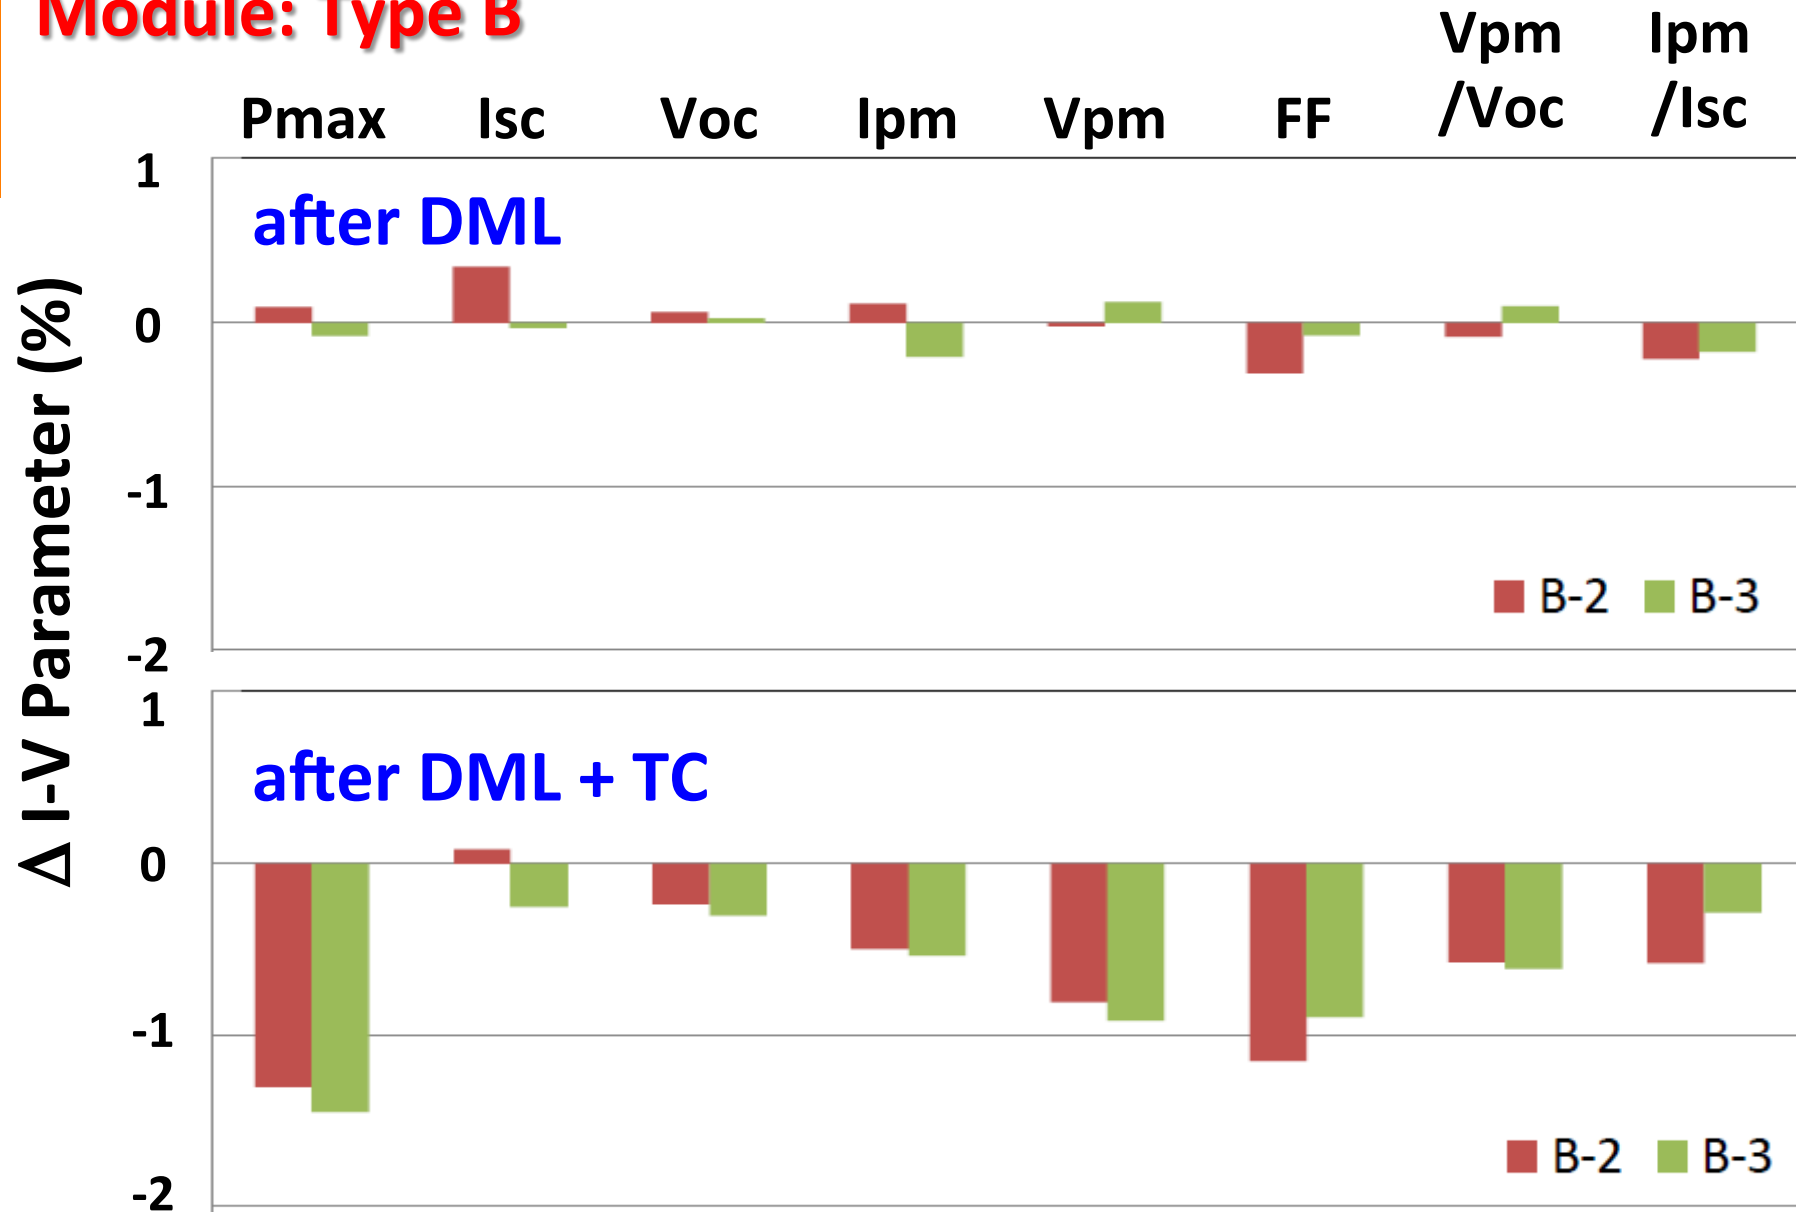
Module: Type B

Changes of I-V Parameters after DML/TC Testing

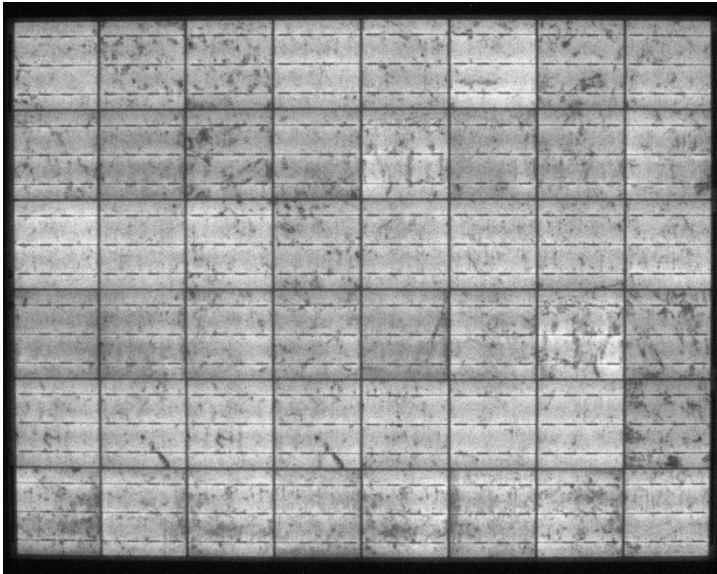
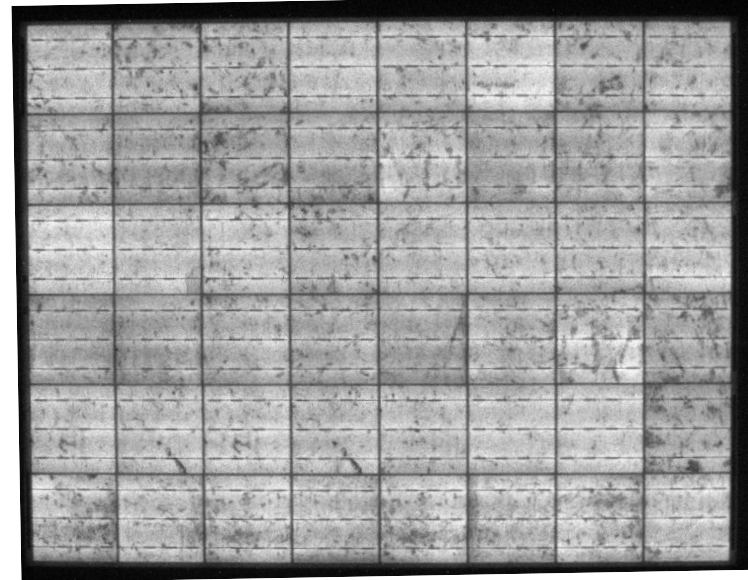
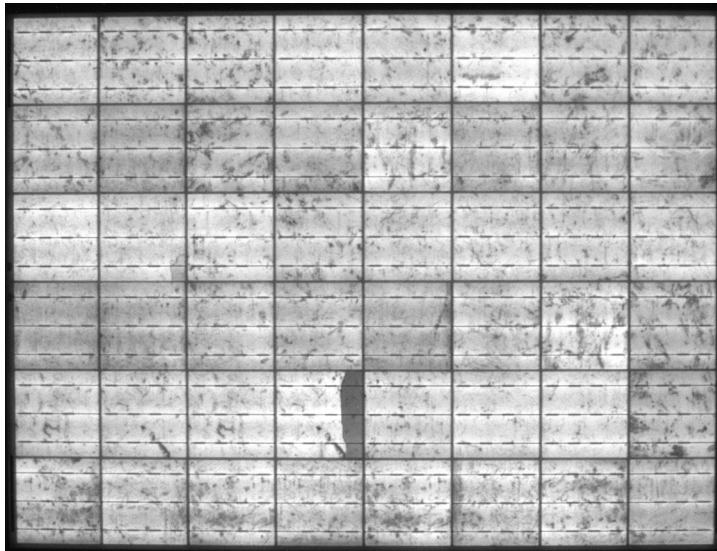
DML-TC Sequential Test (EL Images) : **Module A** (A-1 Module)

Initial

after DML

after DML + TC

The multiplication of asymmetrical dark area along bus-bar **was not observed** in the modules after DML & TC.

After DML & TC, the cell crack was observed in EL image.

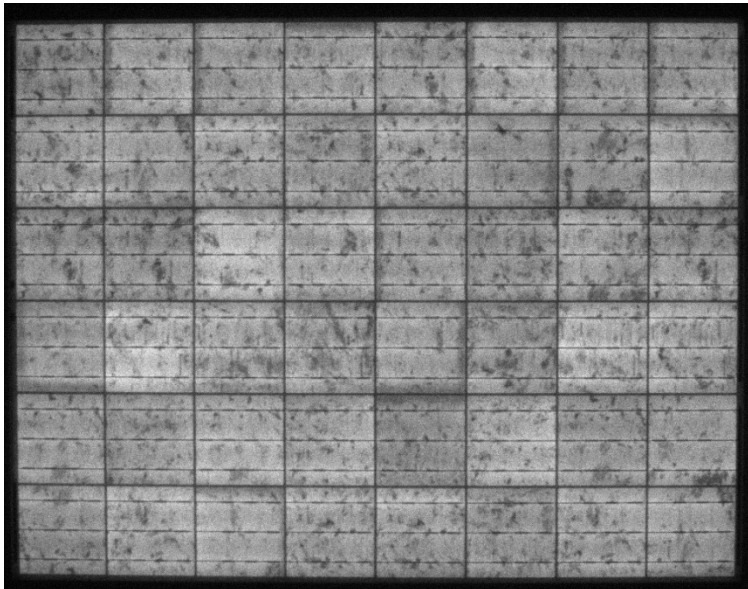
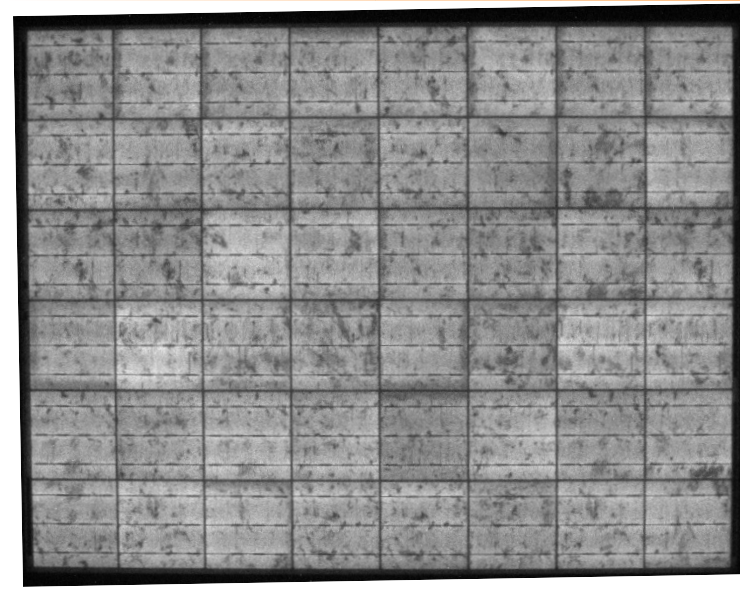
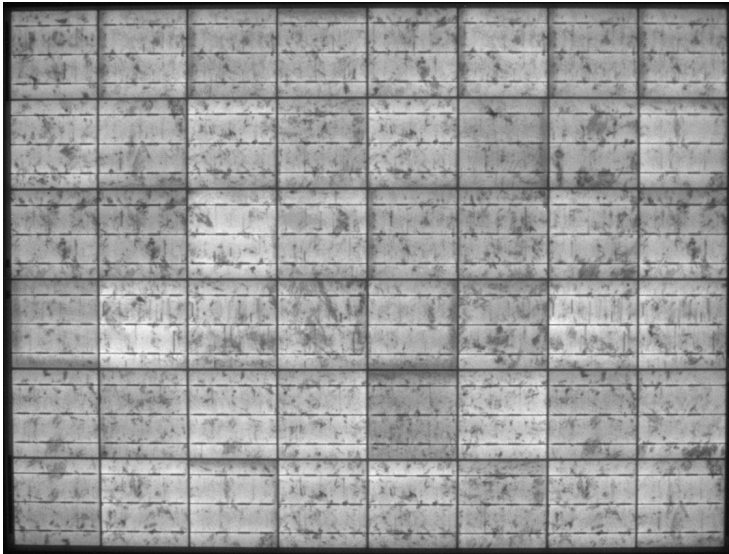
DML-TC Sequential Test (EL Images) : **Module A** (A-3 Module)

Initial

after DML

after DML + TC

The multiplication of asymmetrical dark area along bus-bar **was not observed** in the modules after DML & TC.

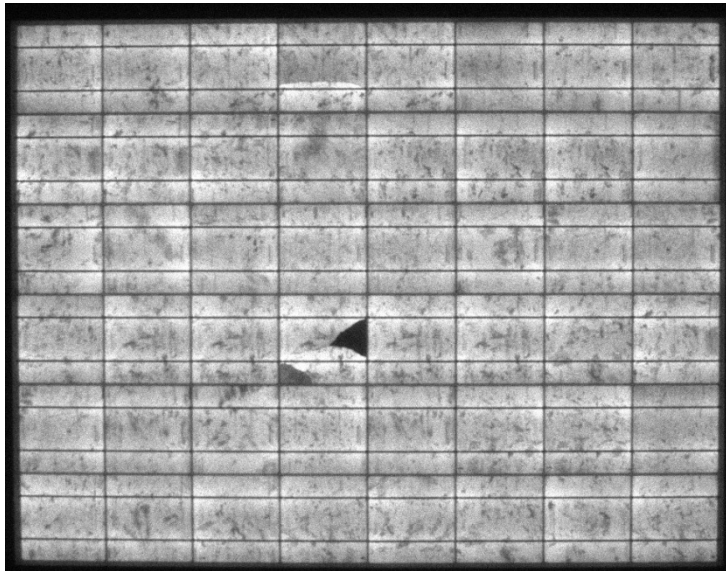
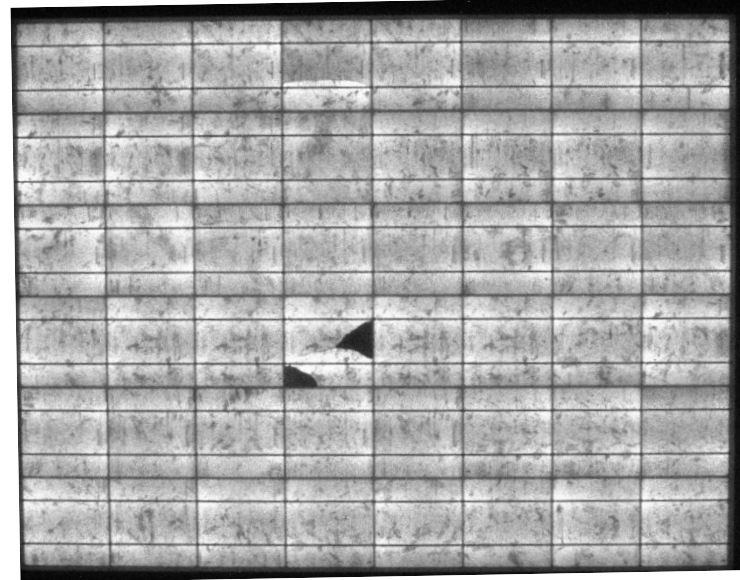
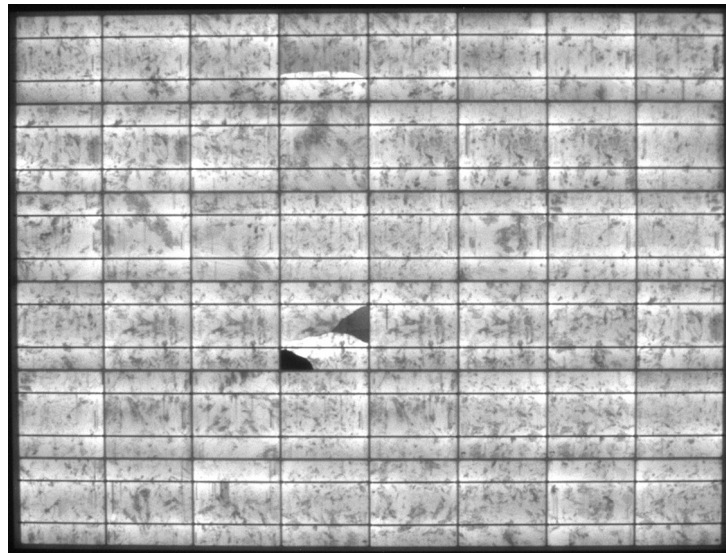
DML-TC Sequential Test (EL Images) : **Module B** (B-2 Module)

Initial

after DML

after DML + TC

The multiplication of asymmetrical dark area along bus-bar **was not observed** in the modules after DML & TC.

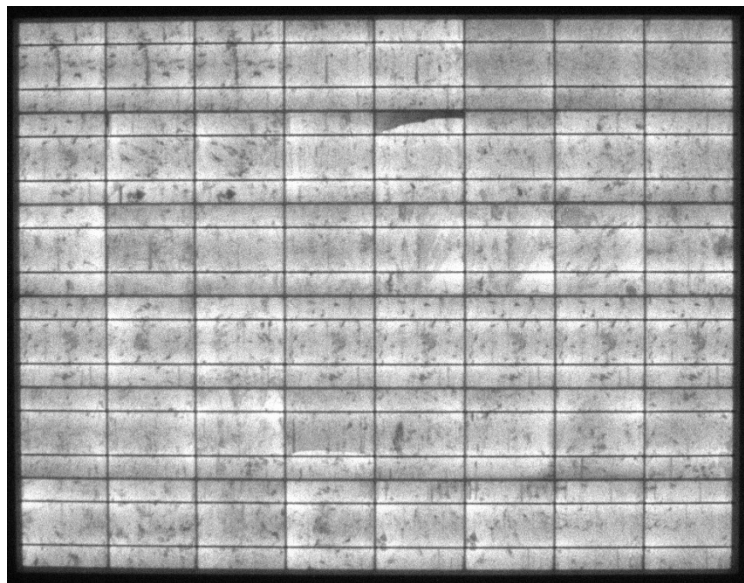
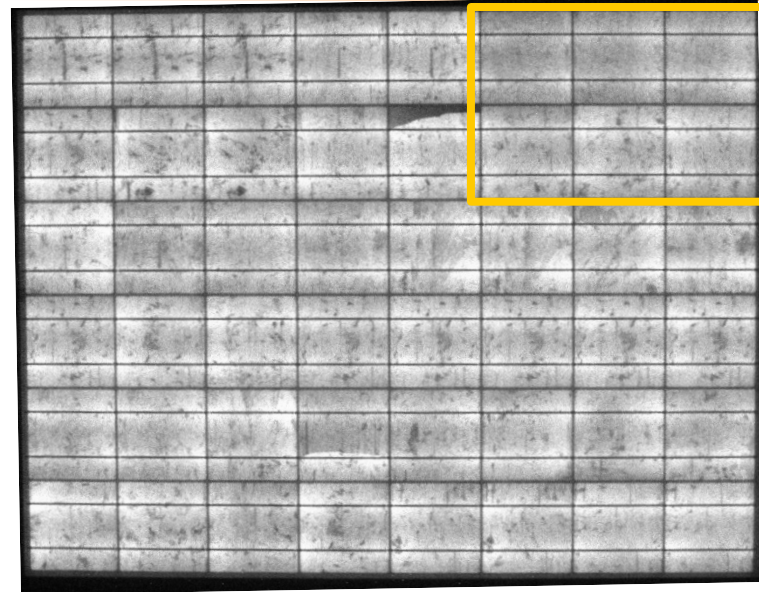
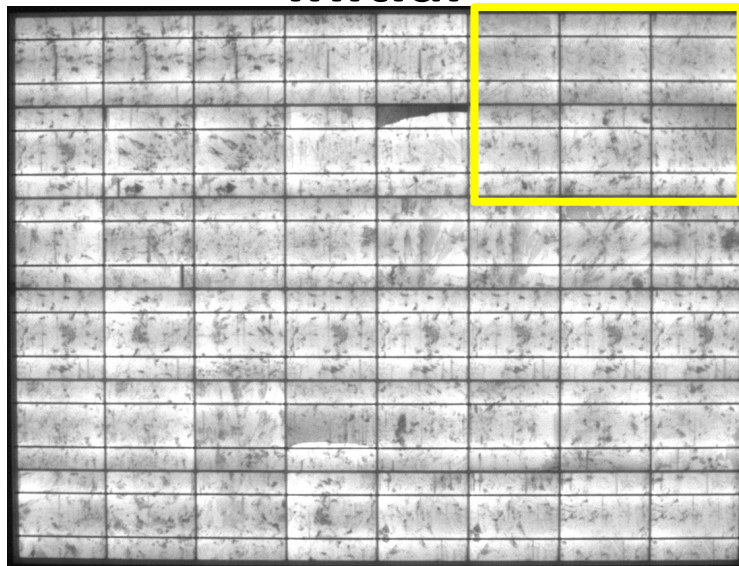
DML-TC Sequential Test (EL Images) : **Module B** (B-3 Module)

Initial

after DML

after DML + TC

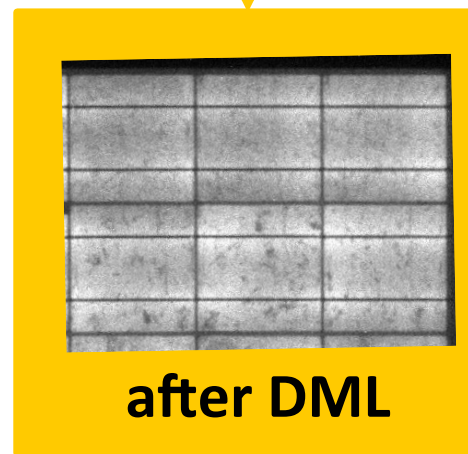
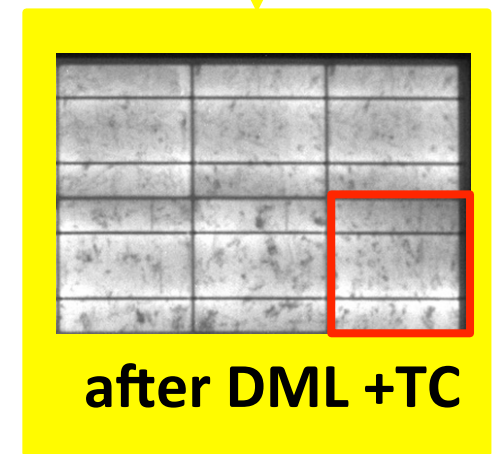
after DML

after DML +TC

Cracked Cell Number

Module		Initial	after DML	*after TC
Type A	Reference	0	1	
	A-1	0	3	
	A-3	1	3	
Type B	Reference	1	8	
	B-2	4	4	
	B-3	4	5

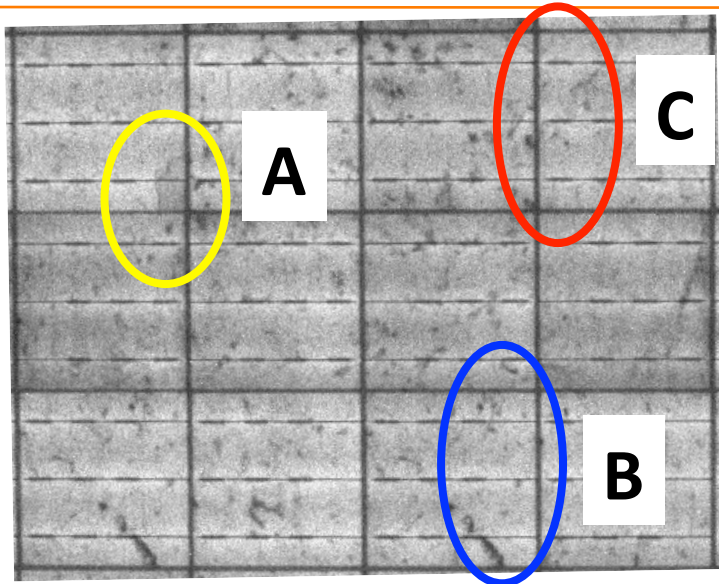
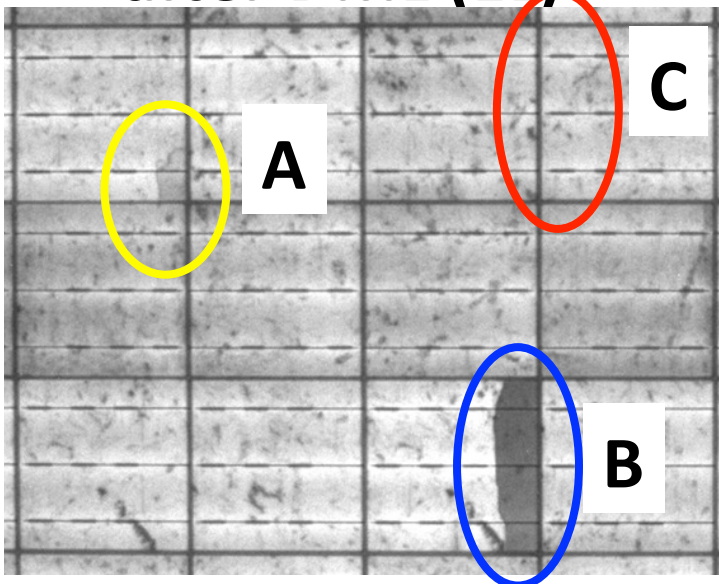
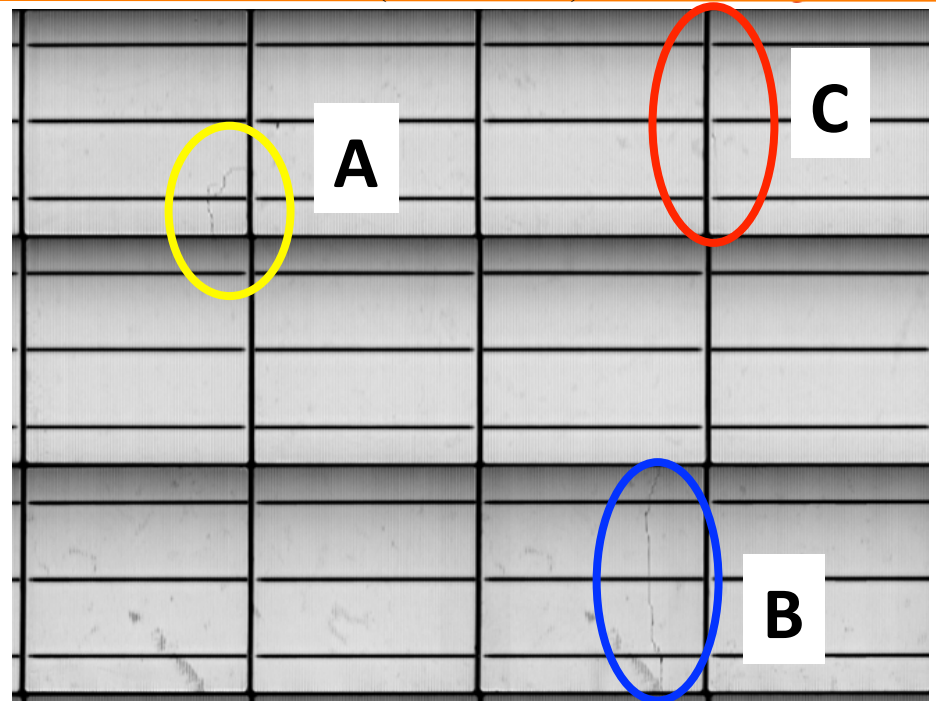
DML-TC Sequential Test (LS Images) : **Module A**

(A-1 Module)

after DML (EL)

after DML + TC (EL)

after DML (LS)

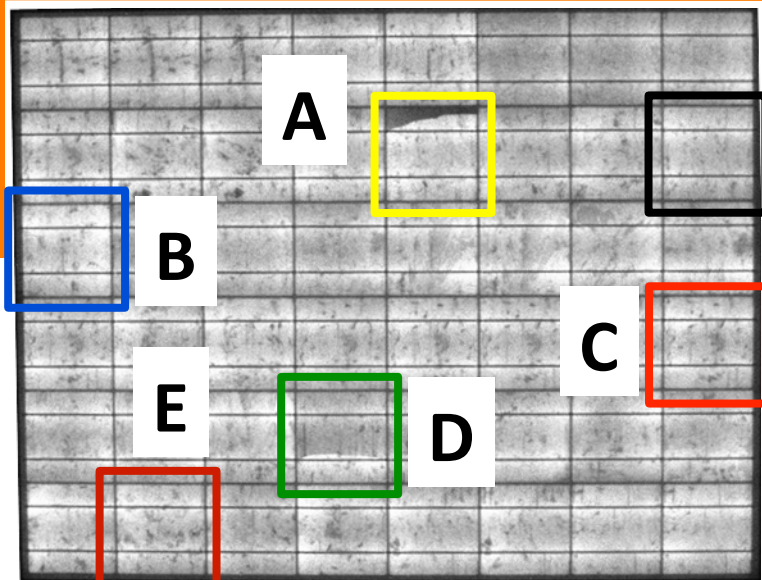
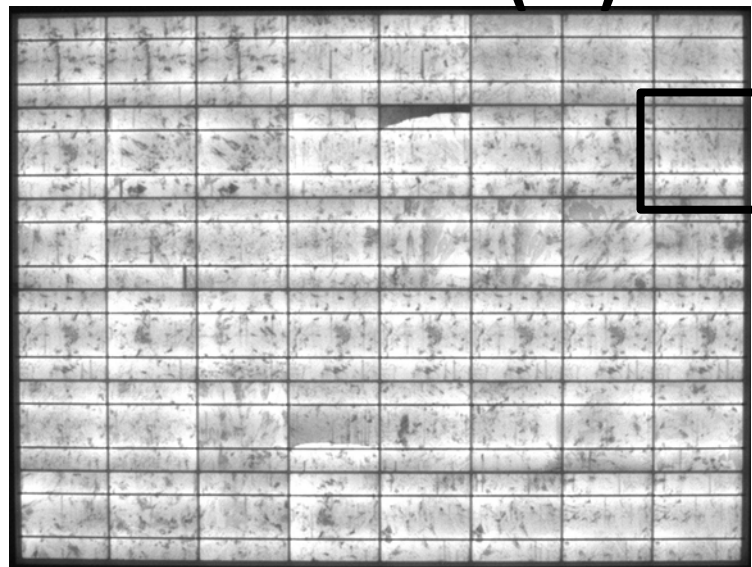
DML-TC Sequential Test (LS Images) : **Module B**

(B-3 Module)

after DML (EL)

after DML + TC (EL)
