GATEWAY Demonstration of LED Lighting in a High-Temperature Environment: One Year Later

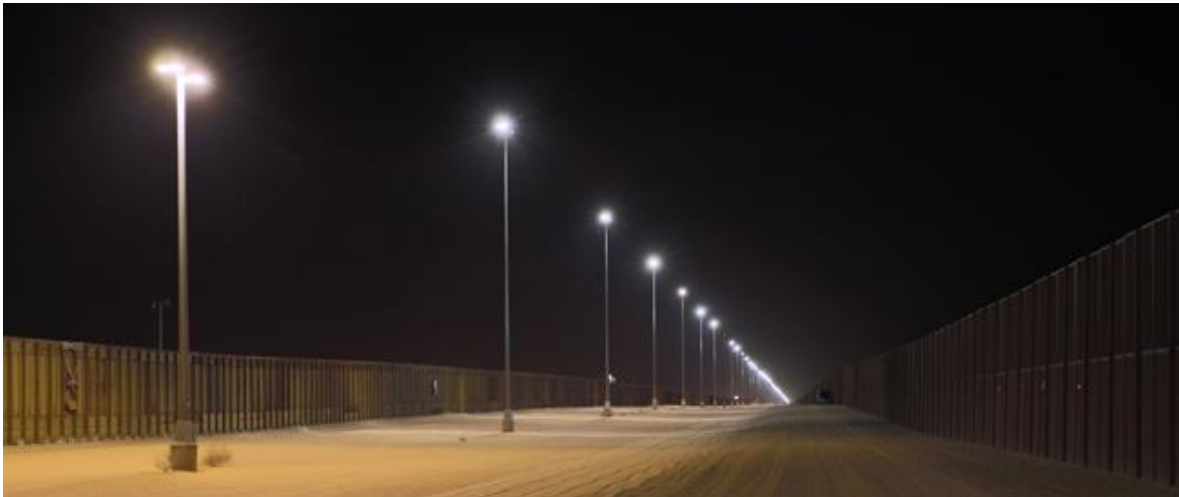
You may recall that last year, DOE's [GATEWAY](#) program published the [initial report](#) on a demonstration involving an LED retrofit of the incumbent quartz metal halide (QMH) area lighting along a 7.2-mile stretch of the Yuma (Arizona) Sector Border Patrol Area along the U.S.-Mexico border. The high temperatures often reached in the desert, coupled with the high-flux needs of the application, make for a unique opportunity to document the long-term performance of the LED system in this challenging environment. The first report described how the new LED system was found to equal or better the QMH system in terms of both uniformity and illuminance, when comparing the initial output of the LED system and the maintained output of the QMH system; and now DOE has just published a [follow-up report](#) that reviews performance a year later.

The initial demonstration of the six LED luminaires installed on three poles in February 2014 was intended as a short-term trial before proceeding with the complete installation of more than 400 luminaires. Unexpected delays in the full installation have prevented the detailed evaluations that were planned, but ongoing tracking of the performance of the trial installation provides useful insights.

Measurements taken at the time of installation, again at about 2,500 hours of operation (September 2014), and again at about 5,000 hours of operation (March 2015) indicate that illuminance is changing more rapidly than anticipated. The distribution of illuminance has also changed, with values nearest to the pole increasing while the values have decreased farther away from the pole. The average horizontal illuminance decreased by 18% near the primary fence marking the border, and the vertical illuminance decreased by 25% on the primary fence. These changes in the illuminances delivered by the lighting system occurred after 2,500 hours of operation and persisted after 5,000 hours of operation. There was no measured shift in the color of the light.
