# Investigation of deformation localization in irradiated austenitic steels

Light Water Reactor Sustainability R&D Program

DOE Cross-cutting Materials Meeting,  
August, 16, 2016

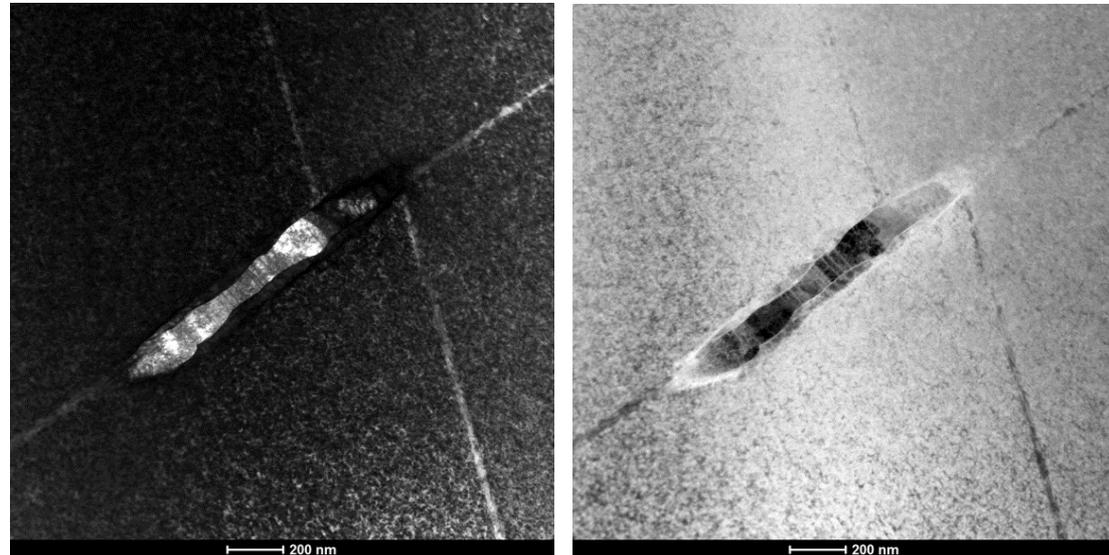
Specific feature formed at the dislocation channel.
