Office of Health, Safety and Security

Monthly Analysis of Electrical Safety Occurrences

December 2011

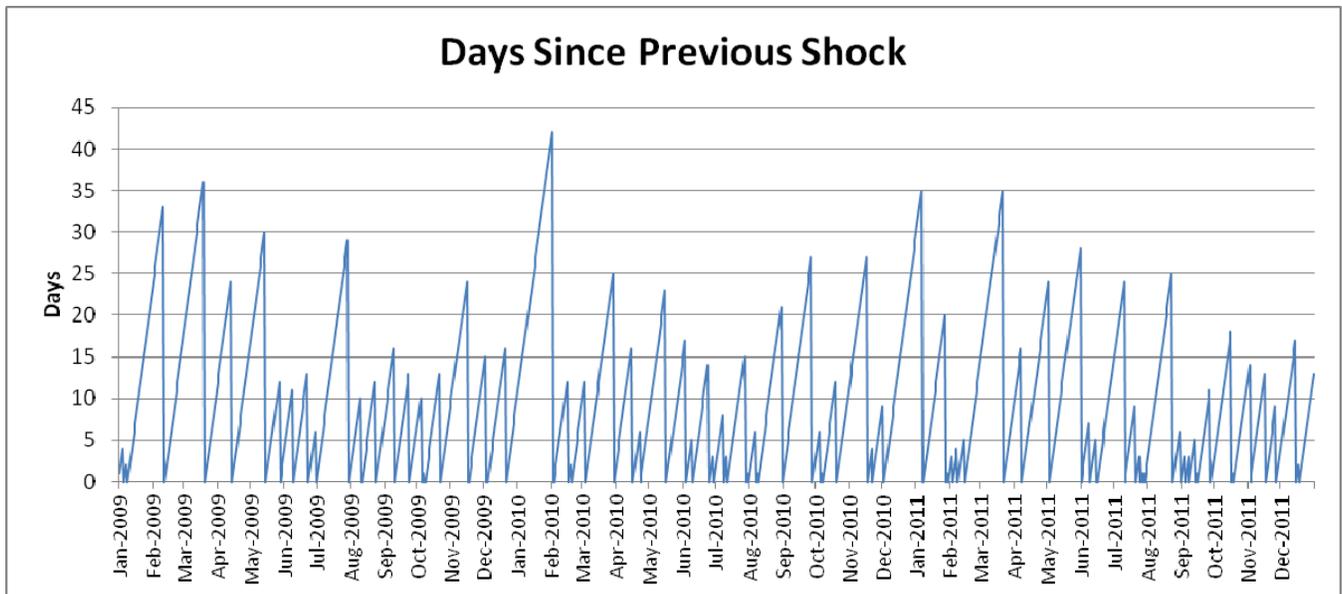
Figure 1 - Days since Previous Shock

Figure 1 shows the number of days since the previous electrical shock for the DOE complex. The present interval is 13 days. The longest interval was 41days in 2010.

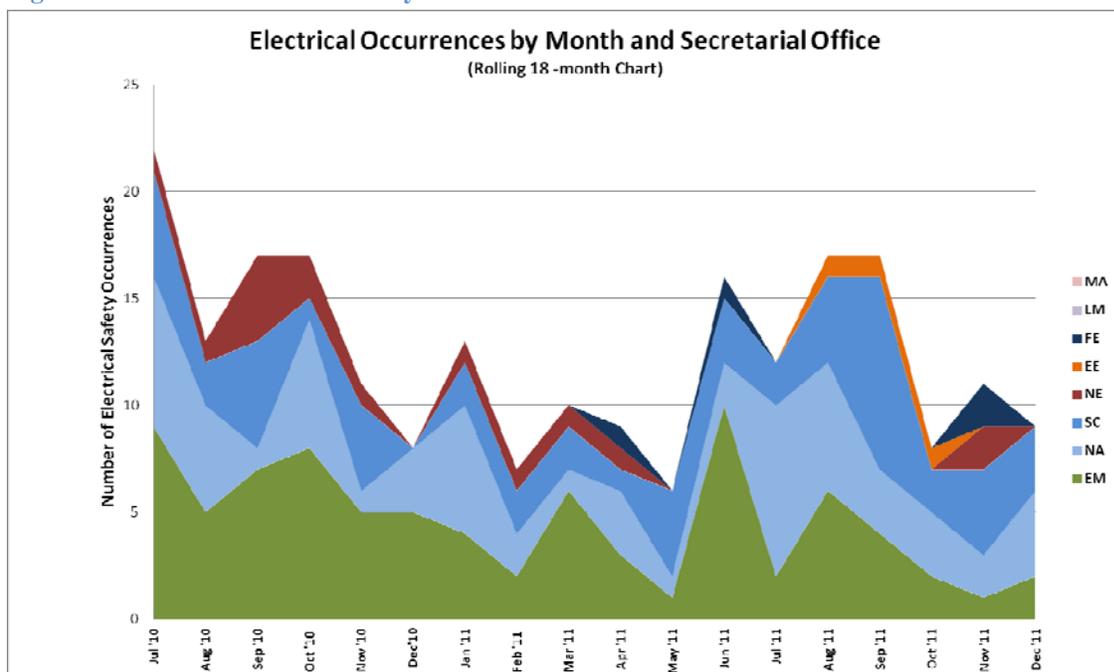
Figure 2 - Electrical Occurrences by Month and Secretarial Office

Figure 2 shows the distribution of electrical safety occurrences by Secretarial Office, with Environmental Management with the fewest reports and NNSA with the most reports.

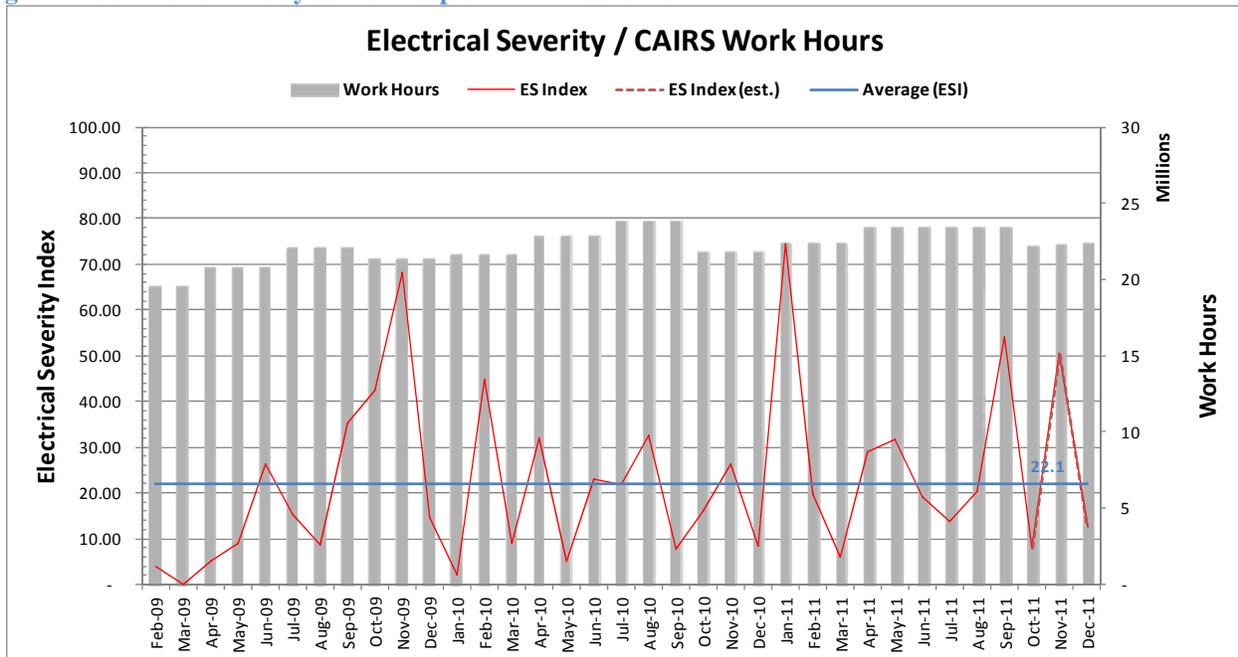
Figure 3 - Electrical Severity Index Compared to Work Hours

The Electrical Severity Index (ESI) is a performance metric that was developed to normalize events against organizational work hours. The ESI is calculated monthly and trended. Figure 3 shows a calculated ESI for the DOE complex and Table 4 shows the ESI and how it has changed from the previous month.

Note: An estimated ESI is calculated until accurate CAIRS man-hours are available. The chart is updated monthly.

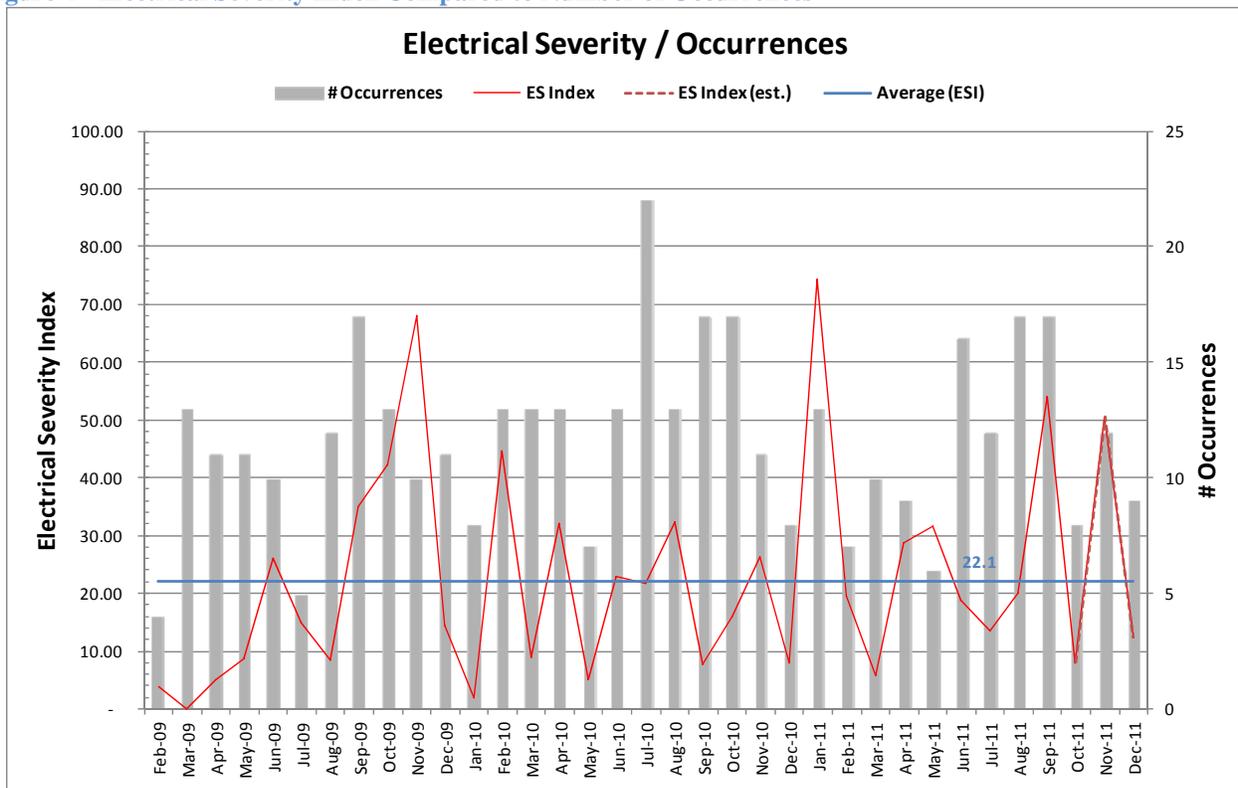
Figure 4 - Electrical Severity Index Compared to Number of Occurrences

Figure 4 shows the ESI with the number of Occurrences instead of Work Hours.

The average ESI has remained fairly constant over the past several month and decreased slightly from November to 22.1 in December. The lowest average ESI was 19.2 in June 2010.

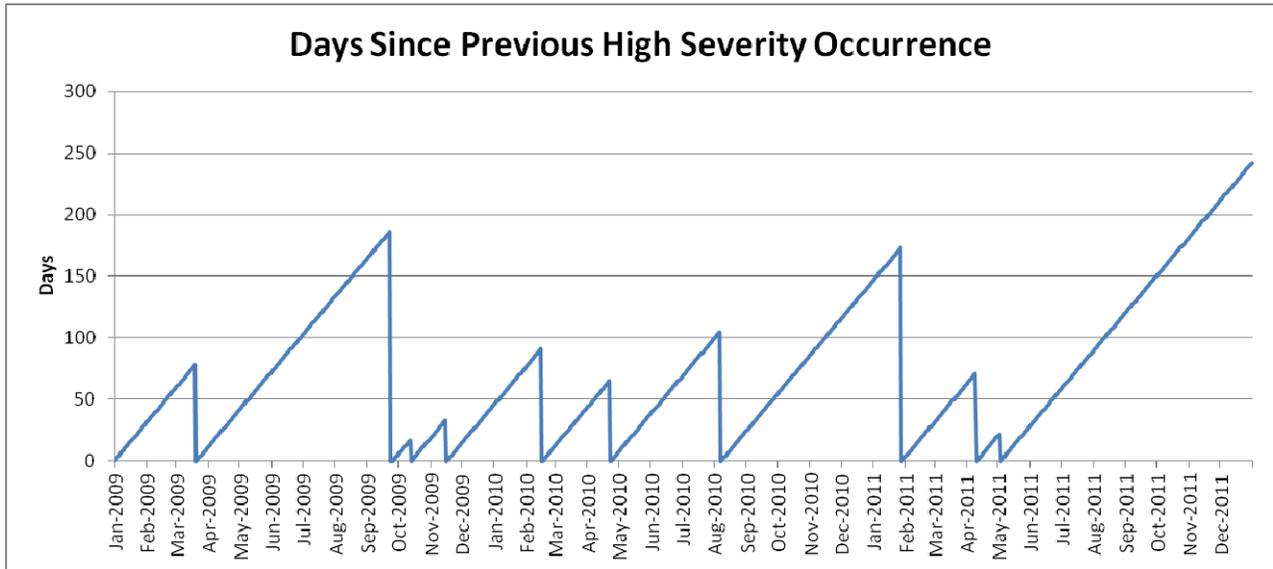
Figure 5 - Days since Previous High Severity Occurrence

Figure 5 shows the number of days since the previous high severity occurrence. The present interval is 240 days. The previous longest interval was 181 days in 2009.

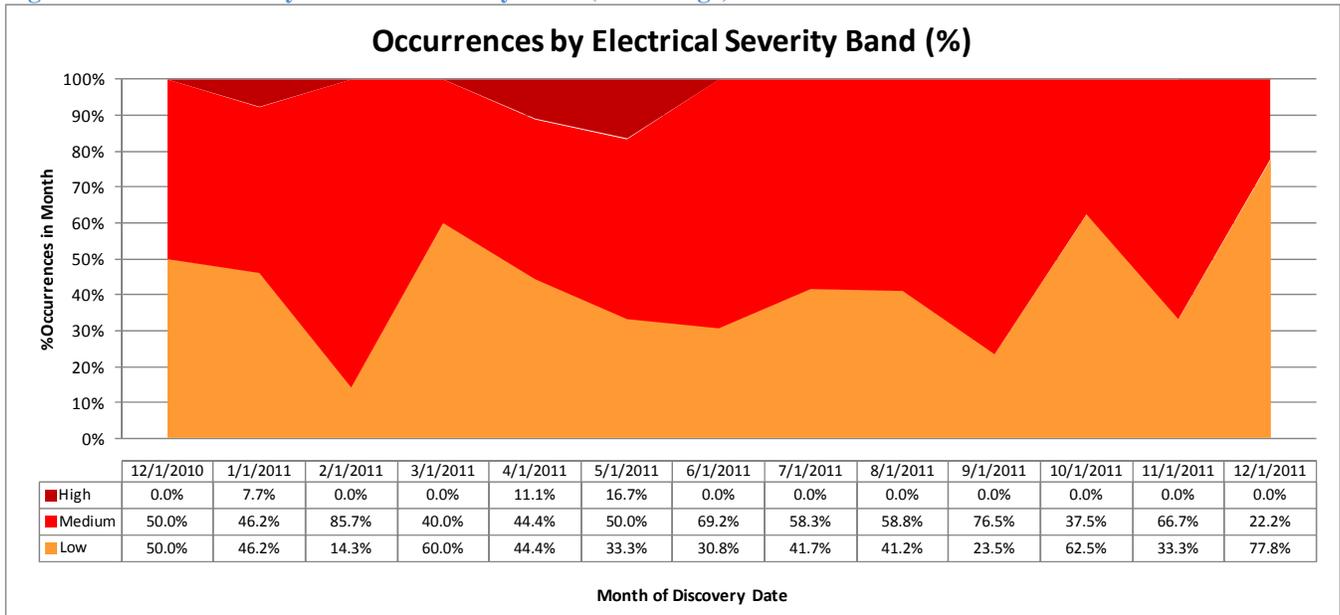
Figure 6 - Occurrences by Electrical Severity Band (Percentage)

For the interval December 2010 through December 2011 (current month and the past 12), Figures 6 and 7 summarize occurrences by severity band and month of discovery date by percentage of total occurrences in month and number of occurrences in month.

What can be seen from the previous two charts is that the number of occurrences with High electrical severity scores has remained at zero for the past seven months and that the number of occurrences with Medium scores has decreased below the number of Low severity occurrences, which is a favorable trend.

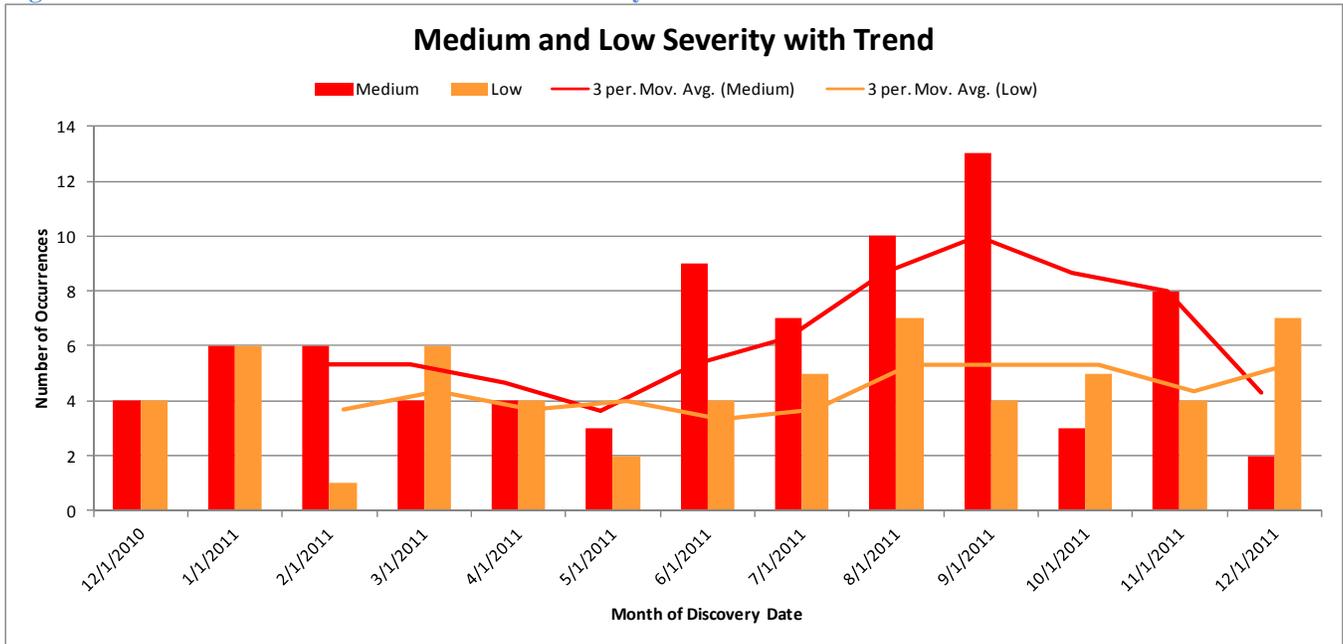
Figure 8 - Trend of Medium and Low Electrical Severity Occurrences

Figure 8 focuses on the Medium and Low severity data series for December 2010 through December 2011. Trend lines are included for each, using a 3-month moving average.

The 3-month moving average shows a decreasing trend in the Medium severity occurrences following the peak in September 2011. The figure also shows a slight increase in the number of of Low severity occurrences.
