Office of Health, Safety and Security

Monthly Analysis of Electrical Safety Occurrences

July 2011

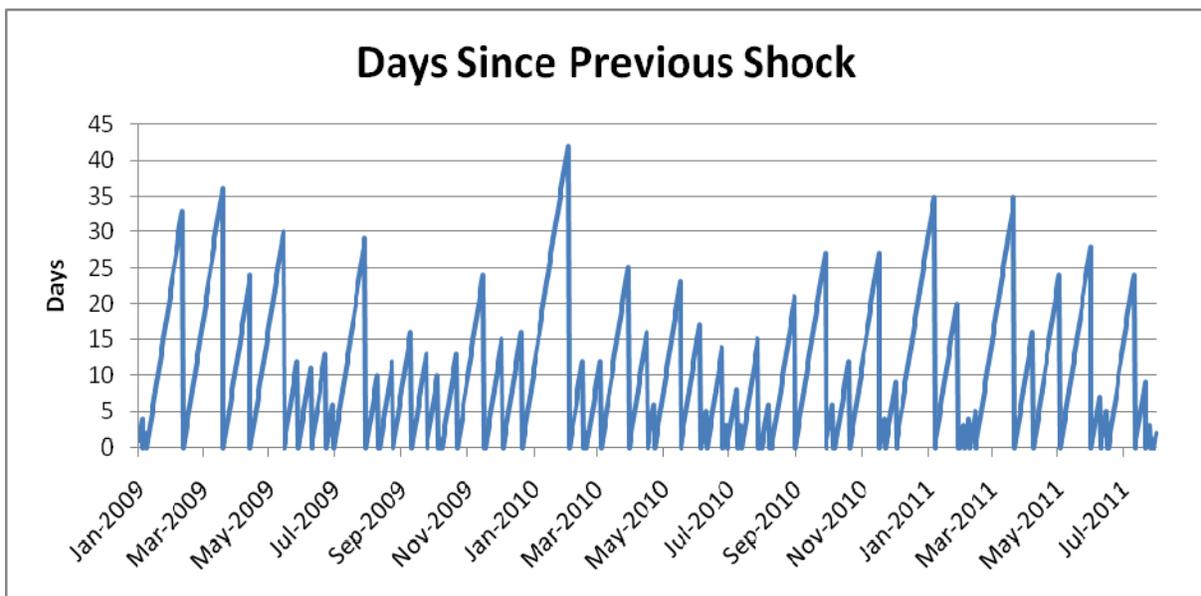
The following chart shows the number of days since the previous electrical shock for the DOE complex. The present interval is 2 days. The longest interval was 41 days in 2010.

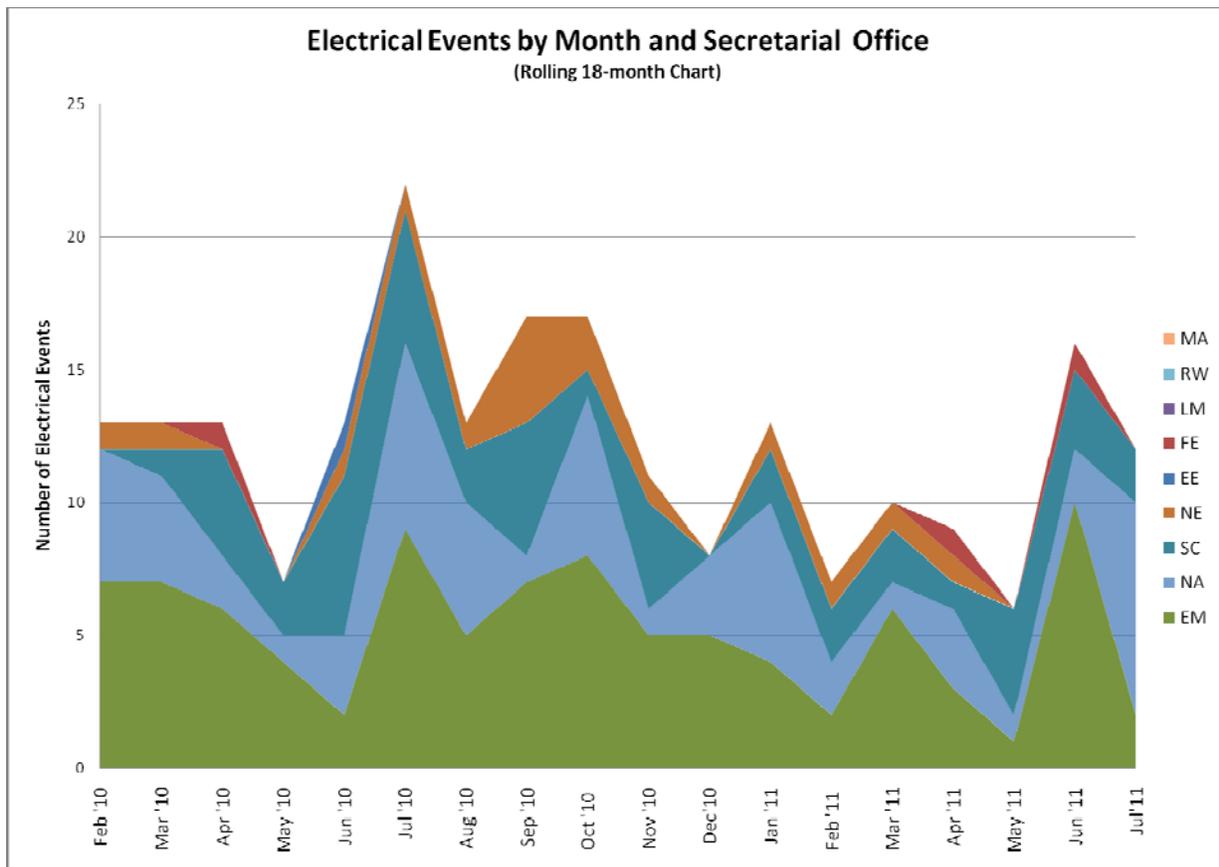
The following chart shows the distribution of electrical safety occurrences by secretarial office. As can be seen, National Nuclear Security Administration sites were the largest contributor. The Office of Energy Efficiency and Renewable Energy last reported in June 2010.

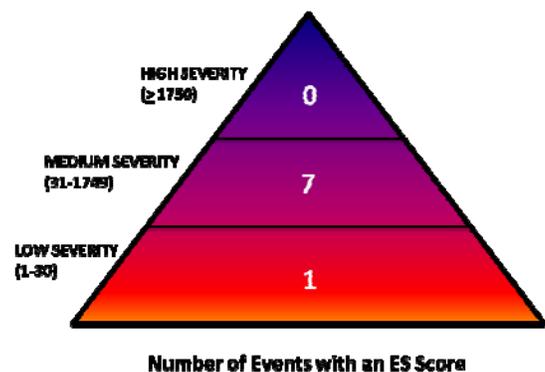
Electrical Severity Scores

The electrical severity scores are calculated using Revision 2 of the Electrical Severity Measurement Tool, which can be found on the EFCOG website at http://www.efcog.org/wg/esh_es/docs/Electrical_Severity_Measurement_Tool.pdf. Four of the electrical occurrences this month did not have an Electrical Severity (ES) score. The other eight occurrences are distributed as shown in the triangle, with the highest ES score being 630. The actual score for each event is provided in the event tables (Attachment 1).

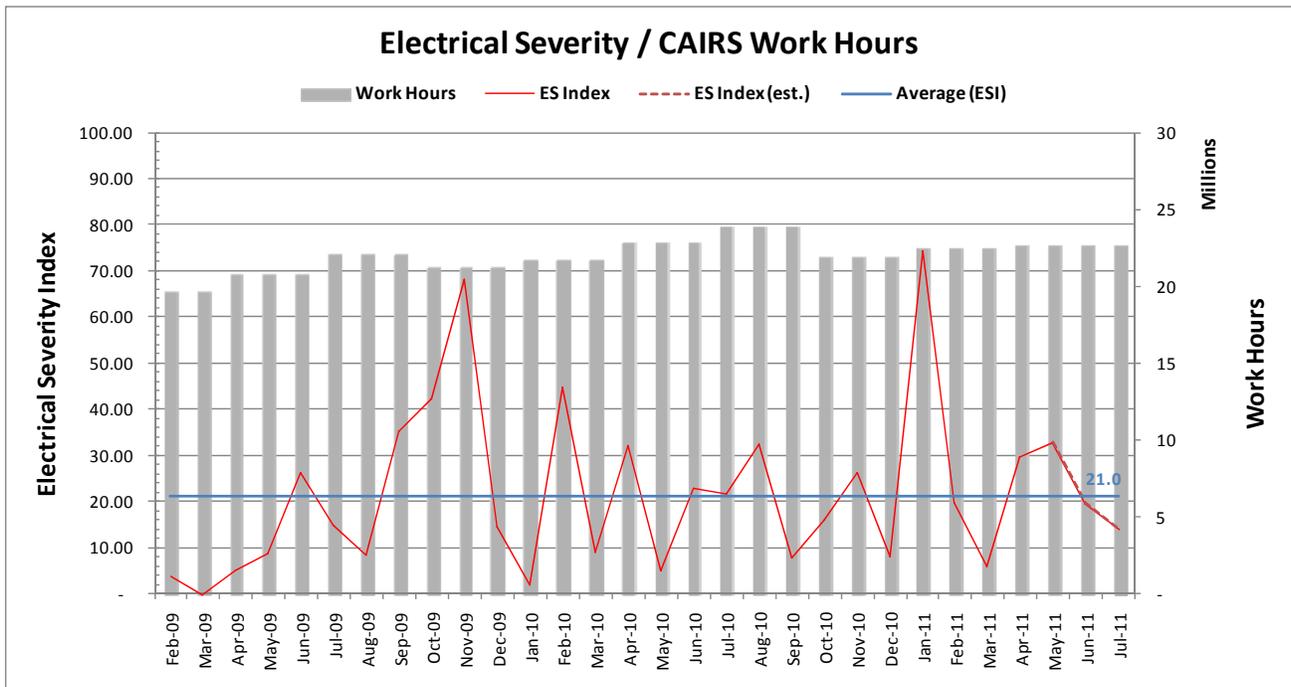
The Electrical Severity Index (ESI) is a performance metric that was developed to normalize events against organizational work hours. The ESI is calculated monthly and trended. Each DOE site calculates their own ESI and sets their own annual ESI goals. These ESI goals can vary from 0.22 to 160.0. Presently, the DOE complex goal is for the monthly ESI to be below the average ESI and to reduce the average ESI for the DOE complex to < 20.0. This average ESI goal was established based on the average ESI for 2009 (18.99) and 2010 (19.03). The following chart shows a calculated ESI for the DOE complex, which has decreased over that past two months.

Note: An estimated ESI is calculated until accurate CAIRS man-hours are available. The chart is updated monthly.

Category	June	July	Δ
Total Occurrences	16	12	-4
Total Electrical Severity	2,211	1,578	-633
Estimated Work Hours	22,631,855* (22,631,855)	22,629,691	-2,164
ES Index	19.54* (19.54)	13.95	-5.59
Average ESI	21.3	21.0	-0.3

$$\text{Electrical Severity Index} = (\Sigma \text{Electrical Severity} / \Sigma \text{Work Hours}) 200,000$$

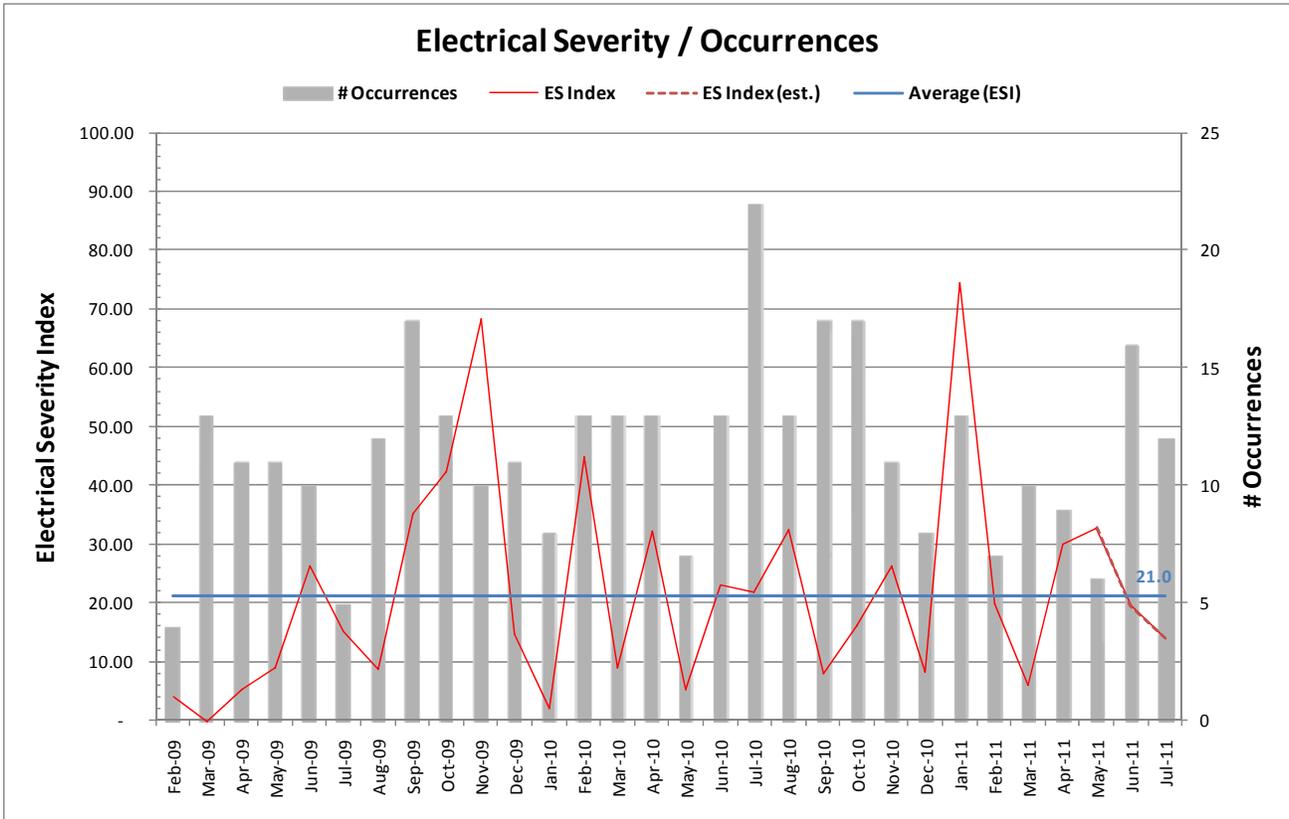
The following chart shows ESI with the number of Occurrences instead of Work Hours.

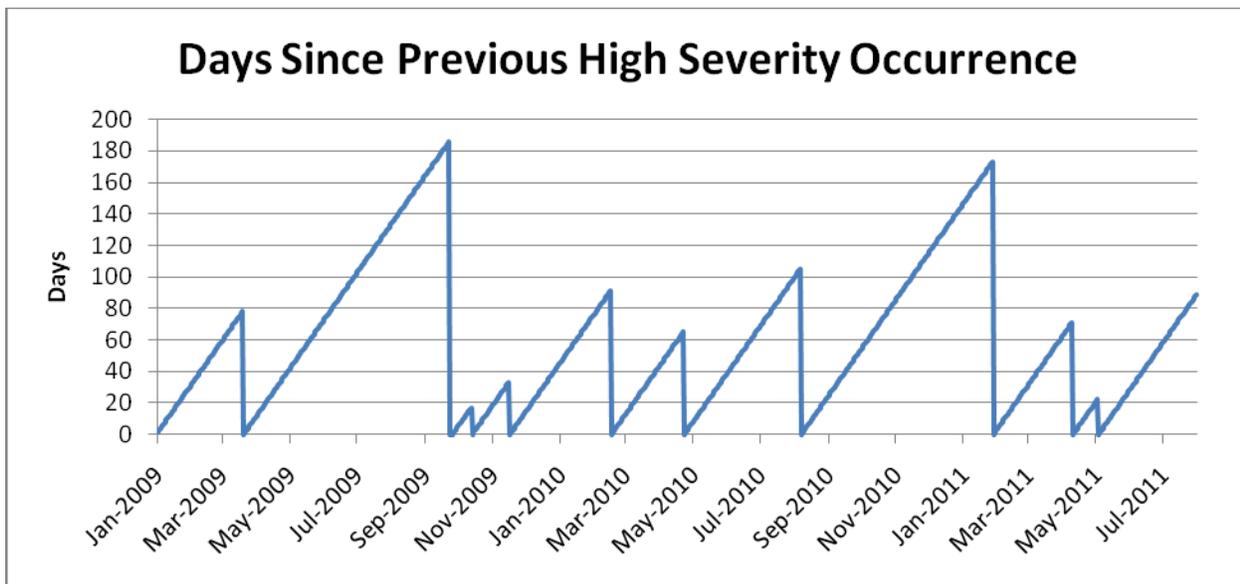
The average ESI has increased from 19.2 in June 2010 to 21.3 in June 2011. The ongoing efforts of the EFCOG Electrical Safety Subgroup and the recommendations from the various subcommittees can help reduce the number of medium and high electrical severity events and thus reduce the ESI. The following chart shows the number of days since the previous high severity occurrence. The present interval is 83 days. The longest interval was 181 days in 2009.

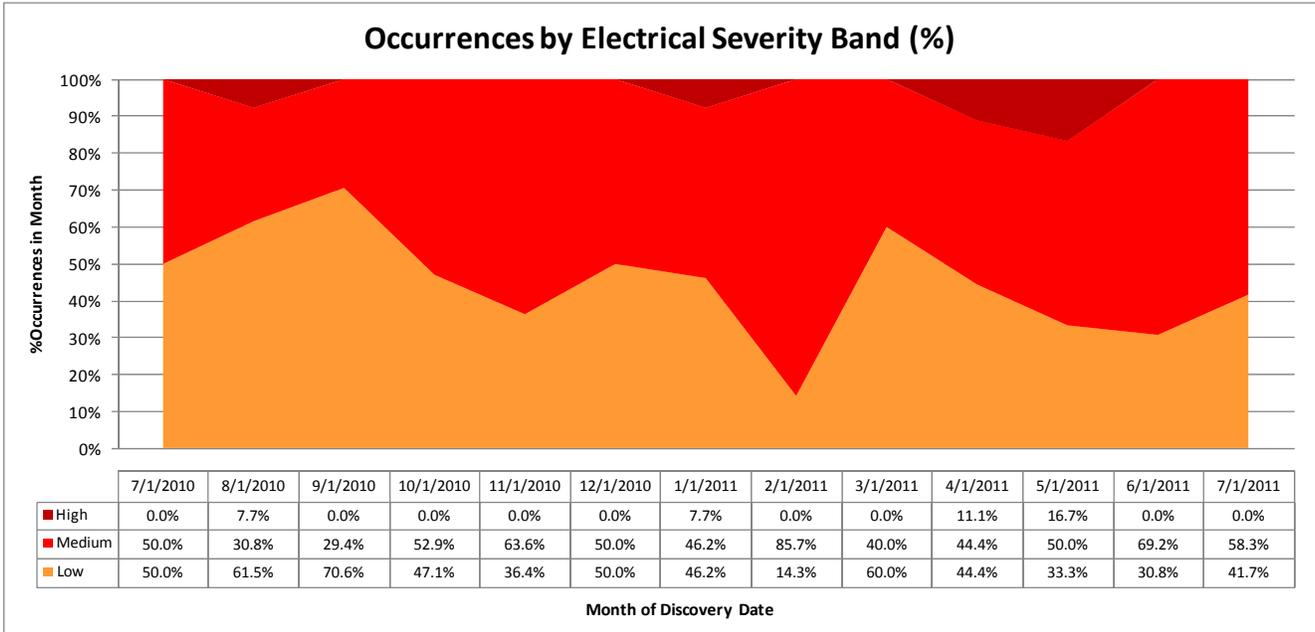
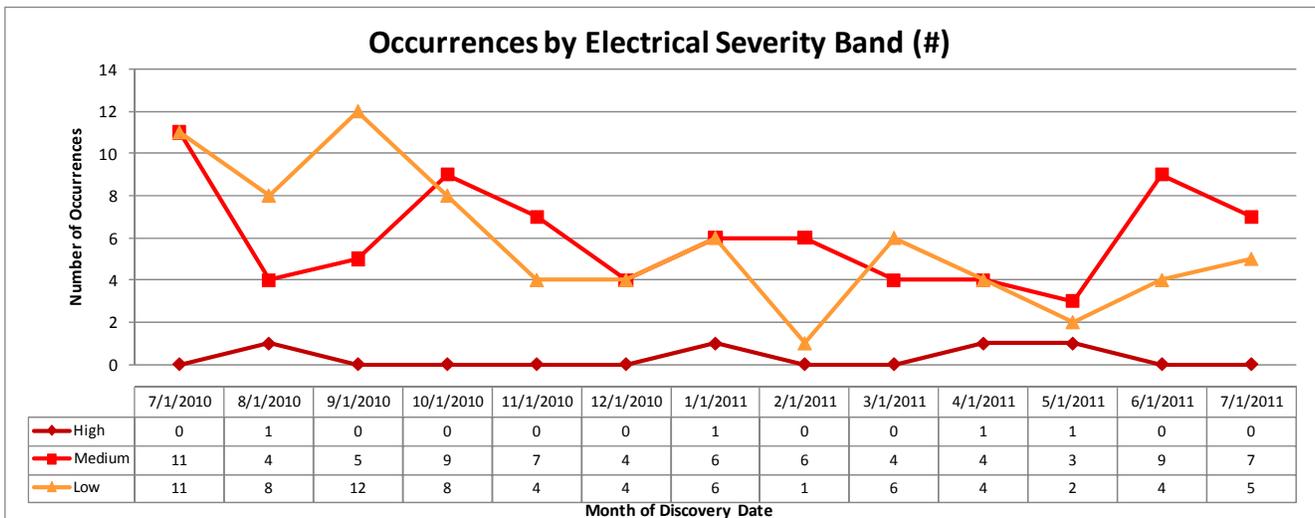
Summary of Occurrences by Severity Band

For the interval July 2010 through July 2011 (current month and the past 12), the next two charts summarize occurrences by severity band and month of discovery date:

- By percentage of total occurrences in month
- By number of occurrences in month

What can be seen from the previous two charts is that the number of occurrences with High electrical severity scores has remained at zero for the past two months and that the number of occurrences with Medium scores decreased as Low electrical severity scores increased. It is more desirable to see more Low than Medium severity occurrences as was seen in September 2010 and March 2011.

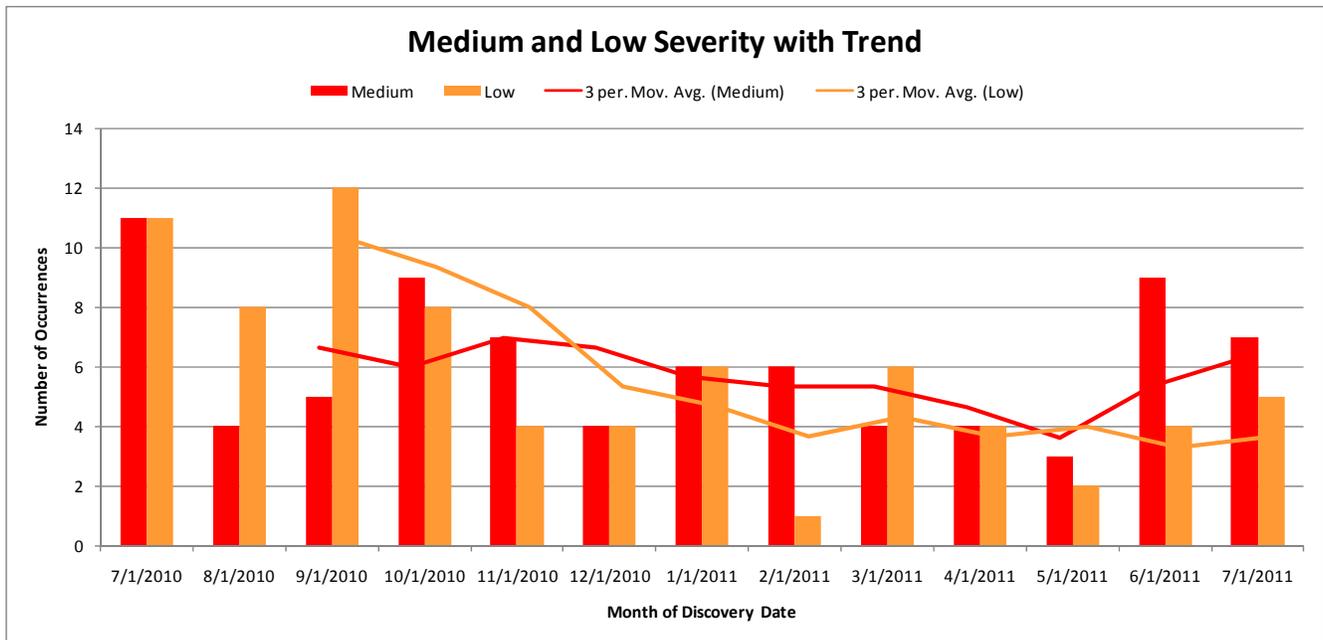
Medium and Low Severity with Trend

The following chart focuses on the Medium and Low severity data series for July 2010 through July 2011. Trend lines are included for each, using a 3-month moving average.

The 3-month moving average shows a slightly higher increase in Medium severity occurrences than in Low severity occurrences.
