Office of Health, Safety and Security

Monthly Analysis of Electrical Safety Occurrences

July 2012

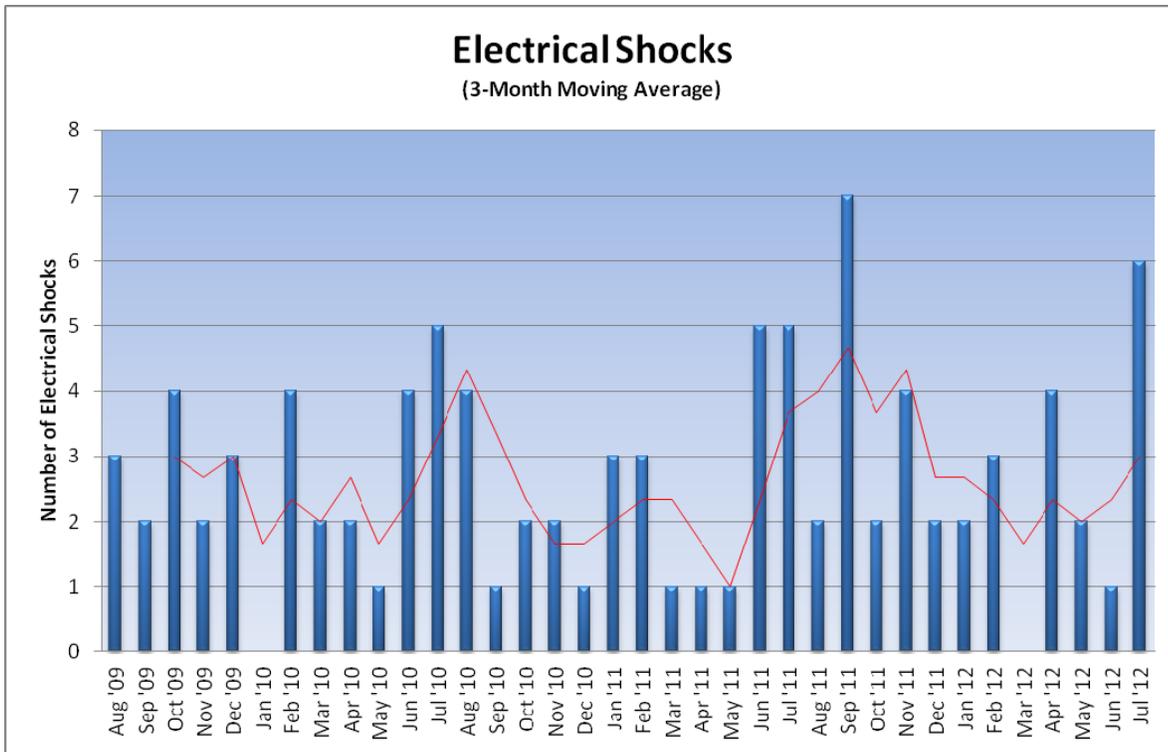
Figure 1 – Three-Year Trend of Electrical Shocks

Figure 1 shows a 3-year trend of electrical shocks for the DOE complex. During this period, the average number of electrical shocks has remained below three per month

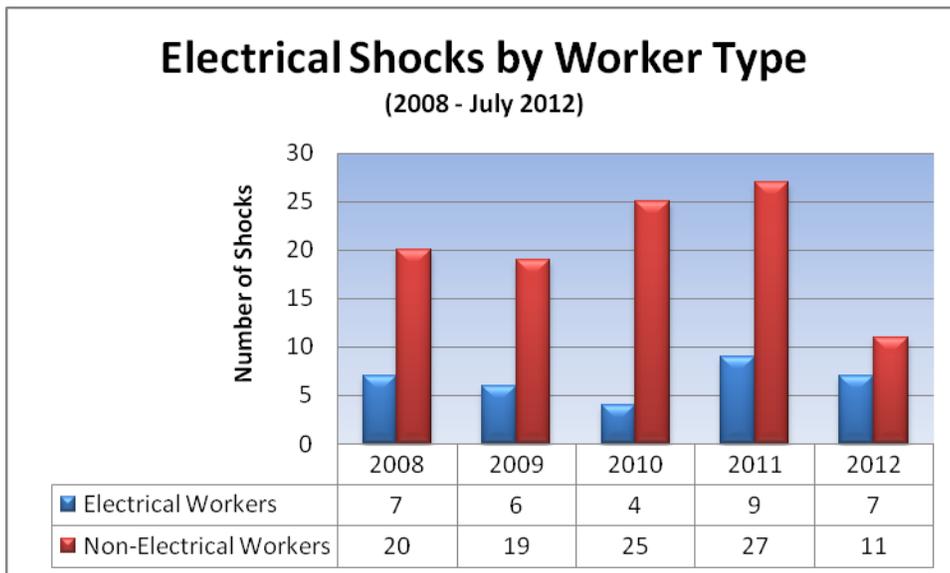
Figure 2 - Electrical Shock by Worker Type

Figure 2 shows electrical shock by worker type. The majority of shocks (about 75 percent) involve non-electrical workers.

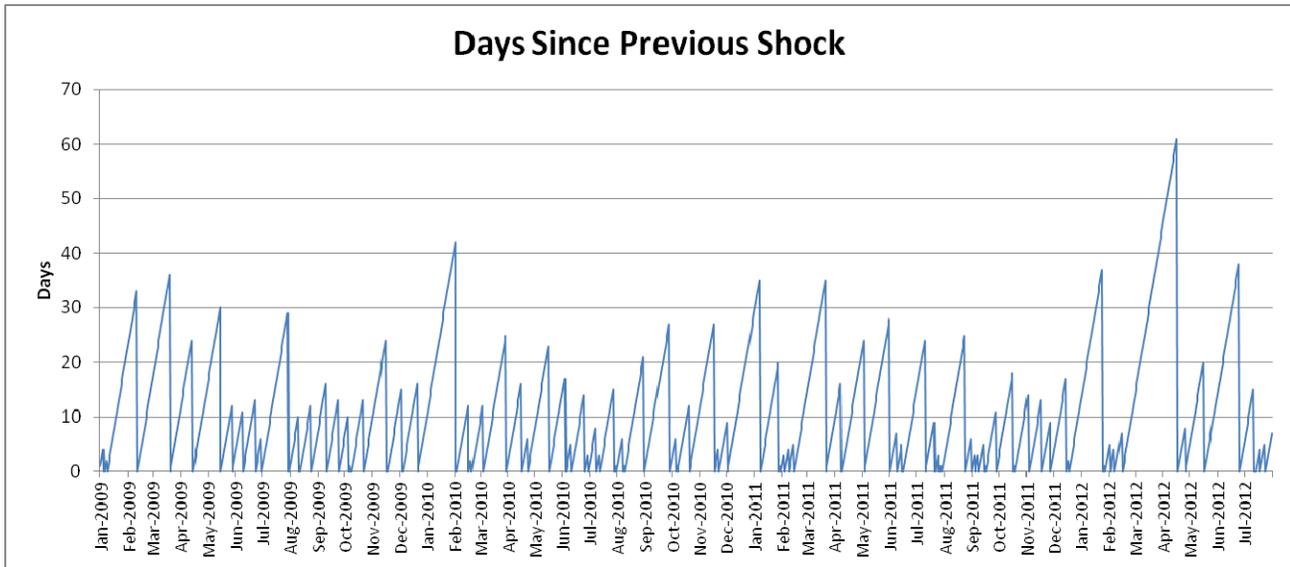
Figure 3 - Days since Previous Shock

Figure 3 shows the number of days since the previous electrical shock for the DOE complex. The longest interval was 61 days (April 16, 2012) and the present interval is 7 days as of July 31.

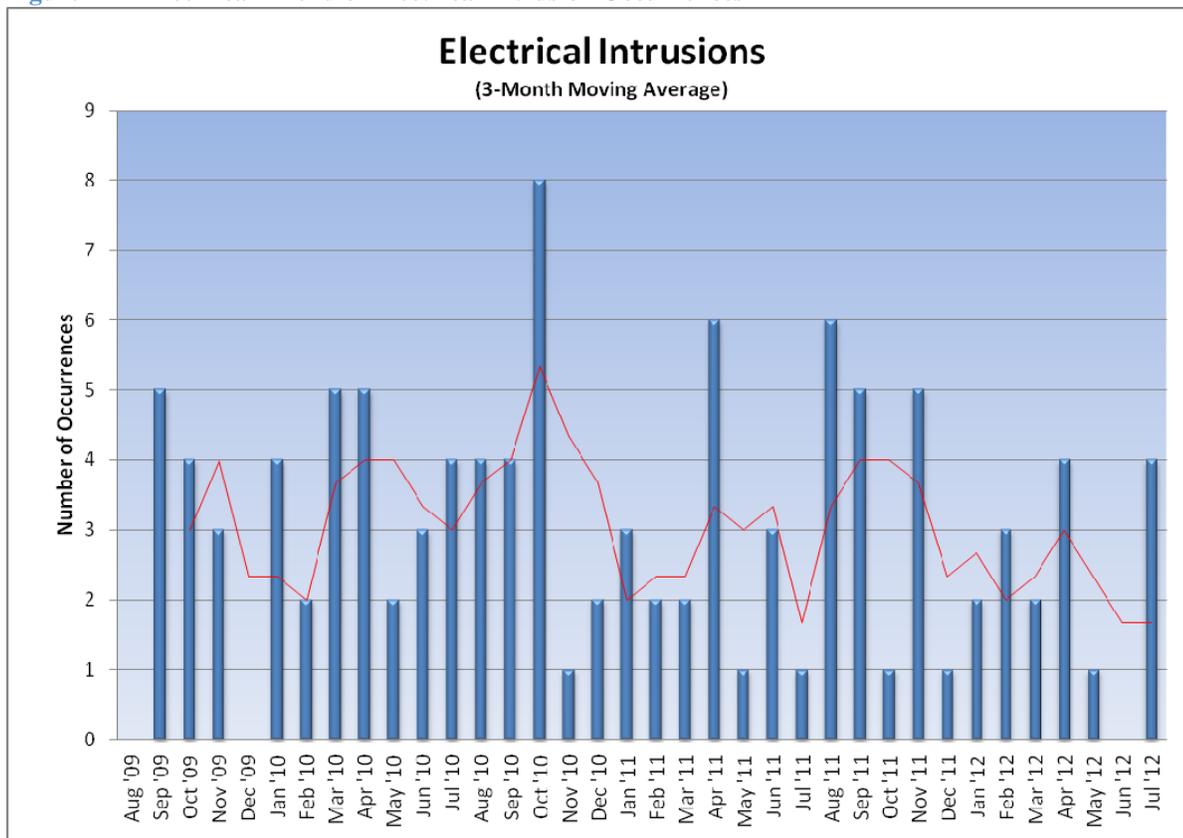
Figure 4 – Three-Year Trend of Electrical Intrusion Occurrences

Figure 4 shows a 3-year trend of electrical intrusion occurrences for the DOE complex. During this period we have seen an average of 3 occurrences per month.

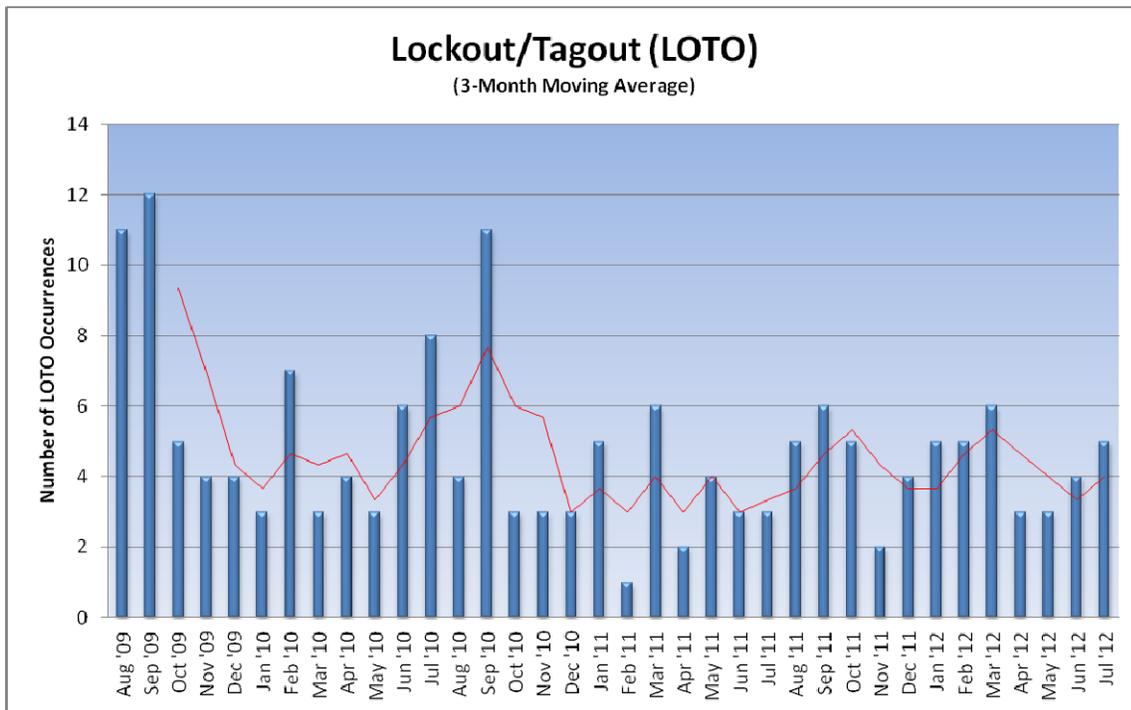
Figure 5 – Three-Year Trend of Lockout/Tagout Occurrences

Figure 5 shows a 3-year trend of LOTO occurrences for the DOE complex. Although there was a small increase from last month, we can see a general decrease since March in the

number of occurrences involving the implementation of lockout/tagout for electrical work during this period. The monthly average is 4.8 occurrences.

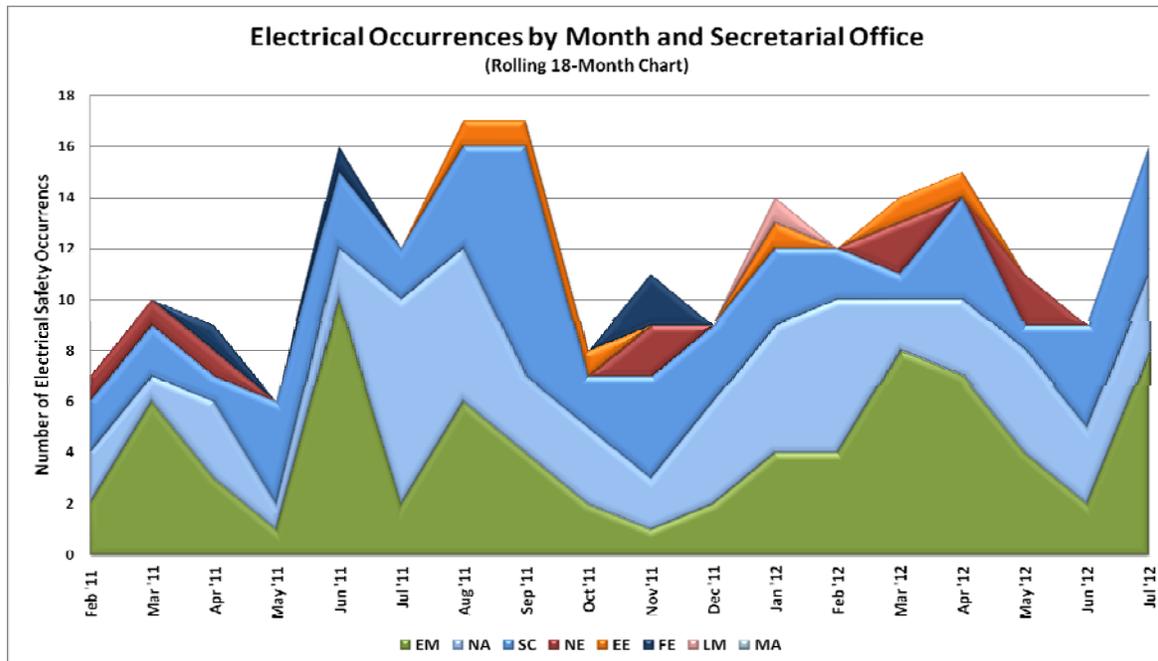
Figure 6 - Electrical Occurrences by Month and Secretarial Office

Figure 6 shows the distribution of electrical safety occurrences by Secretarial Office. The Office of Environmental Management (EM), the Office of Science (SC), and the National Nuclear Security Administration (NA) typically report the most occurrences of all the offices.

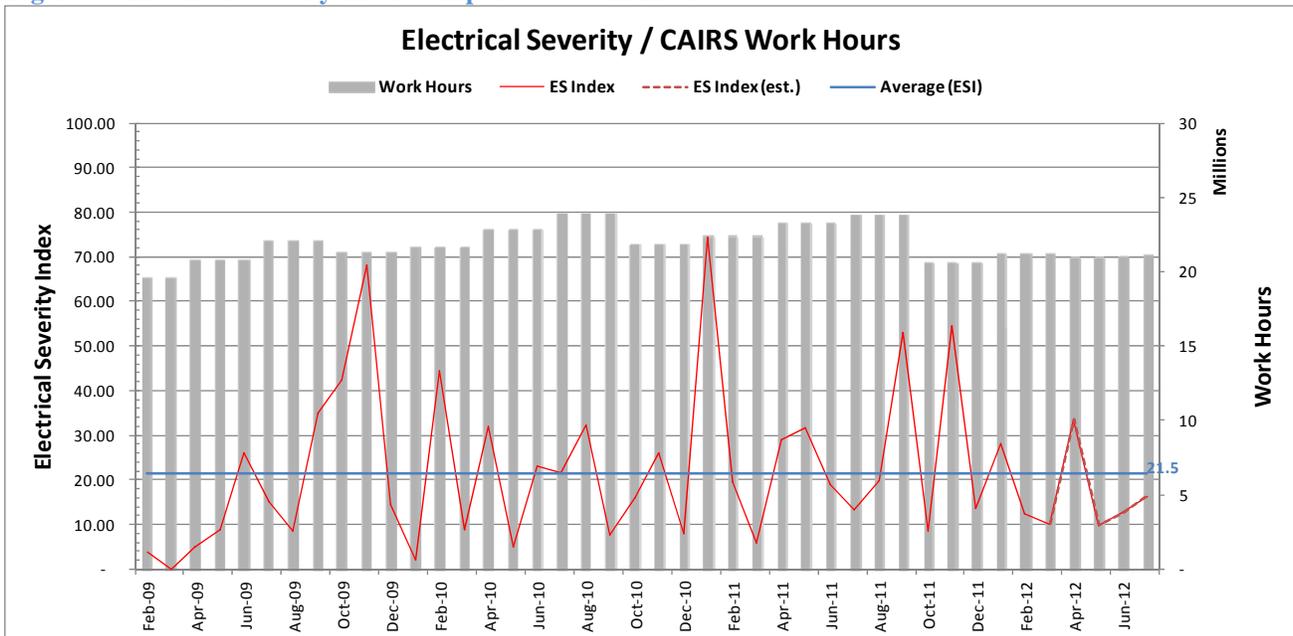
Figure 7 - Electrical Severity Index Compared to Work Hours

The Electrical Severity Index (ESI) is a performance metric that was developed to normalize events against organizational work hours. The ESI is calculated monthly and trended. Figure 7 shows a calculated ESI for the DOE complex and Table 4 shows the ESI and how it has changed from the previous month.

Note: An estimated ESI is calculated until accurate CAIRS man-hours are available. The chart is updated monthly.

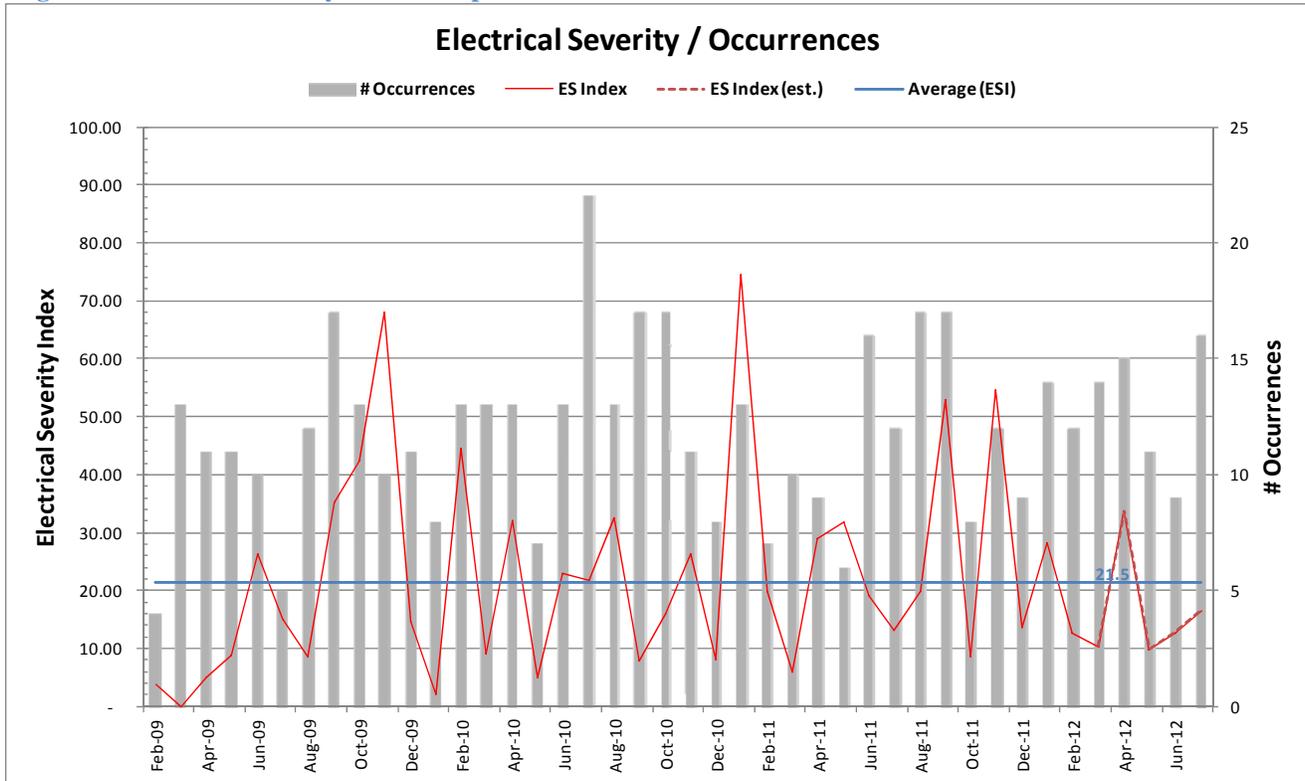
Figure 8 - Electrical Severity Index Compared to Number of Occurrences

Figure 8 shows the ESI with the number of Occurrences instead of Work Hours.

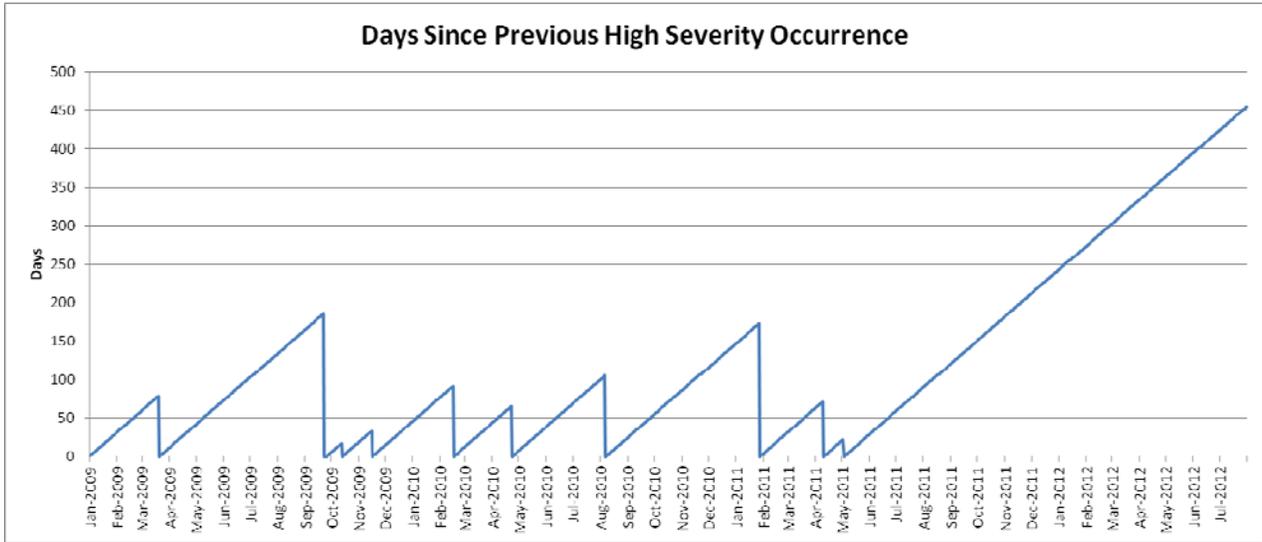
Figure 9 - Days since Previous High Severity Occurrence

The average ESI (21.5) has decreased for three consecutive months. The lowest average ESI was 19.2 in June 2010. Figure 9 shows the number of days since the previous high severity occurrence. The present interval is 455 days as of July 31. The previous longest interval was 181 days in 2009.

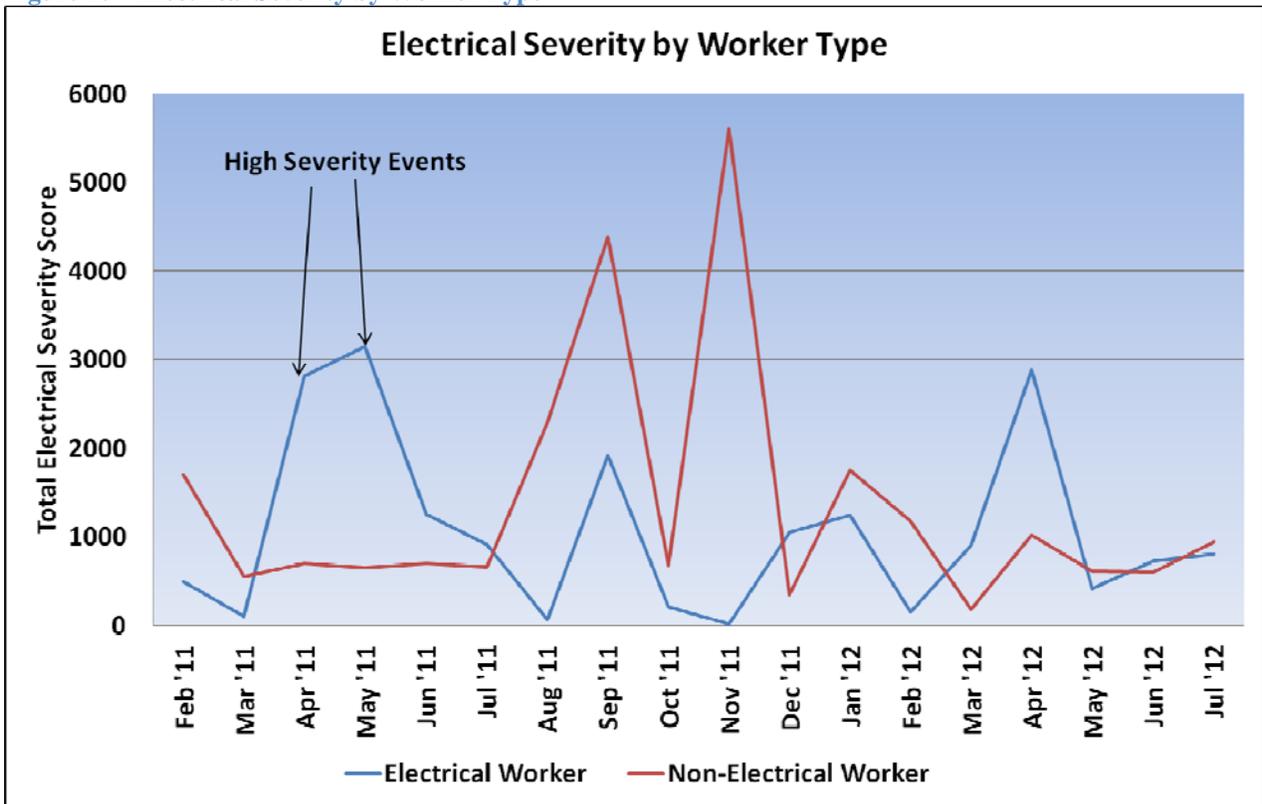
Figure 10 – Electrical Severity by Worker Type

Figure 10 shows the total electrical severity score by worker type for each month.

Electrical Workers typically have the fewest number of occurrences but they had High-Severity events while Non-Electrical Workers have Low to Medium ES scores. The ES scores for July were close with Non-Electrical Workers at 950 and Electrical Workers at 810.

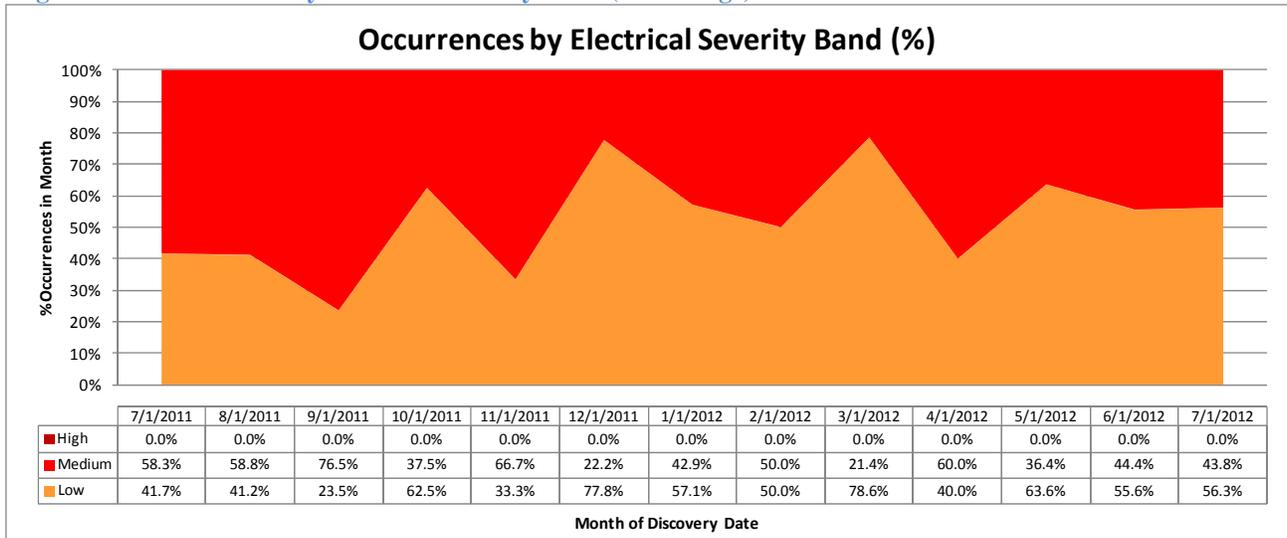
Figure 11 - Occurrences by Electrical Severity Band (Percentage)

For the interval July 2011 through July 2012 (current month and the past 12), Figures 11 and 12 summarize occurrences by severity band and month of discovery date by percentage of total occurrences in month and number of occurrences in month.

What can be seen from the previous two charts is that the number of occurrences with High electrical severity scores has remained at zero for the past 13 months and that the number of occurrences with Medium scores remains below the number of Low severity occurrences.

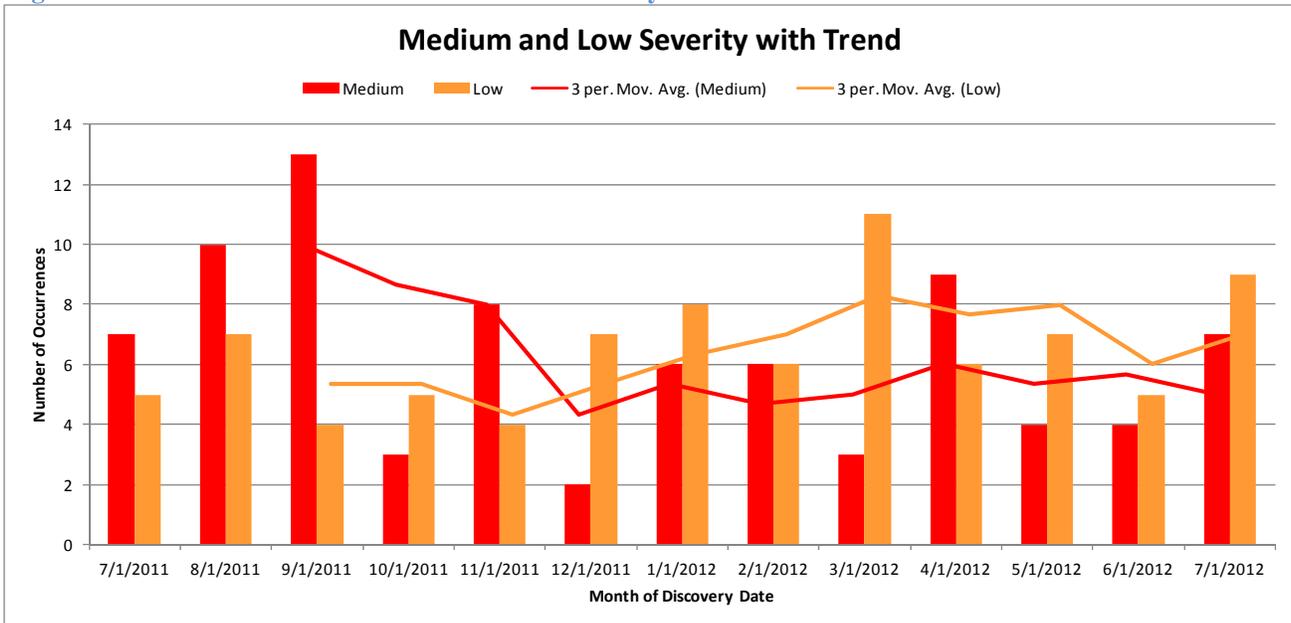
Figure 13 - Trend of Medium and Low Electrical Severity Occurrences

Figure 13 focuses on the Medium and Low severity data series for July 2011 through July 2012. Trend lines are included for each, using a 3-month moving average.

The 3-month moving average shows a decreasing trend for Medium severity occurrences while Low severity occurrences have increased. A higher percentage of Low severity occurrences is preferred.
