Office of Health, Safety and Security

Monthly Analysis of Electrical Safety Occurrences

March 2013

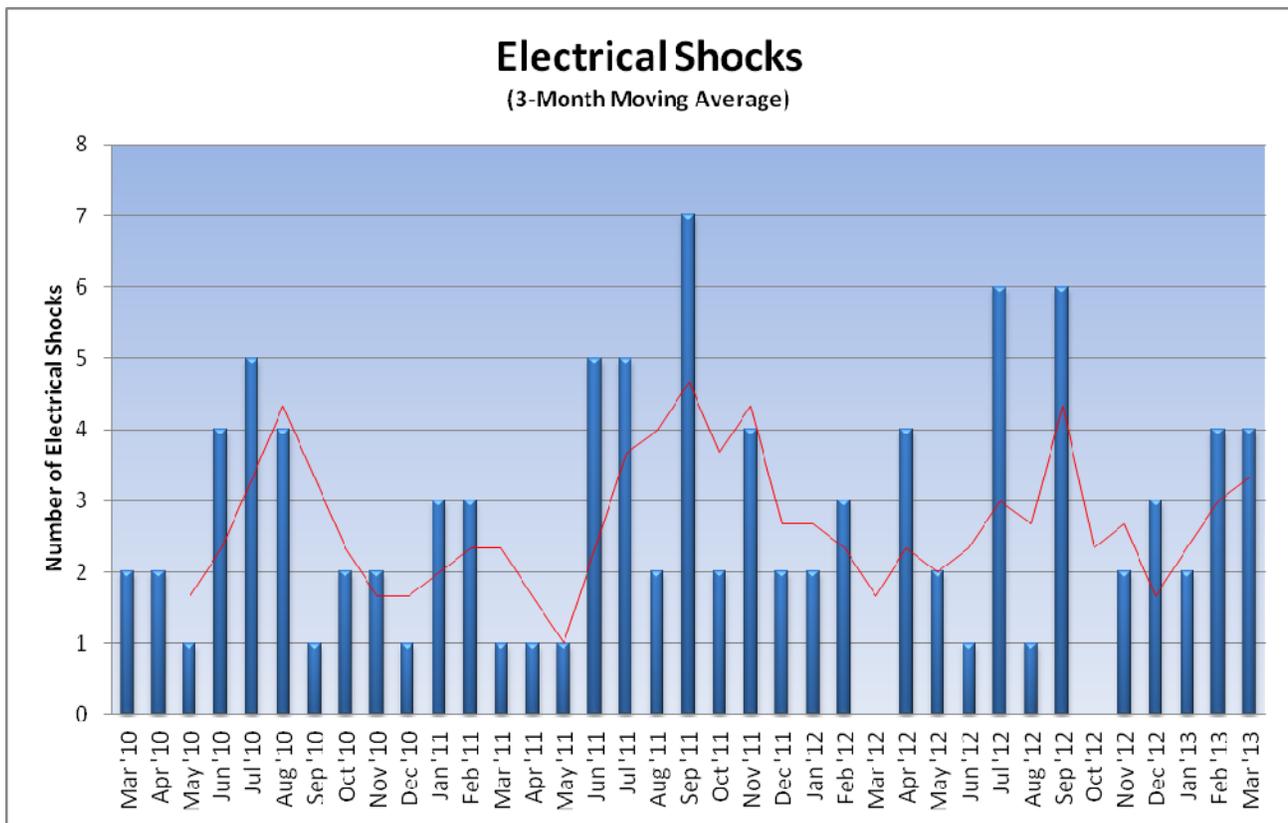
Figure 1 – Three-Year Trend of Electrical Shocks

Figure 1 shows a 3-year trend of electrical shocks for the DOE complex. During this period, the average number of electrical shocks has remained below three (2.7) shocks per month.

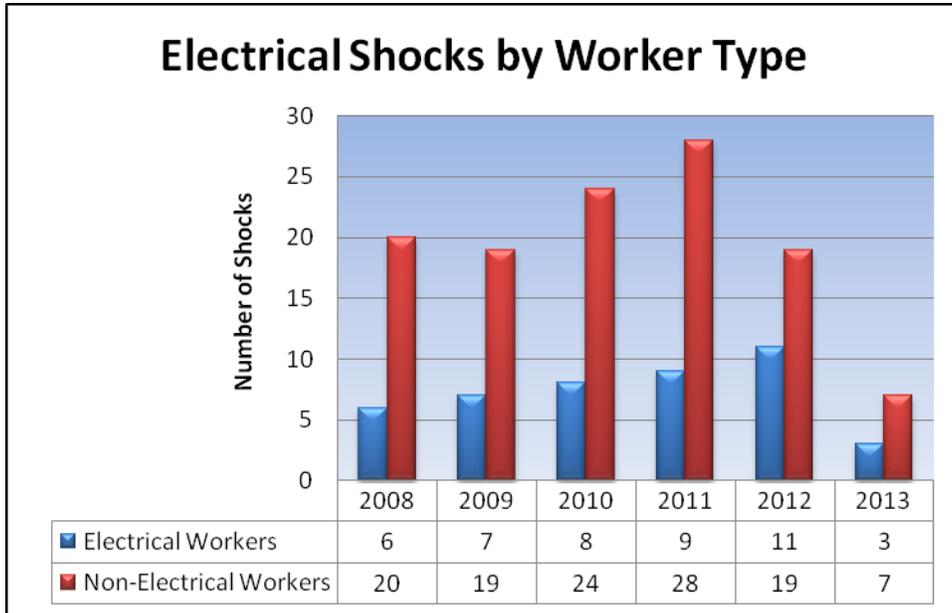
Figure 2 - Electrical Shock by Worker Type

Figure 2 shows electrical shocks by worker type through March 2013. The number of shocks involving electrical workers slowly increased through 2012 and then dropped in 2013, while those involving non-electrical workers decreased after 2011. Since 2008, the majority of shocks (about 73 percent) involve non-electrical workers.

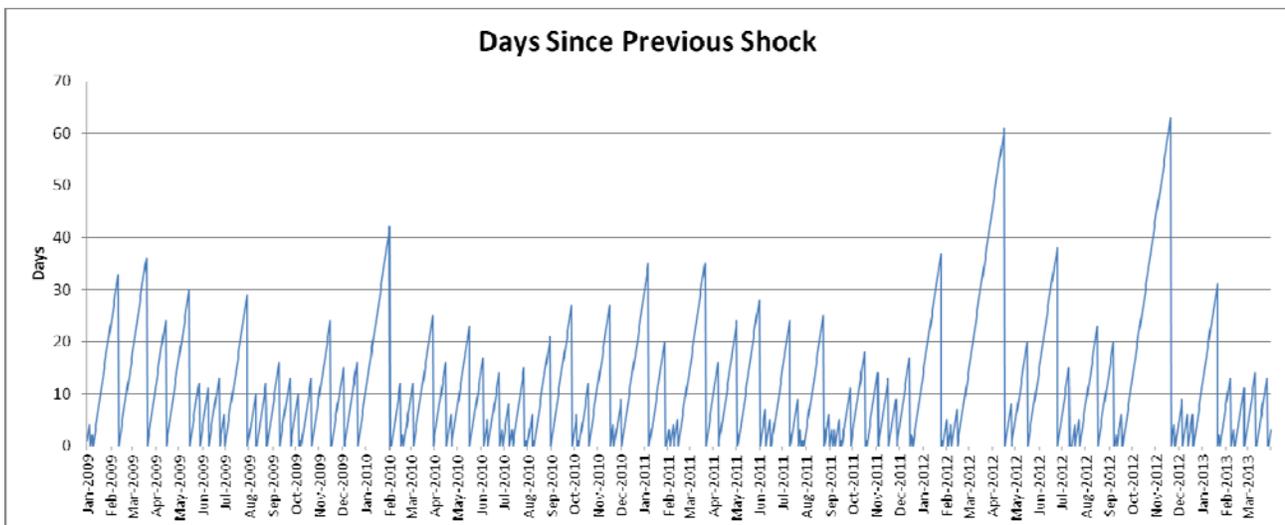
Figure 3 - Days since Previous Shock

Figure 3 shows the number of days since the previous electrical shock for the DOE complex. The longest interval was 63 days (November 20, 2012) and the present interval is 3 days as of March 31.

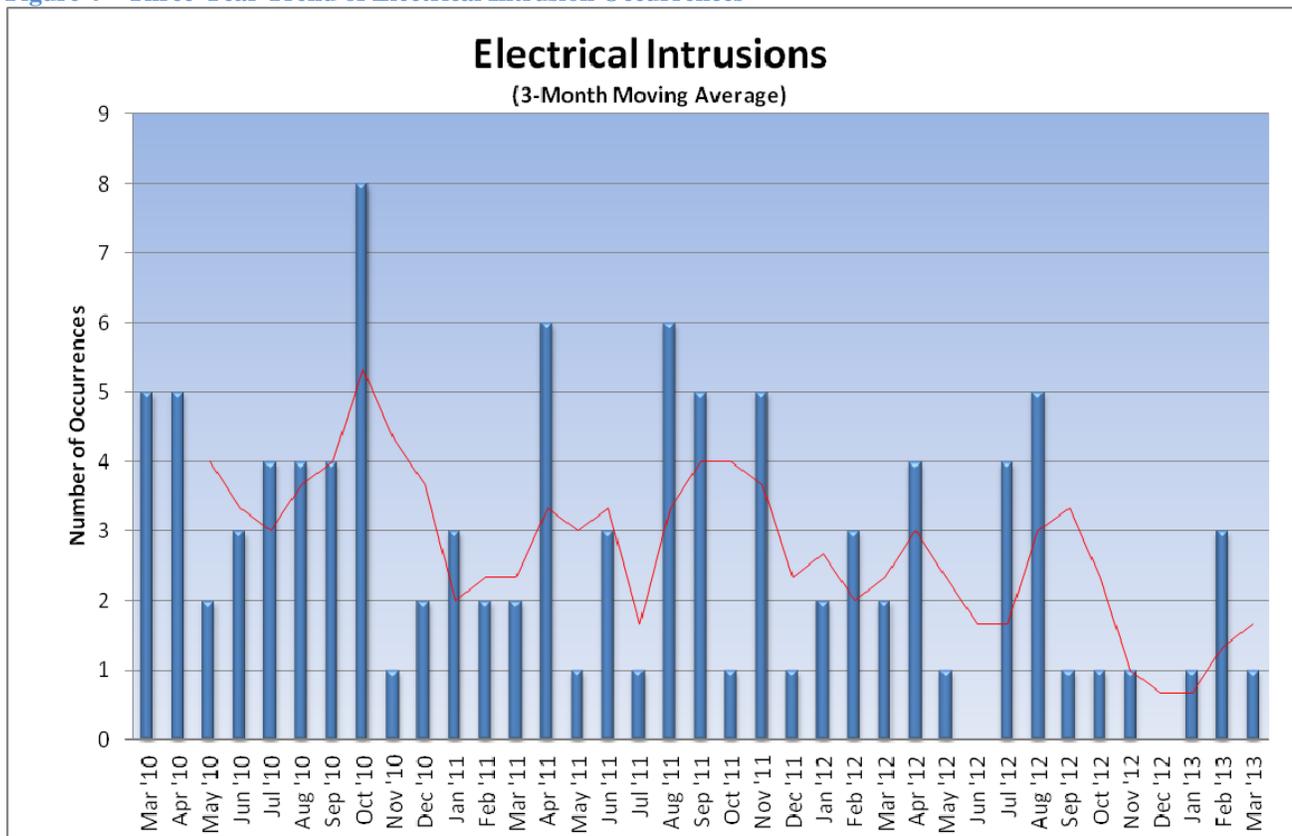
Figure 4 – Three-Year Trend of Electrical Intrusion Occurrences

Figure 4 shows a 3-year trend of electrical intrusion occurrences for the DOE complex. During this period we have seen an average of just under 3 occurrences per month (2.7).

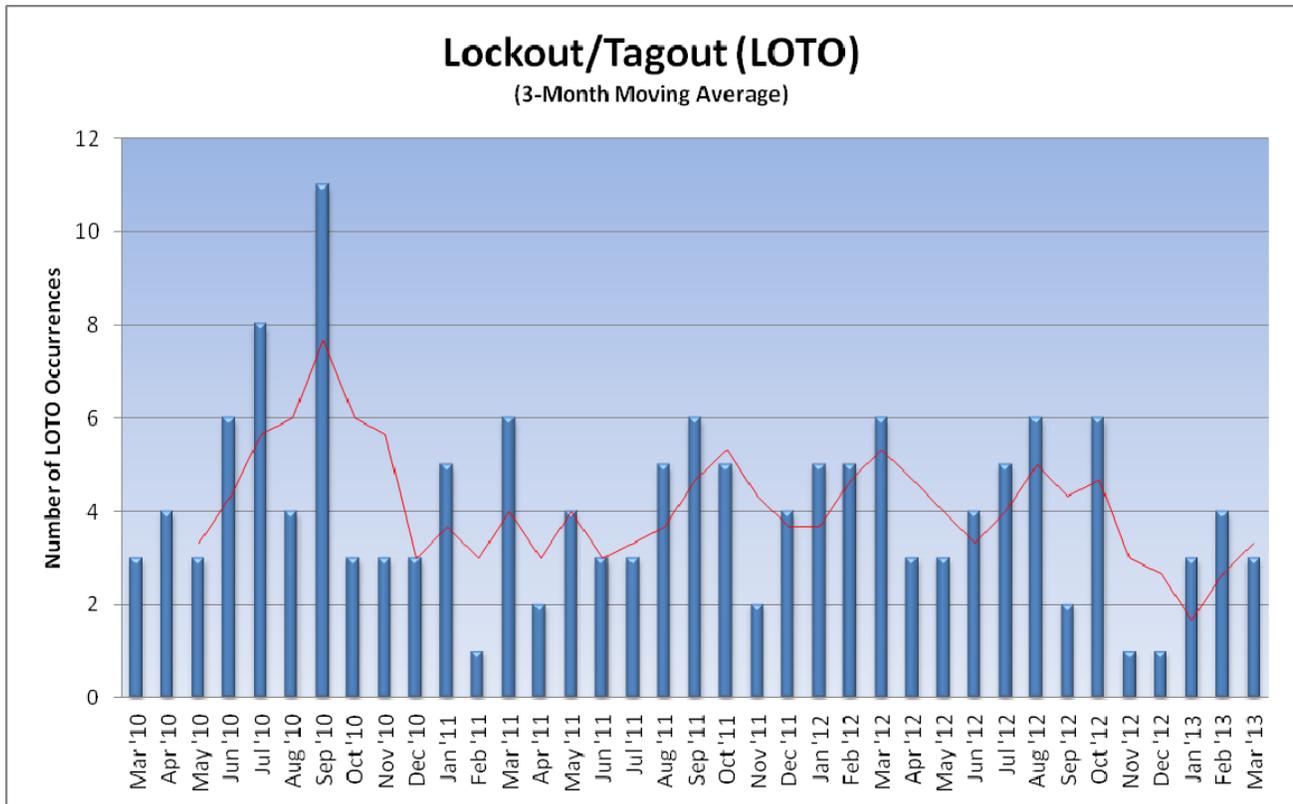
Figure 5 – Three-Year Trend of Lockout/Tagout Occurrences

Figure 5 shows a 3-year trend of LOTO occurrences for the DOE complex. The monthly average is 4.1 occurrences.

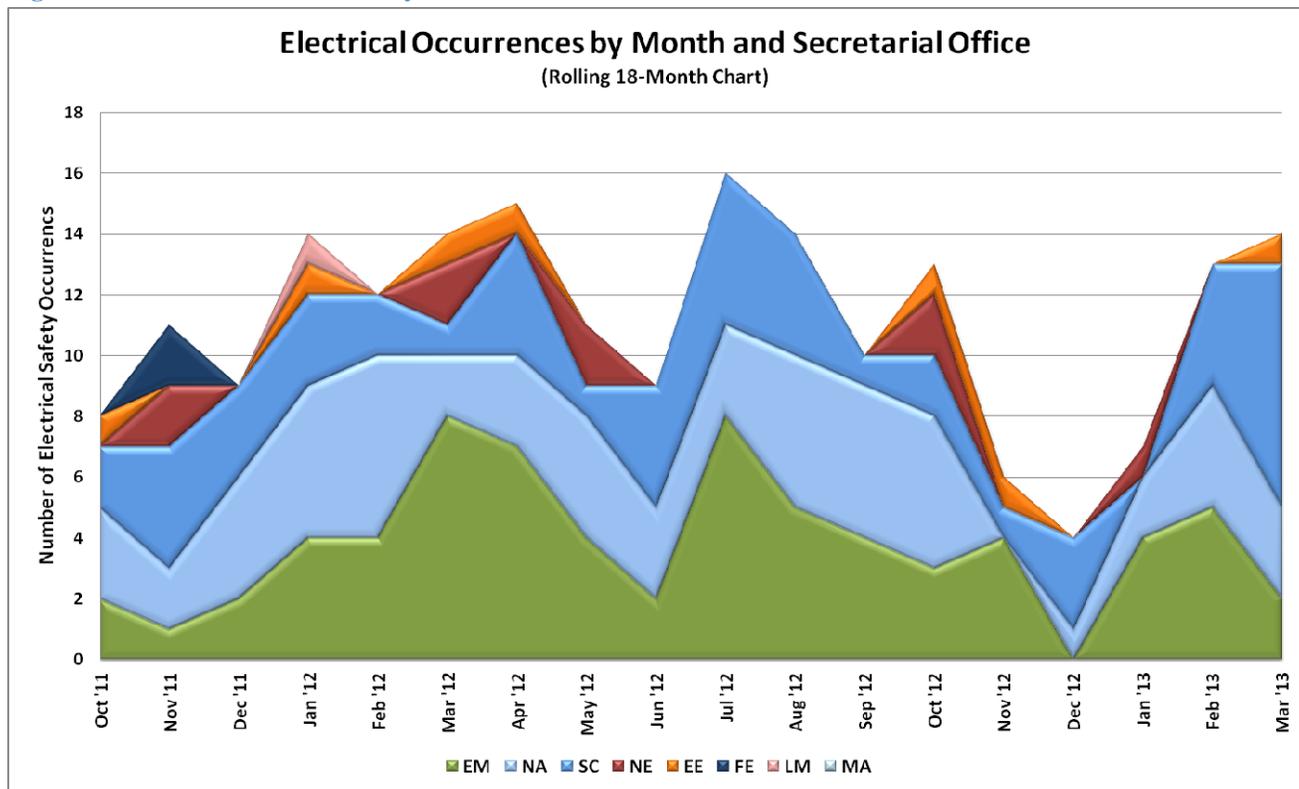
Figure 6 - Electrical Occurrences by Month and Secretarial Office

Figure 6 shows the distribution of electrical safety occurrences by Secretarial Office. The Office of Science reported the most occurrences. The Office of Nuclear Energy has reported only one occurrence in the last five months.

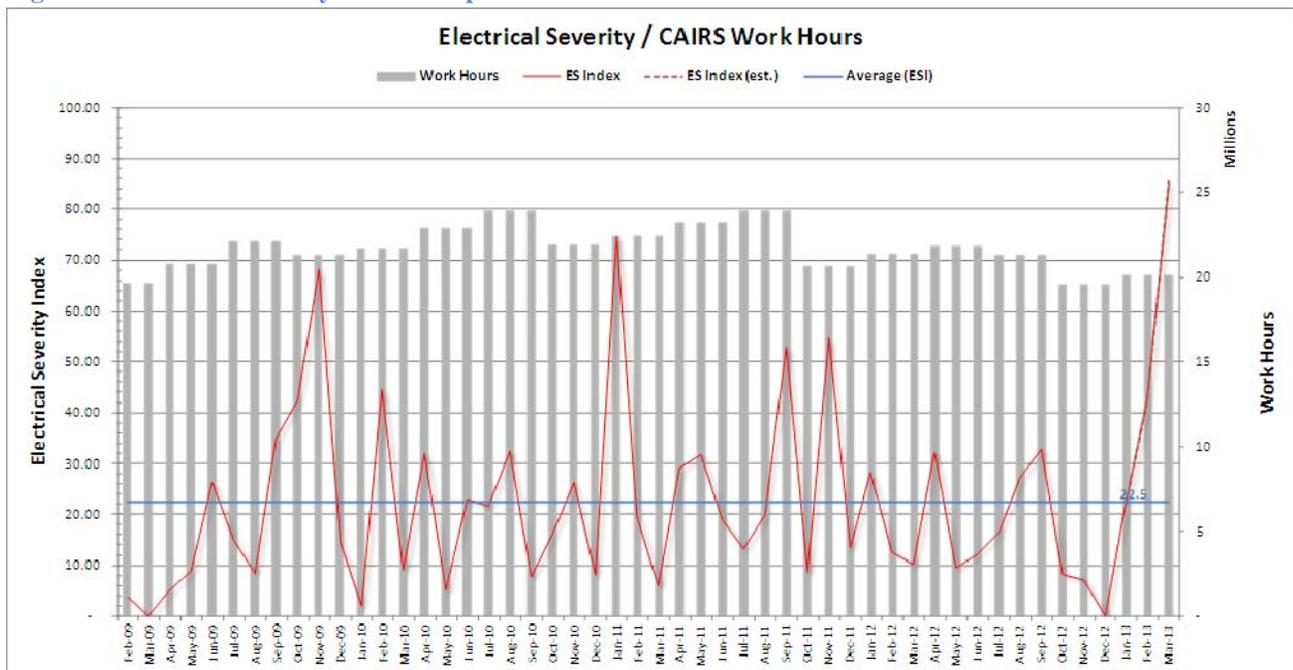
Figure 7 - Electrical Severity Index Compared to Work Hours

The Electrical Severity Index (ESI) is a performance metric that was developed to normalize events against organizational work hours. The ESI is calculated monthly and trended. Figure 7 shows a calculated ESI for the DOE complex and Table 4 shows the ESI and how it has changed from the previous month.

Note: An estimated ESI is calculated until accurate CAIRS man-hours are available. The chart is updated monthly.

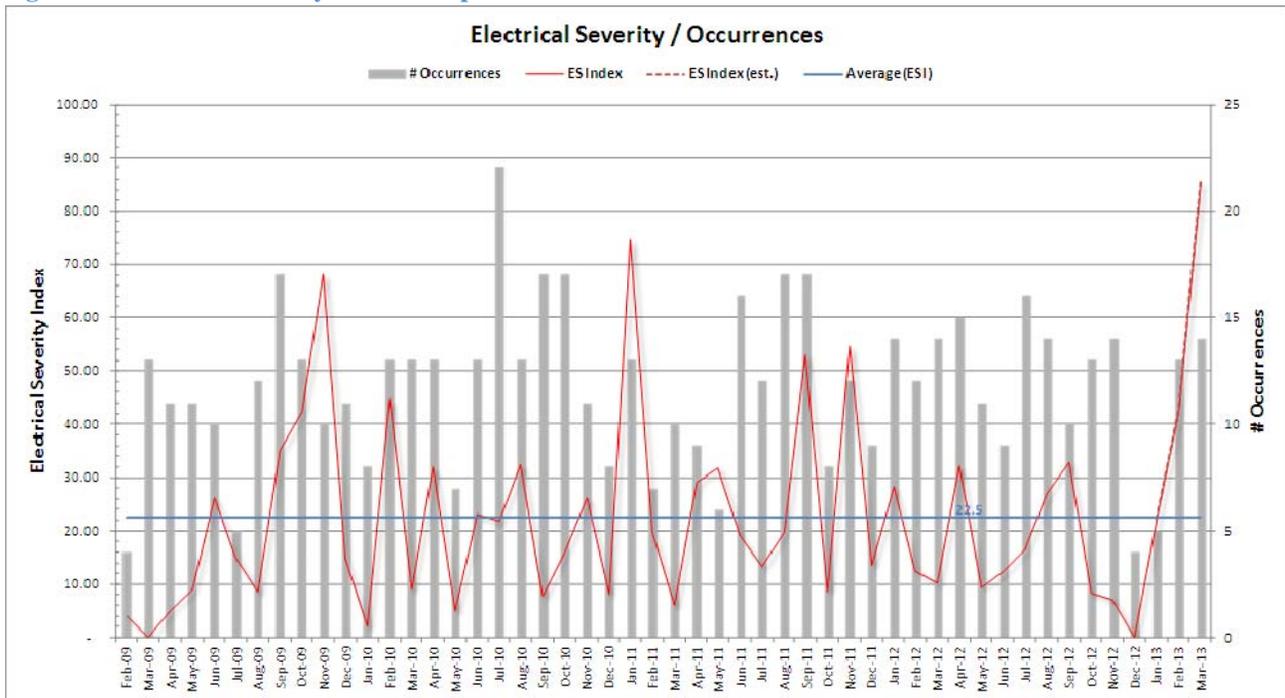
Figure 8 - Electrical Severity Index Compared to Number of Occurrences

Figure 8 shows the ESI with the number of Occurrences instead of Work Hours.

The average ESI (22.5) has increased for the last two months. The lowest average ESI was 19.2 in June 2010.

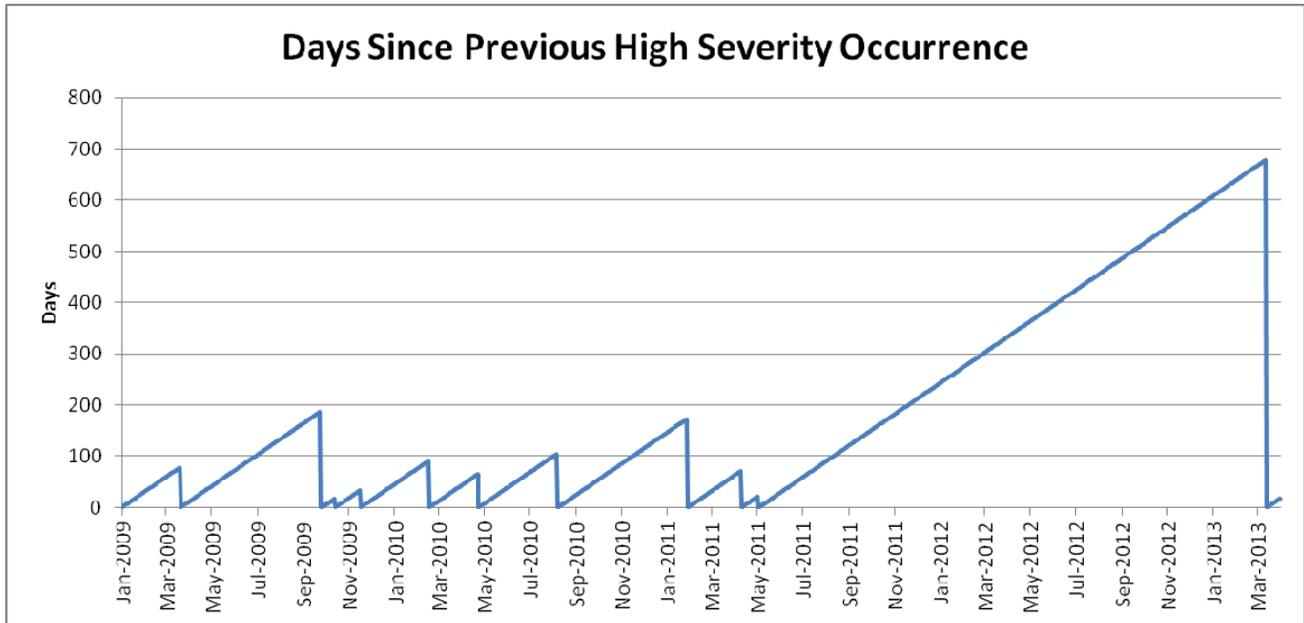
Figure 9 - Days since Previous High Severity Occurrence

Figure 9 shows the number of days since the previous high severity occurrence. The present interval is 18 days as of March 31. The previous longest interval was 679 days ending March 12, 2013.

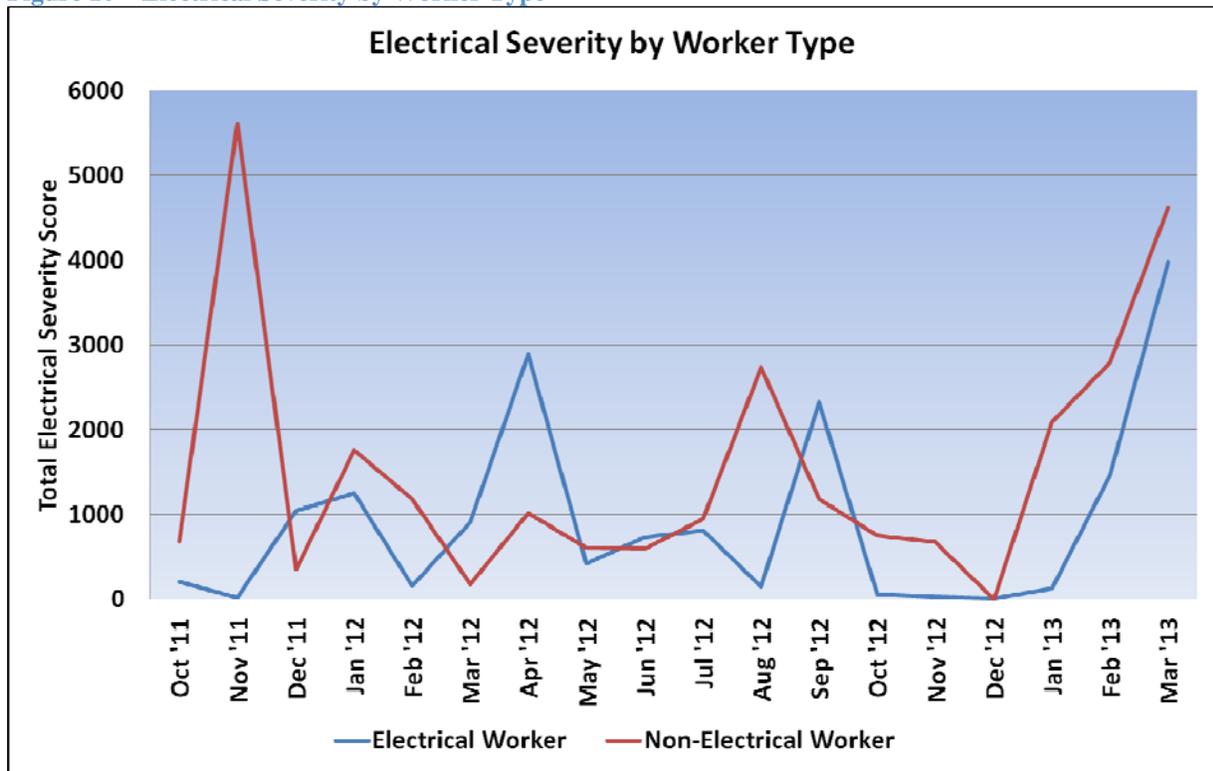
Figure 10 – Electrical Severity by Worker Type

Figure 10 shows the total electrical severity score by worker type for each month.

Following very low numbers in December 2012 for electrical workers (12) and non-electrical workers (6), the ES score for both groups began a steady rise. Electrical workers ES scores are up to 3970 and non-electrical workers ES score are at 4,620. The average ES scores for the 18

month period are 922 for electrical workers and 1,543 for non-electrical workers. The large increase relates to the increased number of occurrences and higher individual event scores.

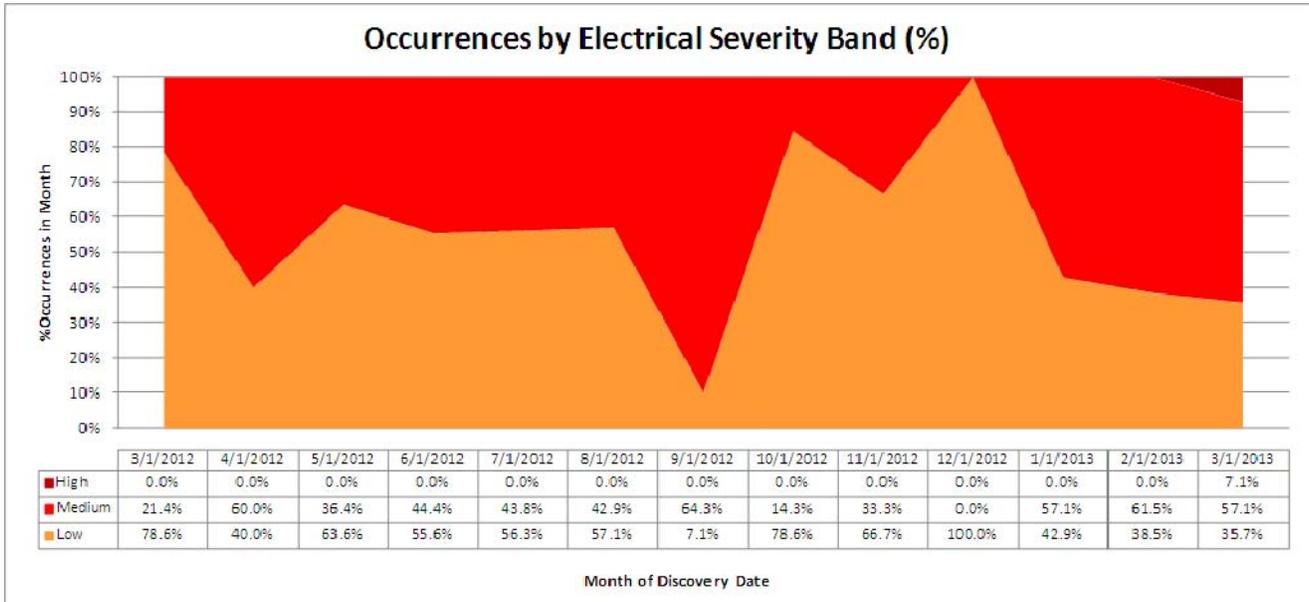
Figure 11 - Occurrences by Electrical Severity Band (Percentage)

For the interval March 2012 through March 2013 (current month and the past 12), Figures 11 and 12 summarize occurrences by severity band and month of discovery date by percentage of total occurrences in month and number of occurrences in month.

The previous two charts shows that a high electrical severity event occurred in March, ending a 679-day period since the last occurrence in May 2011. The number of occurrences with Medium, Low and zero severity occurrences remained the same from the previous month.

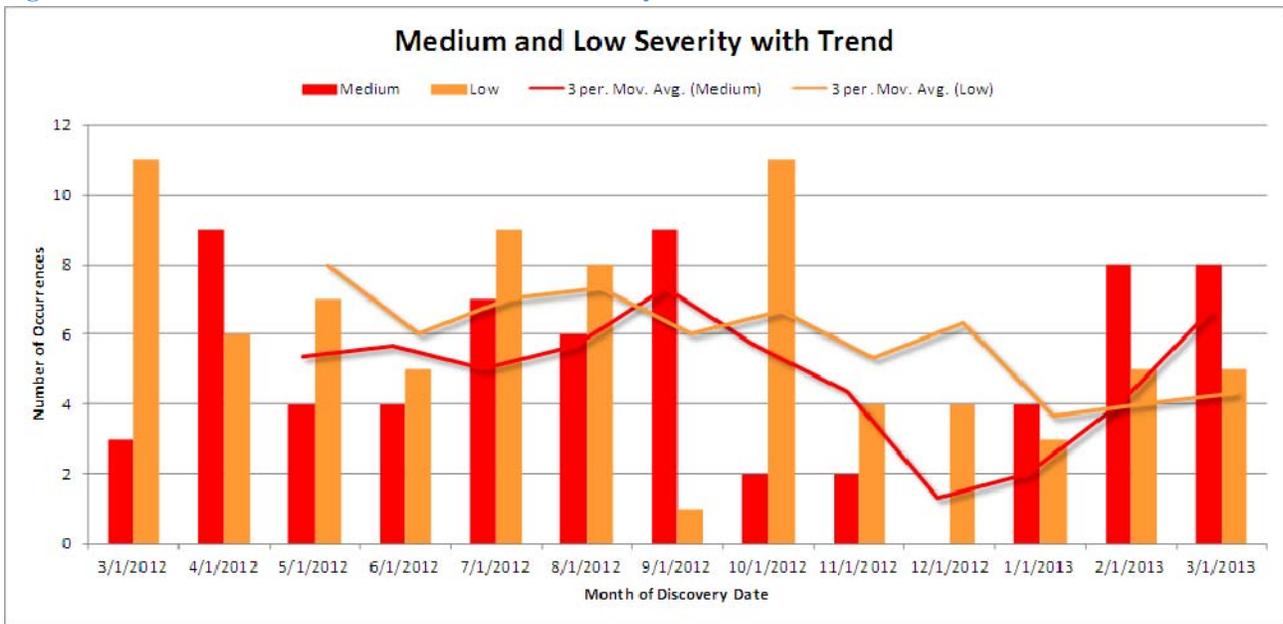
Figure 13 - Trend of Medium and Low Electrical Severity Occurrences

Figure 13 focuses on the Medium and Low severity data series for March 2012 through March 2013. Trend lines are included for each, using a 3-month moving average.

The 3-month moving average shows an increasing trend for Medium severity occurrences and a slight increase for Low severity occurrences.
