**DOE CHALLENGE HOME  
CASE STUDY****e2 Homes**

Winter Park, Florida

**FEATURED HOME/DEVELOPMENT:****Project Data:**

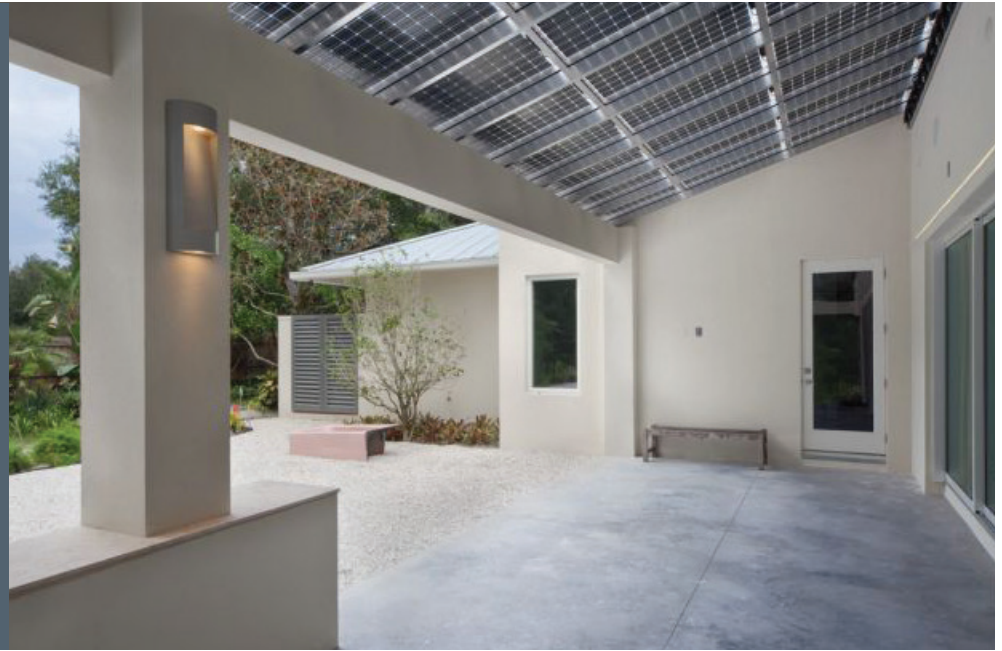
All of the 962-ft<sup>2</sup> porch roof is comprised of solar panels with a 13.4-kW solar array system. The 69 panels don't sit on top of the roof; they are the roof. The completely watertight structure allows about 15% of natural light to filter through the panels, lighting the space below. The panels are dual surface meaning they can produce power from any sunlight reflected up onto their lower surface for up to 30% greater than rated power production. All wiring is hidden within the canopy's aluminum support beams.

With the home designed for maximum energy efficiency, indoor air quality, and water conservation, the 13.5-kW photovoltaic system is now the appropriate last step for zero net-energy performance. "The key to creating any zero net-energy home while keeping costs down is to focus on energy conservation [in the design]," explains Smith. Rather than mounting the 69 solar panels on the roof, the solar installer fit them together to form a watertight structure that literally is the roof of the home's 962-ft<sup>2</sup> porch. The 195-Watt solar panels are bifacial, meaning they can generate some electricity from reflected light that hits the bottom side of the panels. The panels also permit about 15% of the daylight to filter through them, lighting the porch area beneath. The hybrid inverter converts the panel-produced direct current power into a utility-compatible alternating current, using a unique technology that overcomes the limitations of traditional central string inverter systems, but at a much lower cost than micro-inverter systems.

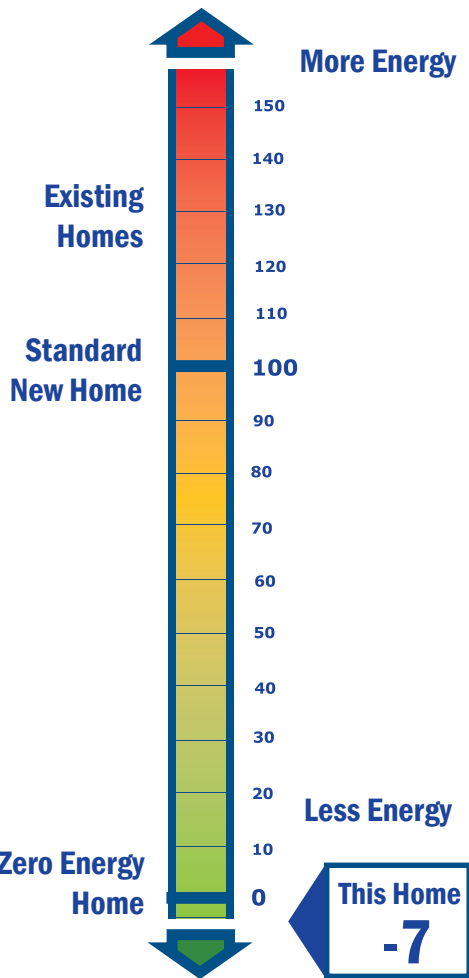
**HERS® Index**

Without solar power, the home scores a HERS 57, which is well below the HERS 100 for a standard home built to code. With its photovoltaic system, the home produces better than zero net-energy performance, with a score of HERS -7. This translates into no electric utility bills and even \$123 annually in the homeowner’s pocket from the utility.

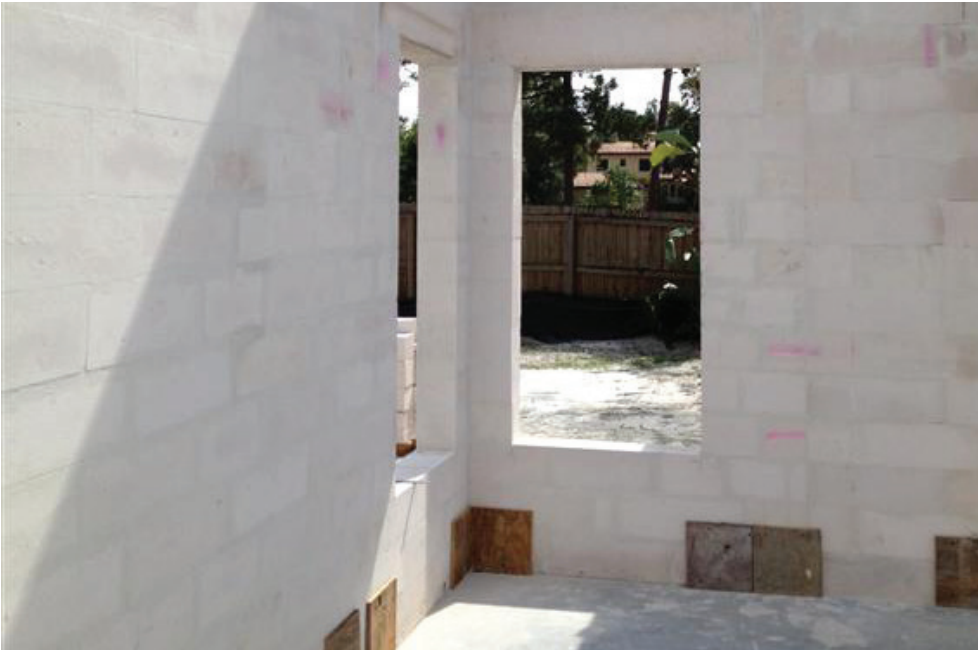
The walls are built of 2 ft. x 8 in. x 8 in. autoclaved aerated concrete (AAC) blocks. AAC is made of most of the ingredients found in concrete but in a process something like bread making: sand is ground like flour and mixed with water, cement, and a little bit of aluminum powder. The mixture is poured into railroad car-sized molds and allowed to sit for 4 hours while the aluminum reacts with the cement forming millions of tiny bubbles in the concrete and causing it to rise, more than doubling in size. Rebar is set into the foam-like concrete, which is cut into blocks or slabs that are baked in ovens. The hardened, aerated concrete is then ready to be used to build walls and foundations.

The exterior walls were constructed of autoclaved aerated concrete (AAC) blocks. “My client wanted AAC to avoid using drywall [in this hot humid climate],” said Smith. Breathable plasters and paints designed for AAC are applied directly to the blocks as finishes. “They have been using it in Europe for about 80 years, and they are about the same price as insulated concrete forms (ICFs),” said Smith. Like concrete block, AAC is mold-resistant, non-combustible, and not penetrable by termites or pests, but the unique foam-like structure of the AAC also results in good insulating performance (R-8 for an 8-inch block), effective sound resistance, light weight (one-fifth the weight of concrete), easy workability since it can be readily sawed or drilled, and excellent structural capabilities (AAC blocks and panels are reinforced with steel rebar). While AAC has a steady state R-value R-8 for an 8-inch wall, researchers say an 8-inch AAC wall has an “effective” or “mass enhanced” value of about R-21, especially in areas with large day-night temperature fluctuations.
