Waste Management Update

Frank Marcinowski
Deputy Assistant Secretary for Waste Management

EM Site-Specific Advisory Board Chairs Meeting April 23, 2015

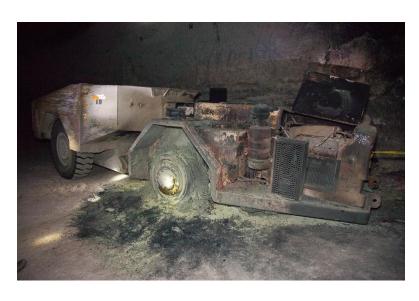
February 5 Underground Fire

Accident Investigation Board (AIB)
 Report issued March 13, 2014

February 5, 2014 Truck Fire:

- All operations at the repository ceased following salt haul truck fire in the WIPP underground.
- An investigation team was deployed to determine the cause of the fire.

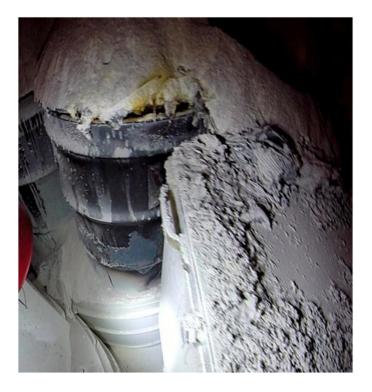
February 14 Radiological Release

- AIB Report, Phase I issued April 24, 2014
- AIB Report, Phase II issued April 16, 2015

February 14, 2014 Radiological Incident:

- A continuous air monitor detected airborne radiation in the underground.
- WIPP's ventilation system automatically switched to high-efficiency particulate air (HEPA)
 filtration mode when airborne radiation was detected
- Underground and the WIPP mine remains in filtration mode at this time.
- Extensive sampling and monitoring conducted by DOE, New Mexico, and Carlsbad Environmental Monitoring Research Center Monitoring.
 - EPA and the NMED also performed sampling.
- Efforts by the DOE and Nuclear Waste Partnership are ensuring workers are fully protected during recovery and restart.

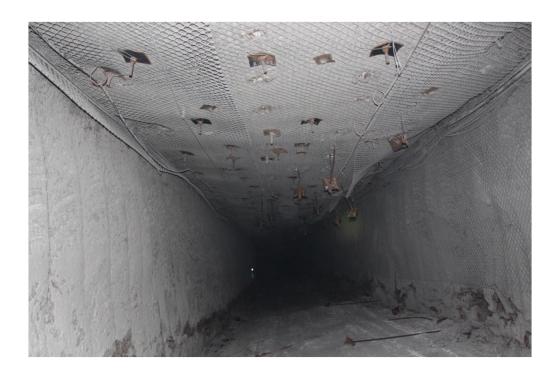
Ground Control

- Bolting activities are being completed in a number of operationally significant areas
- As expected, the salt has moved since the incidents, and some rock-bolts have failed.

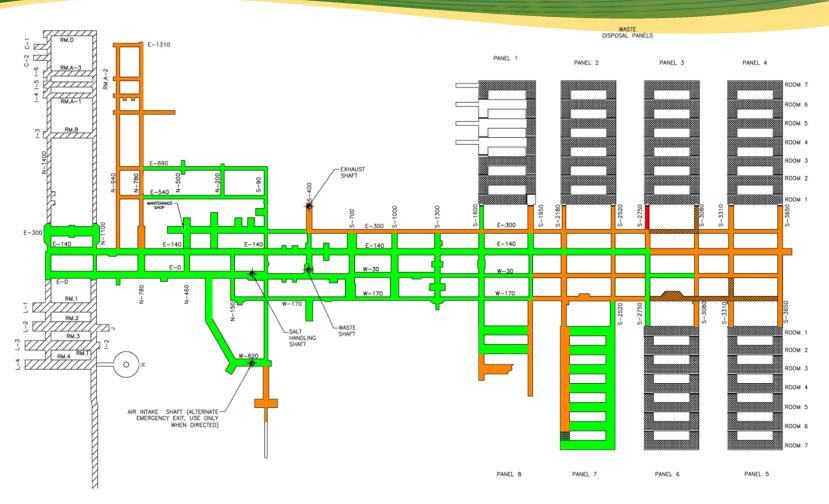
Recovery Status - Bolting

Bolting activities are continuing in both uncontaminated and contaminated areas

- Underground "catch-up" bolting continues with over 1,750 bolts installed
- Bolting activities to the entrance side of Panel 6 completed earlier this month

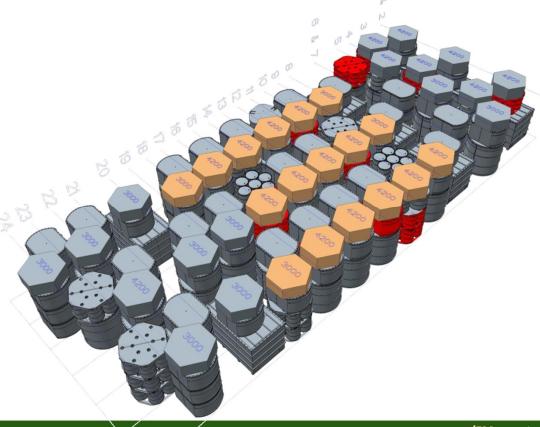
Room 7 Panel 7 Project REACH-Completed

- Videos were completed on January 28, 2015; Accident Investigation Board confirmed no additional videos required.
- REACH project is complete.
- Photographic and video examination found no anomalies or other breached drums.
- Accident Investigation Board released the Phase II report on April 16, 2015.

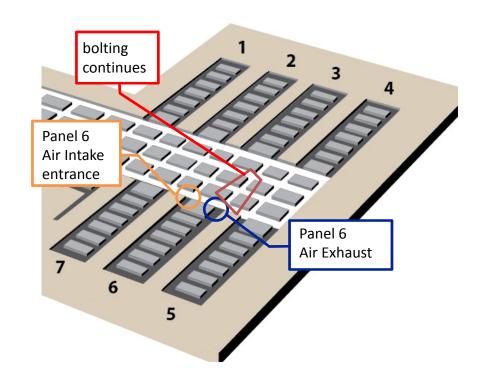
Panel Closure Plans

- Installation of two portable 10 horsepower fans in the entrance access area for air movement
- Bolting at the entrance side of Panel 6
- Installation of a bulkhead at the entrance side of Panel 6 (brattice cloth, chain-link and 10ft of salt already installed)

Bolting activities continue into the exhaust side of Panel 6

Panel 7, Room 7 to follow Panel 6

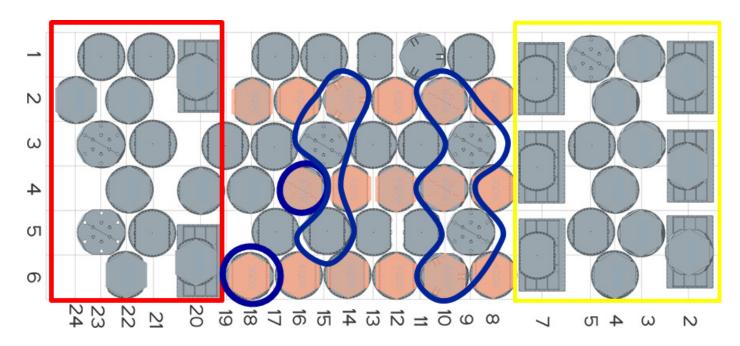
AIB Report Forensics Summary

- Event initiated at R16:C4 Drum 68660
- Ruled out initiation in R15:C5
- Ruled out other start locations
- Greatest damage at areas with most exposed combustibles
- Demonstrated importance of ember transfer propagation
- Radiological and chemical analyses were similar to the TAT results

"Chemically incompatible contents of Drum 68660 from Los Alamos National Laboratory in combination with physical conditions (e.g., the configuration of the materials in the drum) supported exothermic chemical reactions leading to a thermal runaway; the consequent build-up of gases within the drum displaced the drum lid, venting radioactive materials and hot matter that further reacted with air or other materials outside the drum to cause the secondary damage observed in WIPP P7R7."

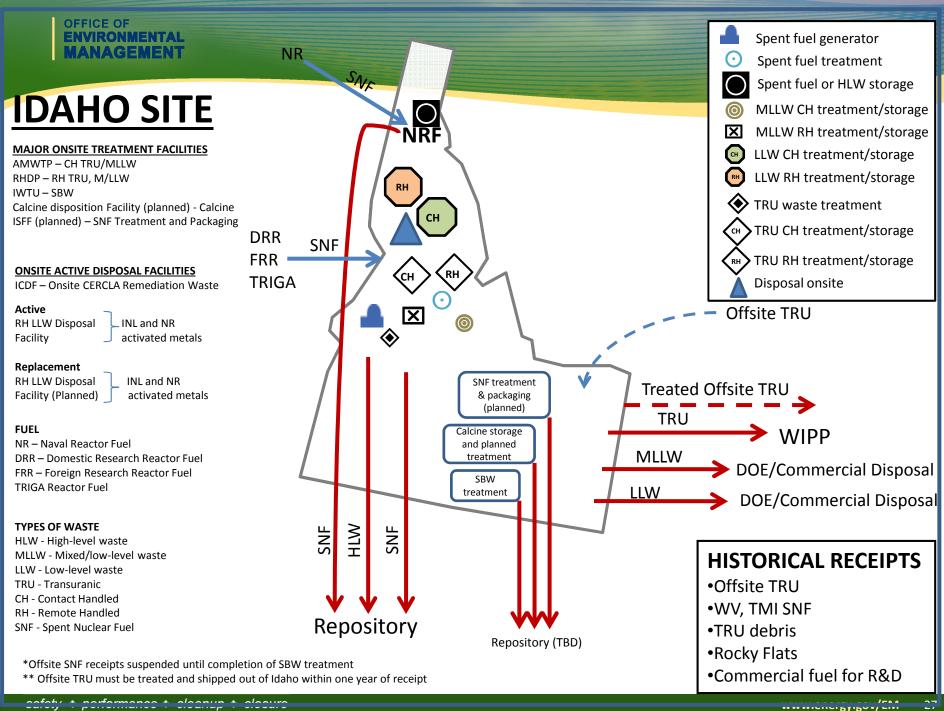
New Disposition Map Model

- Responding to request for site specific disposition maps
- Addressing challenges with WIMS data base used for LLW/MLLW data
- Developing a new graphic, a disposition map model for input
- Idaho
 - Lots of disposition paths
 - Seeking input
