**The Use of Ecological Restoration Principles  
To Achieve Remedy Protection  
At the Fernald Preserve and Weldon Spring Sites - 8354**

J. Powell, F. Johnston, J. Homer  
Fernald Preserve  
10995 Hamilton-Cleves Hwy. Harrison, Ohio 45030

Y. Deyo  
Weldon Spring  
7295 Highway 94 South  
St. Charles, Missouri 63304

WM2008 Conference, February 24-28, 2008, Phoenix, AZ

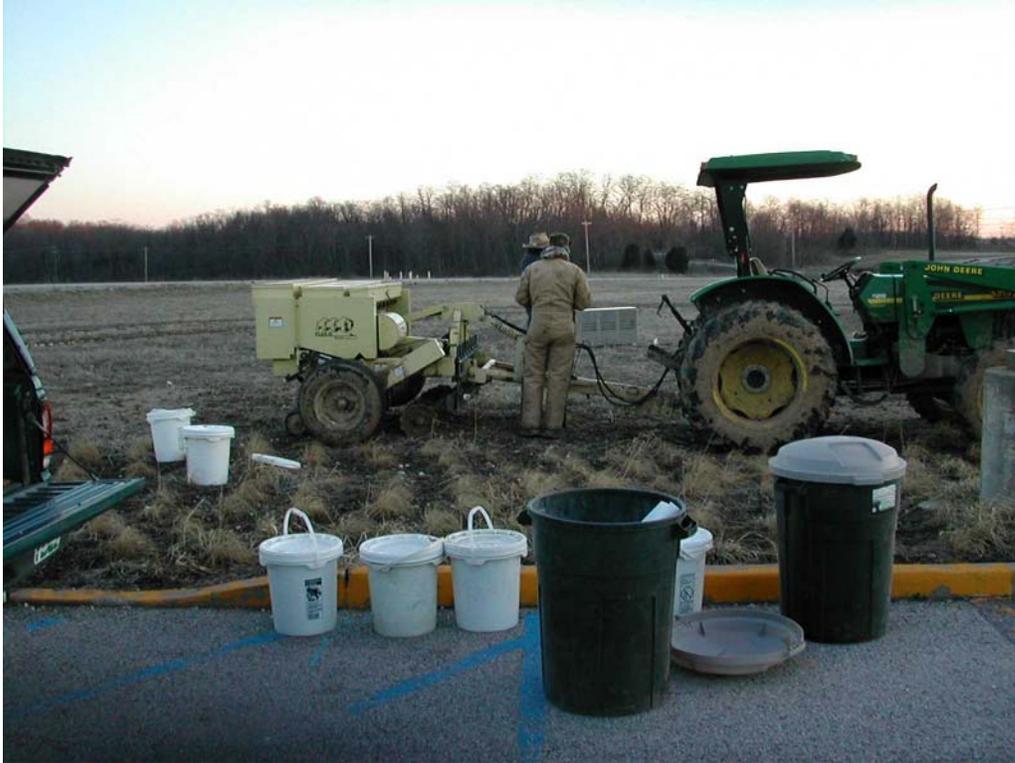
Fig.1. A seed drill was utilized at the Fernald Preserve and Weldon Spring Site for seeding operations.

Additional seeding was performed in January of 2003 and 2004 utilizing a seed drill (Fig. 1). Seed mixes consisted primarily of forbs supplemented by grasses. In 2004, a

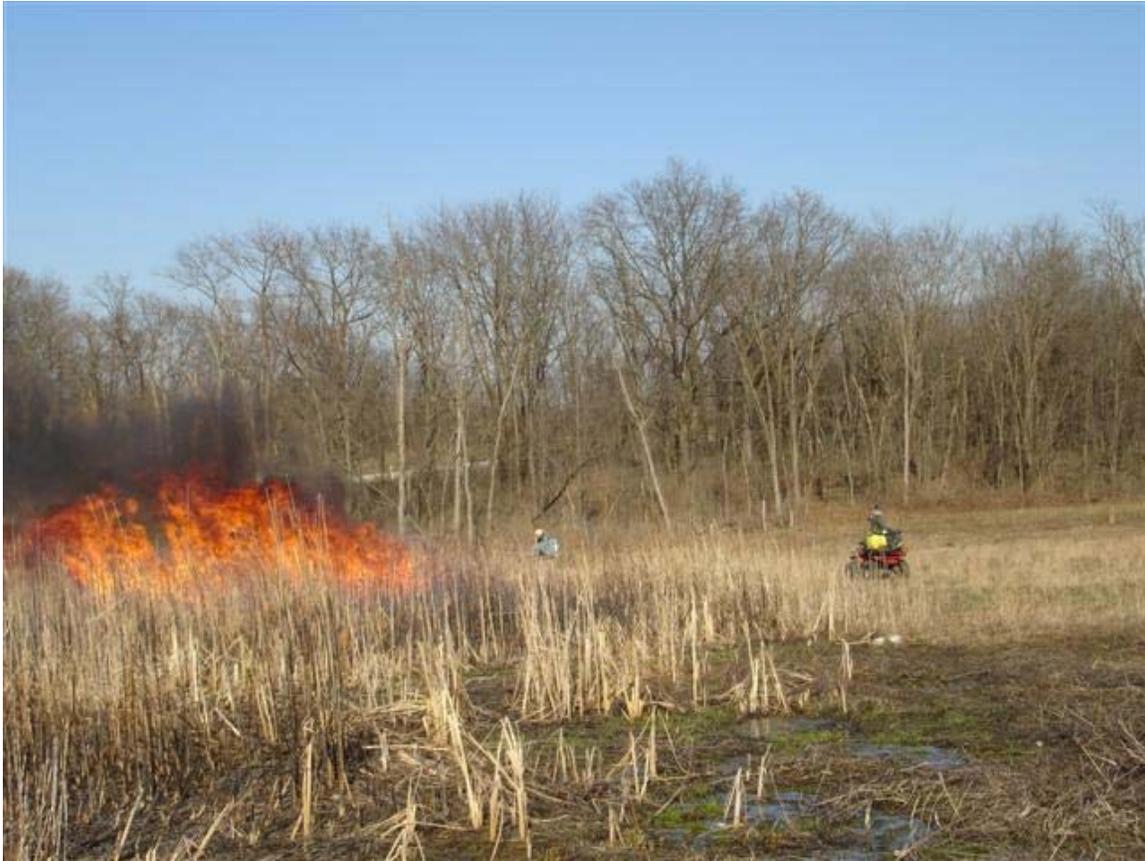
Fig. 2. Prescribed burning is being performed in the drainage outlet area of the Weldon Spring Site in February, 2006.

High mowing was performed from 2002 – 2005 to limit annual weed establishment and encourage natives. The prairie was mowed to a height of approximately 30 centimeters (12 inches) during early summer. Prescribed burning was performed in limited areas with greatest fuel load in 2006 and it is expected that this will be the primary long-term management tool. (Fig. 2)

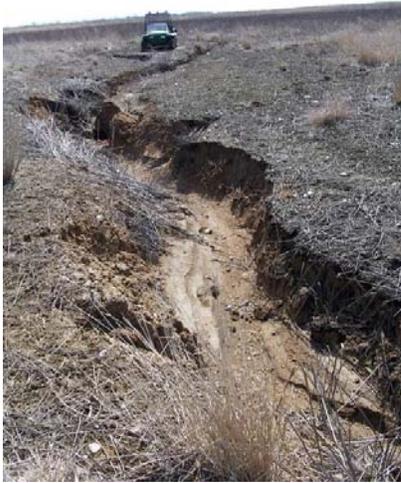
Fig. 3. Erosion channel observed in late winter, 2007. Significant plant establishment has since occurred along the sides and bottom of the channel.

In 2004, a more aggressive strategy was employed for controlling erosion in the worst gullies. Erosion in two areas of the site was repaired by performing limited excavation, applying geo-fabric, digging rock boxes, and then filling gullies and boxes with rock. An extensive summer drought hampered further plant establishment for the season. In 2005, new erosion channels were noted and repaired by digging rock boxes and filling channels with rock. Summer drought conditions continued to hamper plant growth and establishment. In 2006, all erosion areas were monitored and appeared to be stable. However, by late winter of 2007, erosion in one portion of the site appeared to be increasing rapidly and areas repaired with rock were observed to be silting in and new erosion channels starting to cut around the sides. (Fig. 3)

It was decided to evaluate several different components of the prairie to determine if additional similar repairs needed to be performed or if a different approach was necessary. The entire prairie area had previously been segregated into ten different management units to assist in performing prescribed burns and other miscellaneous management activities. In March, 2007, soil samples were obtained from each management unit and analyzed for nutrient value. The results of the tests indicated that the average soil pH was 8.2 and an overabundance of calcium existed. In July, all erosion channels were mapped with GPS coordinates in order to provide an objective means to perform future monitoring of conditions. Utilizing the soil analysis results and erosion map, a field survey team of soil reclamation and prairie ecosystem subject matter experts performed a walkover of the erosion areas in August. After evaluating soil conditions, plant diversity, and plant density, it was determined that overall vegetation establishment was excellent and significant plant establishment along the bottom and sides of all the gullies observed indicated a lack of recent erosion and a trend towards stabilization. It is believed that the rock channels installed to repair erosion will likely fill in with vegetation within the next several years.
