U.S. DEPARTMENT OF  
**ENERGY**

Legacy  
Management

# 2014 Annual Site Inspection and Monitoring Report for Uranium Mill Tailings Radiation Control Act Title II Disposal Sites

November 2014

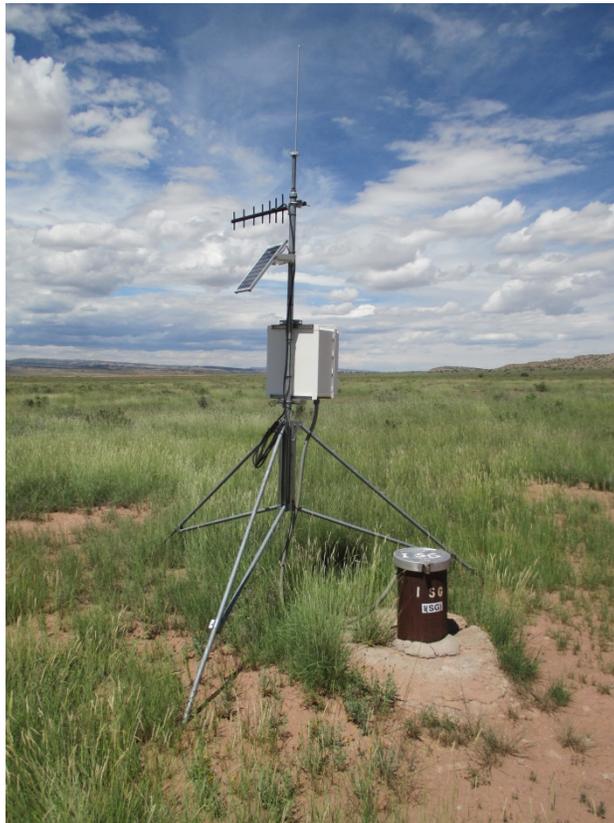
*BLU 8/2014. PL-5. Monitoring well I(SG) and water level monitoring telemetry tower.*

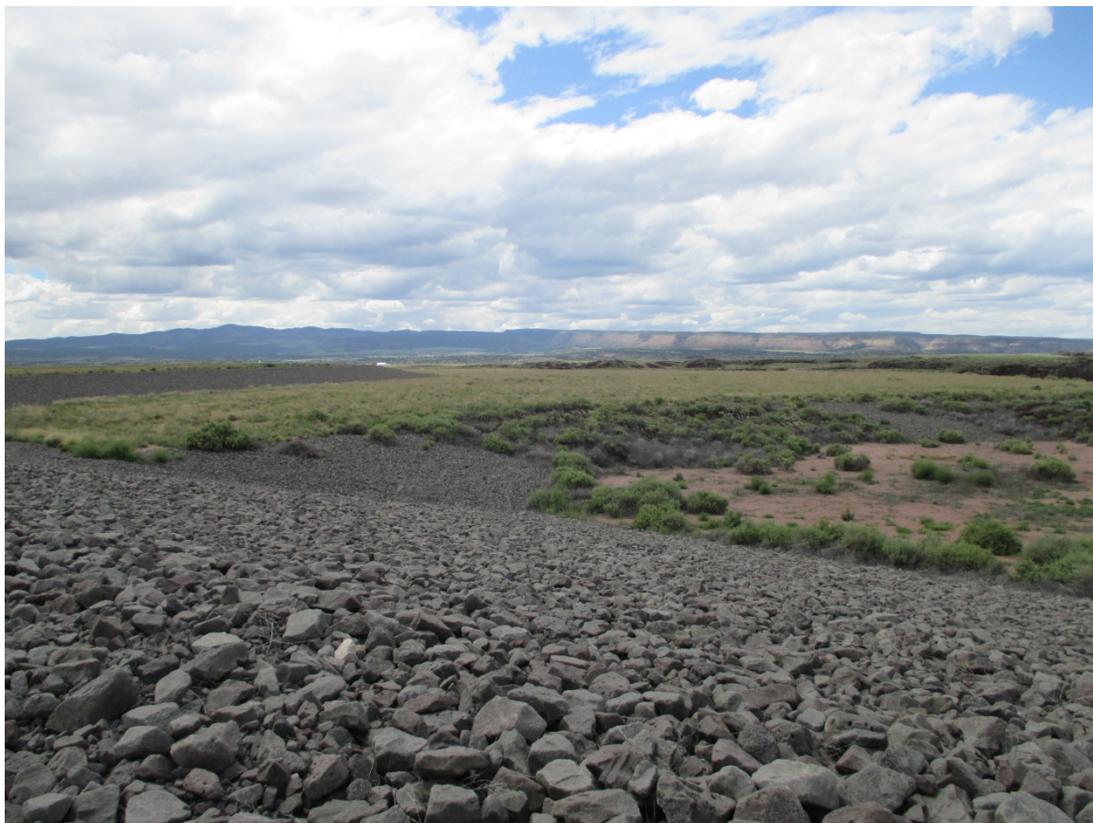
grade is 3 to 4 percent at the south end and decreases to less than 0.5 percent at the north end. The top slopes of the acid tailings (PL-6) and the south bench disposal areas are essentially flat and covered by healthy grass. Basalt riprap protects the side slopes of the three disposal areas. The riprap was in excellent condition.

*BLU 8/2014. PL-6. Acid tailings disposal area adjacent to main tailings disposal cell.*

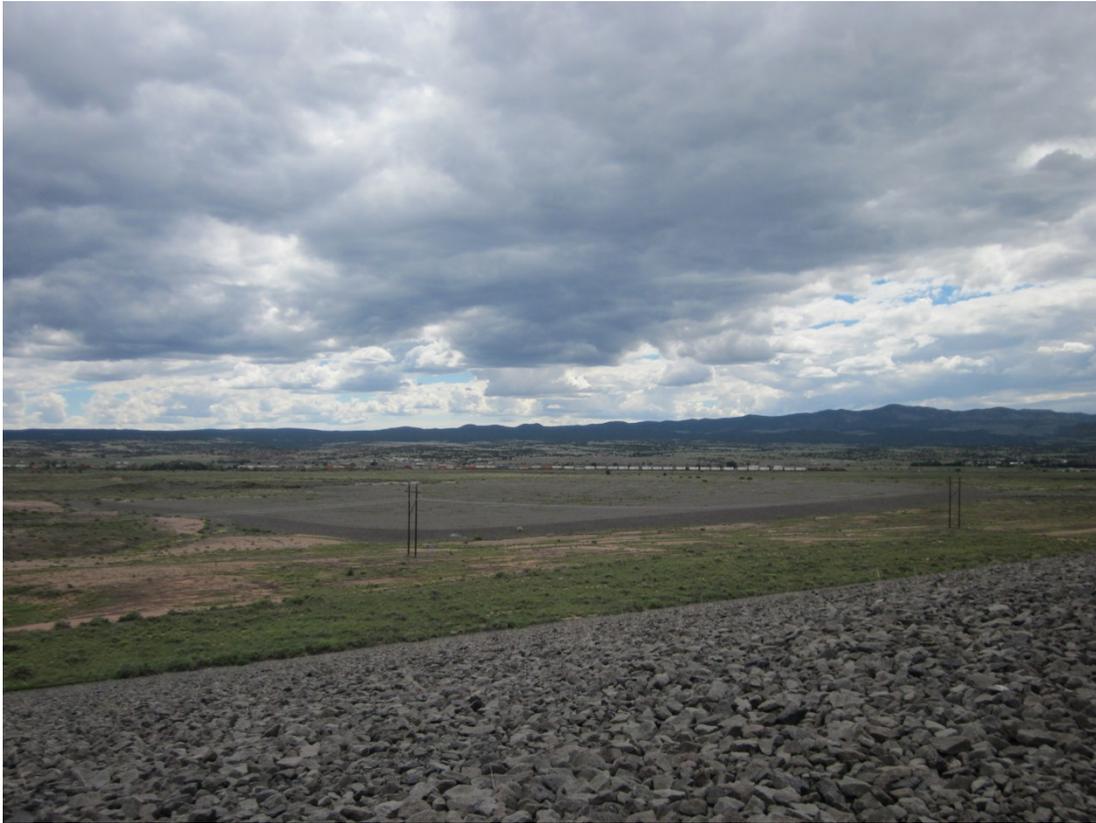
*BLU 8/2014. PL-9. Carbonate tailings disposal cell viewed from main tailings disposal cell.*

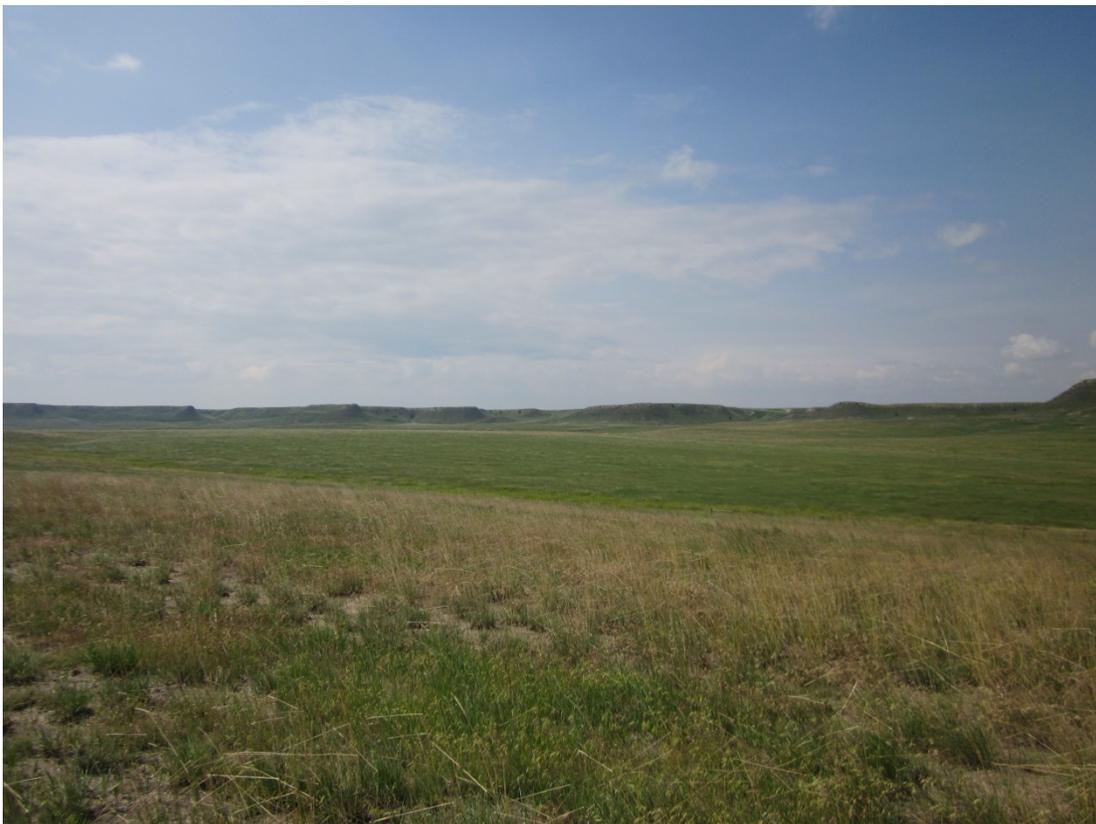
*EDG 7/2014. PL-4. View south across disposal cell surface.*

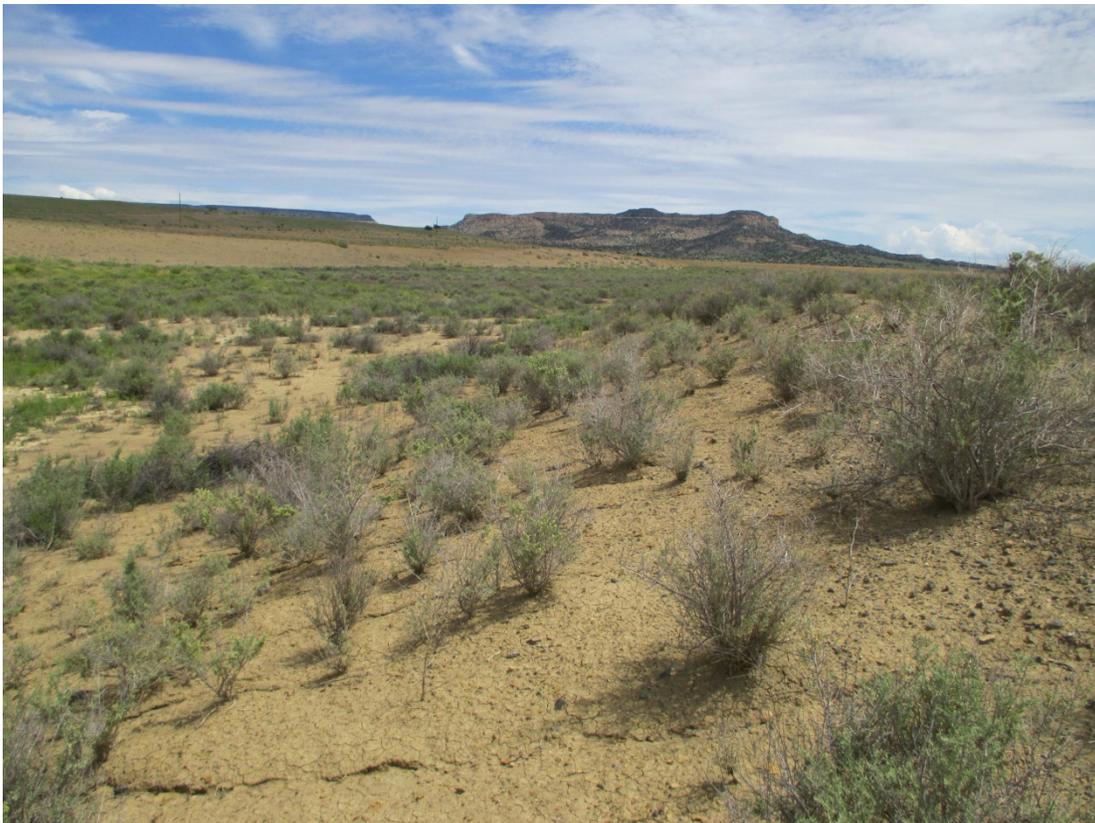
*BAR 8/2014. PL-10. South bank of north diversion channel.*

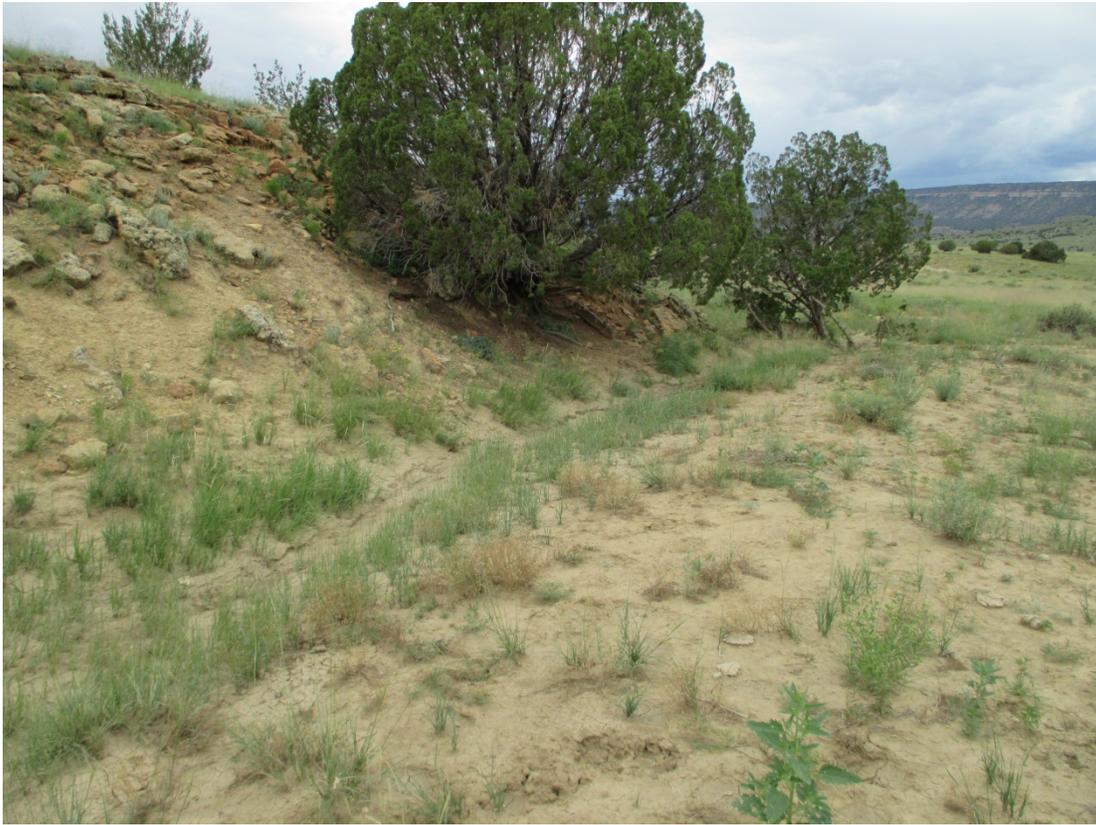
*BAR 8/2014. PL-11. Tres Hermanos sandstone unit outcrop (no seep).*

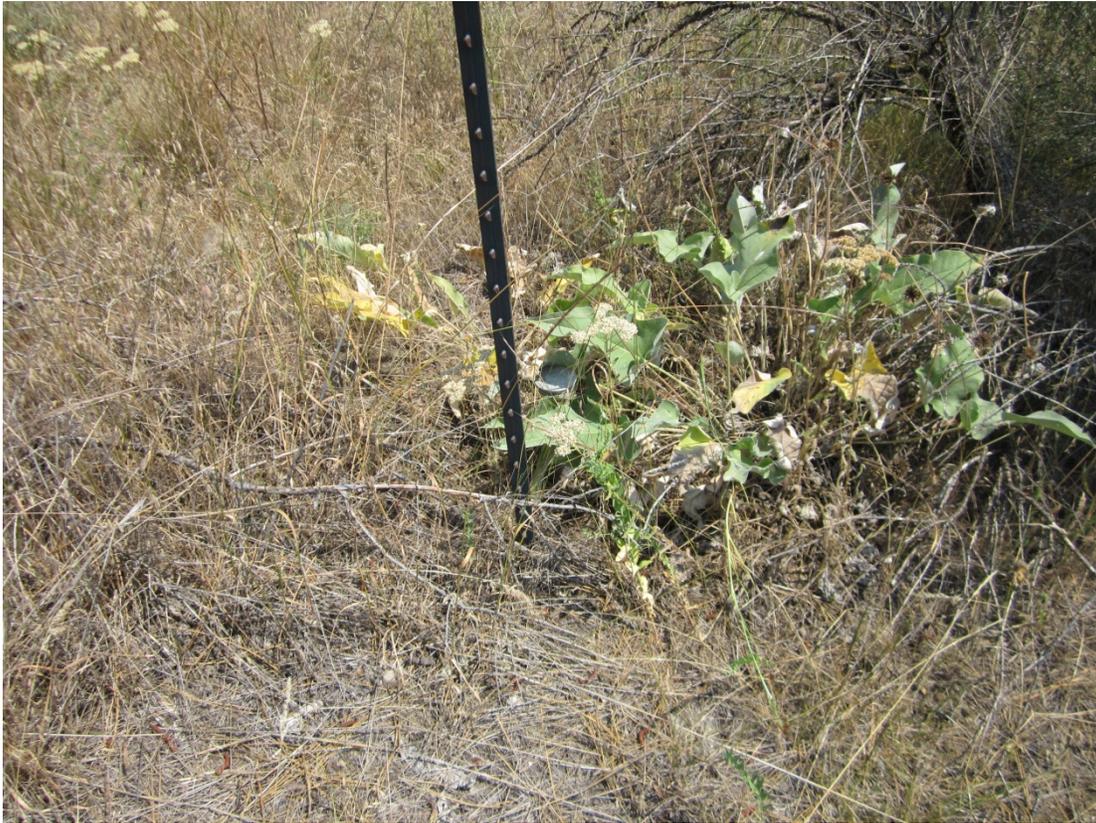
*SHE 7/2014. PL-3. Boundary monument BM-3.*

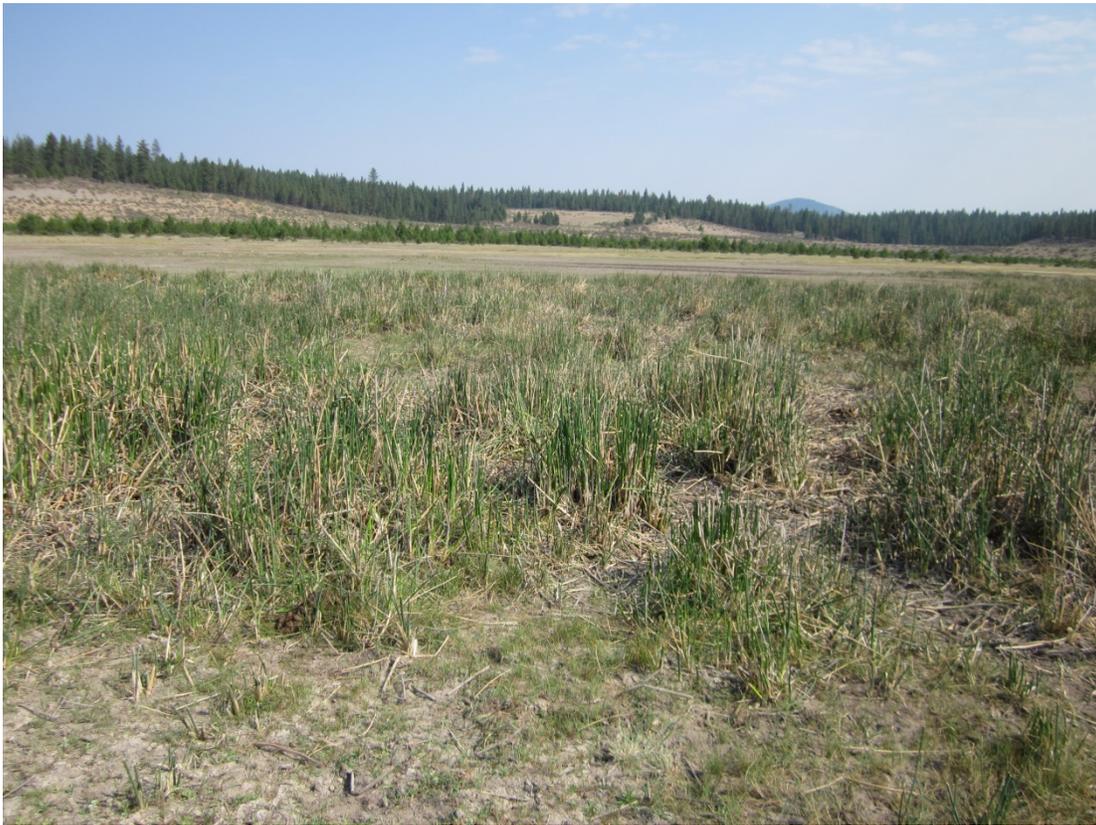
*SHE 7/2014. PL-5. Pond 1 area on tailings impoundment cover.*

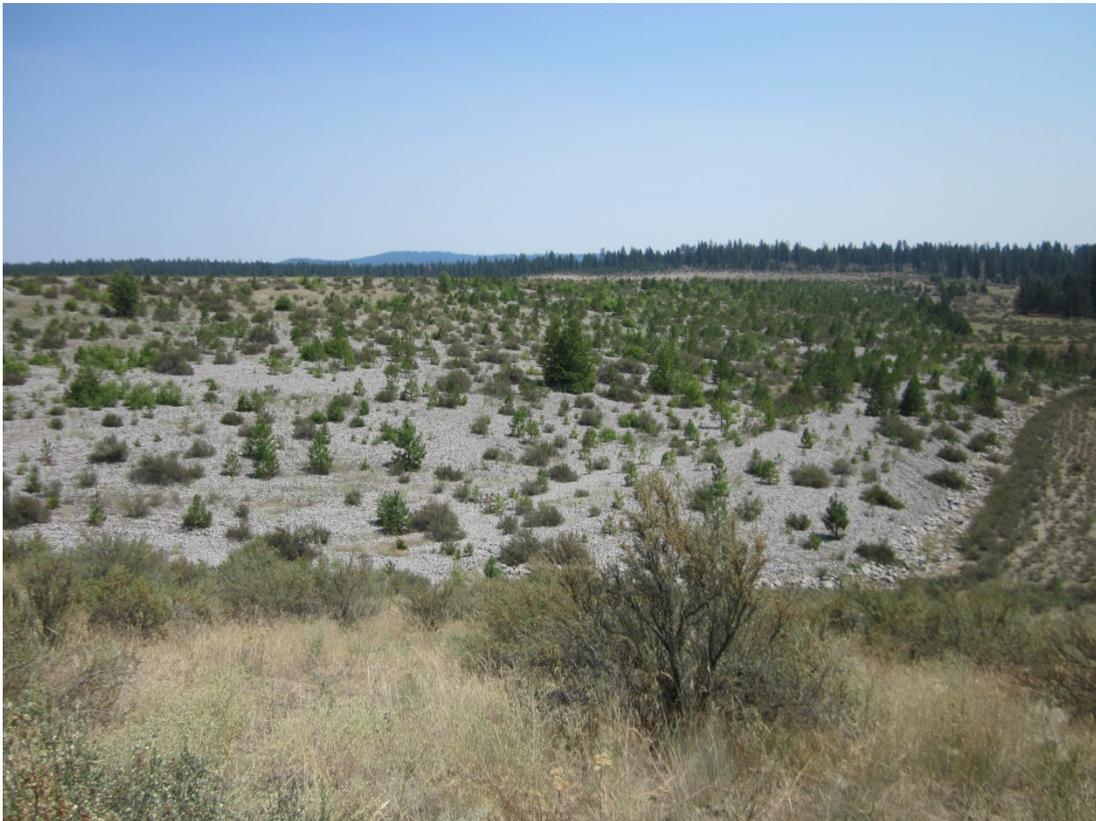
*SHE 7/2014. PL-8. Vegetation on tailings dam face.*

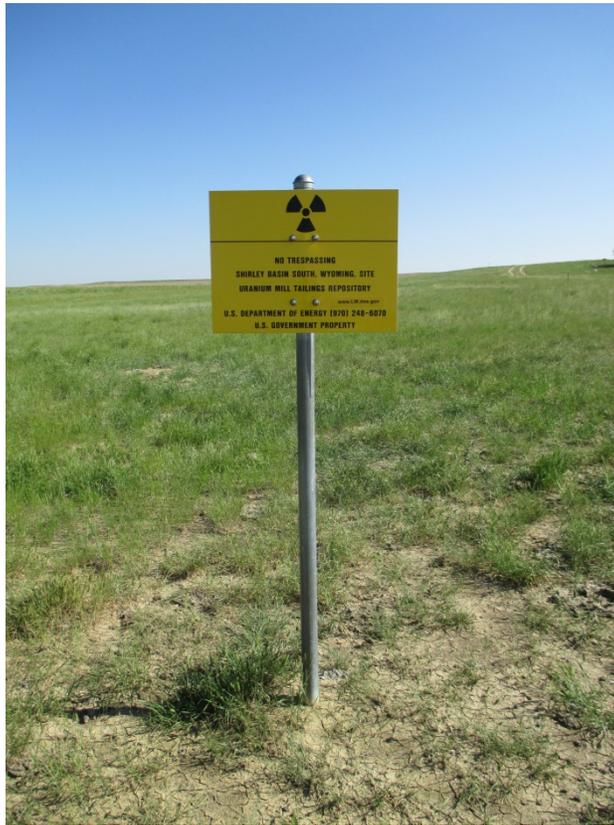
Nine perimeter signs (warning/no-trespassing signs) are along the site perimeter at potential points of access, and another 25 signs are positioned around the disposal cell (PL-1). Other than perimeter signs P1 and P2, which have bullet holes in them, the signs were in excellent condition.

SBS 7/2014. PL-1. Perimeter sign P26 at site entrance.

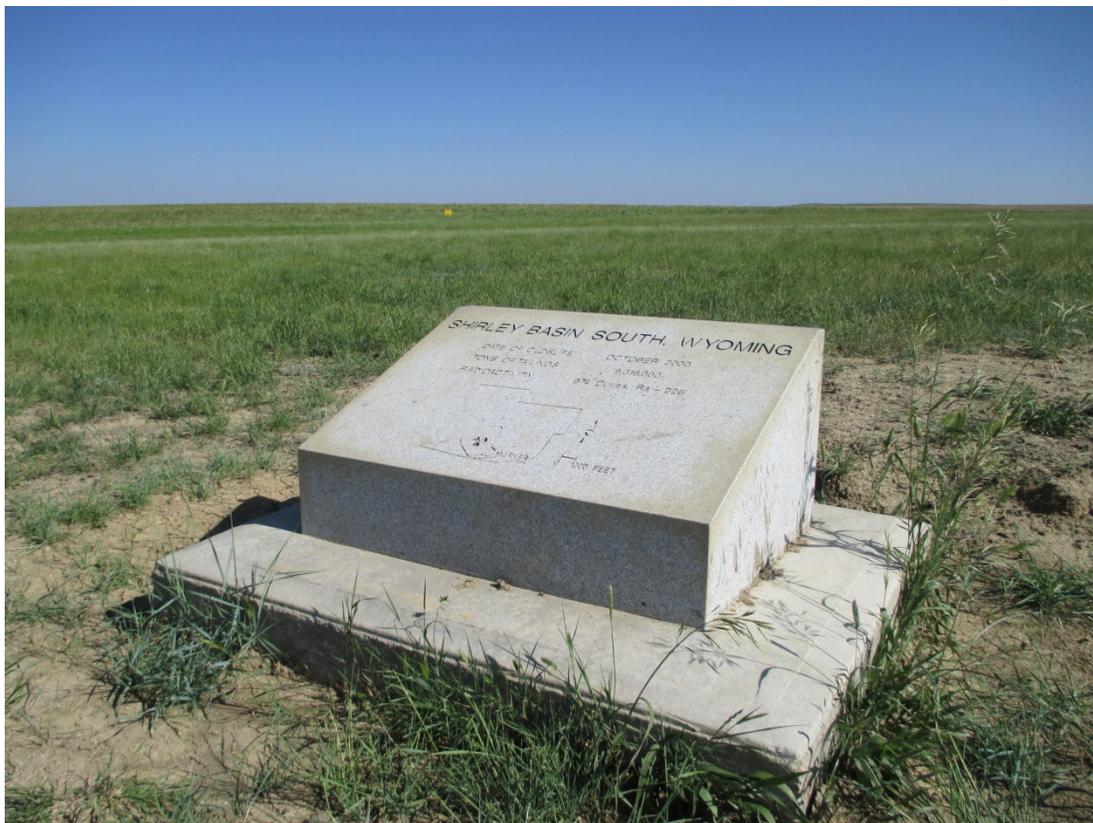
The granite site marker, which is located at the site entrance, was in excellent condition (PL-2). Twenty-six monuments delineate the site property boundary; the observed boundary monuments were in excellent condition (PL-3).

SBS 7/2014. PL-2. Site marker at site entrance.

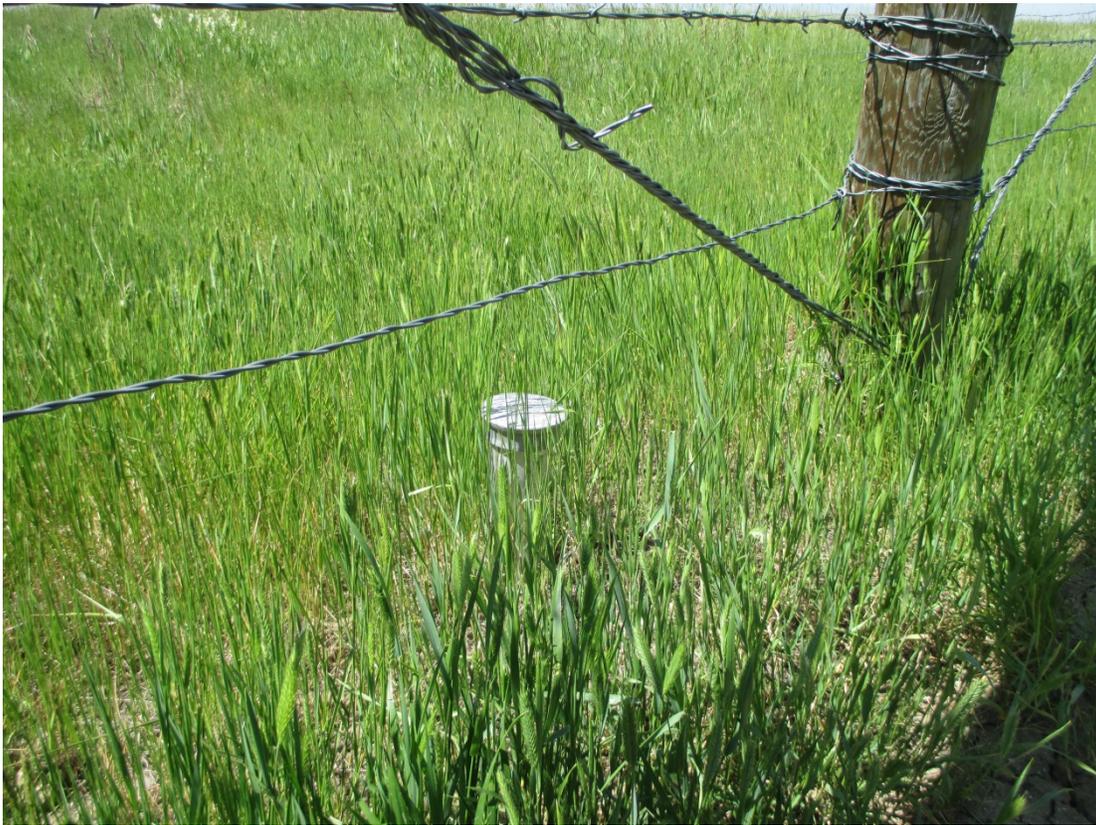
*SBS 7/2014. PL-3. Boundary monument BM-18.*

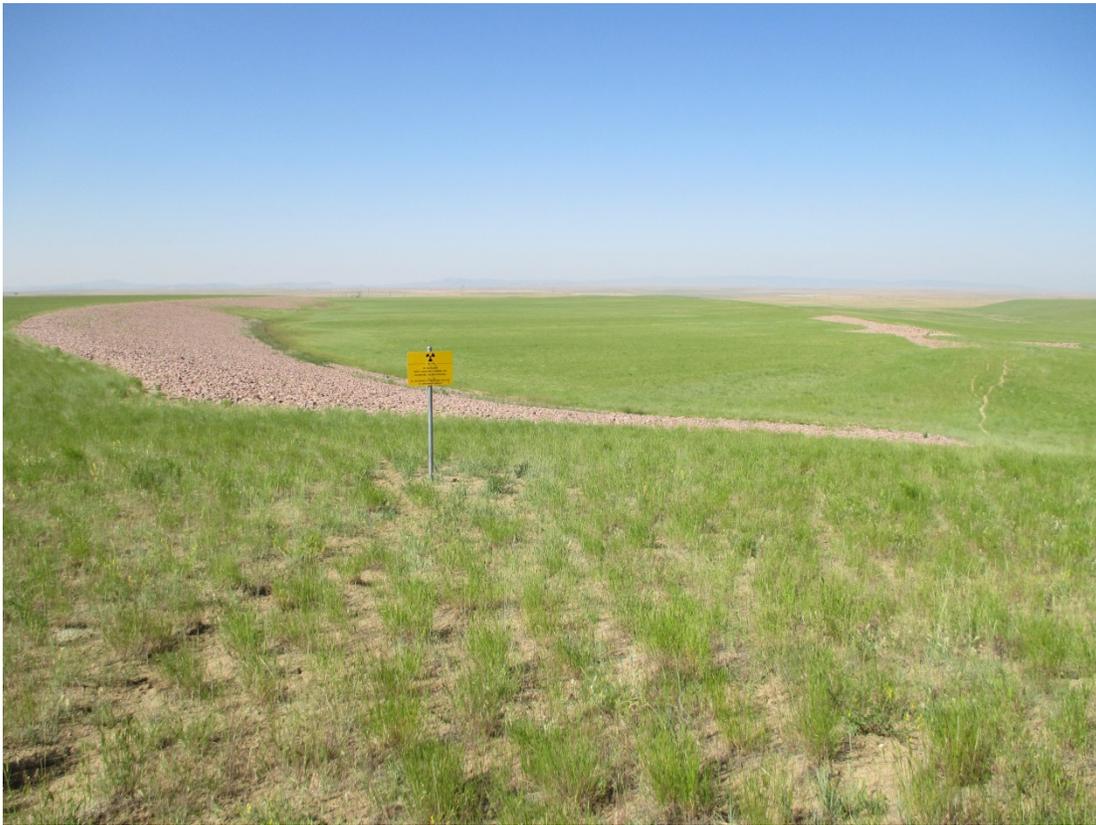
*SBS 7/2014. PL-5. Lower surface of disposal cell.*

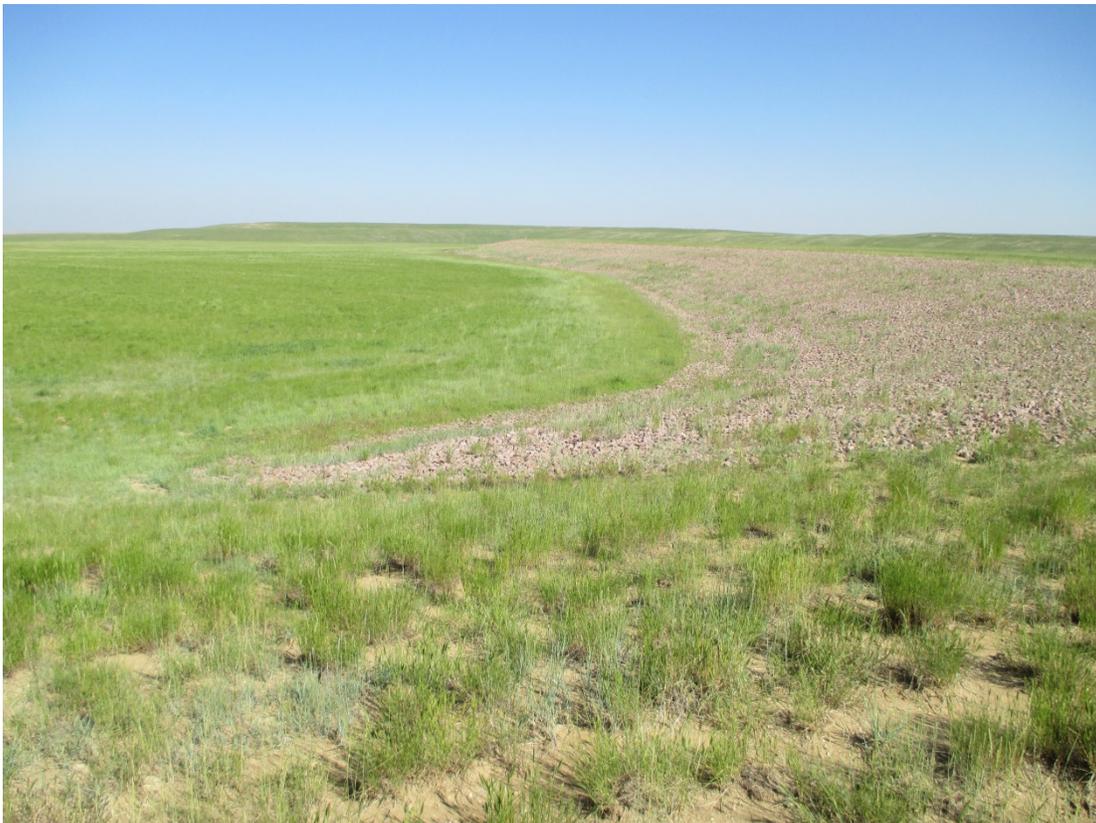
*SBS 7/2014. PL-6. Riprap-armored slope between disposal cell upper and lower surfaces.*

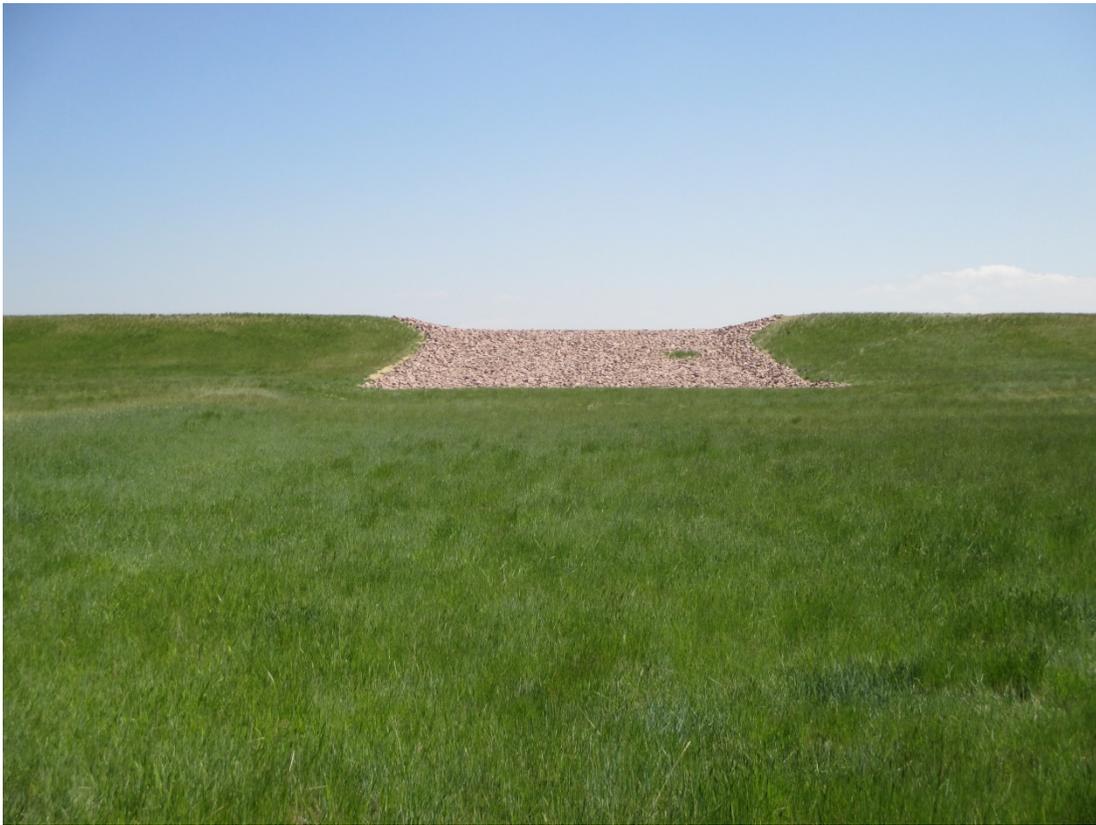
*SBS 7/2014. PL-7. South swale discharge point.*

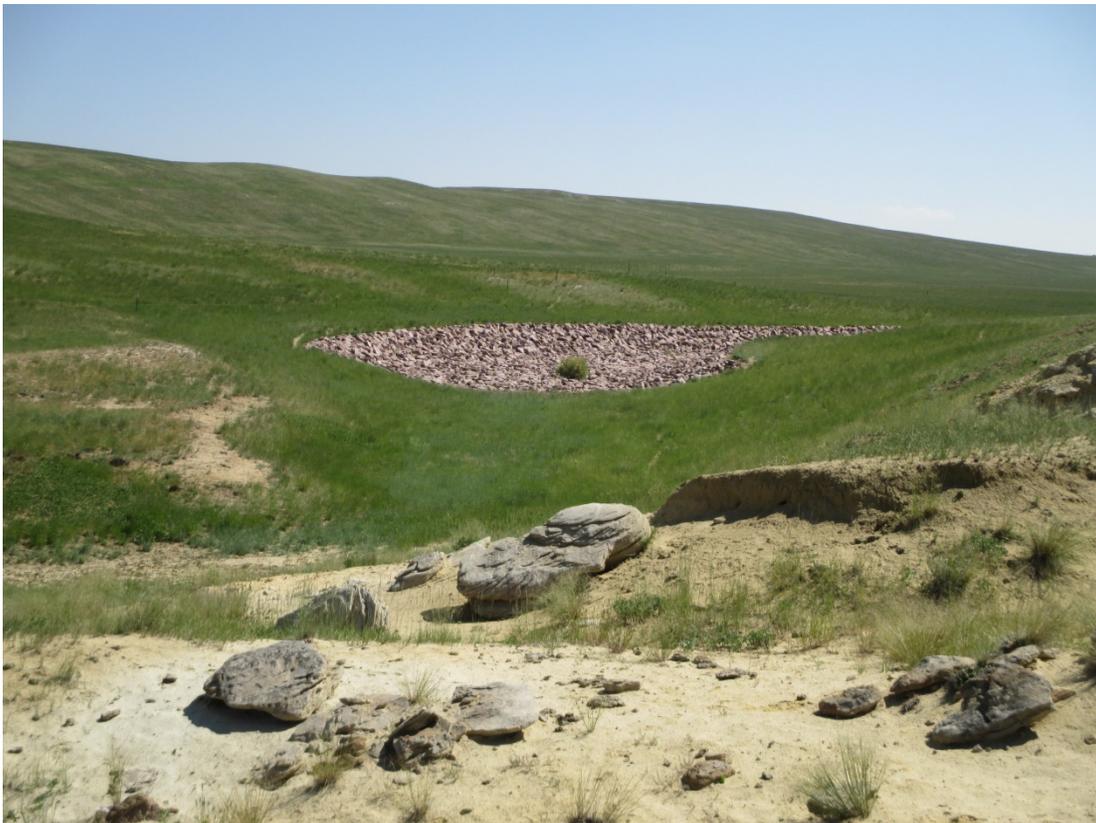
*SBS 7/2014. PL-8. Outlet of riprap-armored drainage channel.*

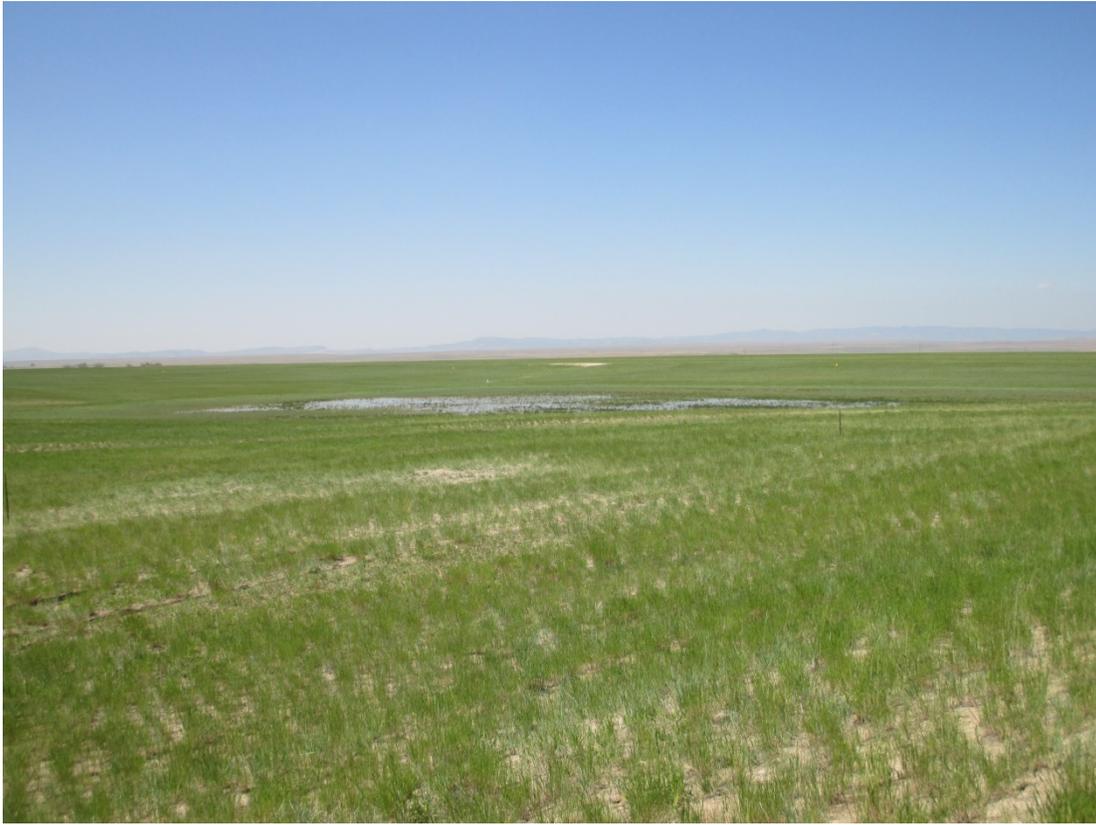
portion of the PMF channel that flows eastward and discharges into the east drainage basin captures a larger drainage area; this basin contained water at the time of the inspection (PL-9). These closed drainage basins are large enough to accommodate the PMF water volumes. The diversion channels were in excellent condition, and no active erosion was apparent in the channels.

*SBS 7/2014. PL-9. Pond in east drainage basin.*

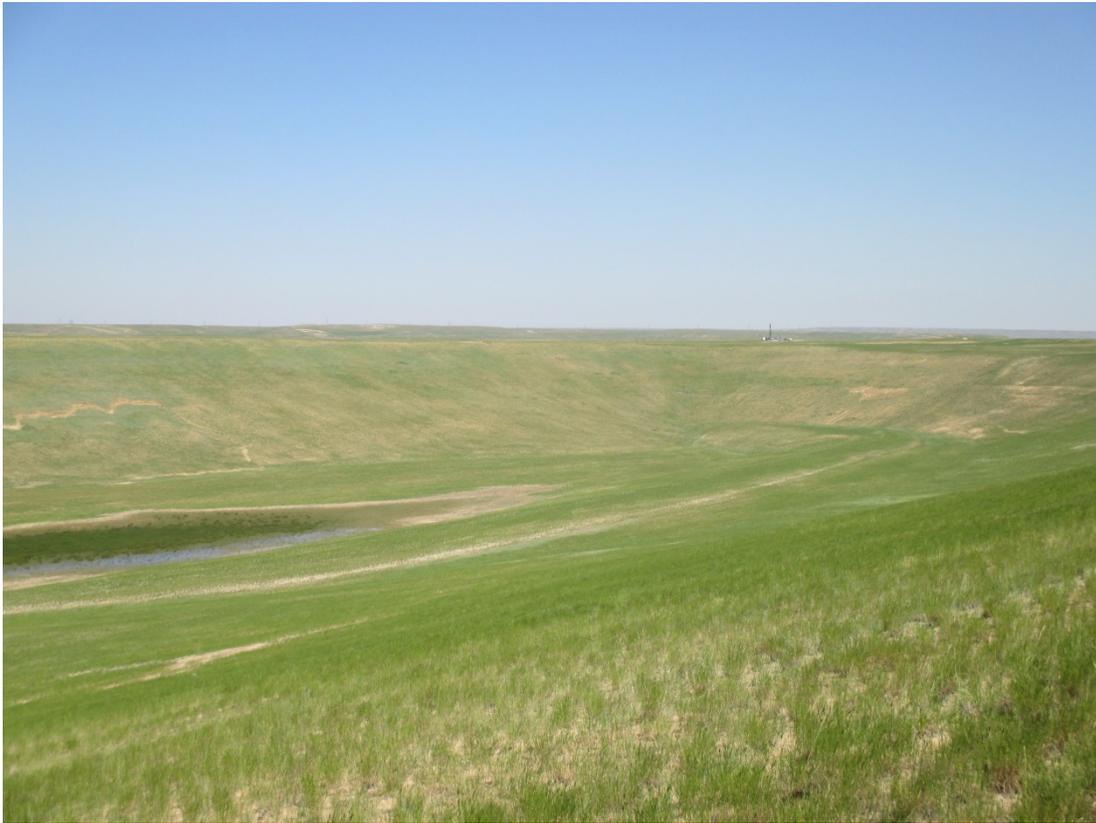
The other major feature on the site is reclaimed Pit 4, in the northeast portion of the site (PL-10). Reclamation activities included rounding the side slopes, partially backfilling the pit to an elevation above the local water table, revegetating the surfaces, and protecting potential erosion areas with riprap. Vegetation is well established, and a wetland area has formed at the bottom of the pit where standing water from runoff is often present; the surface of this area tends to dry out later in the summer. Overall, Pit 4 was in good condition, with some minor slumps and displacement features present on the west side slope of the pit.

*SBS 7/2014. PL-10. North portion of reclaimed Pit 4.*

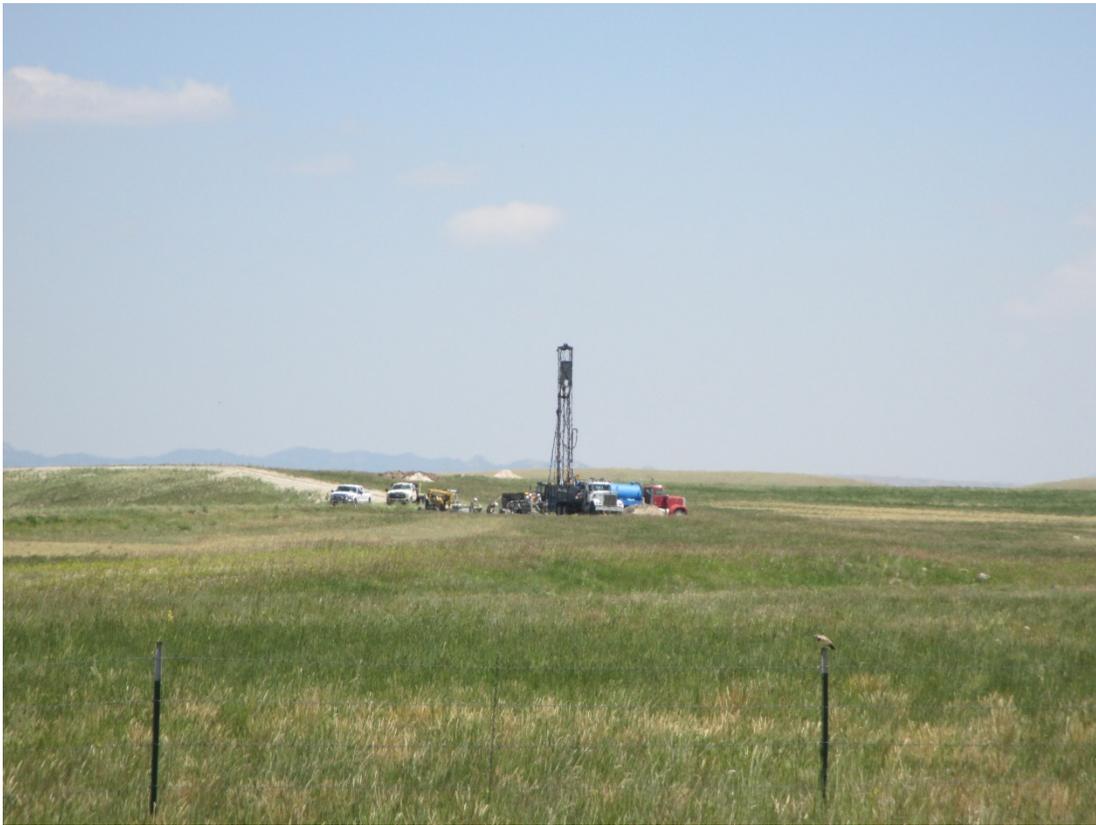
*SBS 7/2014. PL-11. Ur-Energy exploration drill rig on adjacent property.*

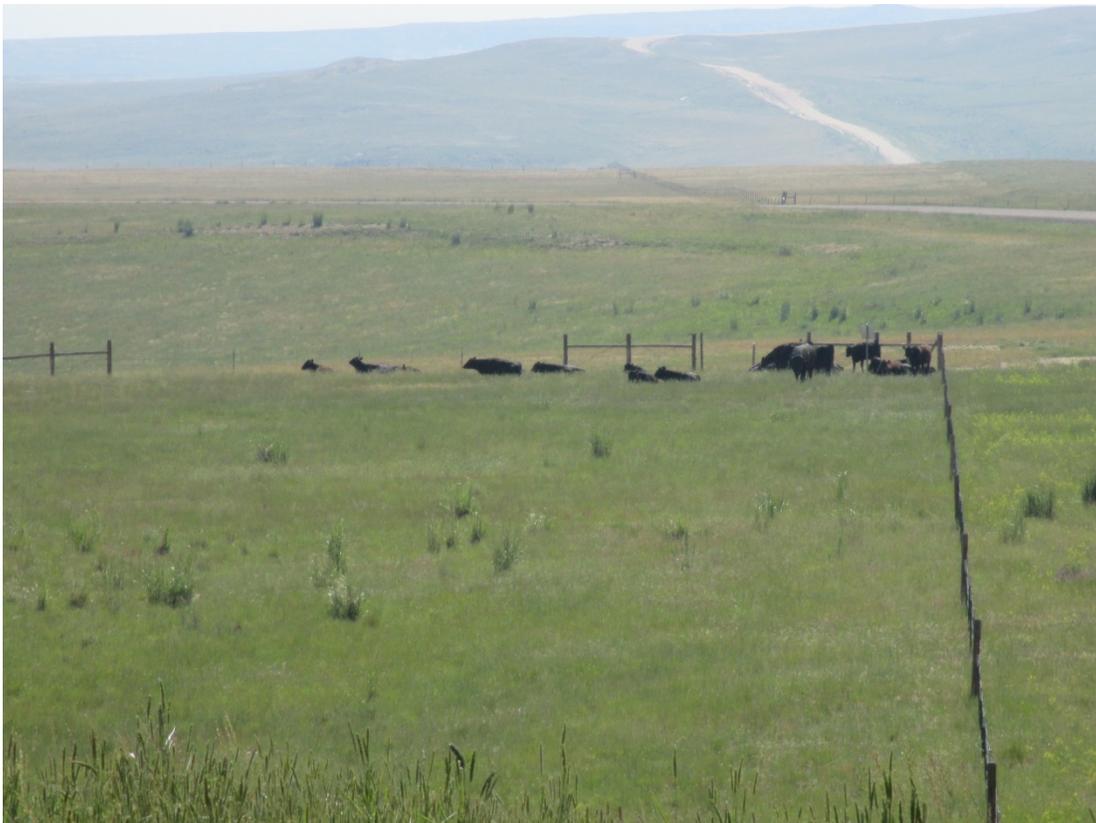
*SBS 7/2014. PL-12. Cattle at southeast corner of site.*
