U.S. DEPARTMENT OF  
**ENERGY**

Legacy  
Management

# 2012 Annual Site Inspection and Monitoring Report for Uranium Mill Tailings Radiation Control Act Title I Disposal Sites

February 2013

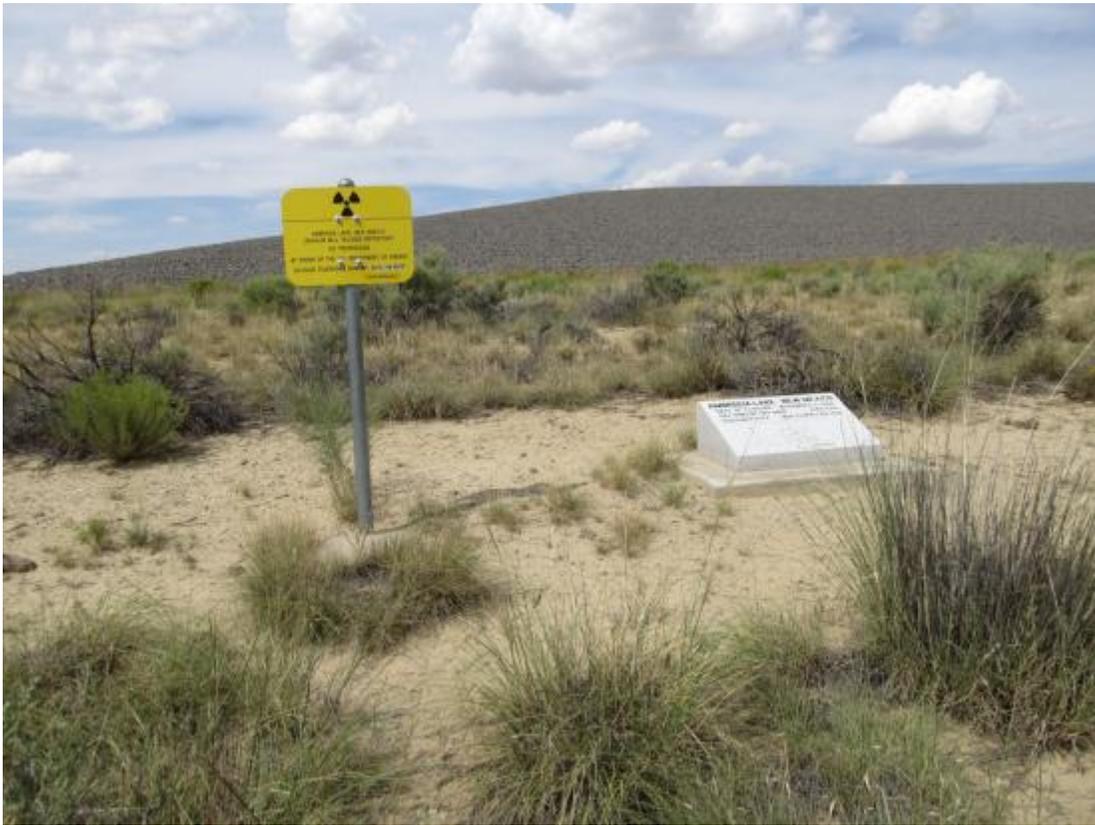
The entrance sign was in good condition (PL–1).

AMB 8/2012. PL-1. Entrance sign and site marker SMK-1.

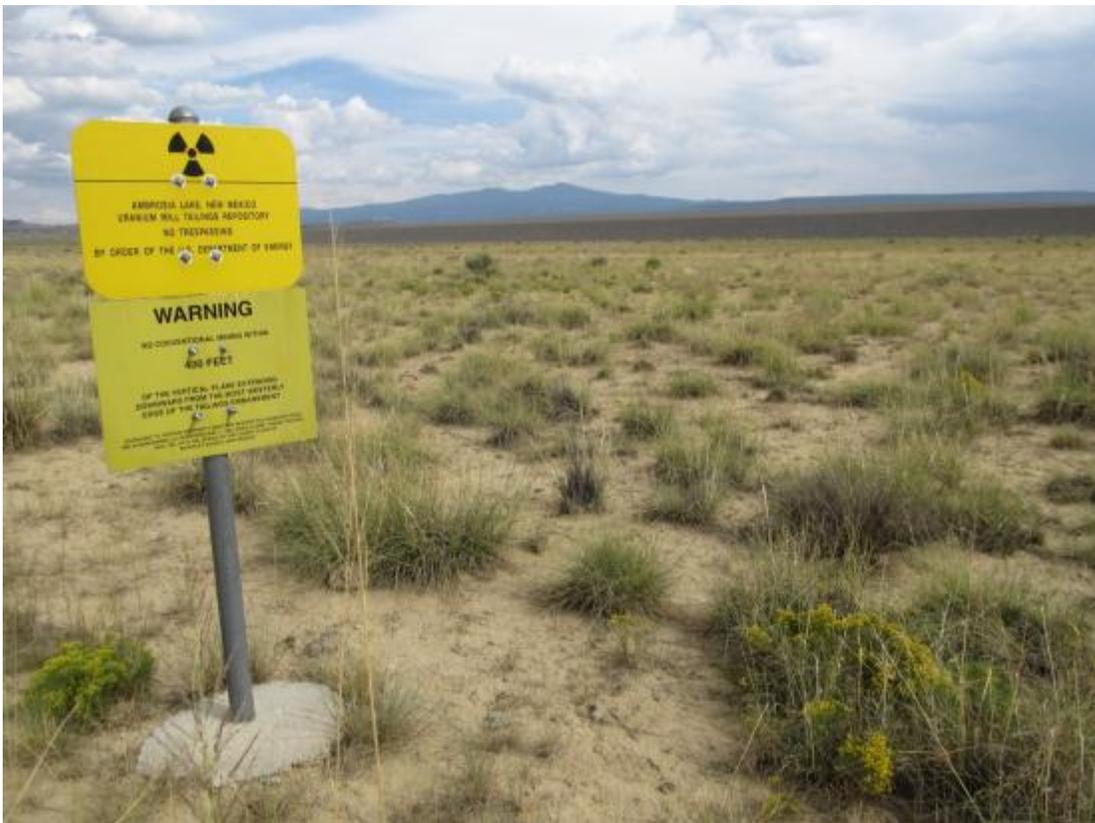
The site is not fenced. Seventy perimeter signs, positioned on the site boundary, also were in good condition. Posts for perimeter signs P1 through P15 include mining-restriction-area warning signs (PL–2).

AMB 8/2012. PL-2. Perimeter sign P14 and mining-restriction sign.

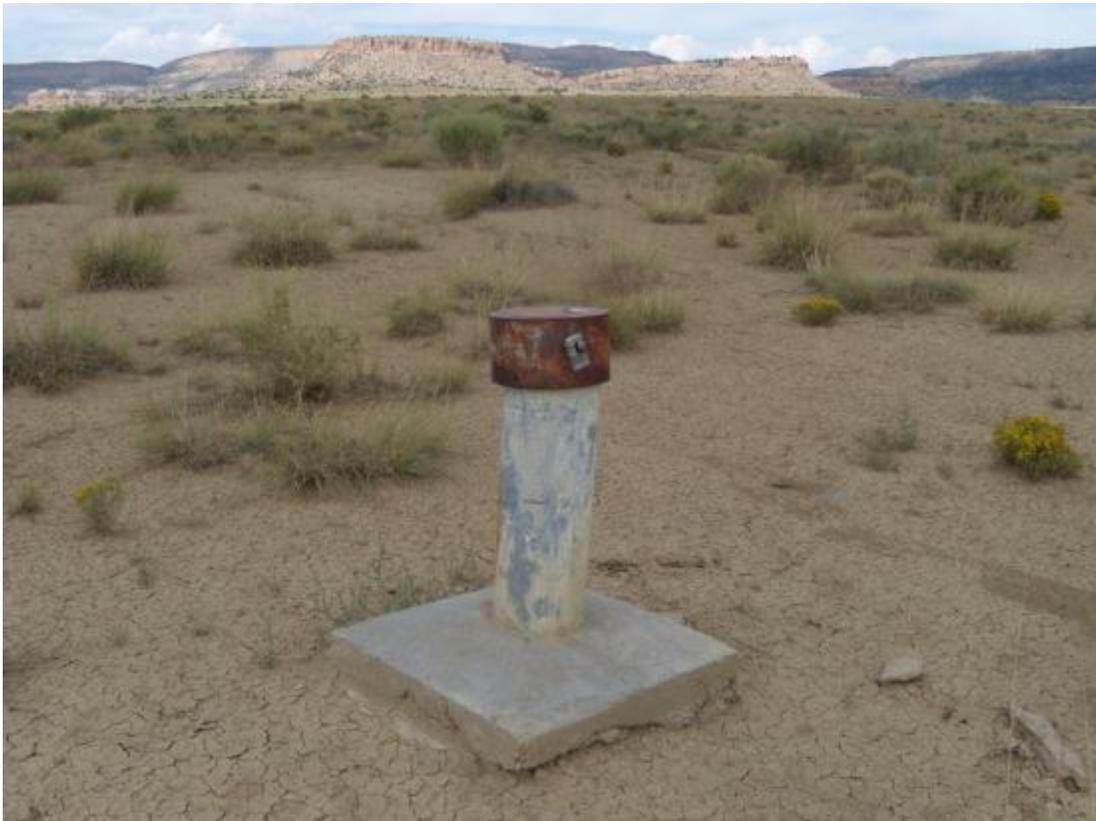
Monitoring wells 0409, 0675, and 0678 were in good condition (PL–6, PL–7, and PL–8). Gully formation adjacent to monitoring well 0678 appears to be stable, and the well is not threatened.

AMB 8/2012. PL-8. Monitoring well 0678.

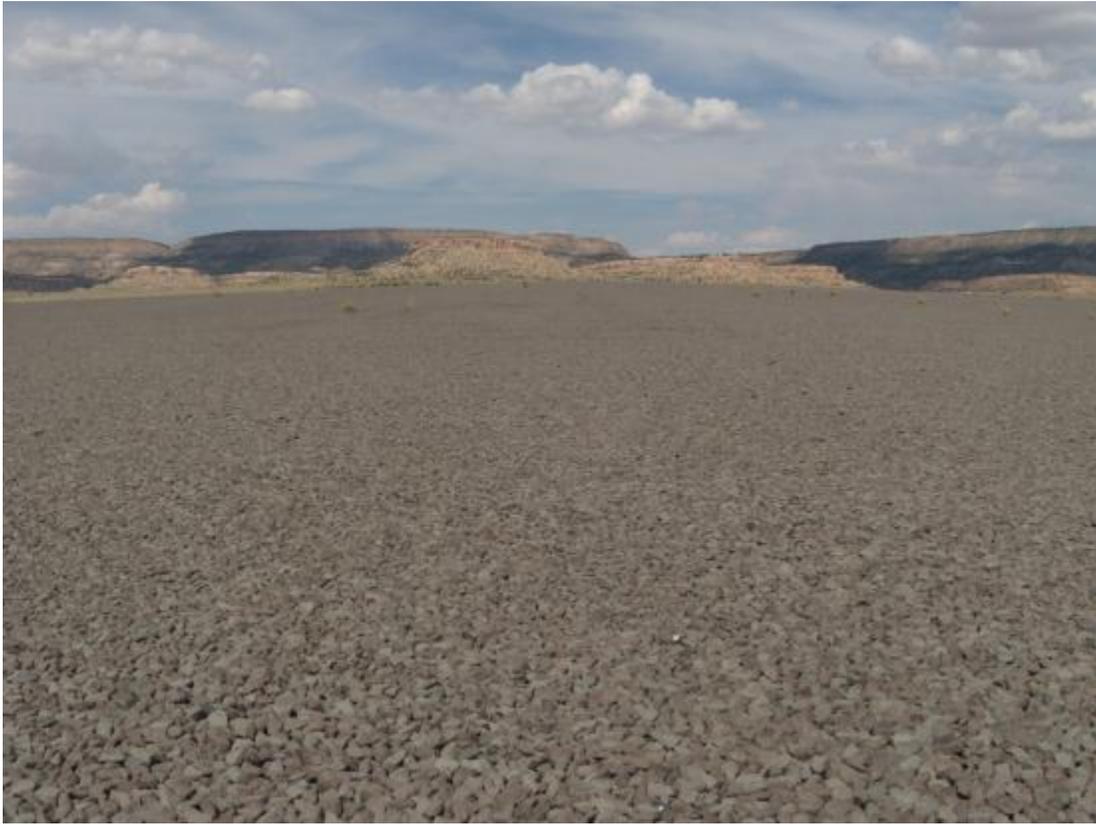
The 91-acre disposal cell was completed in 1994. The basalt riprap-covered top slope of the disposal cell was in excellent condition. There was no evidence of cracking, slumping, or erosion (PL-9).

AMB 8/2012. PL-9. View northeast across the disposal cell top slope.

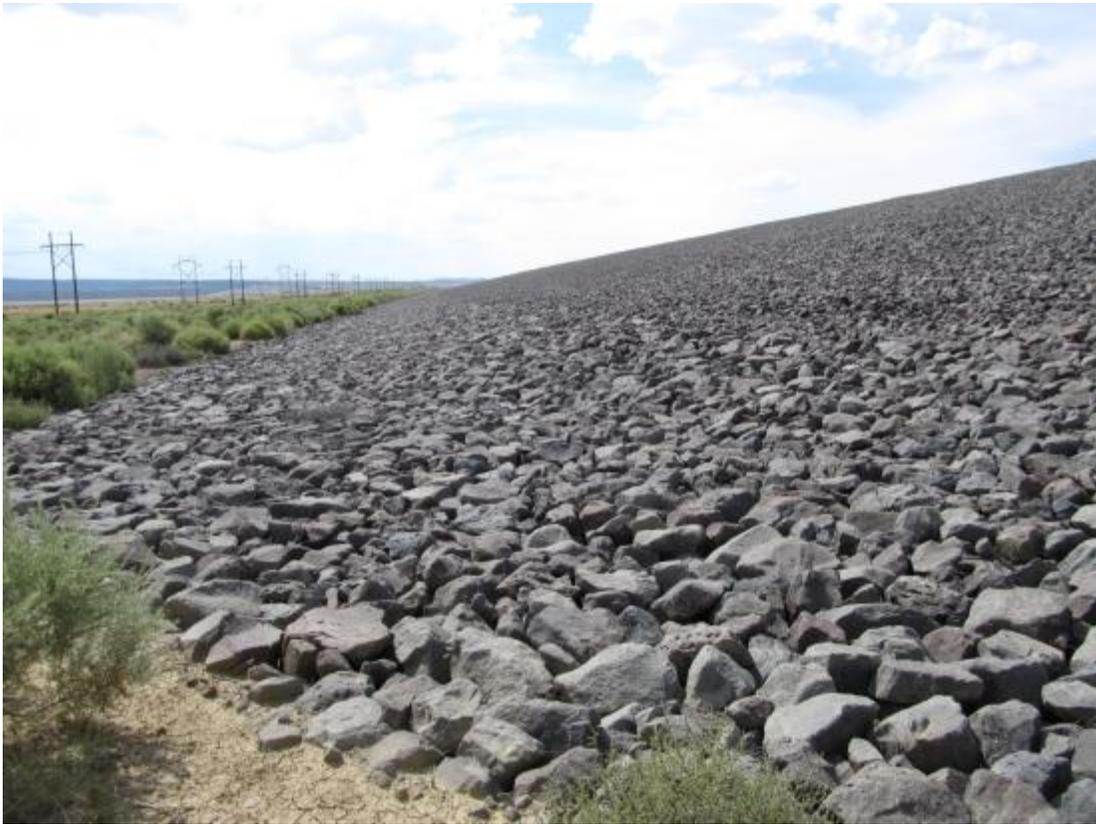
The basalt riprap-covered side slopes and apron were in excellent condition and showed no evidence of cracking, settling, slumping, or erosion (PL-10). Standing water from recent rainfall events was present in the apron along the south side of the disposal cell. This water likely dissipates both through evaporation and through infiltration into the underlying alluvium.

AMB 8/2012. PL-10. South side slope and apron of the disposal cell.

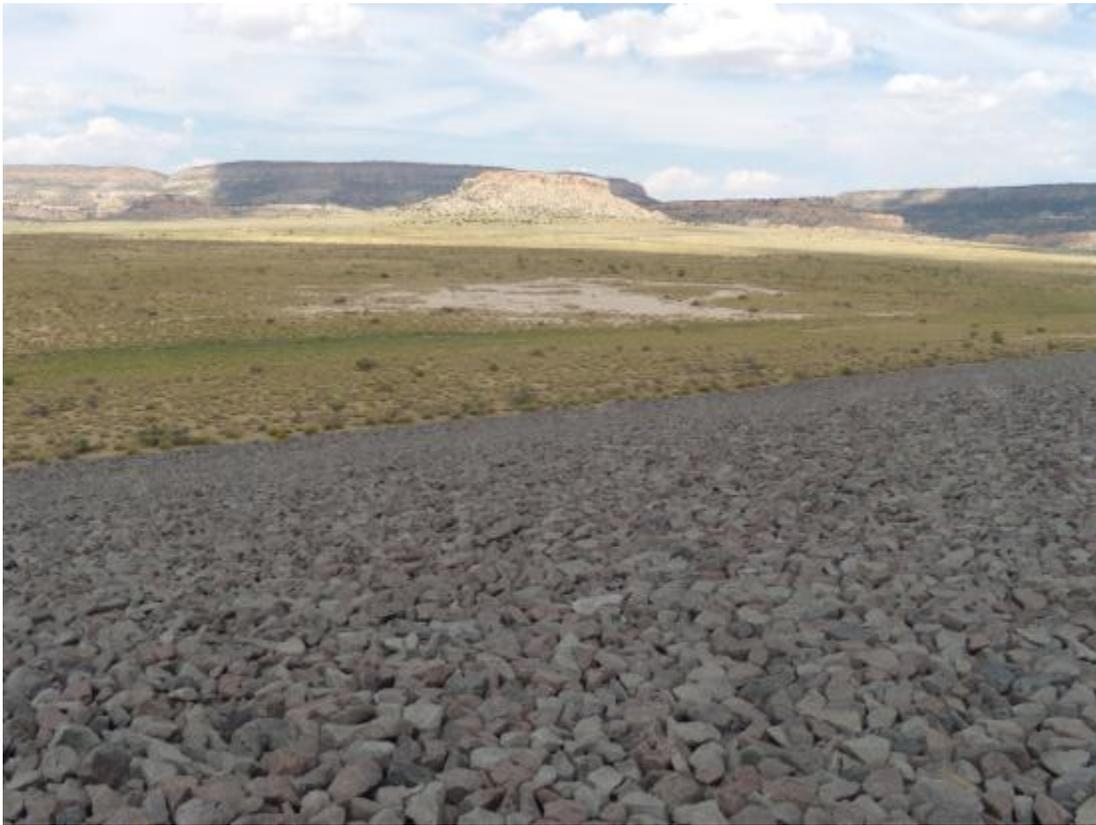
AMB 8/2012. PL-11. Poorly vegetated area north of the disposal cell (remediated tailings stockpile area).

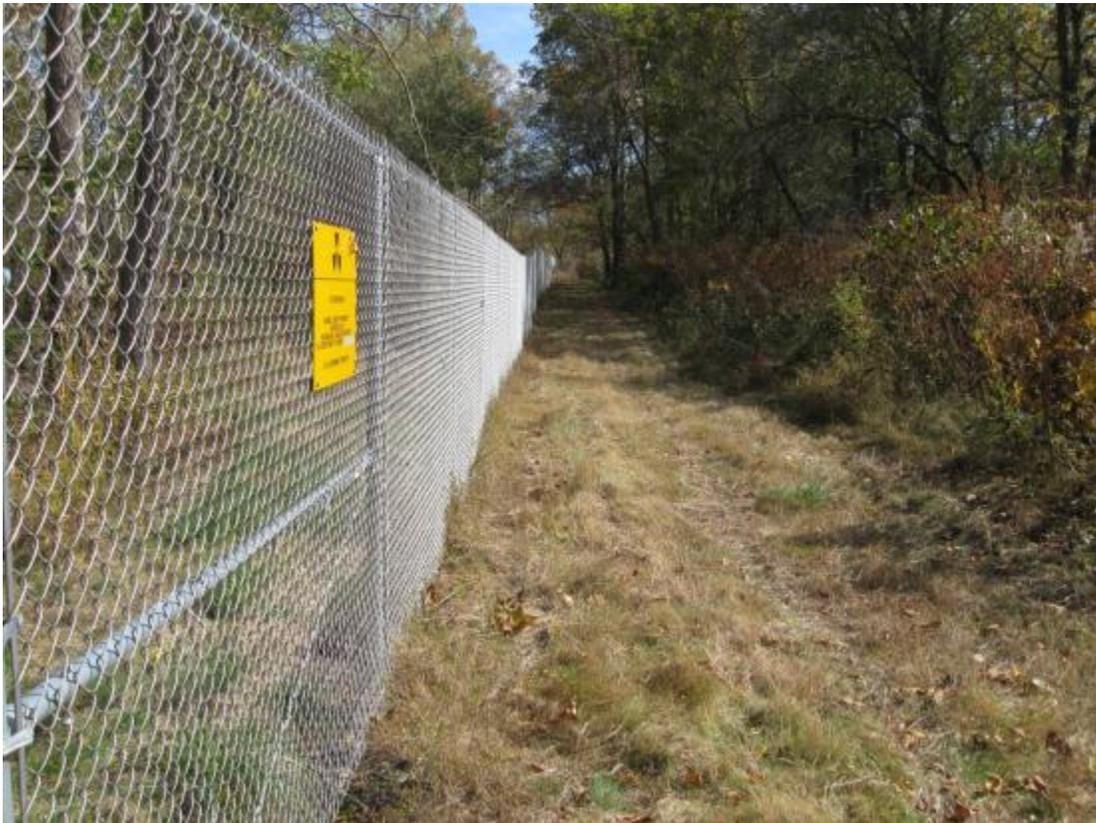
*BUR 10/2012. PL-2. Southwest fence line.*

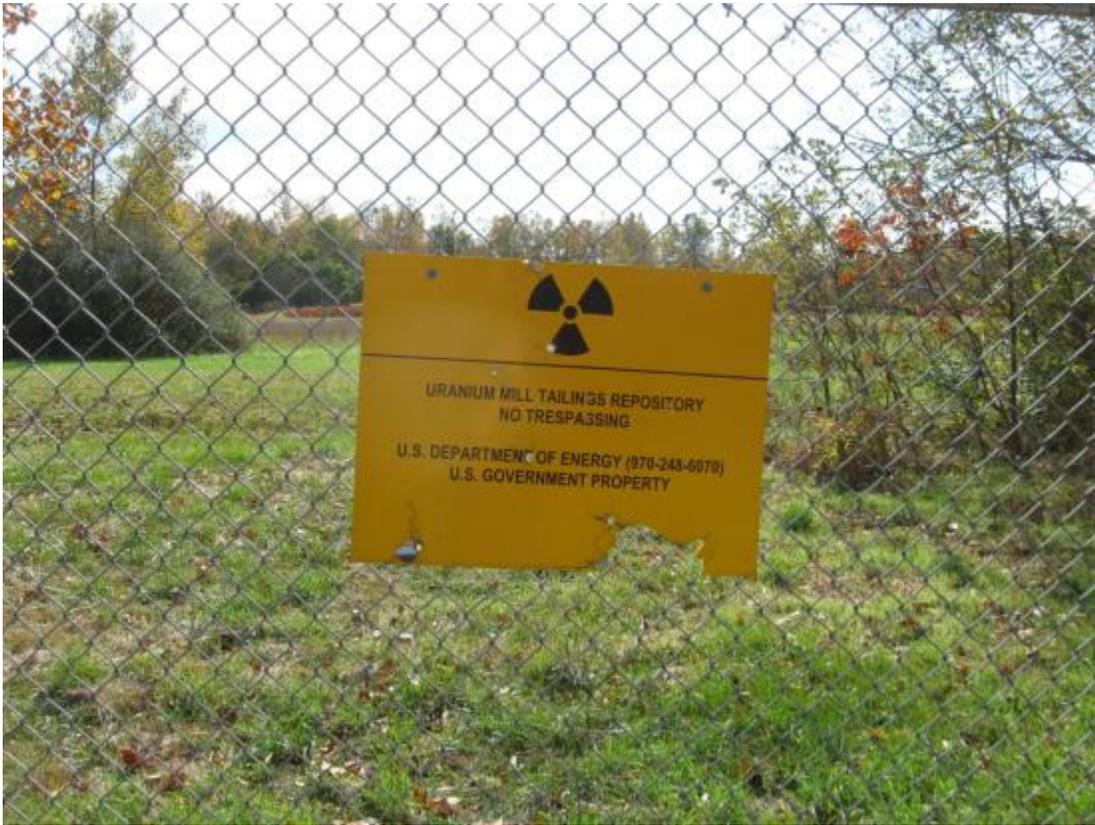
*BUR 10/2012. PL-3. Bullet holes in perimeter fence sign P4.*

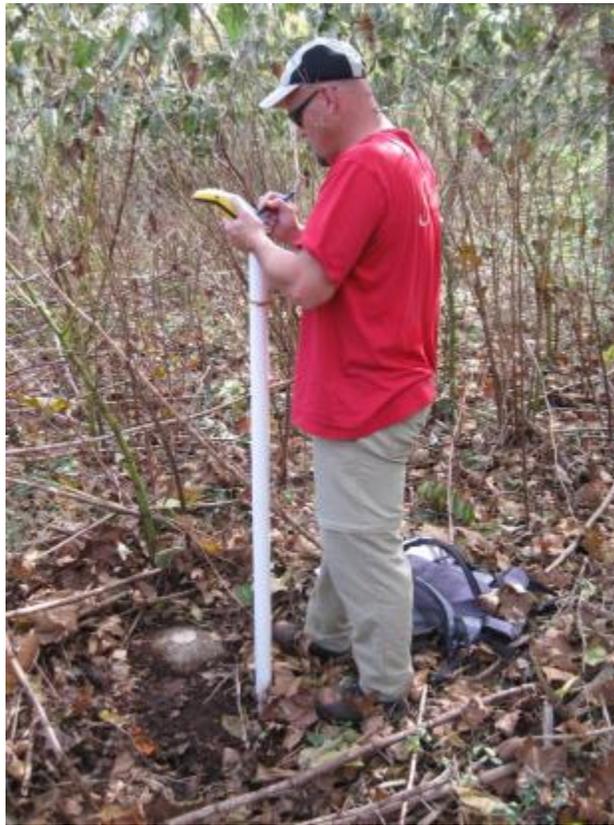
The site has 10 monuments (three survey monuments and seven boundary monuments). All three survey monuments (SM–100, SM–101, and SM–102) are located at points on the property that originally afforded a sweeping view of the site during construction. Several years ago, inspectors installed tall pieces of white PVC pipe near SM–100 and SM–101 to make them easier to locate (PL–5).

*BUR 10/2012. PL-5. Survey monument SM-101.*

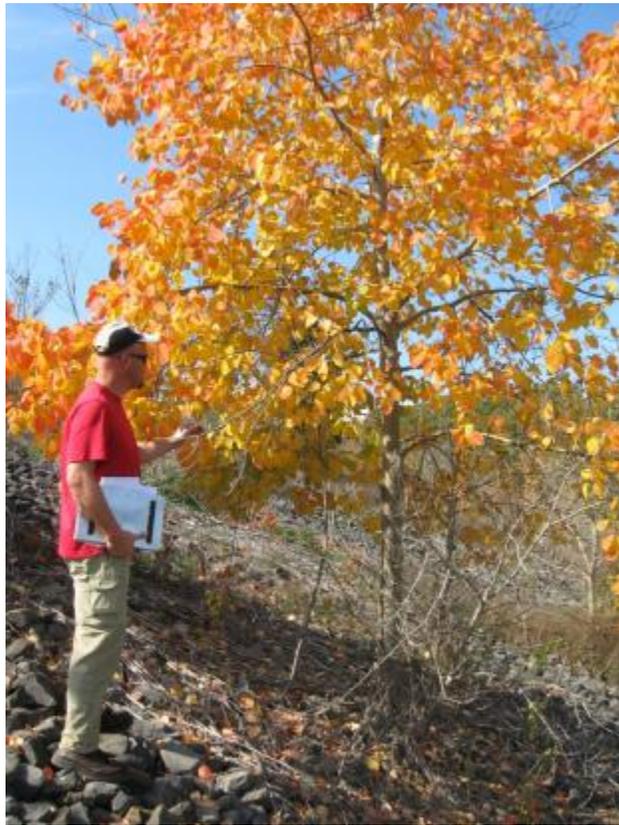
*BUR 10/2012. PL-7. Examining tree at base of disposal cell.*

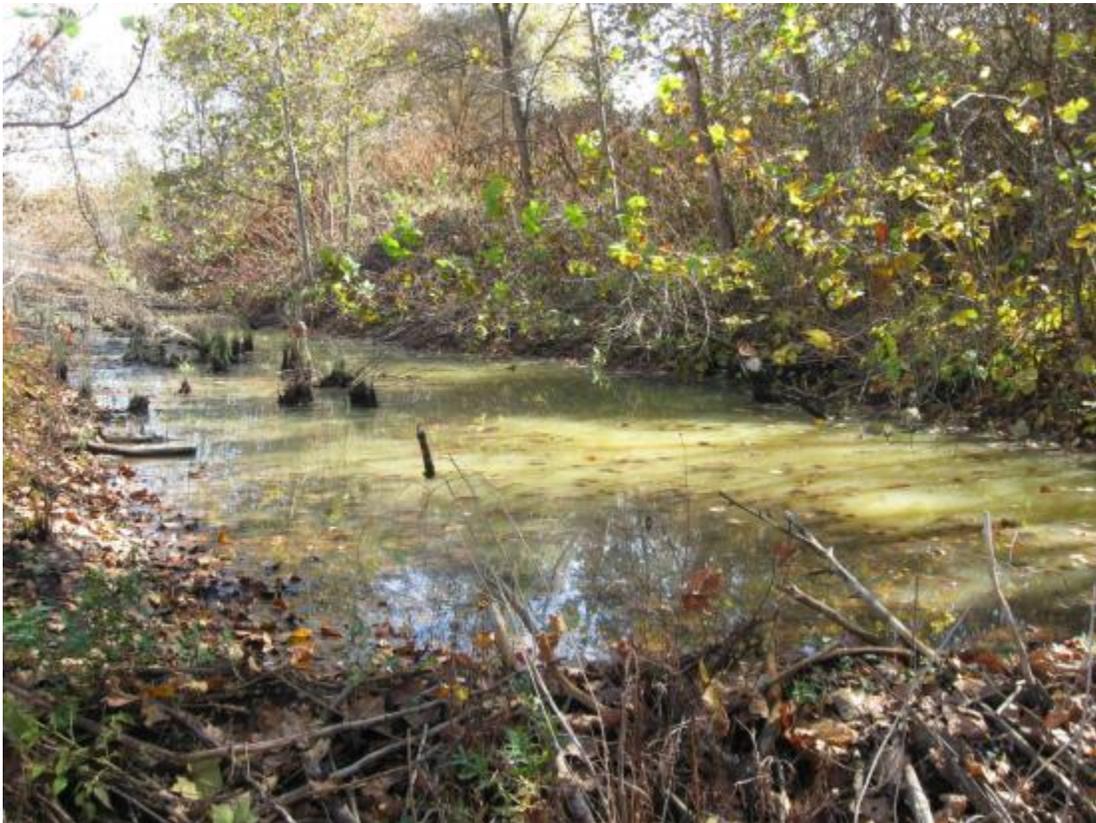
*BUR 10/2012. PL-8. Small inactive beaver dam.*

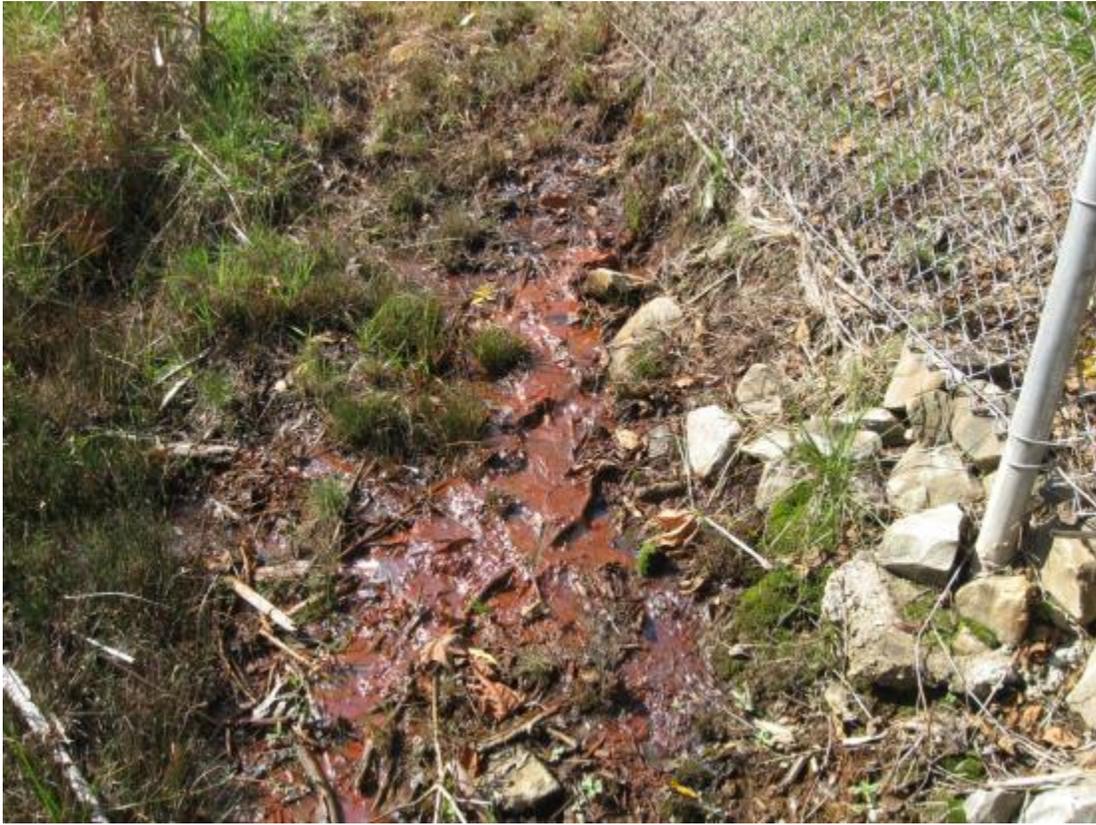
*BUR 10/2012. PL-9. Active seep; north fence.*

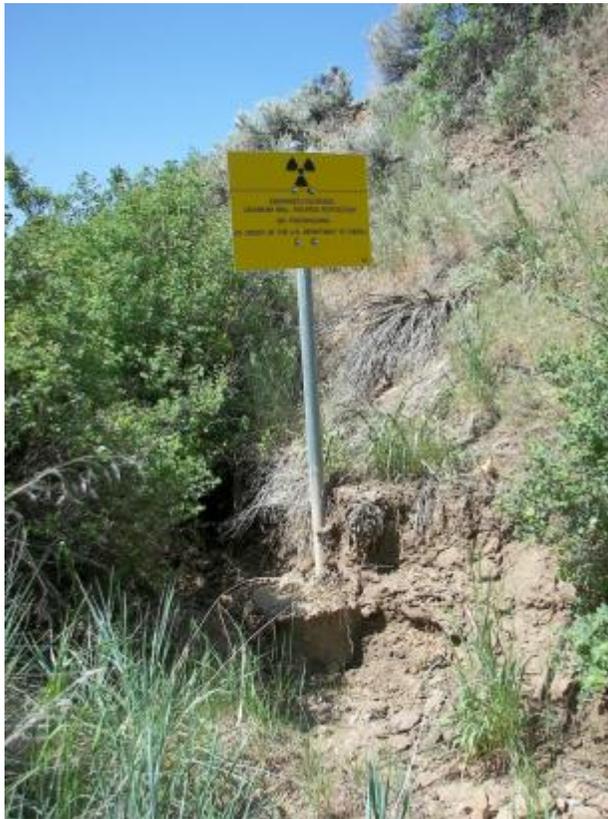
DUD 5/2011. PL- 1. Perimeter sign P45, showing undercut area.

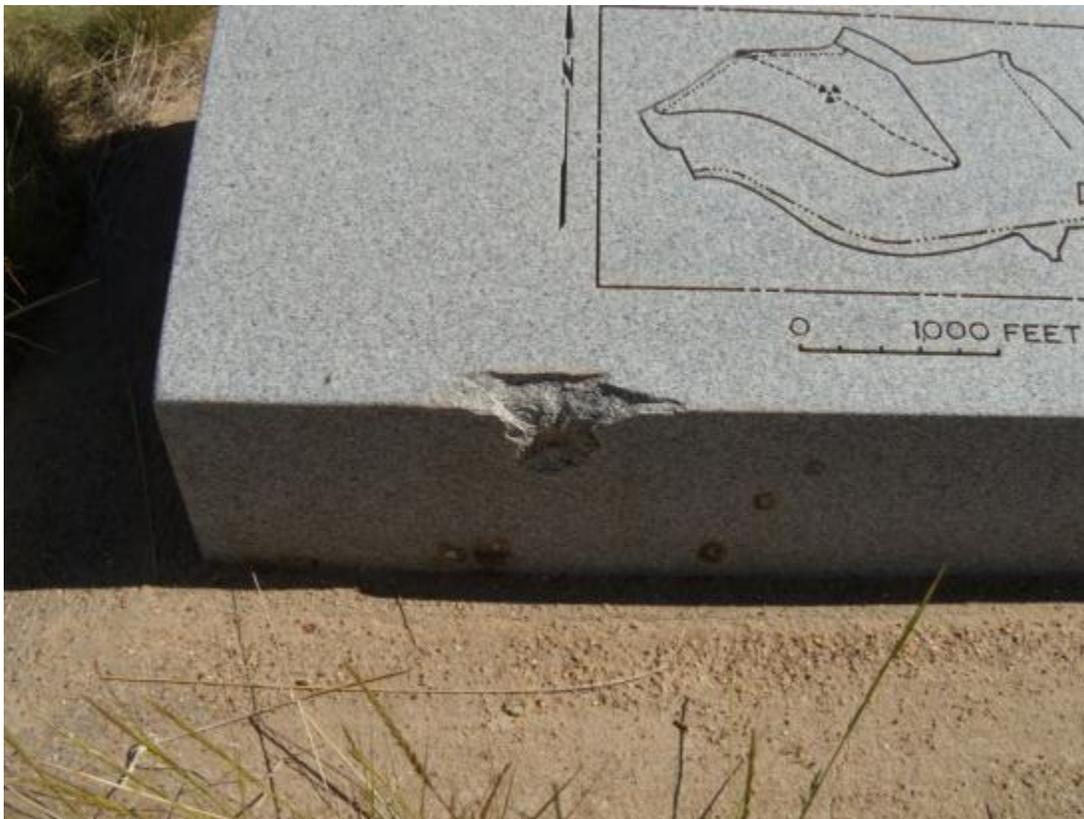
Site marker SMK–1 historically has been superficially pocked from gunfire but has remained legible. Inspectors discovered that an additional chip along the bottom edge of the marker had fallen off (PL–2); however, the information on the face of the marker remains legible. The chipped area will be protected from further erosion with a protective epoxy-glue compound. SMK–2 remains in excellent condition.

DUD 5/2012. PL-2. Chipped portion of site marker SMK-1.

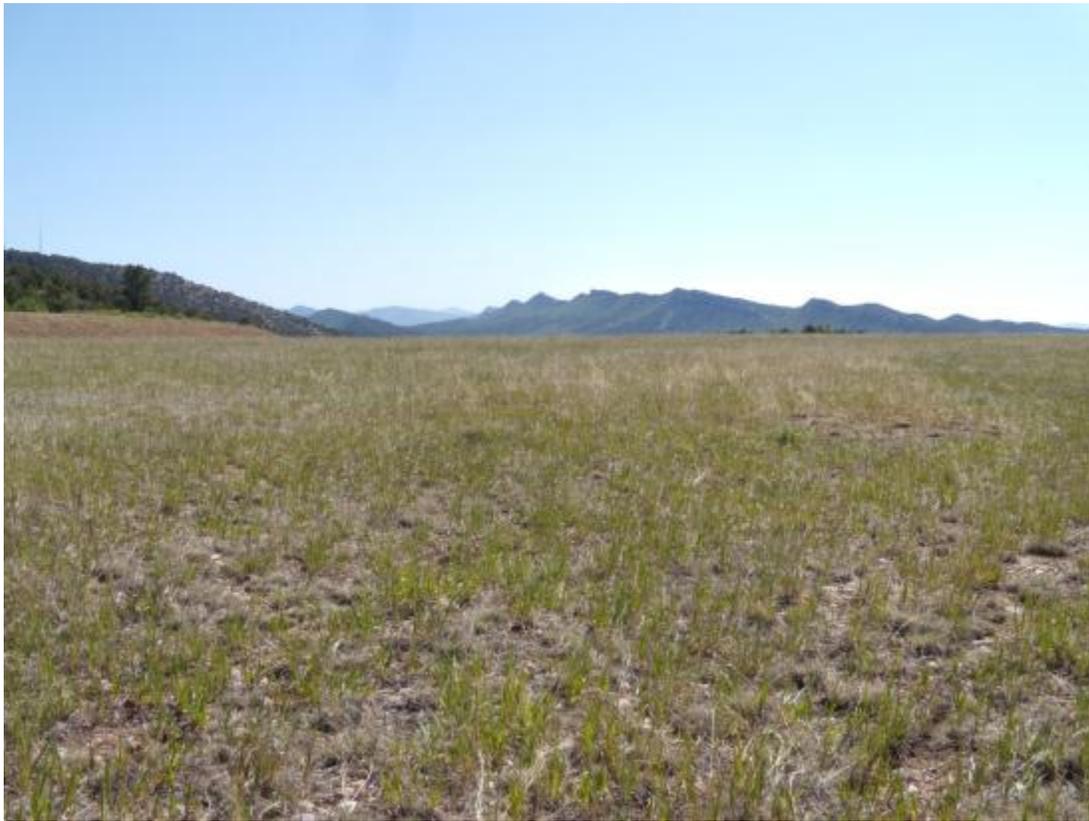
DUD 5/2012. PL-3. Vegetation on cell top, view west-southwest.

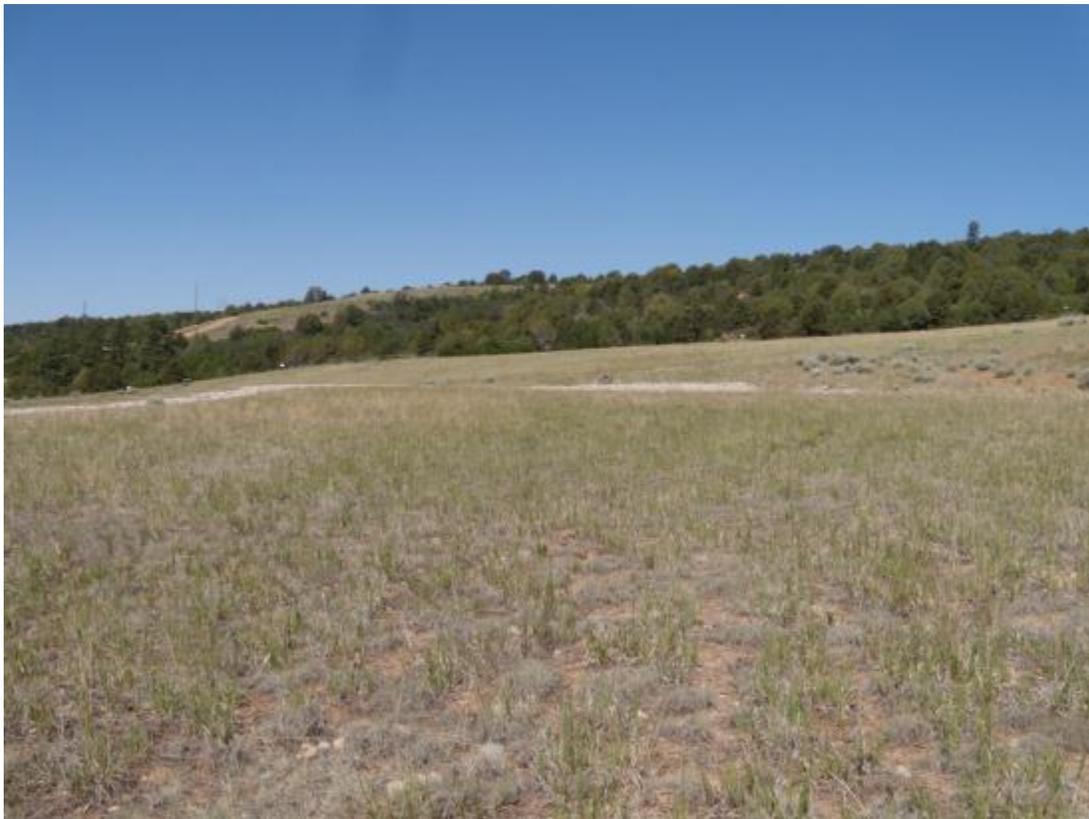
DUD 5/2012. PL-4. Vegetation on cell top, view east-northeast.

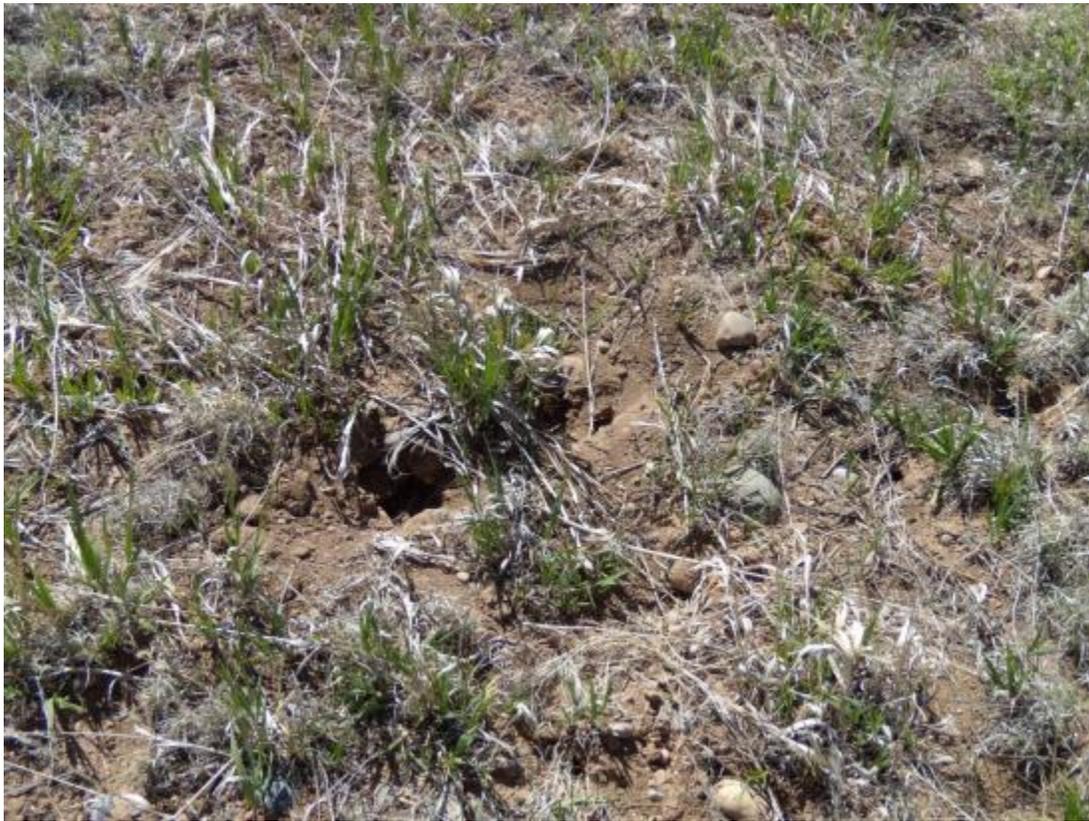
DUD 5/2012. PL-5. Revegetated area associated with removal of permeable reactive barrier treatment system.

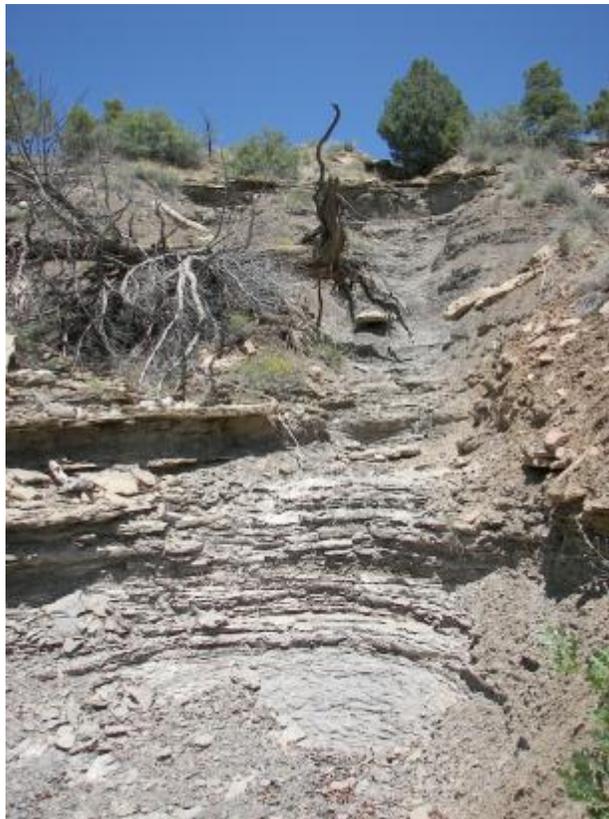
DUD 5/2012. PL-6. Below the southeast outflow channel.

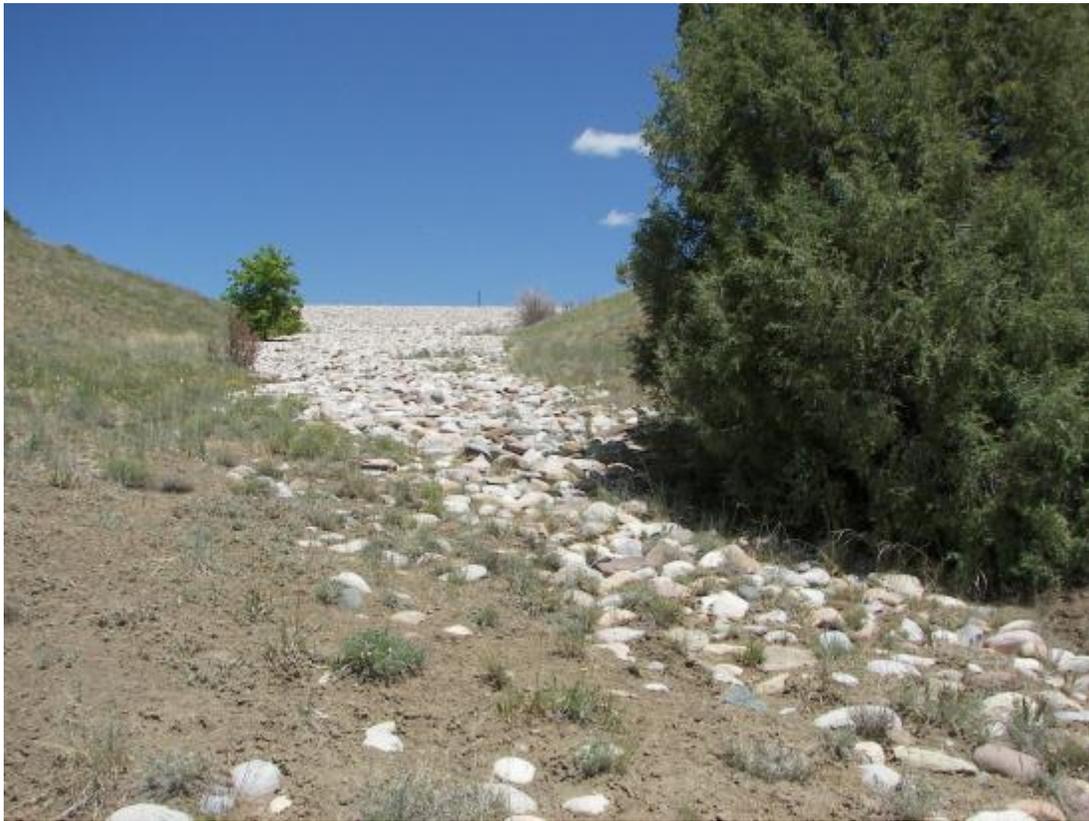
DUD 5/2012. PL-7. South outflow channel.

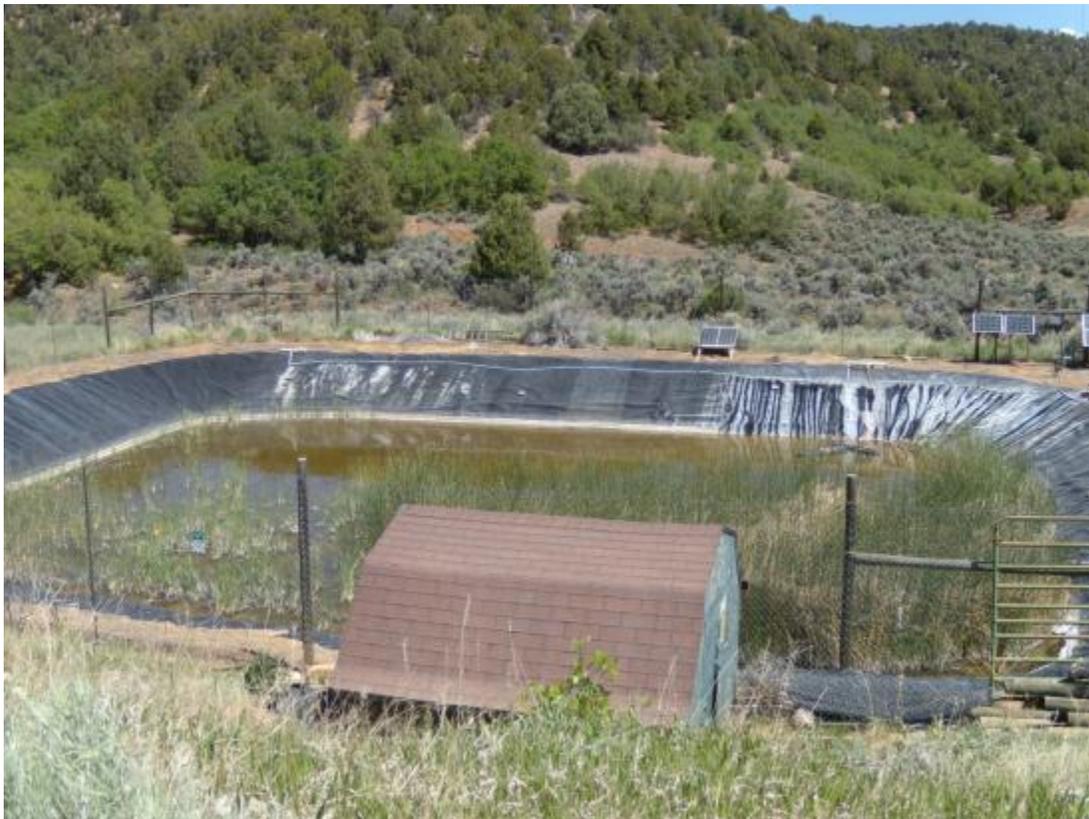
DUD 5/2012. PL-8. Evaporation pond.

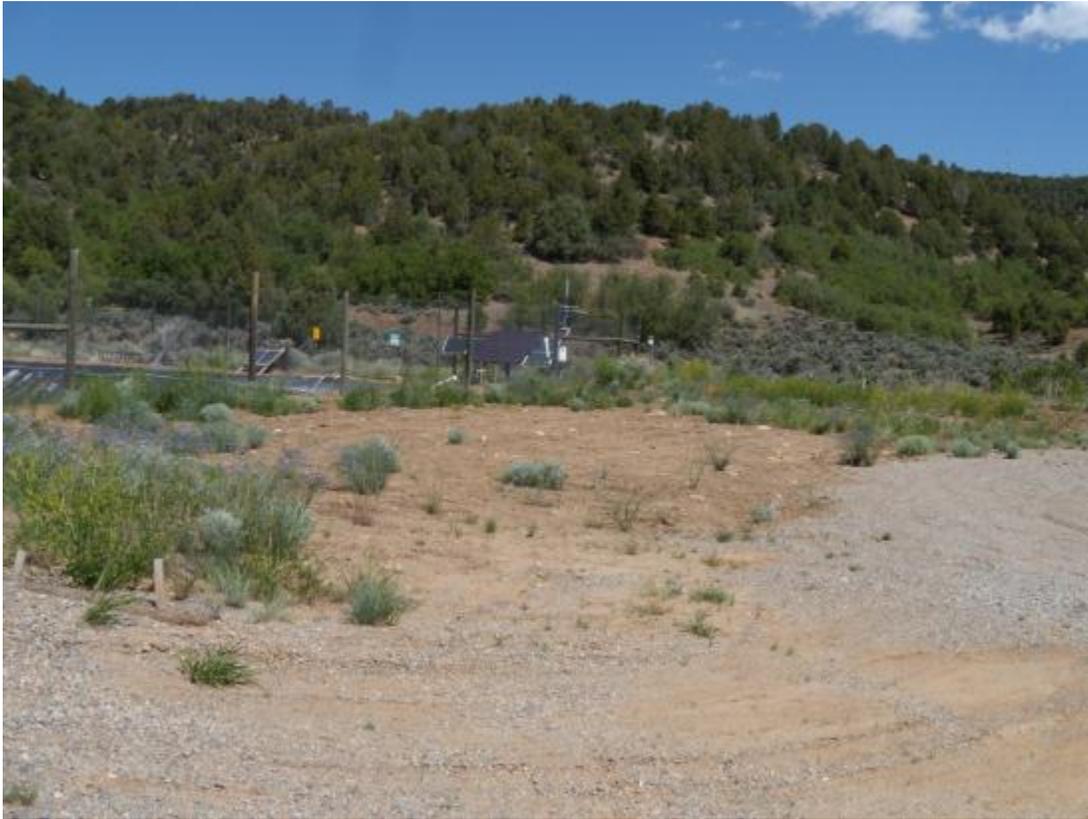
DUD 5/2012. PL-9. Revegetated area associated with removal of permeable reactive barrier treatment system.

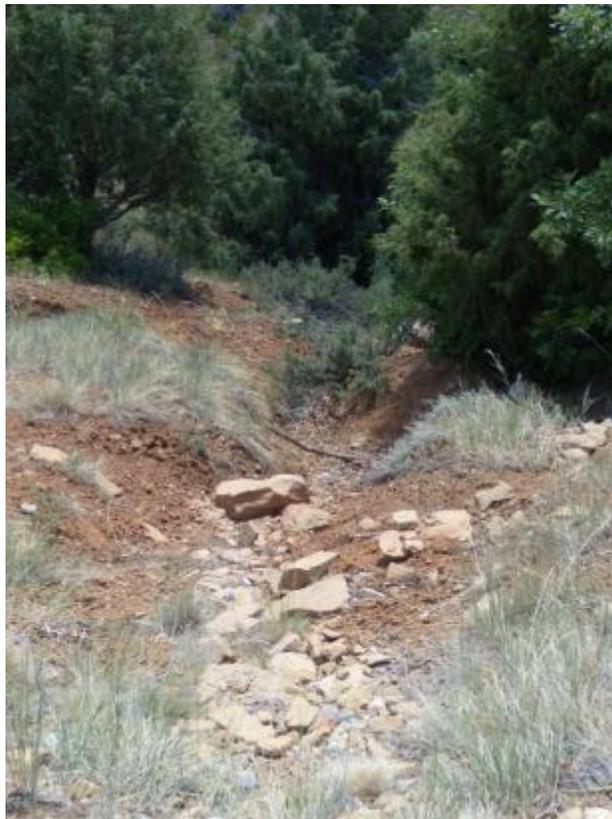
DUD 5/2012. PL-10. West gully (southwest of cell) stabilizing with rock.

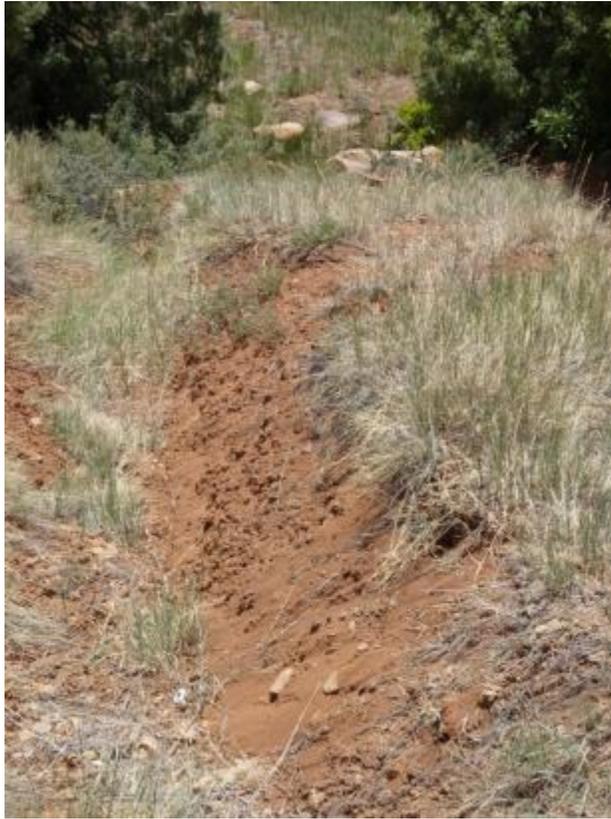
DUD 5/2012. PL-11. East gully (southwest of cell) stabilizing with vegetation.

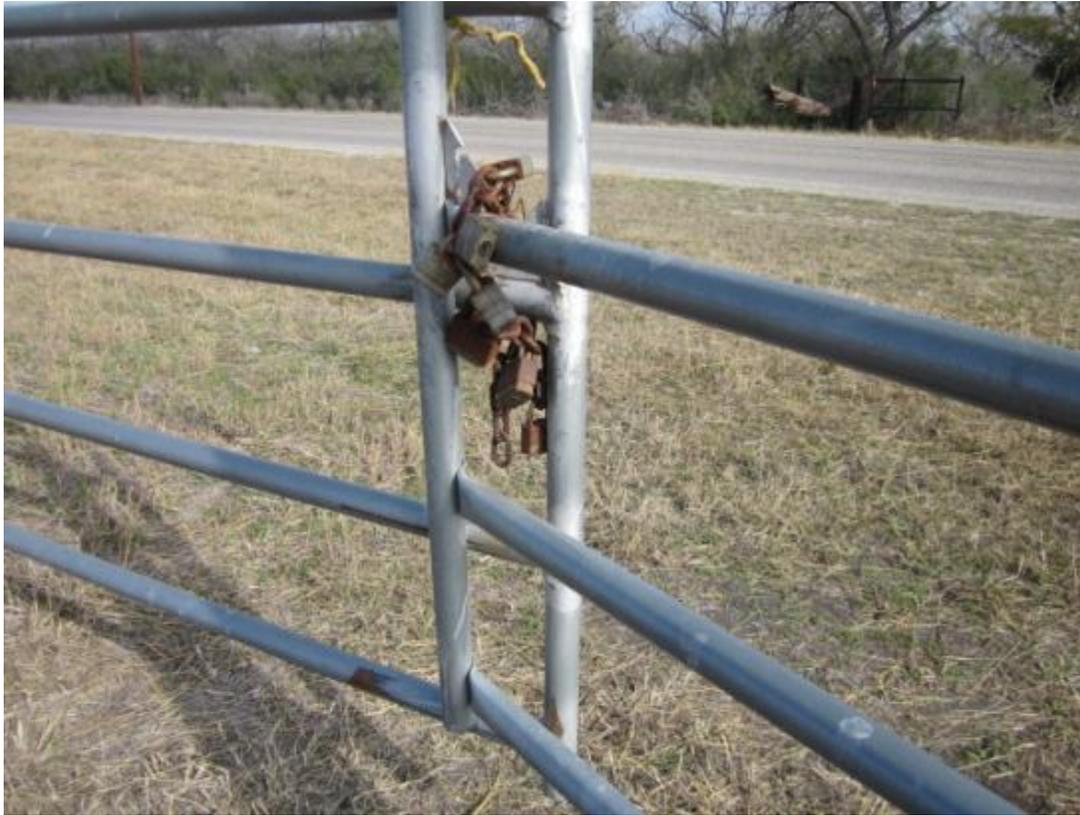
The main entrance gate (which was replaced in 2006) and the vehicle gate at the north corner of the site were found to be locked and functional (PL–1). The entrance sign located next to the main entrance gate was in good condition.

FCT 1/2012. PL-1. Entrance gate locked.

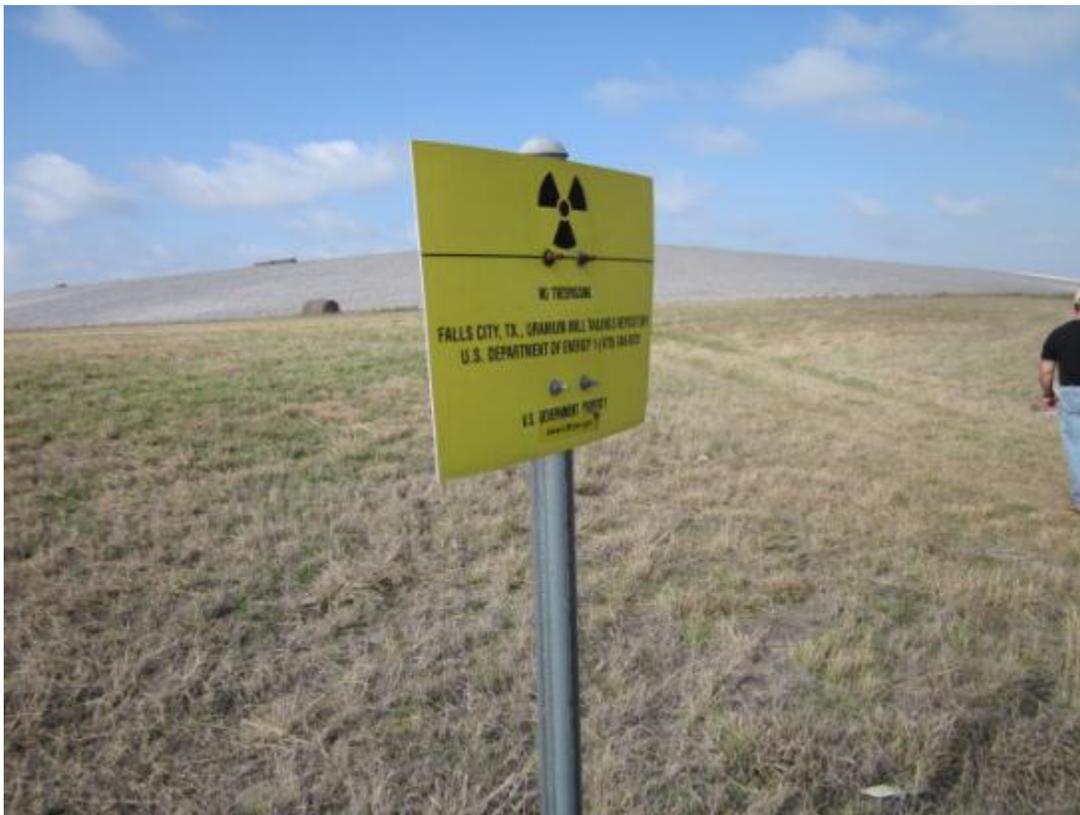
There are 64 perimeter signs at the site (PL–2). The back of the signs are labeled with the appropriate sign numbers, as designated on the site drawings. All of the perimeter signs were in serviceable condition. All of the signs remain serviceable and do not require corrective action at this time; however, a few minor maintenance items noted during the inspection last year remain. Specifically:

- Perimeter sign P20 was bent, and the post is loose.
- Perimeter signs P56 and P61 contain bullet holes.
- Perimeter signs P1, P2, P3, P4, P63, and P64 are plastic and fading.

FCT 1/2012. PL-2. Perimeter sign with DOE website posted.

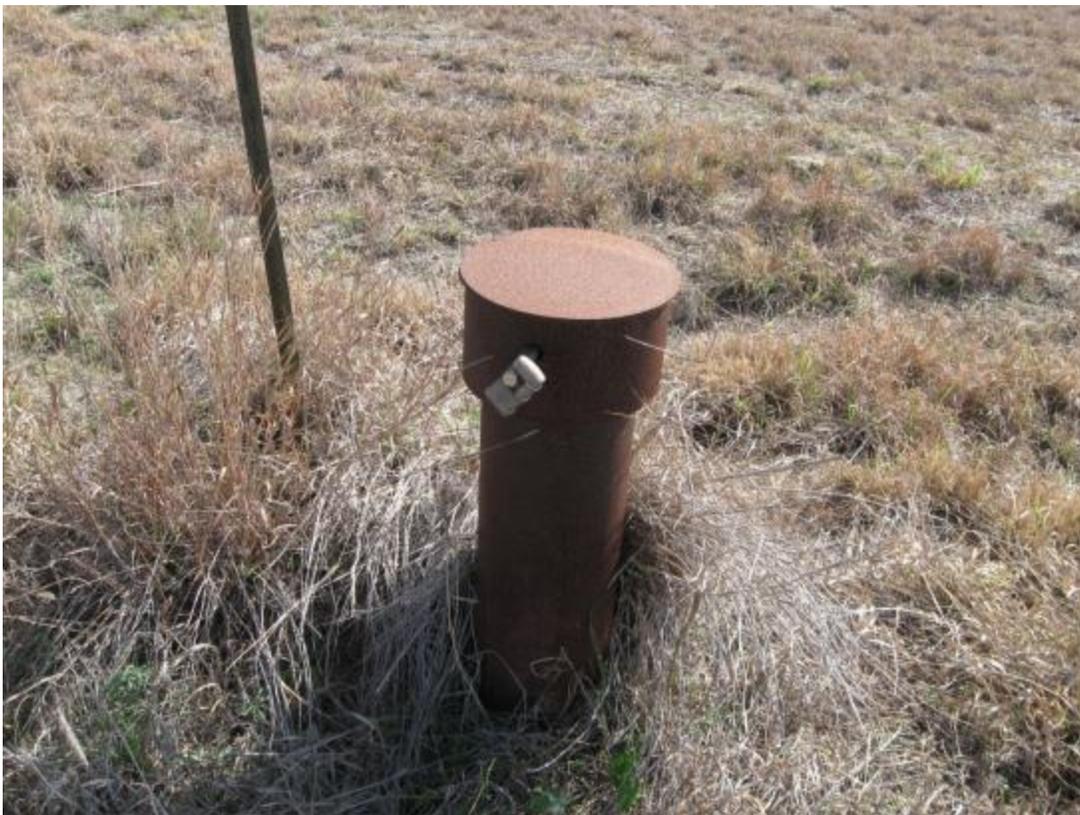
Monitoring wells in the groundwater monitoring network were inspected when they were sampled in April 2011. At that time, all sampled wells were secure and in excellent condition. All monitoring wells observed during the inspection were checked to make sure that they were locked (PL-4).

FCT 1/2012. PL-4. Monitoring well 0709.

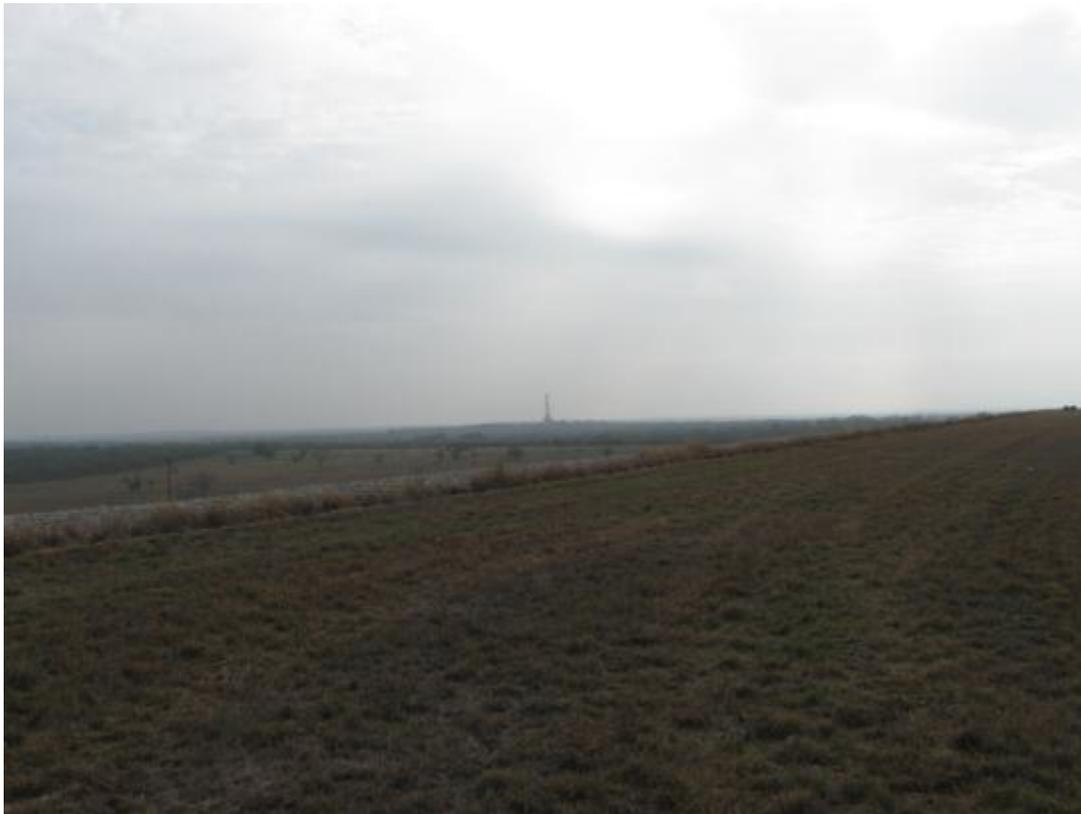
Grass on the top slope of the disposal cell was cut short (PL-5). Vegetation was dense, and no sparse or barren areas were noted. No areas of ponded water were observed on top of the disposal cell. No areas of settlement were observed.

FCT 1/2012. PL-5. View east from north corner of cell.
