U.S. DEPARTMENT OF  
**ENERGY**

Legacy  
Management

# 2012 Annual Site Inspection and Monitoring Report for Uranium Mill Tailings Radiation Control Act Title I Disposal Sites

February 2013

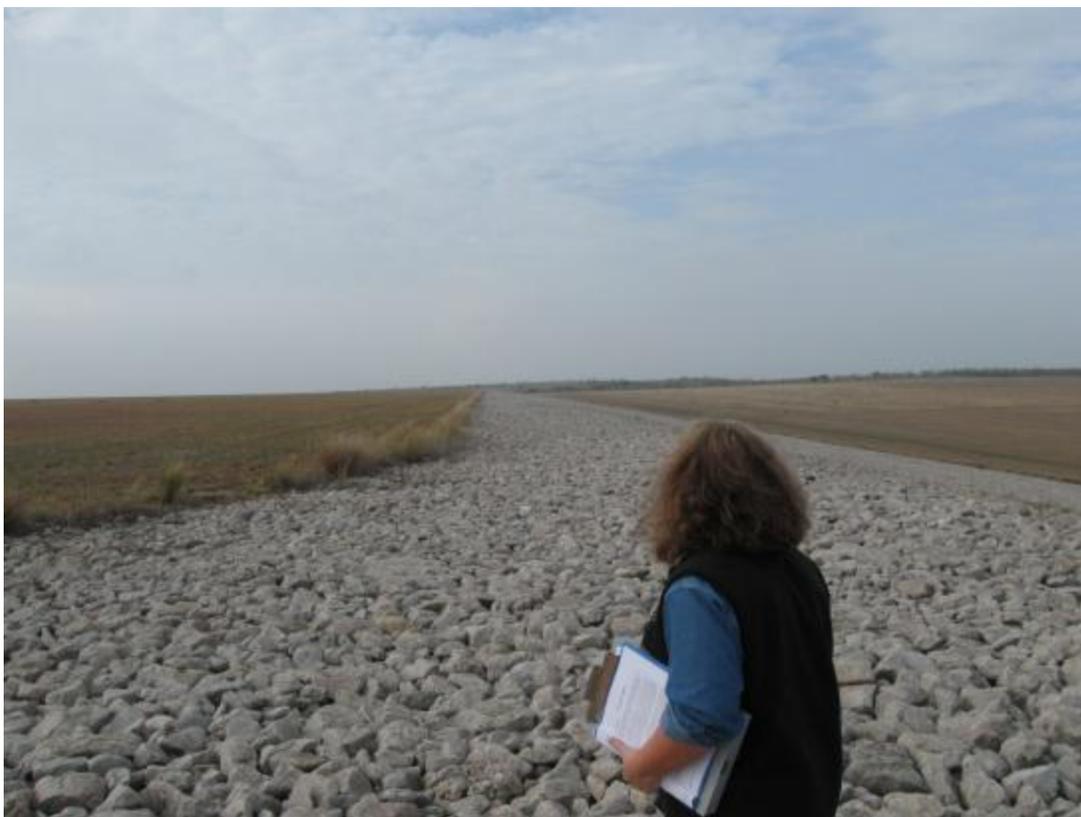
FCT 1/2012. PL-6. Top of northwest side slope.

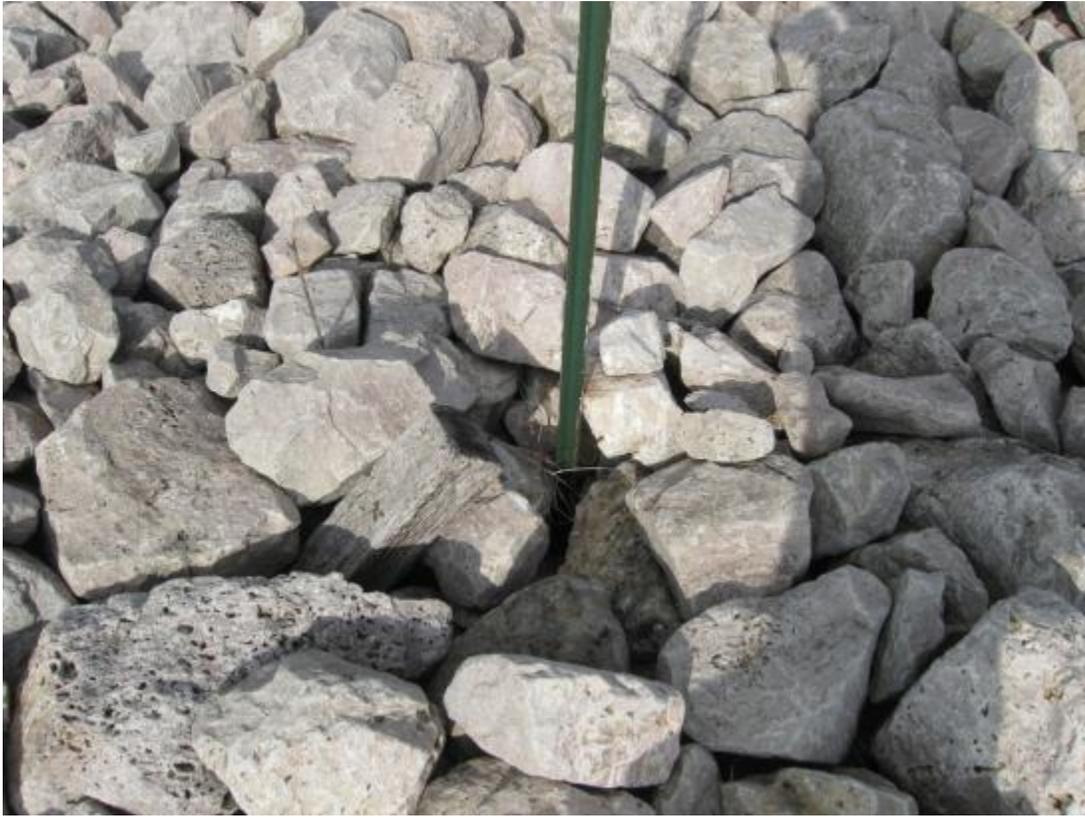
FCT 1/2012. PL-7. Riprap near access ramp and post 4.

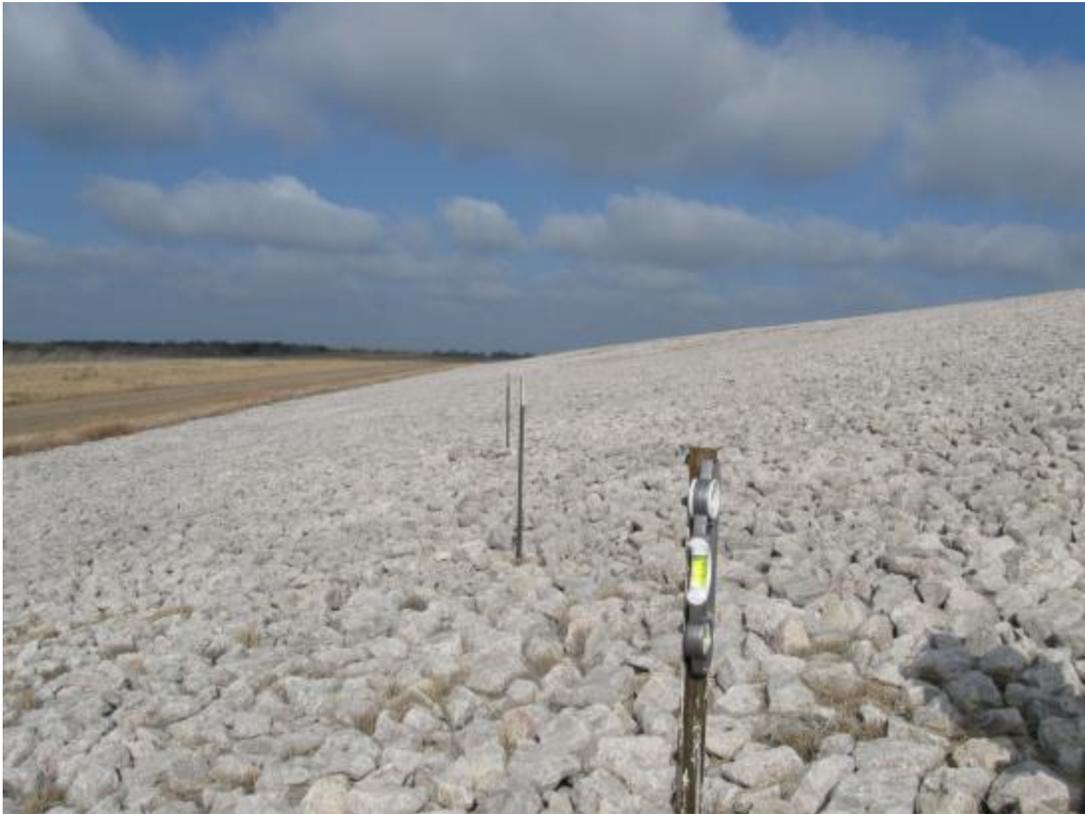
FCT 1/2012. PL-8. Line of t-posts, south corner of cell.

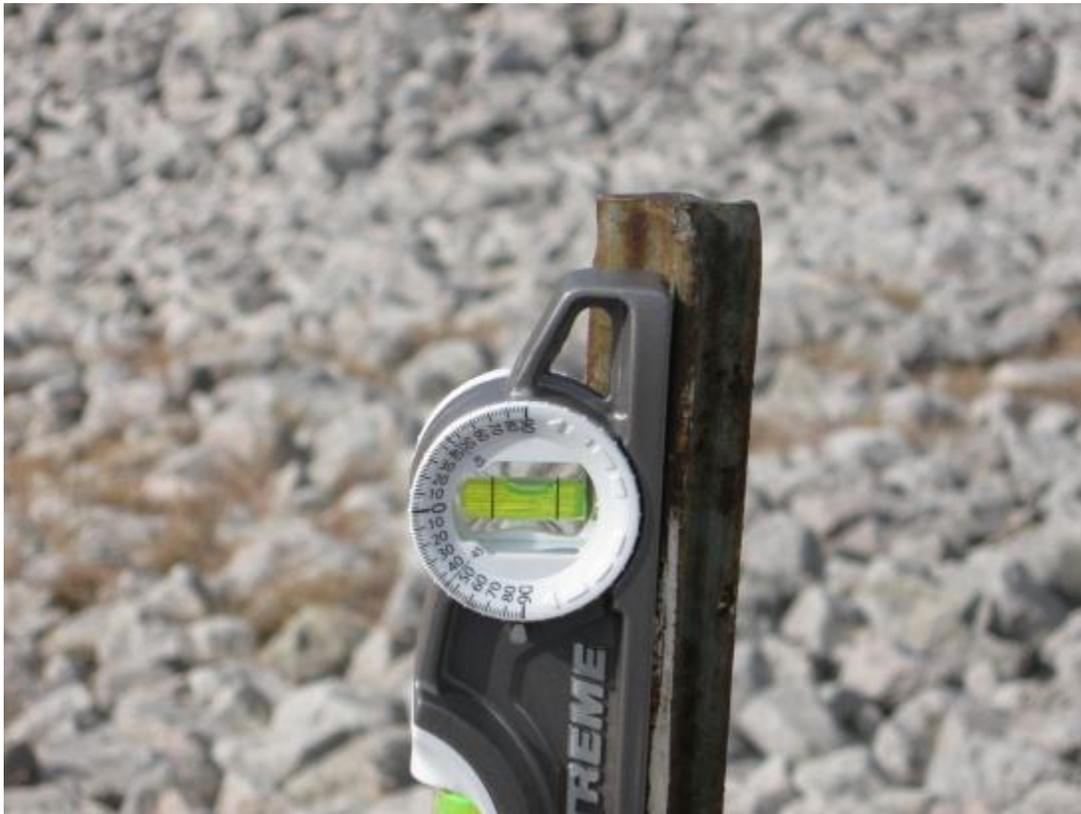
FCT 1/2012. PL-9. Pitch of post 1.

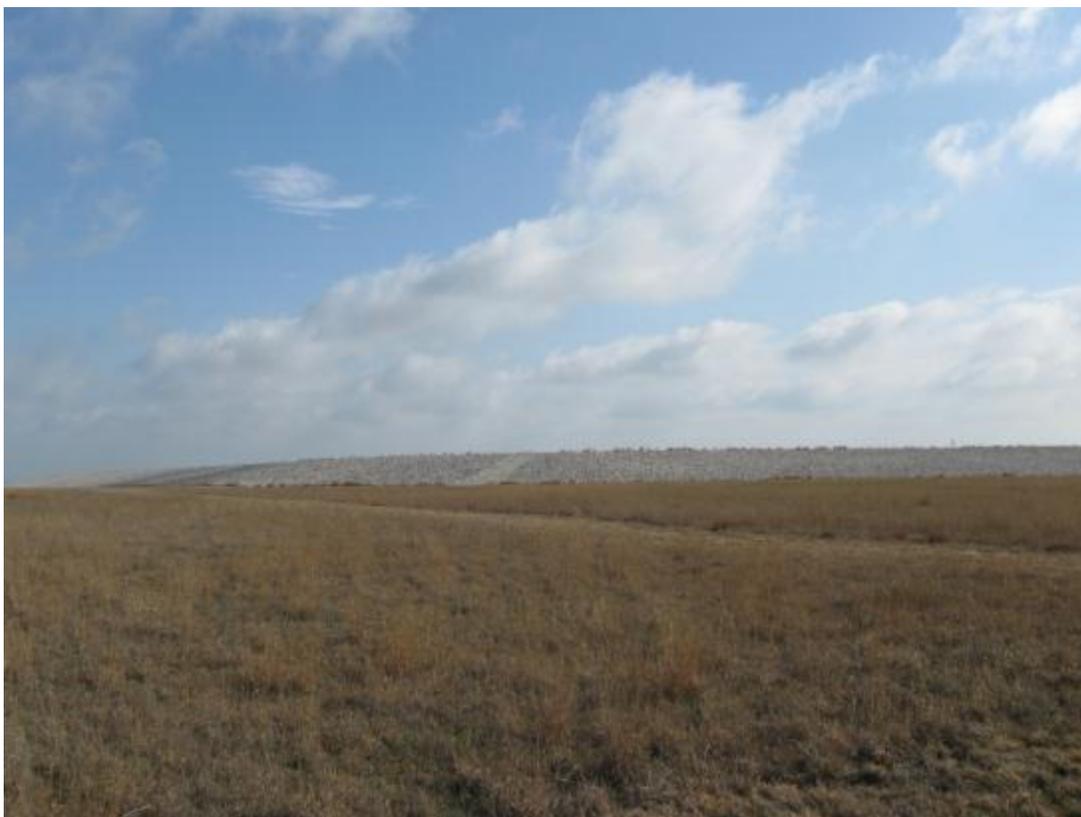
FCT 1/2012. PL-10. Access ramp, west corner of cell.

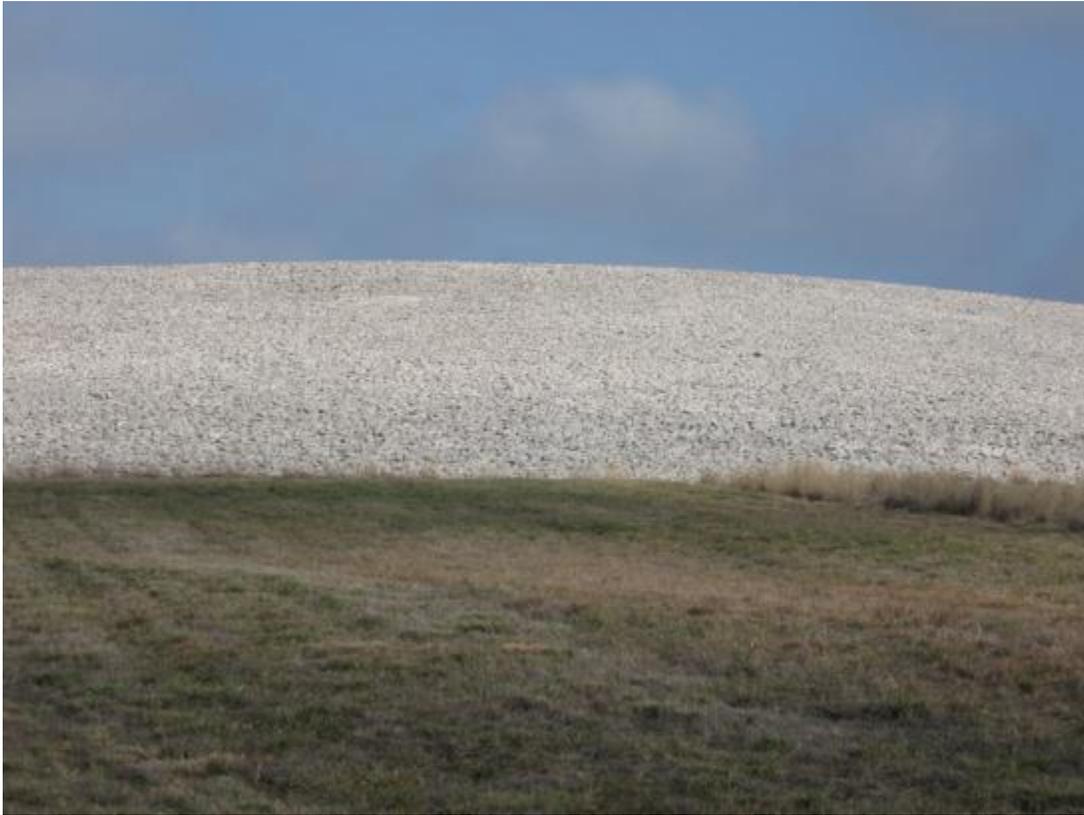
FCT 1/2012. PL-11. Southwest side slope.

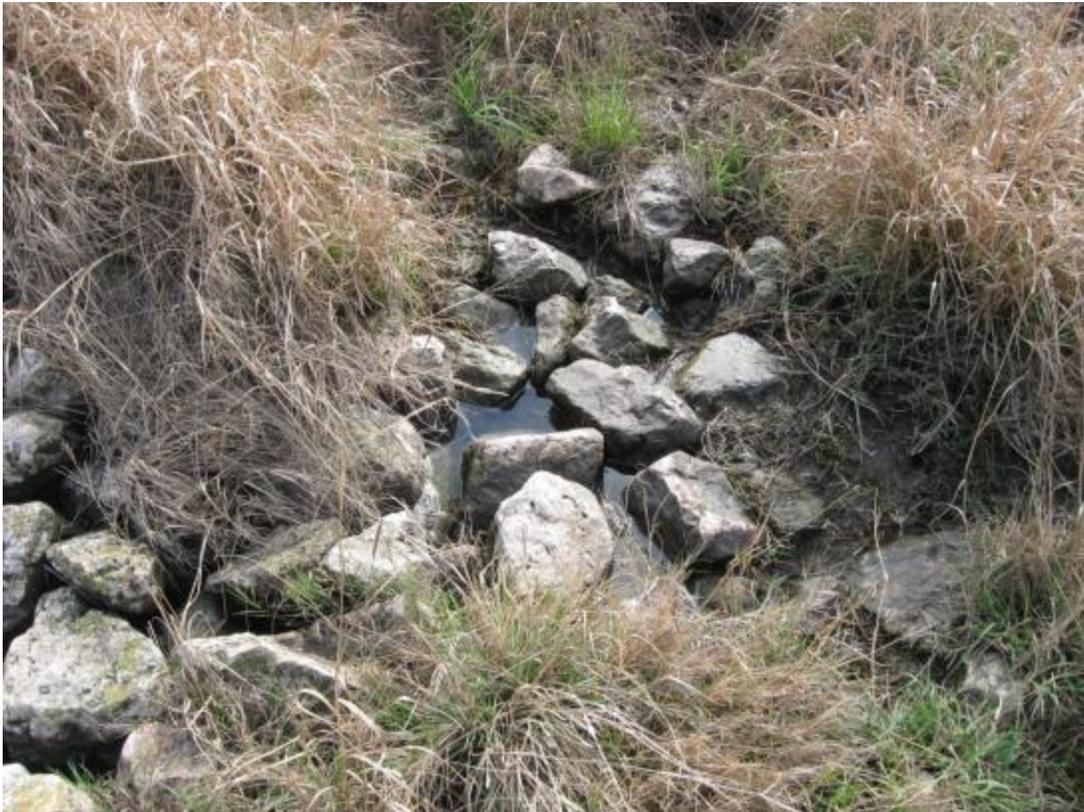
FCT 1/2012. PL-12. Pooled water, south rock drain.

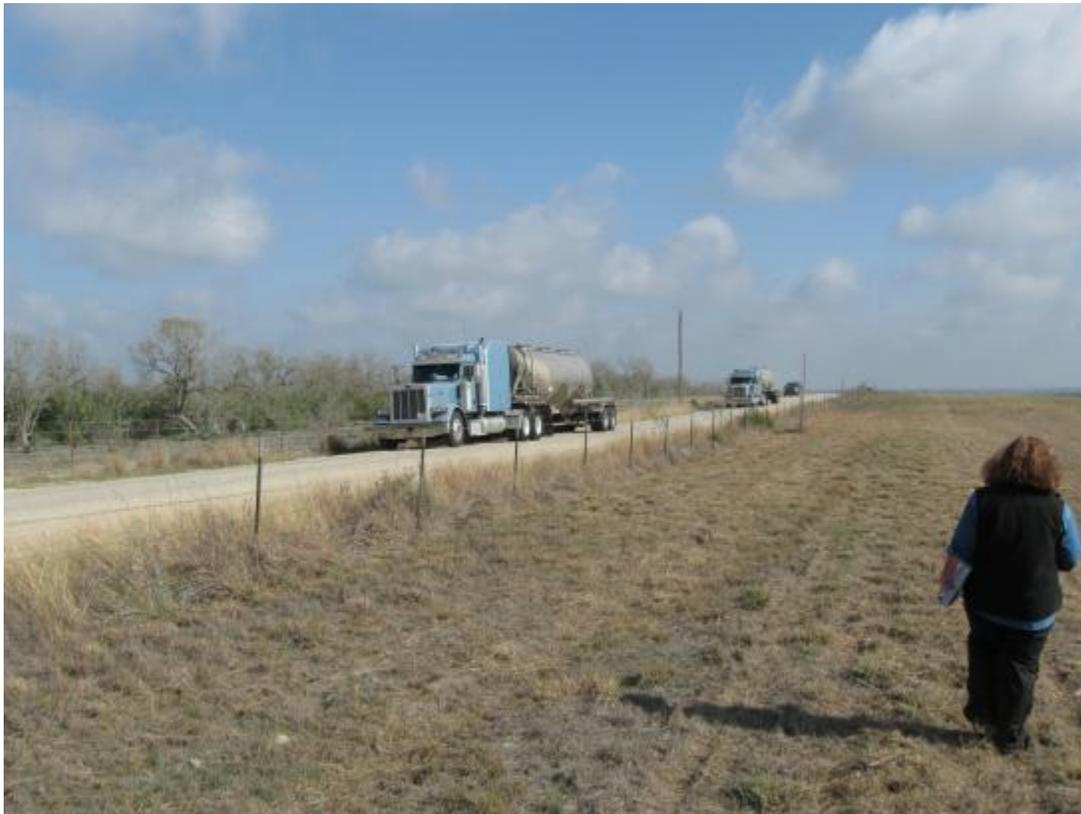
FCT 1/2012. PL-13. Traffic on County Road 202, northwest of site.

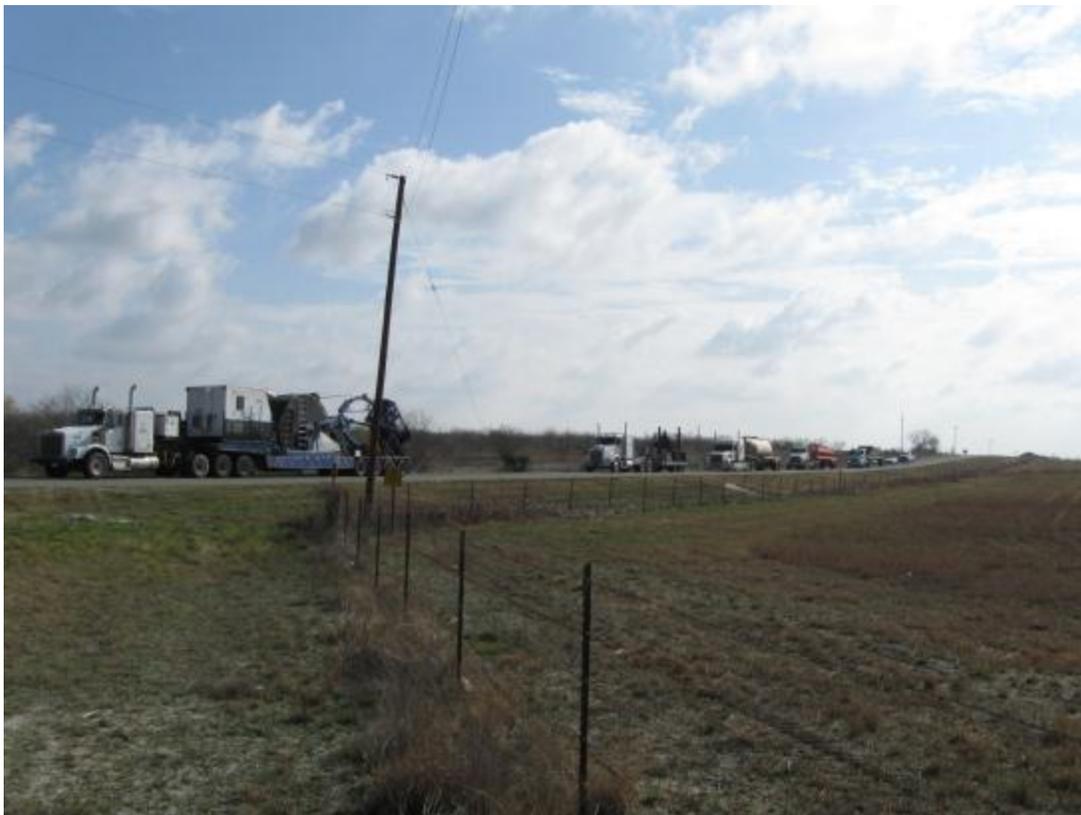
FCT 1/2012. PL-14. Heavy traffic on FM 1344, northeast of site.

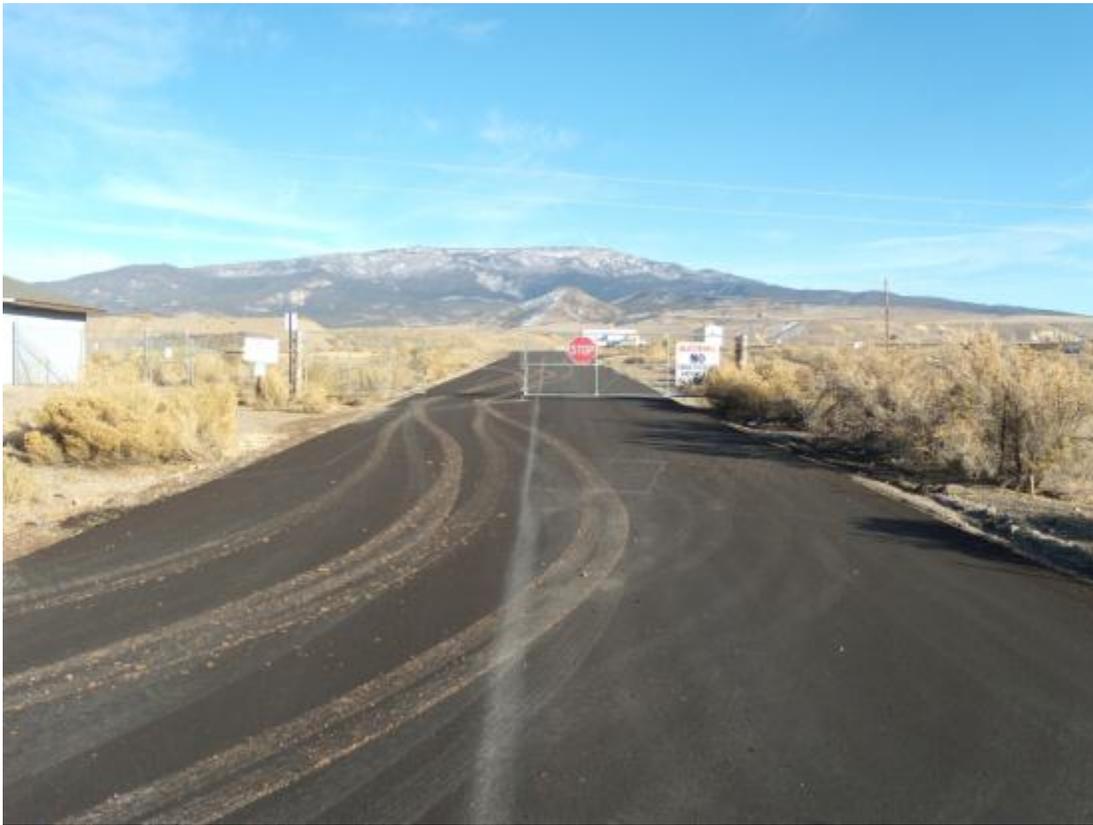
GRJ 11/2012. PL-1. Entrance gate and reconstructed access road.

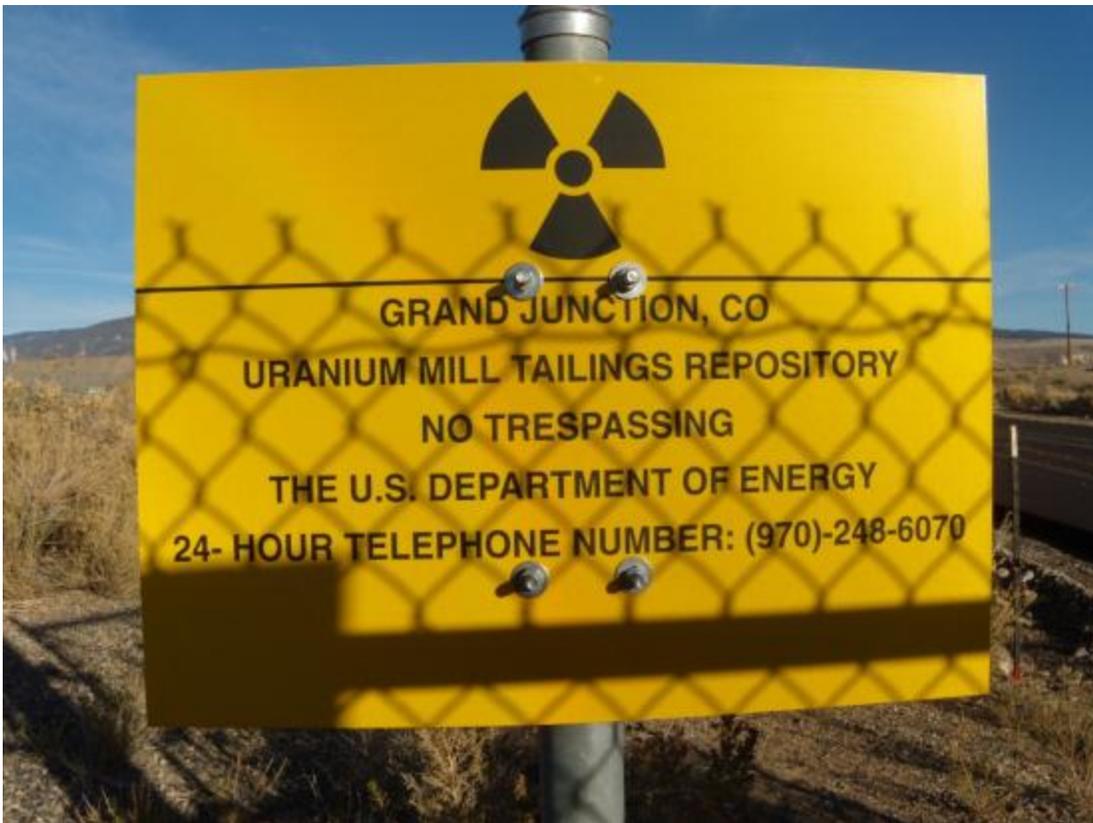
GRJ 11/2012. PL-2. Site entrance sign.

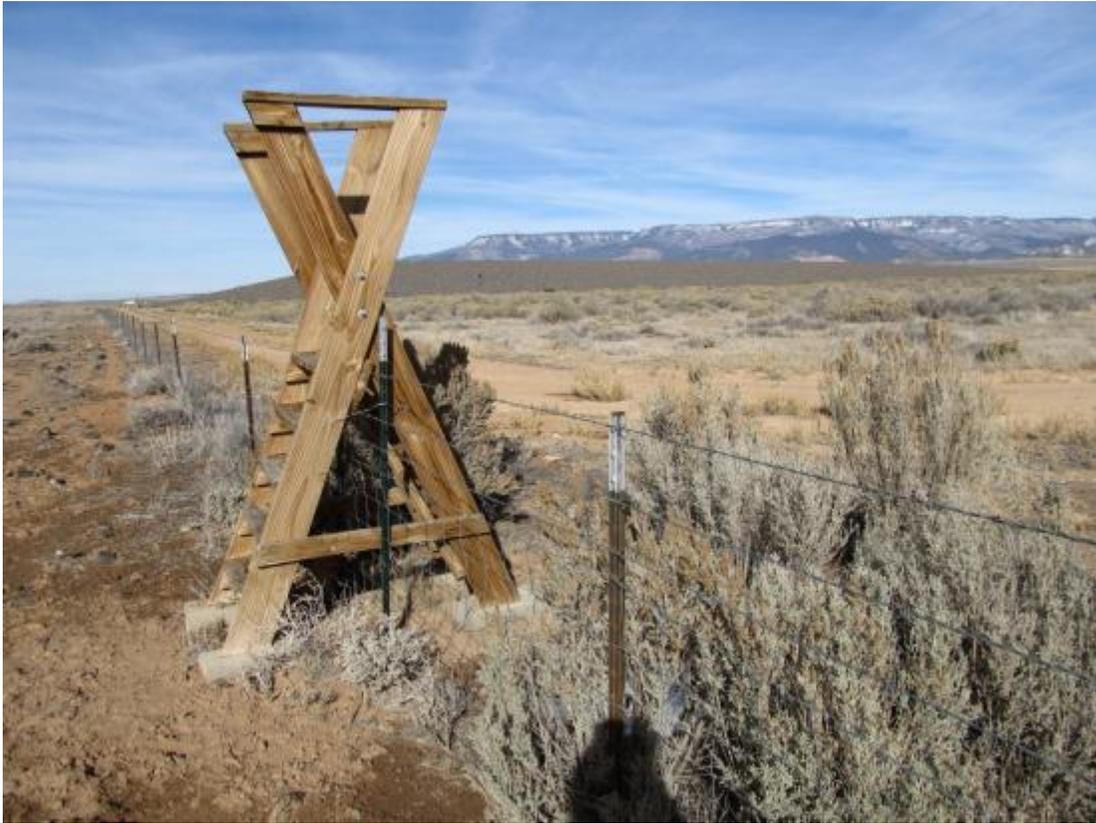
GRJ 11/2012. PL-3. Stile over the perimeter fence in the southwest corner of the site.

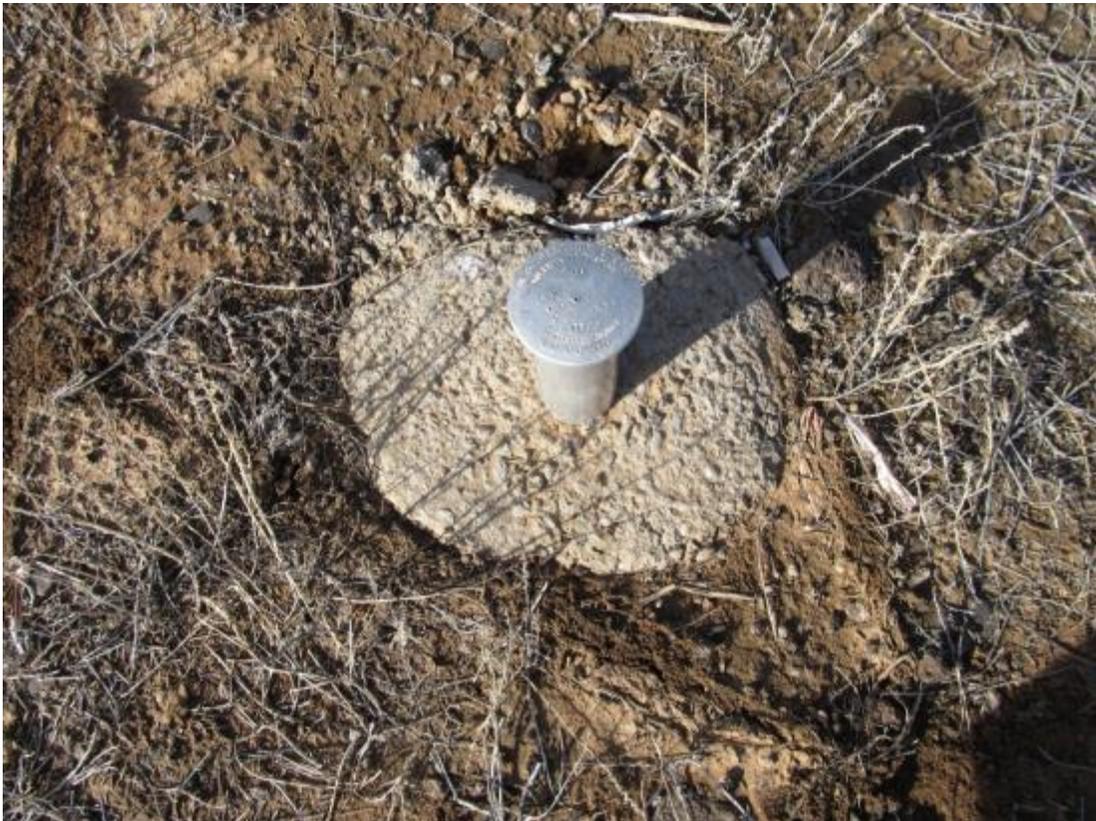
GRJ 11/2012. PL-4. Boundary monument BM-4 at the southwest corner of the site.

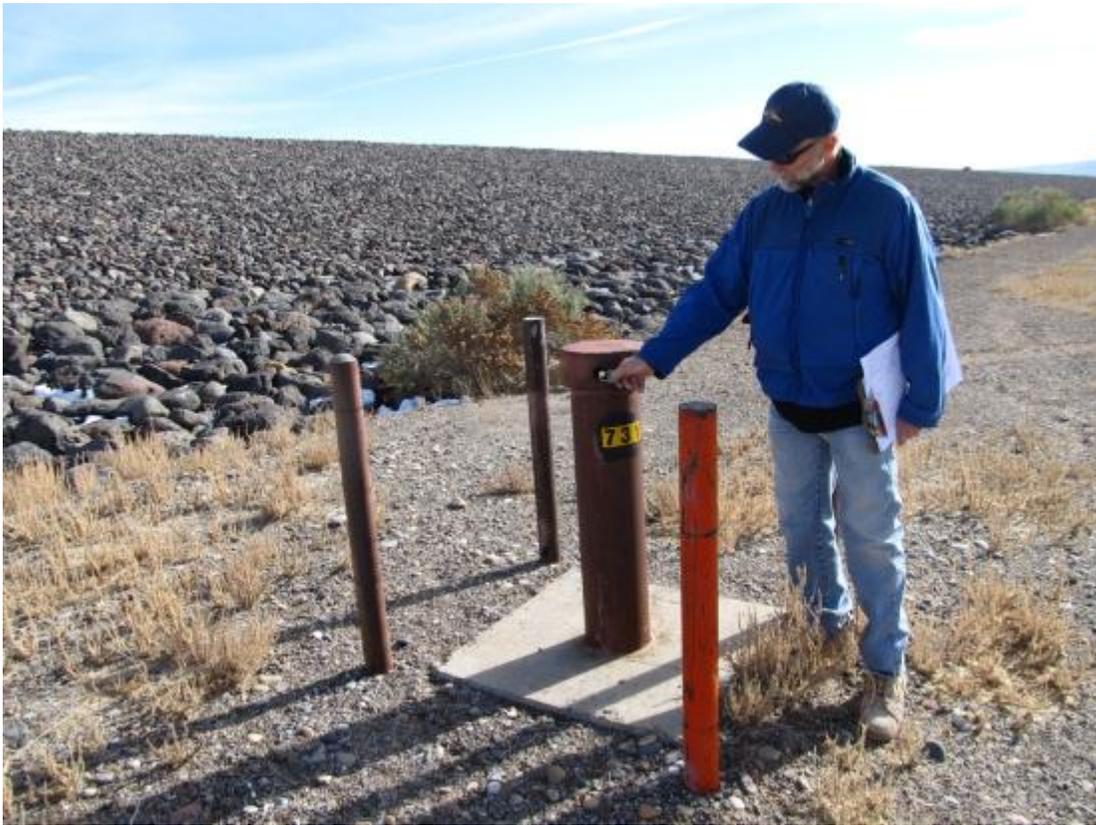
GRJ 11/2012. PL-5. Monitoring well 0731.

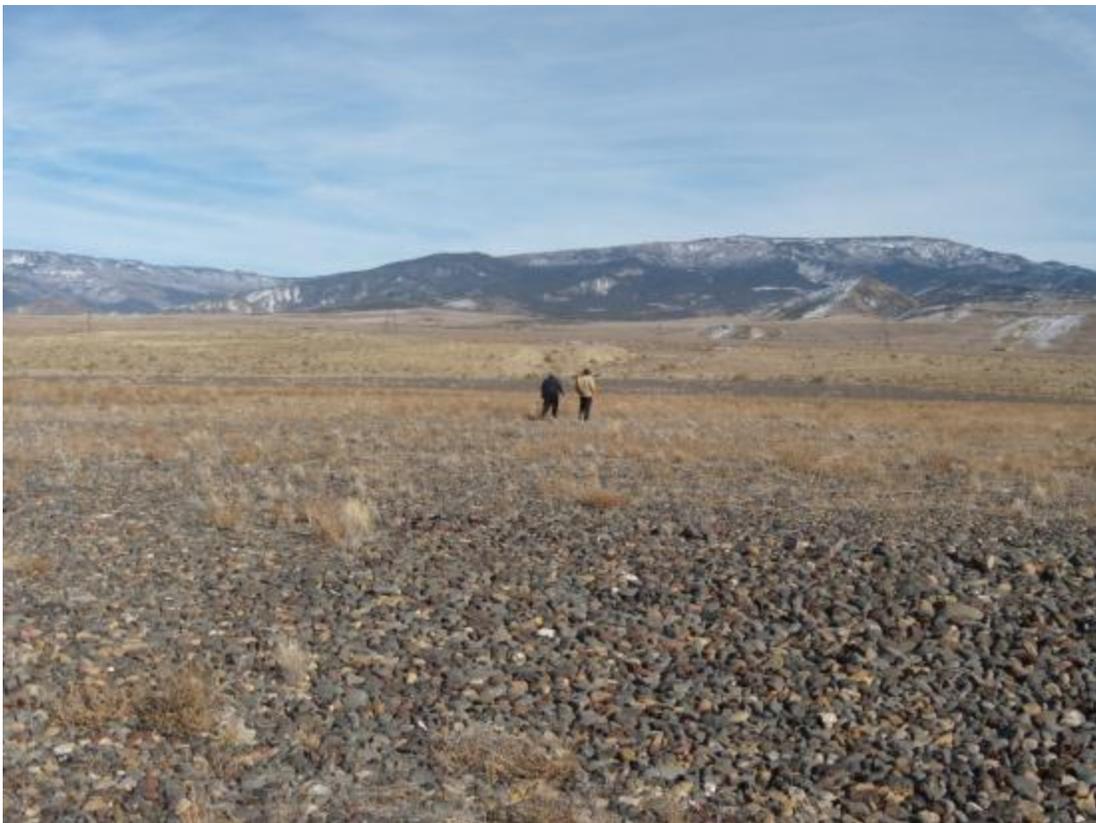
GRJ 11/2012. PL-6. East portion of the disposal cell top slope.

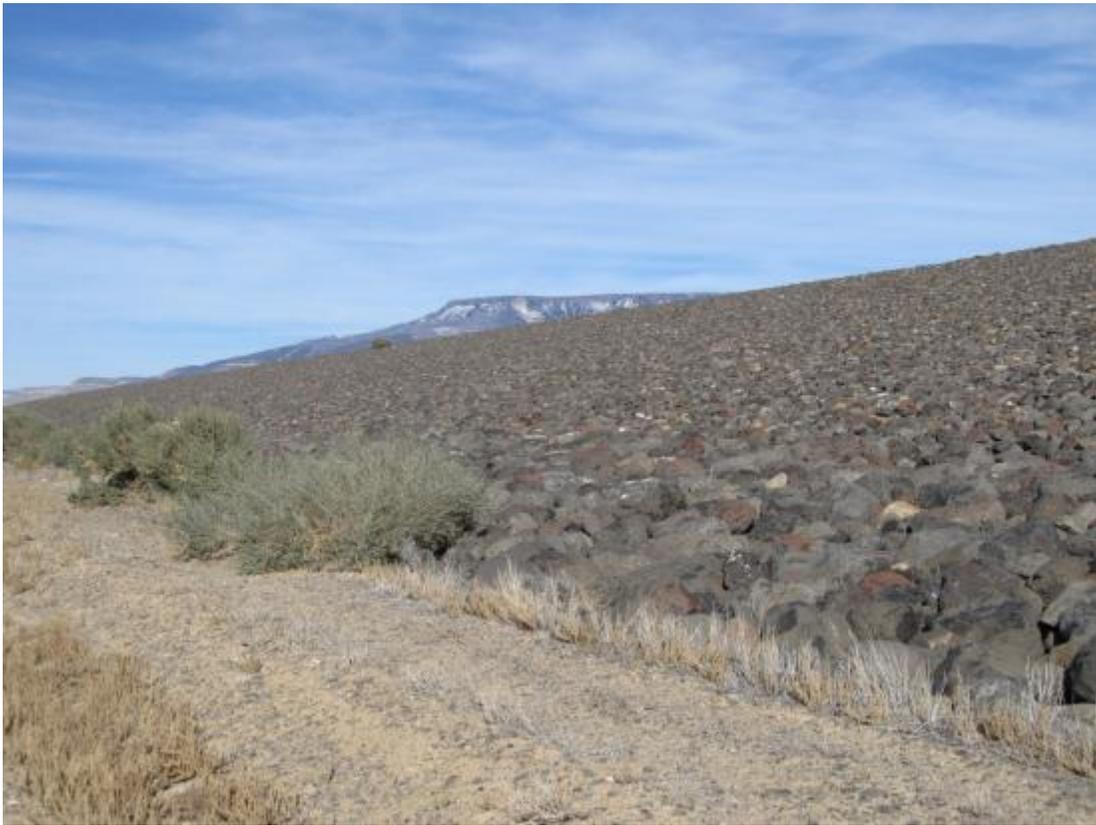
GRJ 11/2012. PL-7. West side slope of the disposal cell.

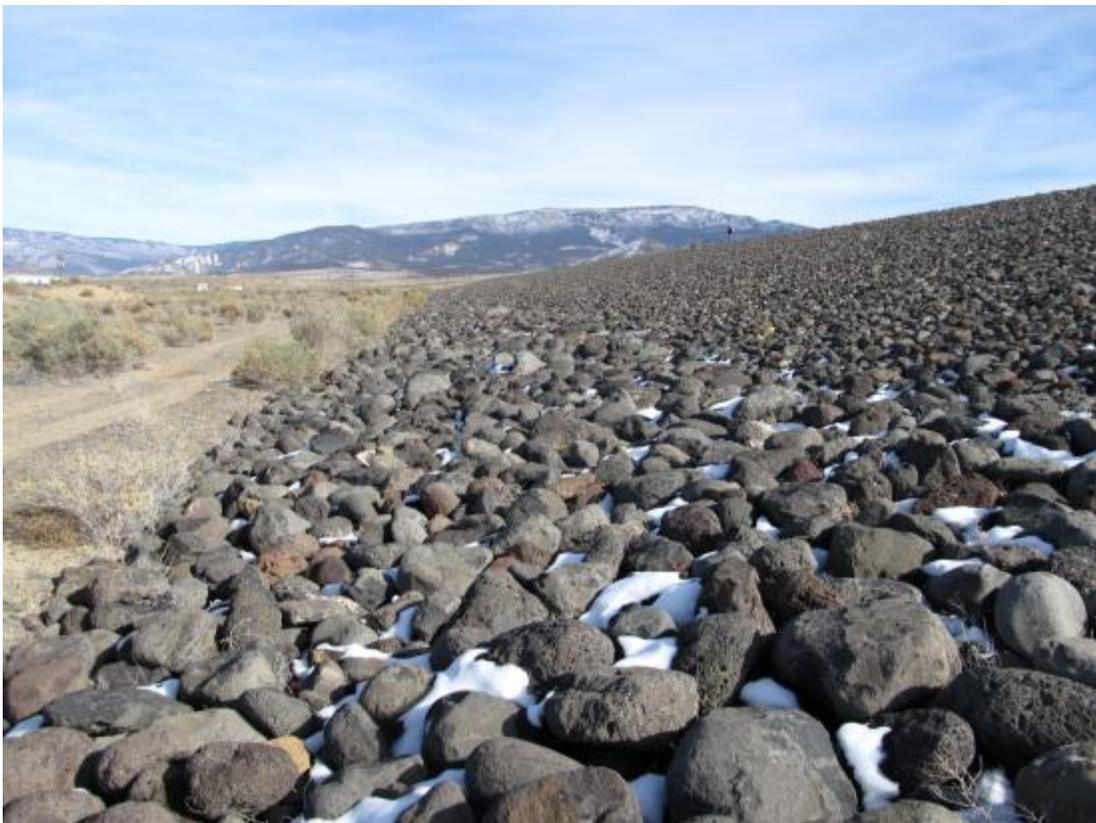
GRJ 11/2012. PL-8. North side slope and apron of the disposal cell.

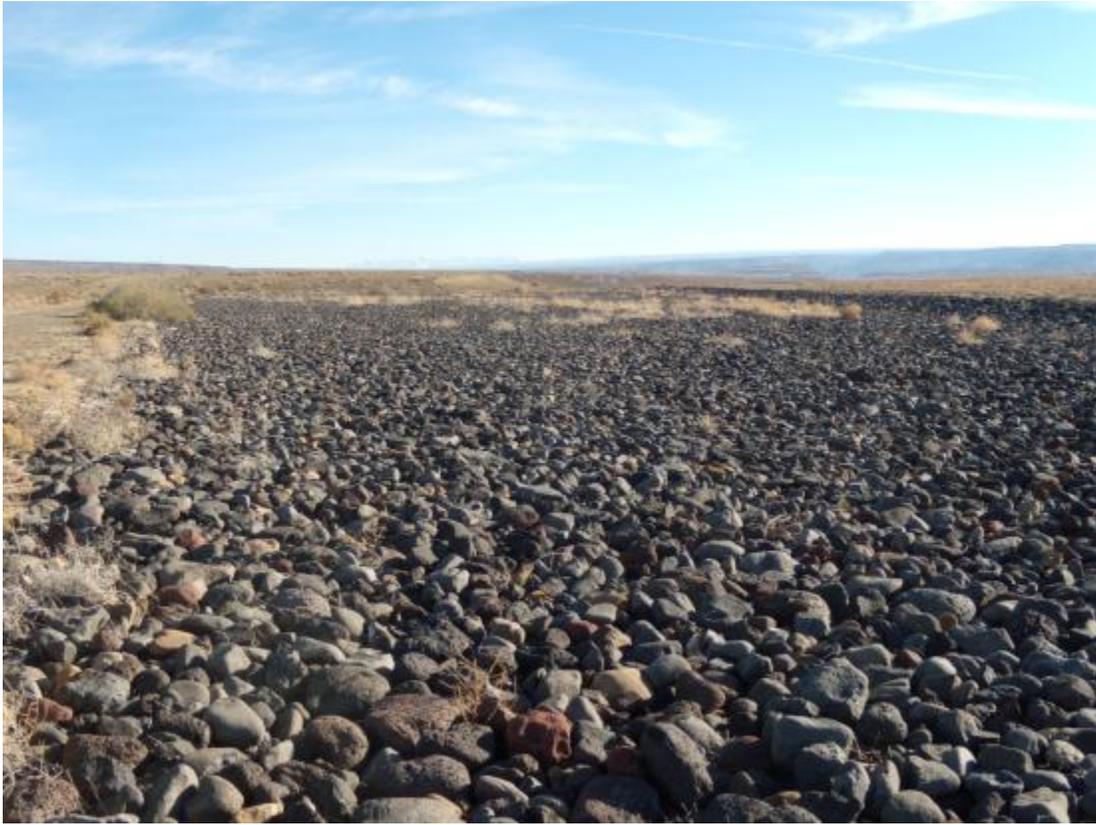
GRJ 11/2012. PL-9. Downgradient view of the south diversion channel.

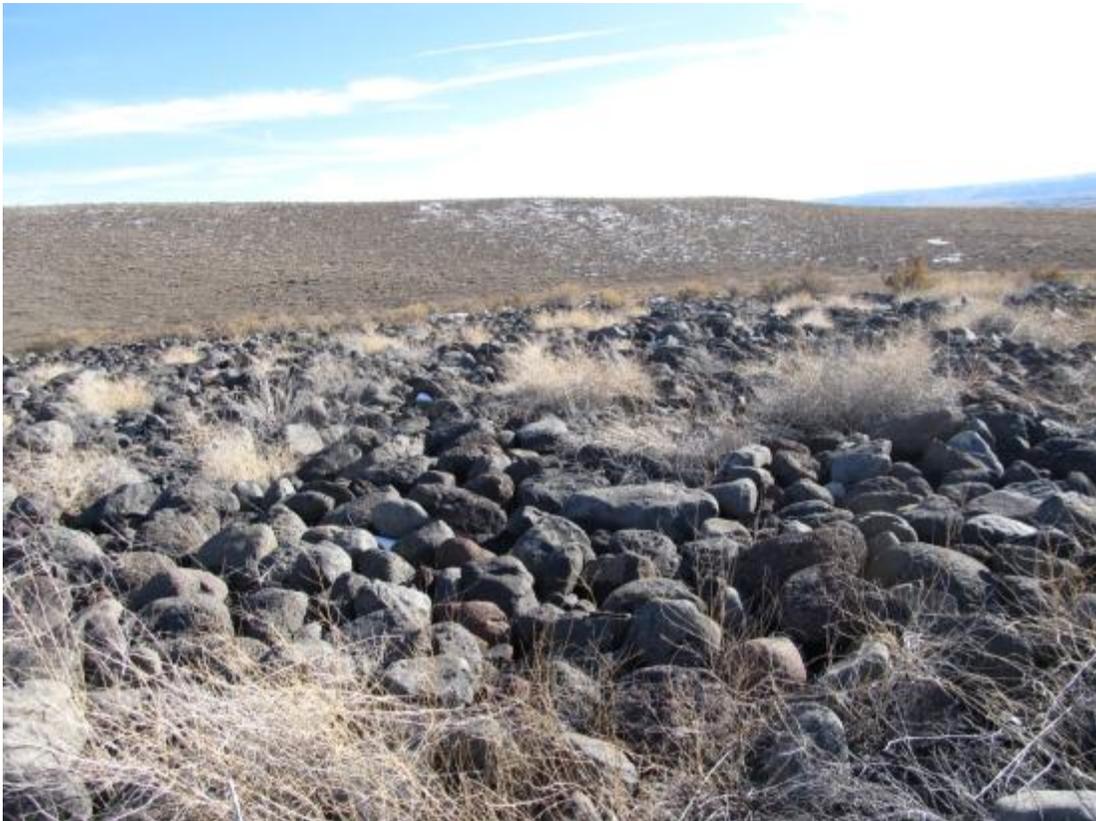
GRJ 11/2012. PL-10. Riprap-armored discharge area of the south diversion channel.

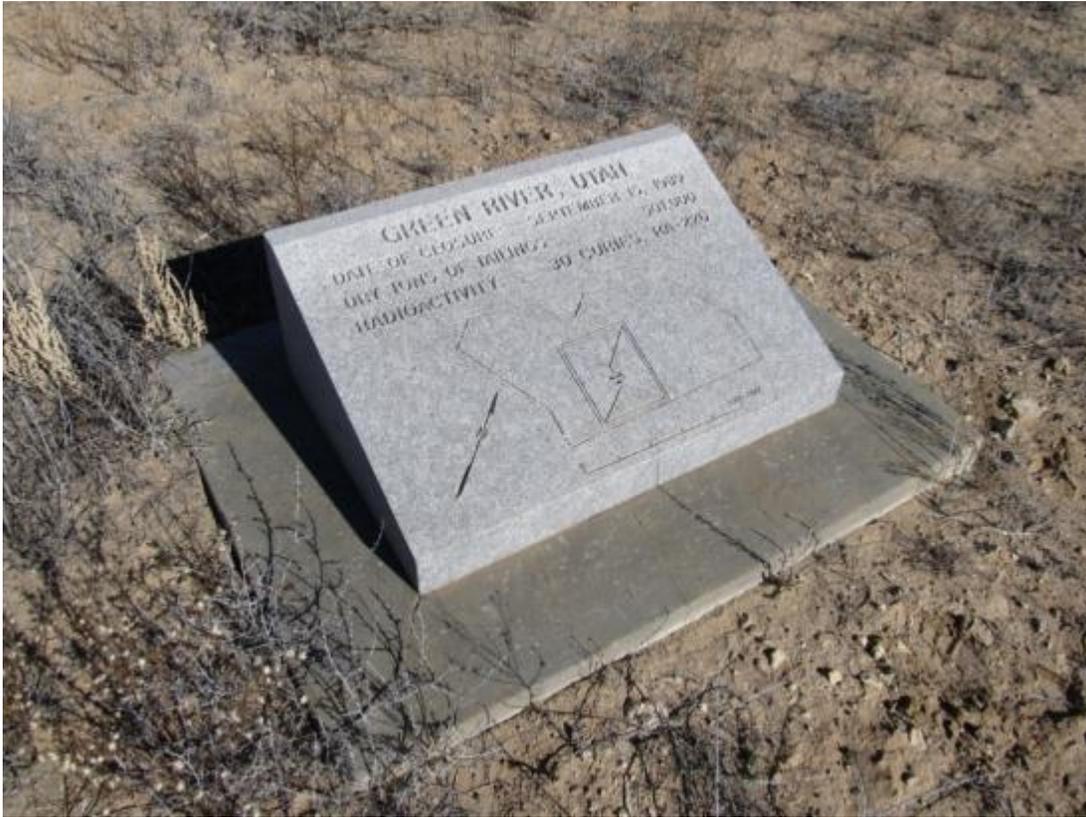
Two granite site markers are on the site. Site marker SMK–1 is on the ground inside the southwest security fence line. Its concrete base has several minor cracks, but there is no need for repairs at this time; overall the site marker was in good condition (PL–3). Site marker SMK–2, located on the crest of the disposal cell, was in excellent condition (PL–4).

GRN 3/2012. PL-3. Site marker SMK-1.

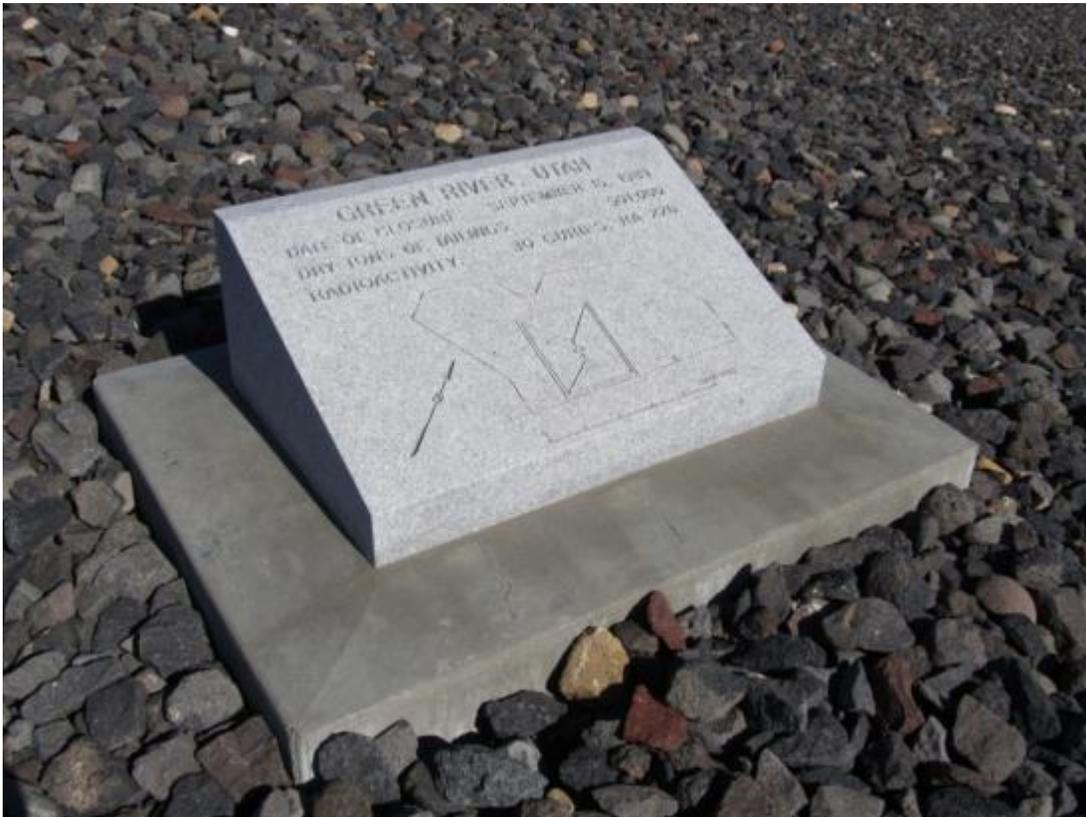
GRN 3/2012. PL-4. Site marker SMK-2.

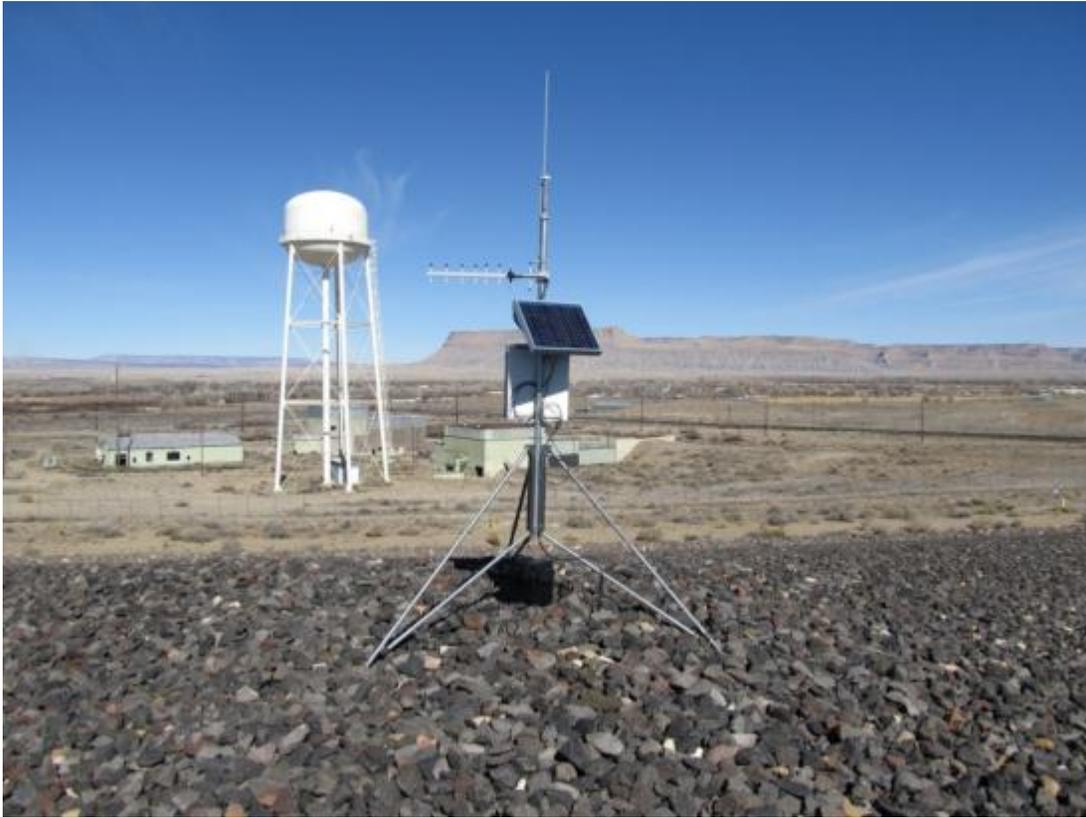
The wells were secure at the time of the inspection, and the visible portions of all wells and telemetry system components were in good condition (PL-5).

GRN 3/2012. PL-5. Telemetry relay station at the disposal cell crest.

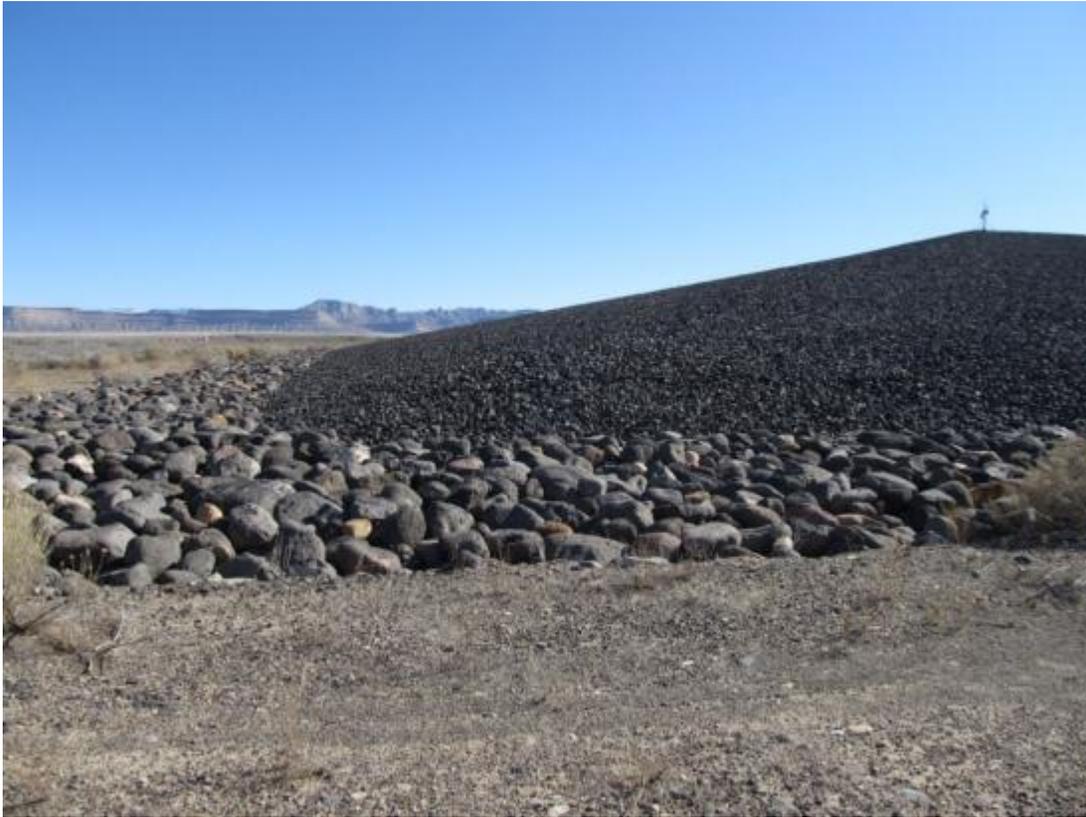
The 6-acre disposal cell was completed in 1989. The slopes of the disposal cell cover are armored with basalt rock. No evidence of any disturbance of the cell surfaces was observed. No vegetation was present on the cell. The quality of the rock is excellent, and the disposal cell cover was in excellent condition (PL-6). A basalt boulder-filled trench, called an apron, surrounds the disposal cell. The apron collects all runoff water from the cell, and the water is reduced by evaporation, evapotranspiration through deep-rooted shrubs that grow along the apron, and infiltration into the underlying bedrock and aquifer through the sides and bottom of the apron. The apron was in excellent condition (PL-7).

GRN 3/2012. PL-7. West corner and apron of the disposal cell.

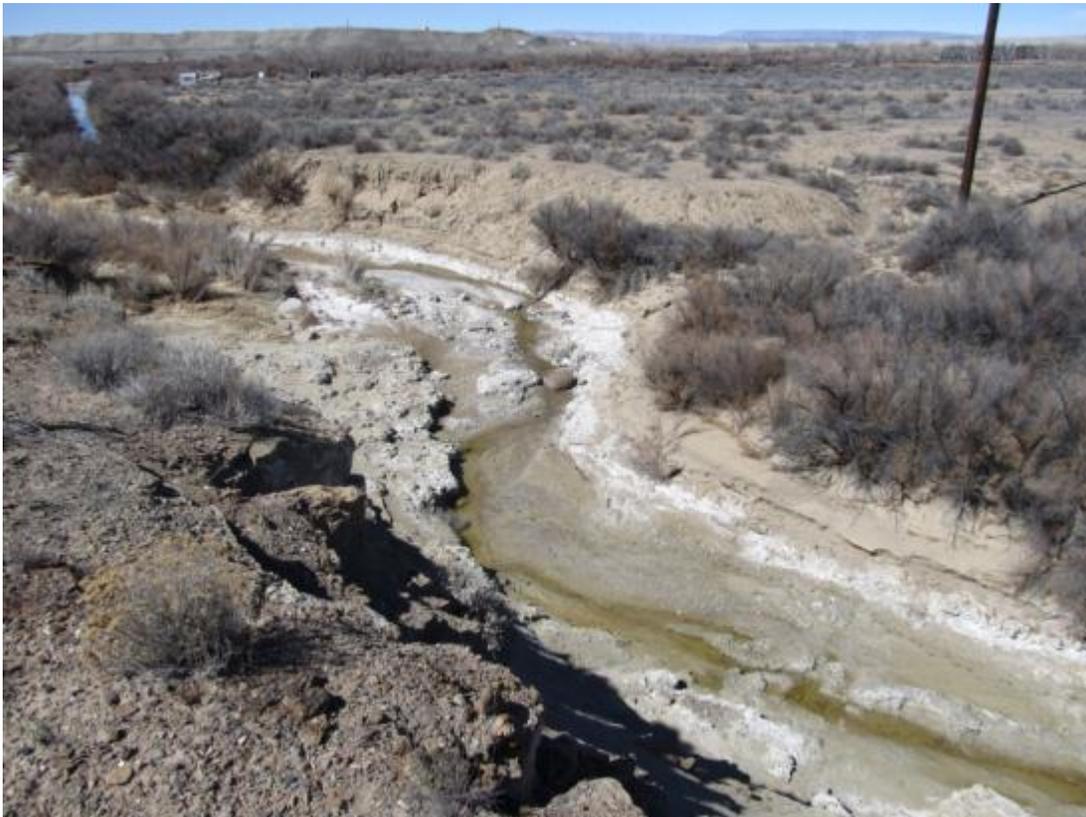
The conditions of Browns Wash were observed during the inspection. Flow was occurring in the channel between the road bridge and the backwater area near the confluence with the Green River (PL-8). The streambed upstream of the bridge was dry; therefore, the flow downstream of the bridge was from seeps. The backwater area near the mouth of Browns Wash is important because of its potential to be a fish-spawning location (PL-9). The conditions of Browns Wash channel and the backwater area change substantially after each runoff event as sediment is either scoured or deposited along the channel bottom.

GRN 3/2012. PL-8. Area of seep 0718 in Browns Wash.

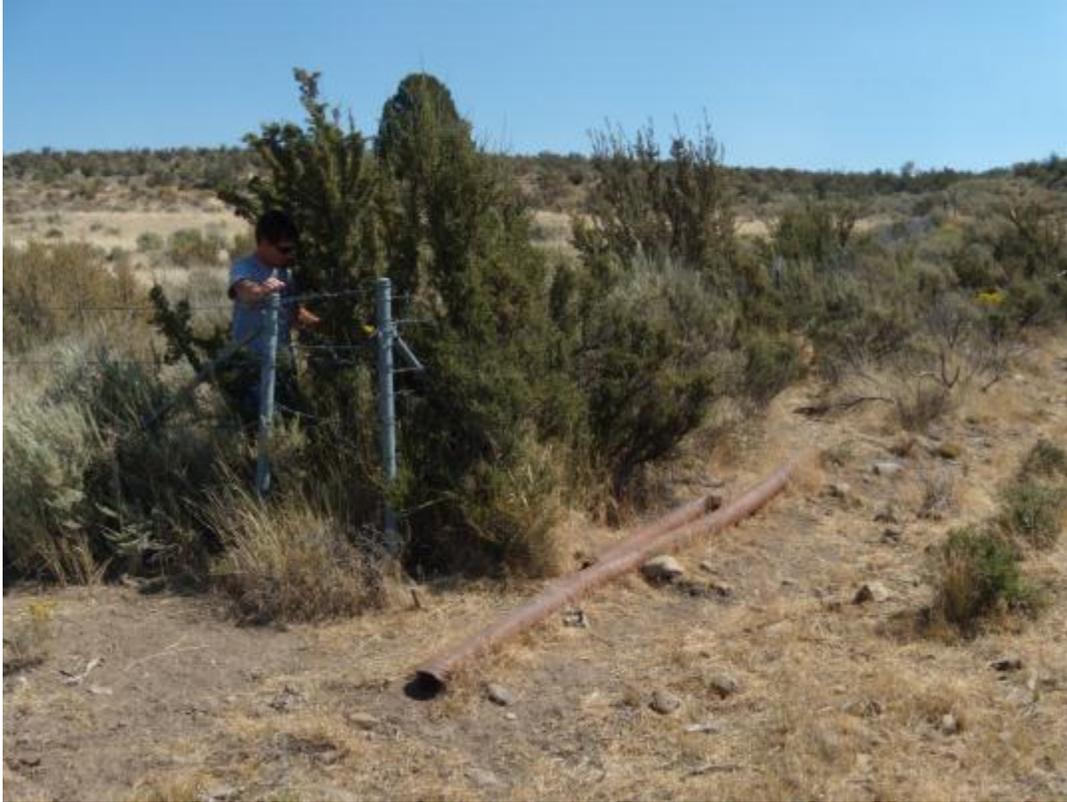
LKV 8/2012. PL-1. Vegetation involved in site fence at southwest corner of site.
