U.S. DEPARTMENT OF  
**ENERGY**

Legacy  
Management

# 2012 Annual Site Inspection and Monitoring Report for Uranium Mill Tailings Radiation Control Act Title I Disposal Sites

February 2013

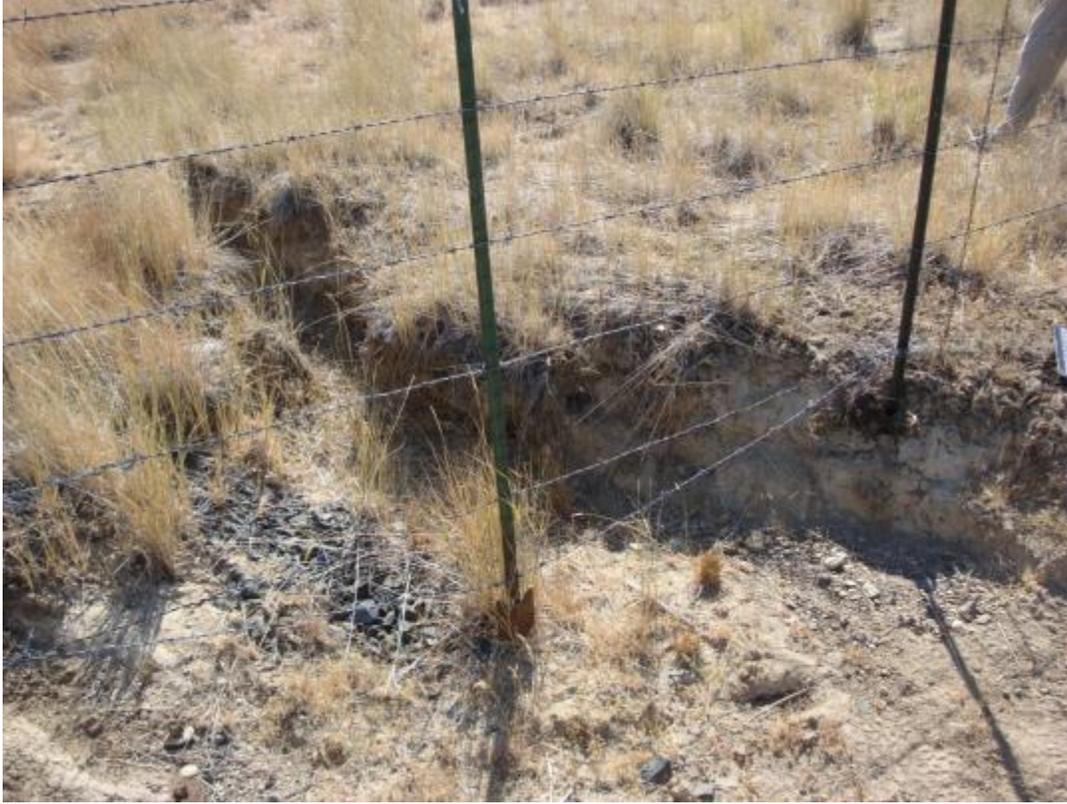
LKV 8/2012. PL-9. Soil erosion from channeling at west fence.

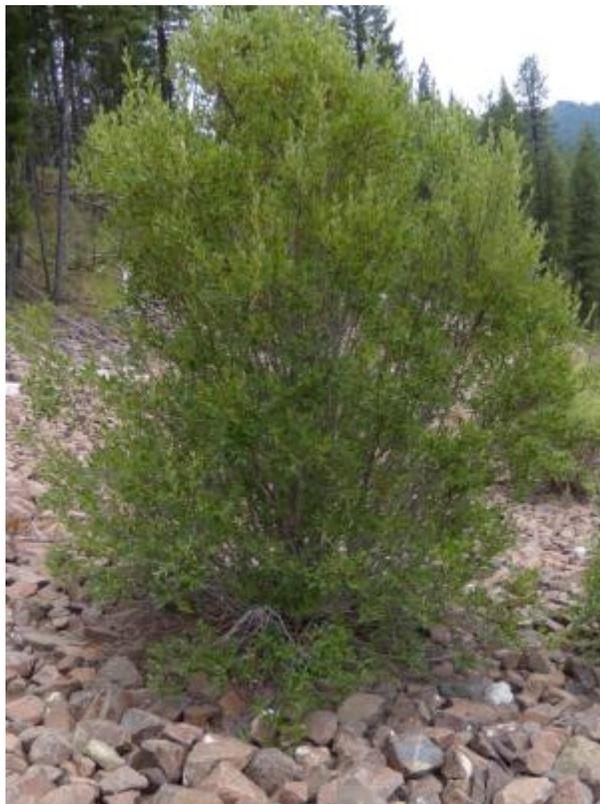
LOW 7/2012. PL-6. Willow (*Salix* sp.) on disposal cell top.

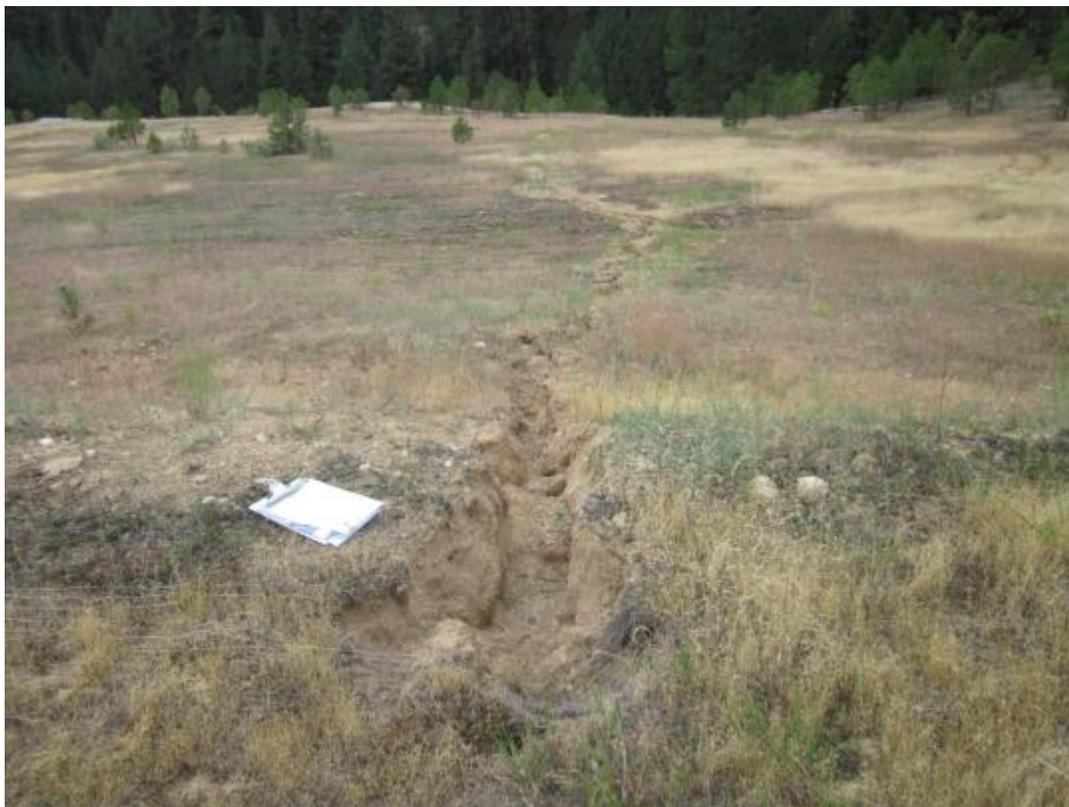
LOW 7/2012. PL-8. Gully forming on State land north of site.

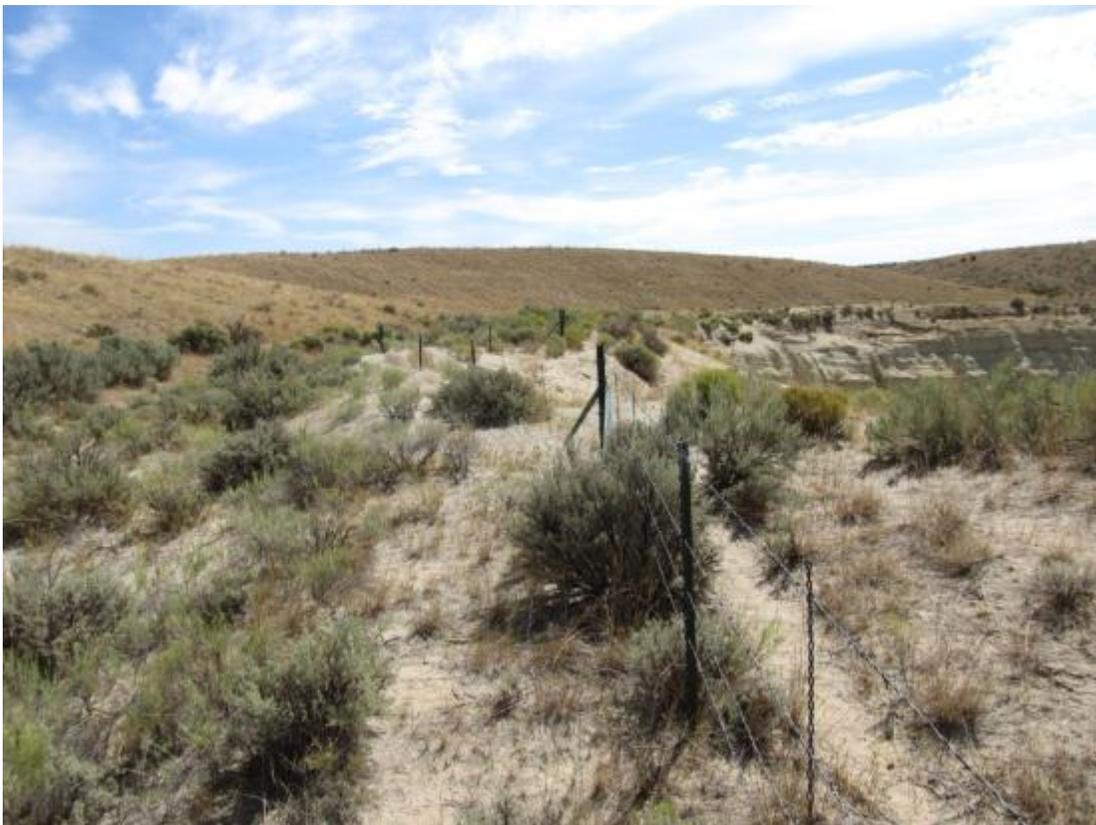
| <b>Photo Location Number</b> | <b>Azimuth</b> | <b>Photograph Description</b> |
|---|---|--|
| PL-14 | 90 | Encroachment of the Johnson Pit along the south perimeter fence. |

MAY 4/2012. PL-14. Encroachment of the Johnson Pit along the south perimeter fence.

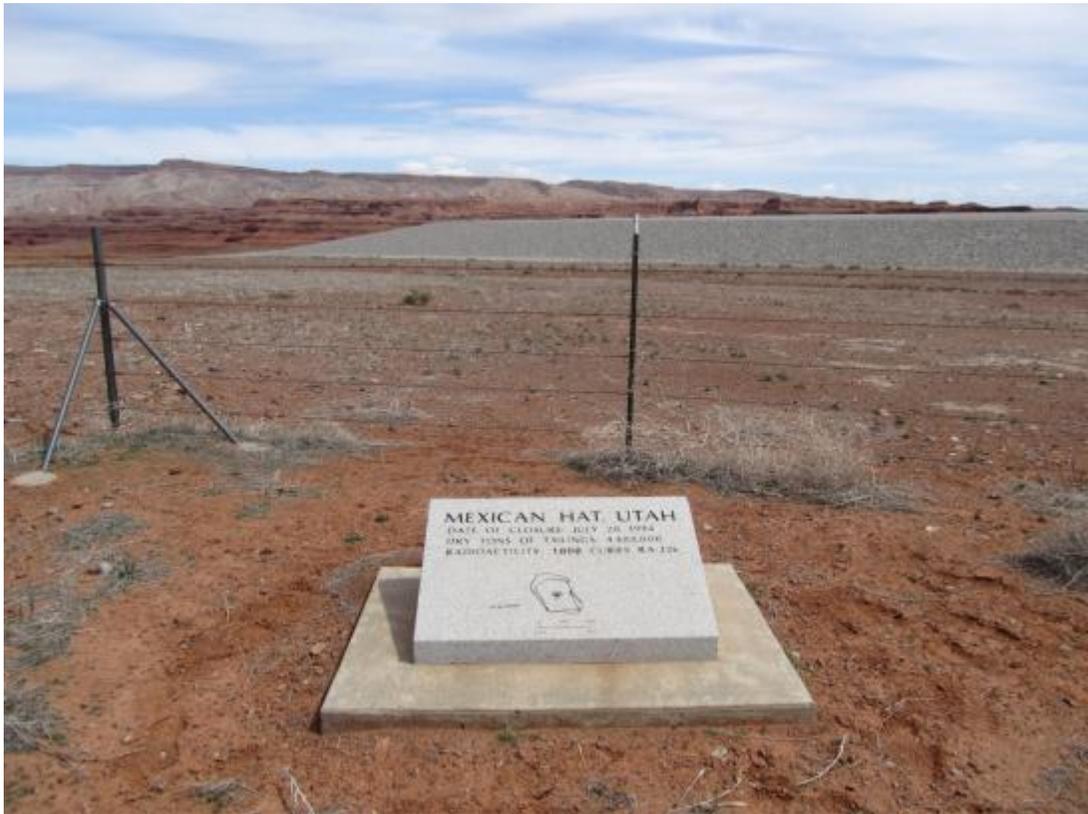
Two granite site markers are on the site. Site marker SMK-1 is on the ground inside the southwest security fence line. Its concrete base has several minor cracks, but there is no need for repairs at this time; overall the site marker was in good condition (PL-3). Site marker SMK-2, located at crest of the disposal cell, was in excellent condition (PL-4).

HAT 4/2012. PL-3. Site Marker 1 (SMK-1).

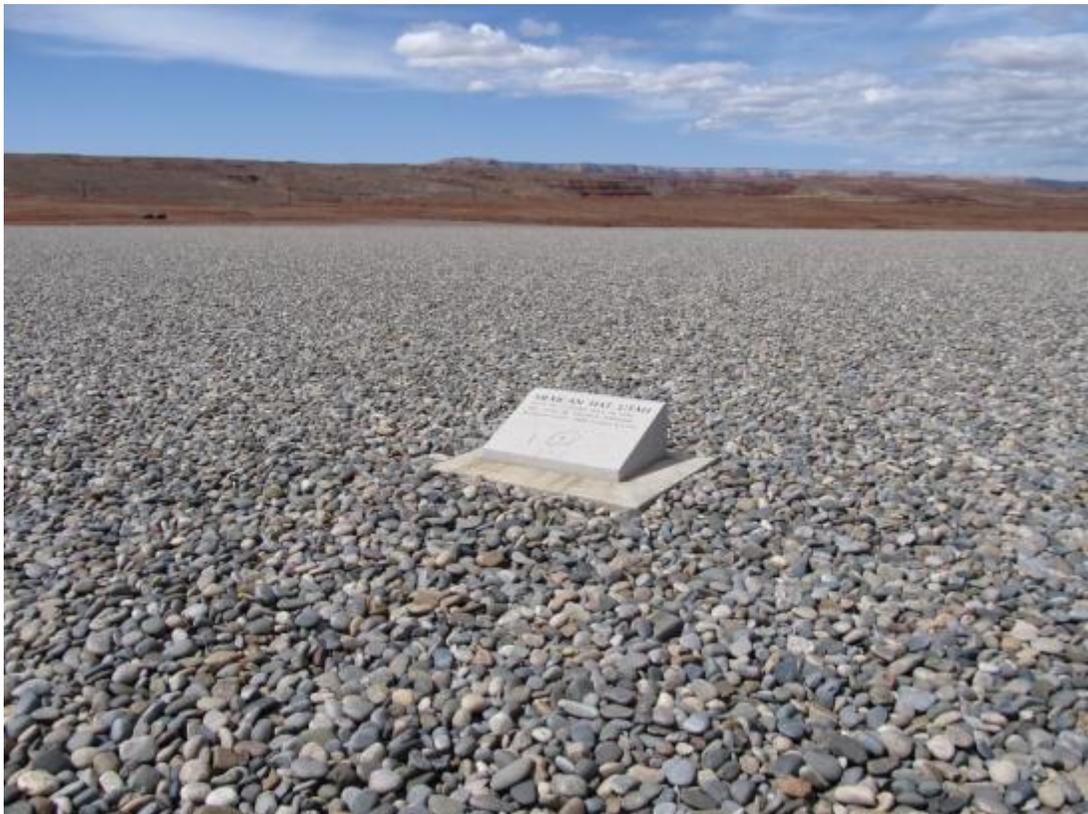
HAT 4/2012. PL-4. Site Marker 2 (SMK-2).

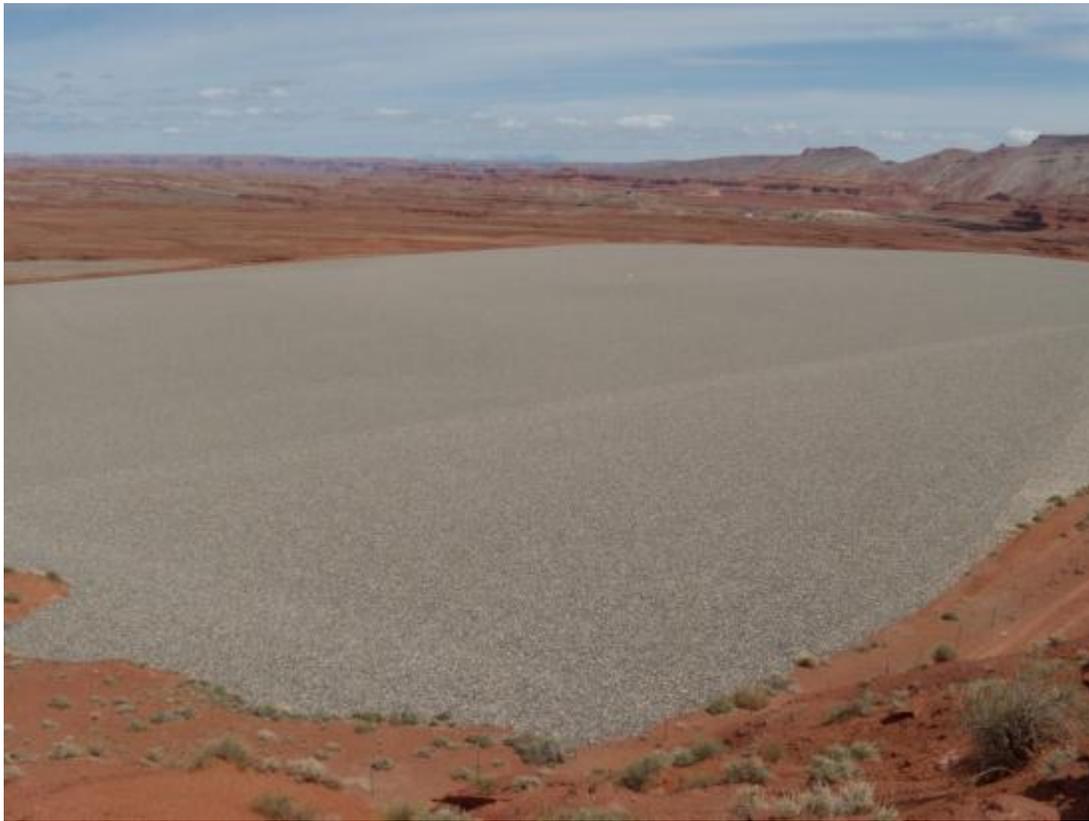
The top of the disposal cell is in excellent condition (PL-5, PL-6, and PL-7). There was no evidence of differential settling, cracking, erosion, or burrowing. All visible components of the disposal cell and cover were functioning as designed. No vegetation was observed to be growing on top of the disposal cell.

HAT 4/2012. PL-5. Central portion of the disposal cell.

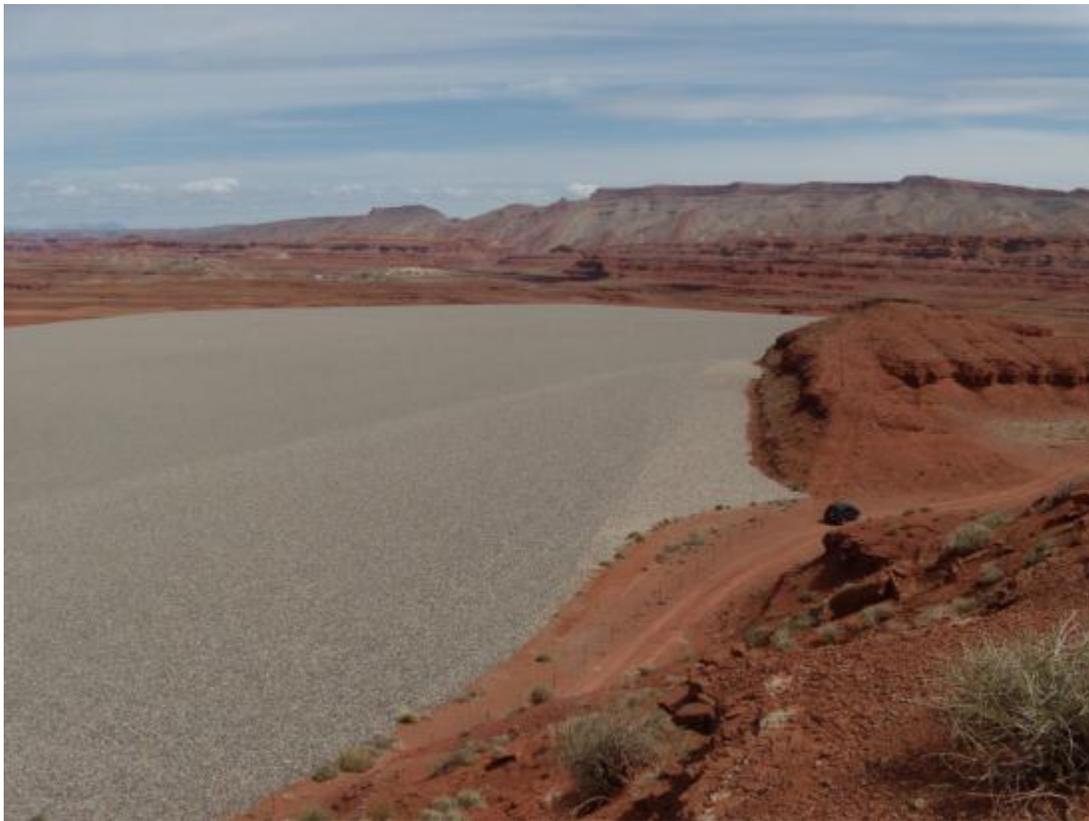
HAT 4/2012. PL-6. Southeast portion of the disposal cell.

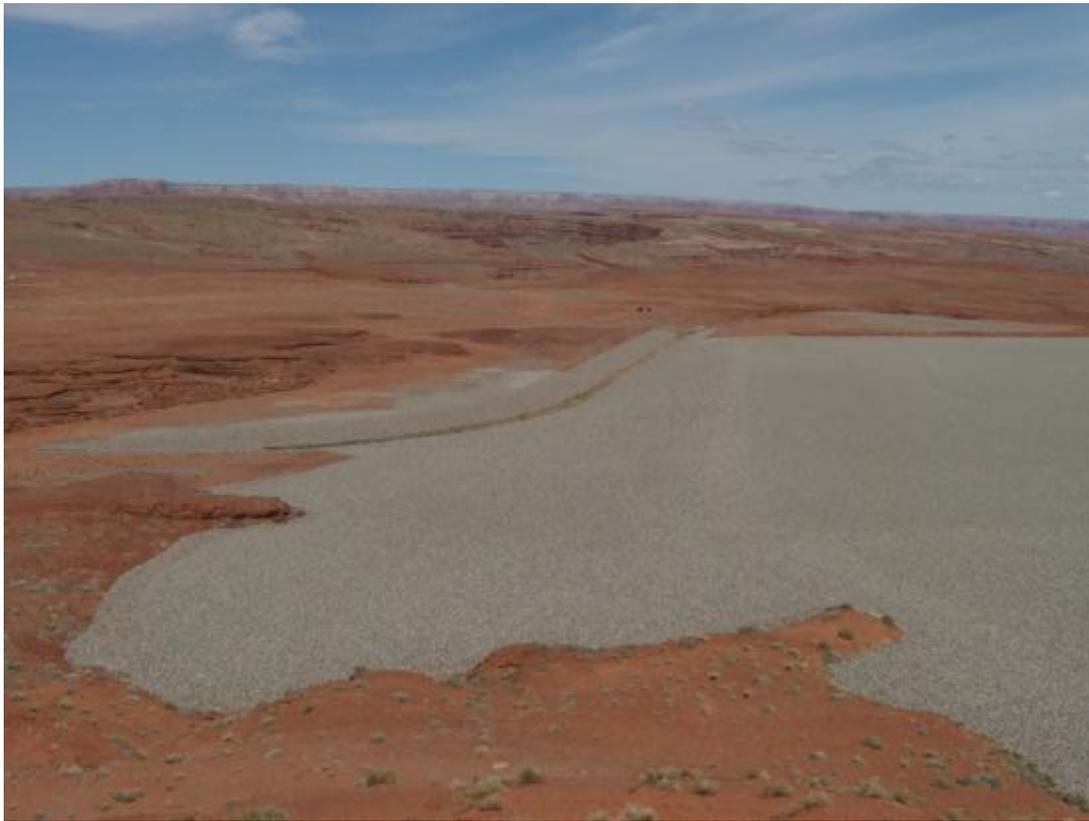
HAT 4/2012. PL-7. West portion of the disposal cell and the west diversion channel.

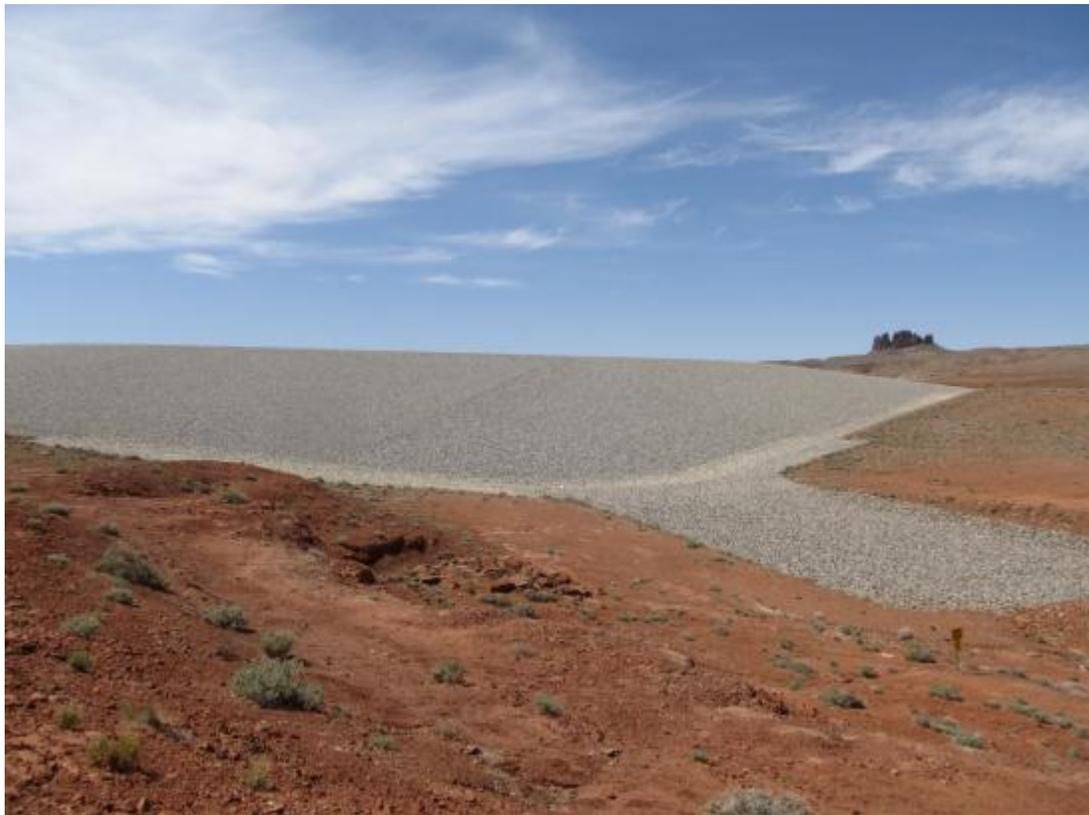
The disposal cell side slopes, toe drains, aprons, and diversion channels were in excellent condition and functioning as designed (PL-8).

HAT 4/2012. PL-8. West view of northeast and east slope.

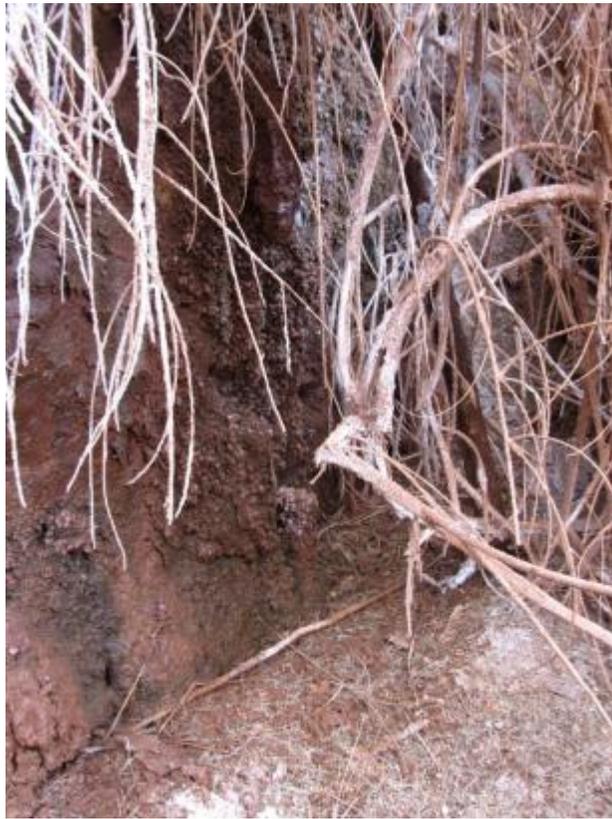
| Seep Location Number | Drainage | Photo Numbers | Observations and Descriptions of Seep Flow (Qualitative) |
|---|---|---|--|
| 0248 | Gypsum Creek | PL–11 | Moist adjacent rock face; soils moist but no flow or pooling in the immediate area. |

HAT 4/2012. PL-11. Seep 0248 close up of bank (no pooling).

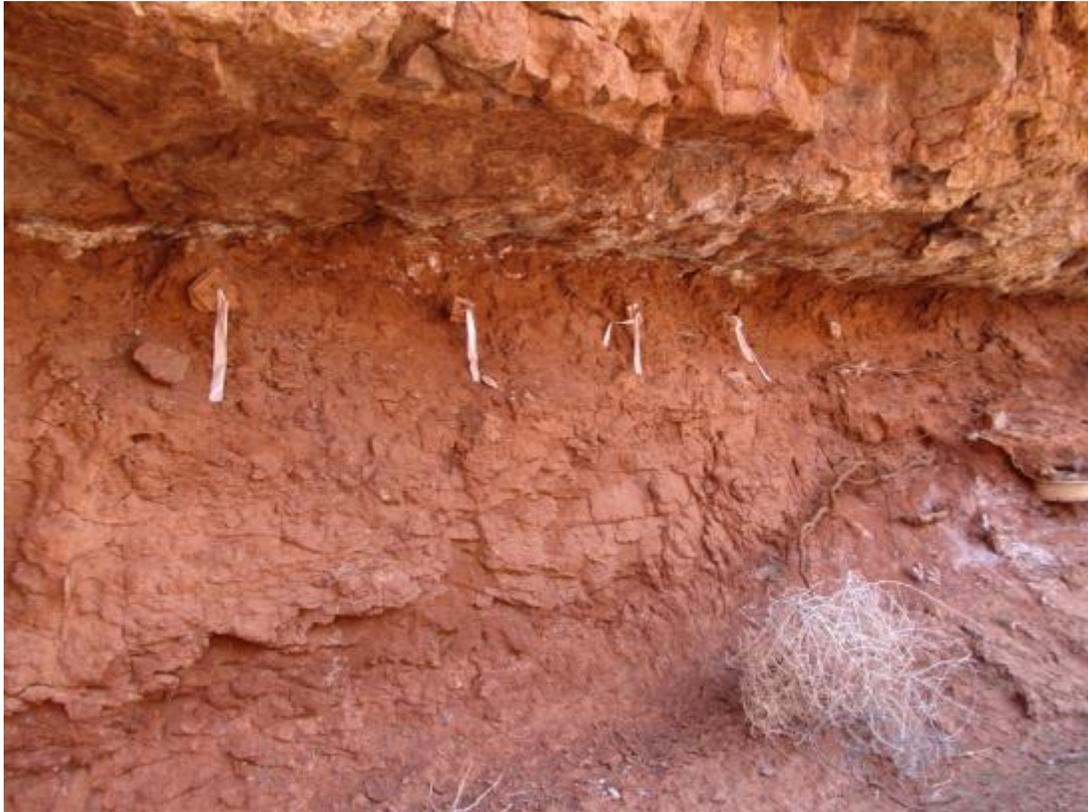
HAT 4/2012. PL-13. Seep 0254.

- 12A A missing radiological warning sign (P31) and some minor fence repair near perimeter sign P22 will be required in the future. A warning sign should also be placed at seep 0254.

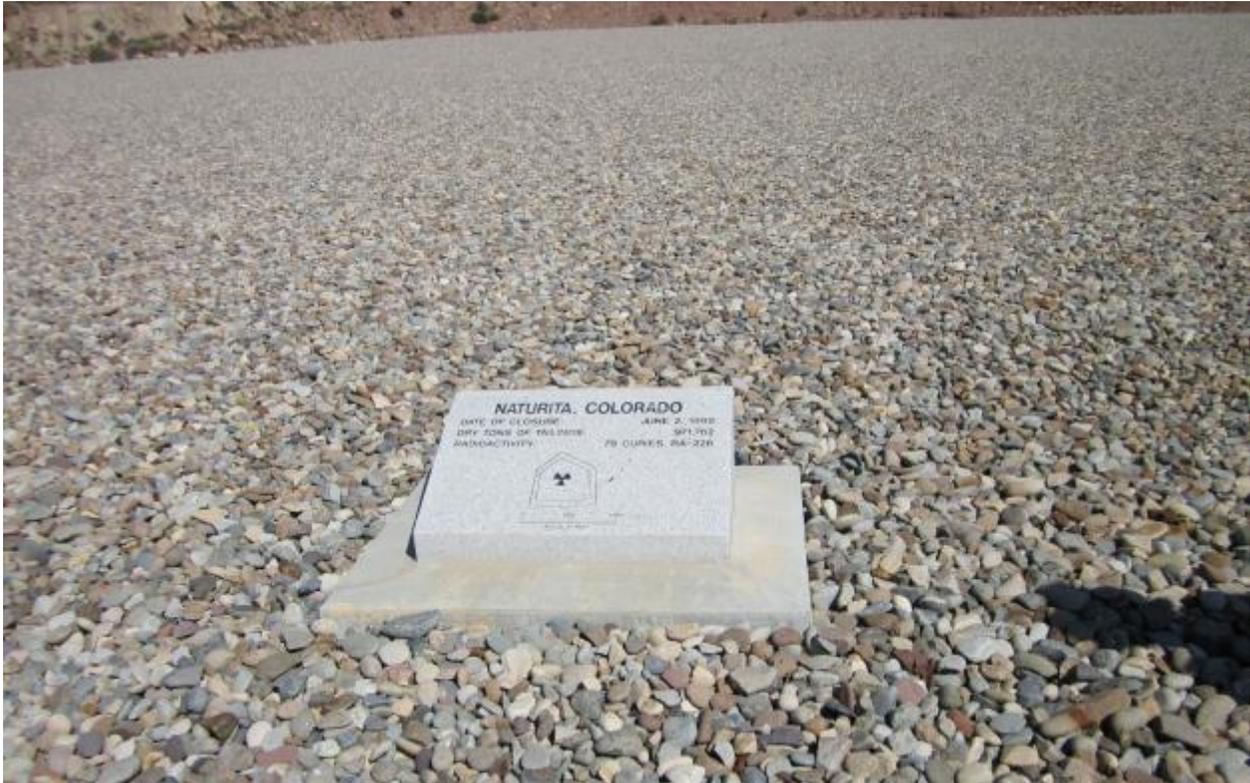
Two granite site markers identify the site. Site marker SMK–1 is set just inside and left of the entrance gate; site marker SMK–2 (PL–3) is located on the disposal cell in the south-central portion of the top slope. Both markers were undisturbed and in good condition; however, SMK-1 has a minor chip off the northeast corner of the concrete pad on which it is placed.

NAD 5/2012. PL-3. Monument on top of cell.

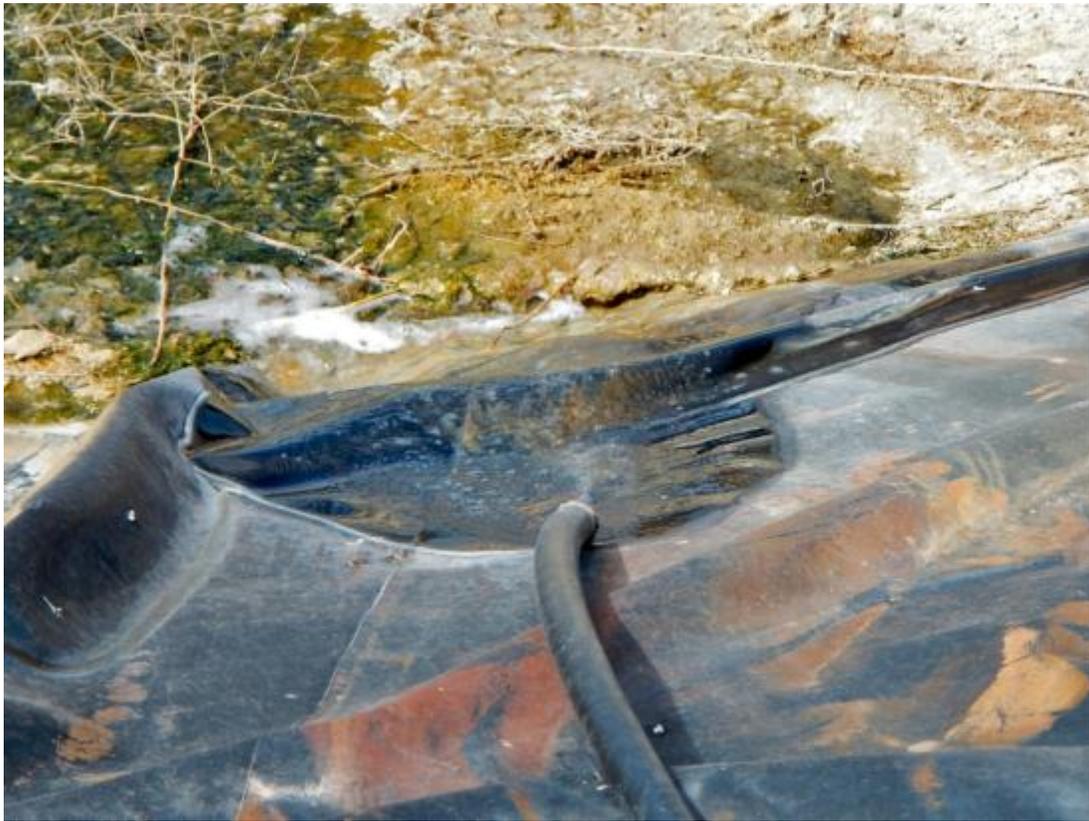
RFL 6/2012. PL-3. Water entering evaporation pond.

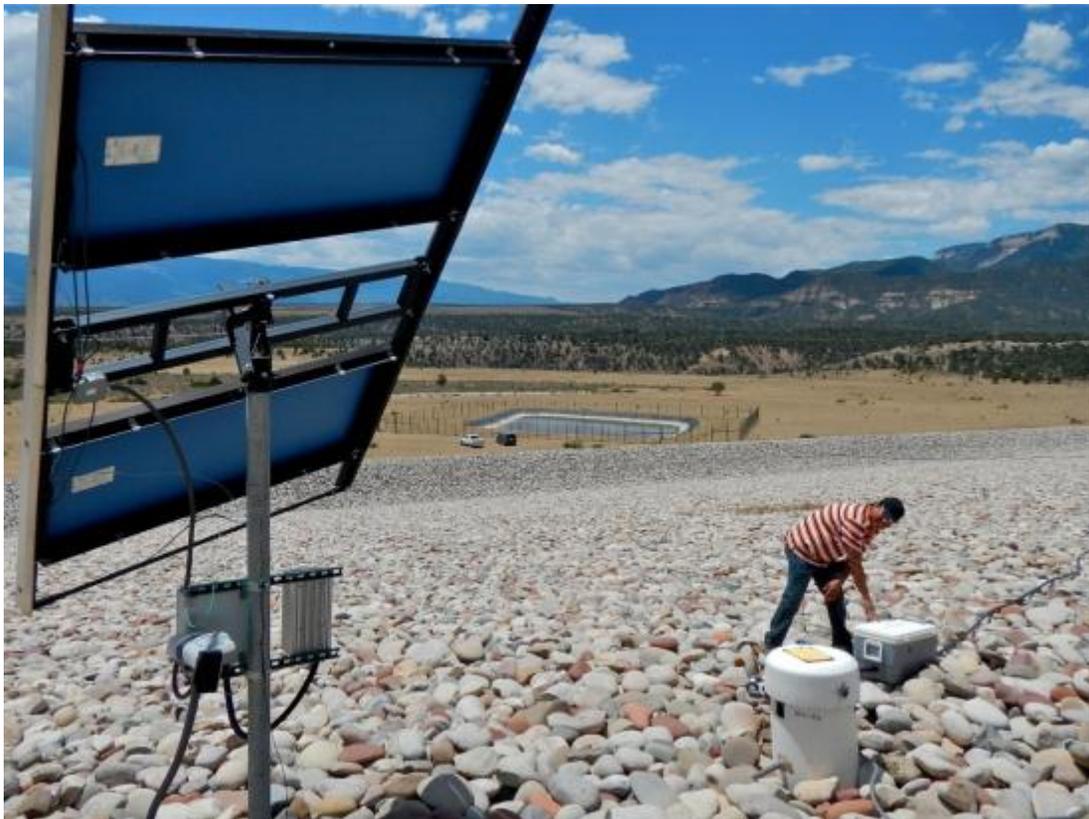
RFL 6/2012. PL-4. Inspecting MW-03 flow meter inside cooler. Solar panel in foreground, evaporation pond in background.

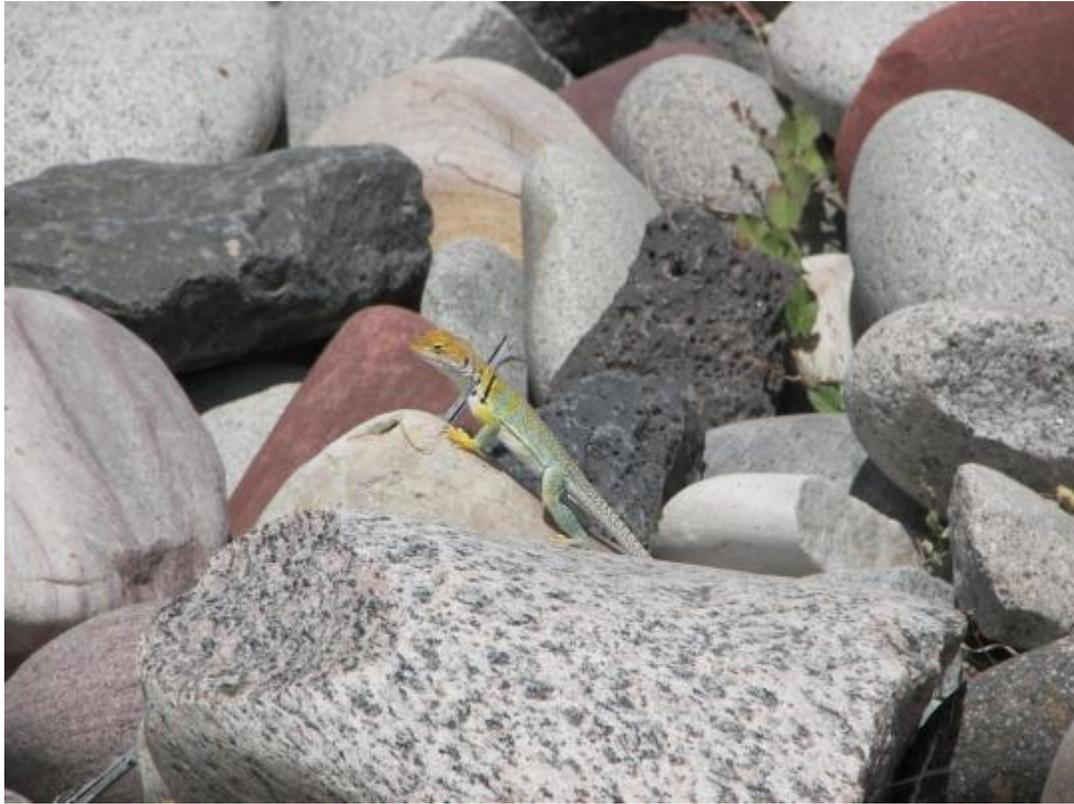
RFL 6/2012. PL-5. Collared lizard on riprap at bottom of cell.

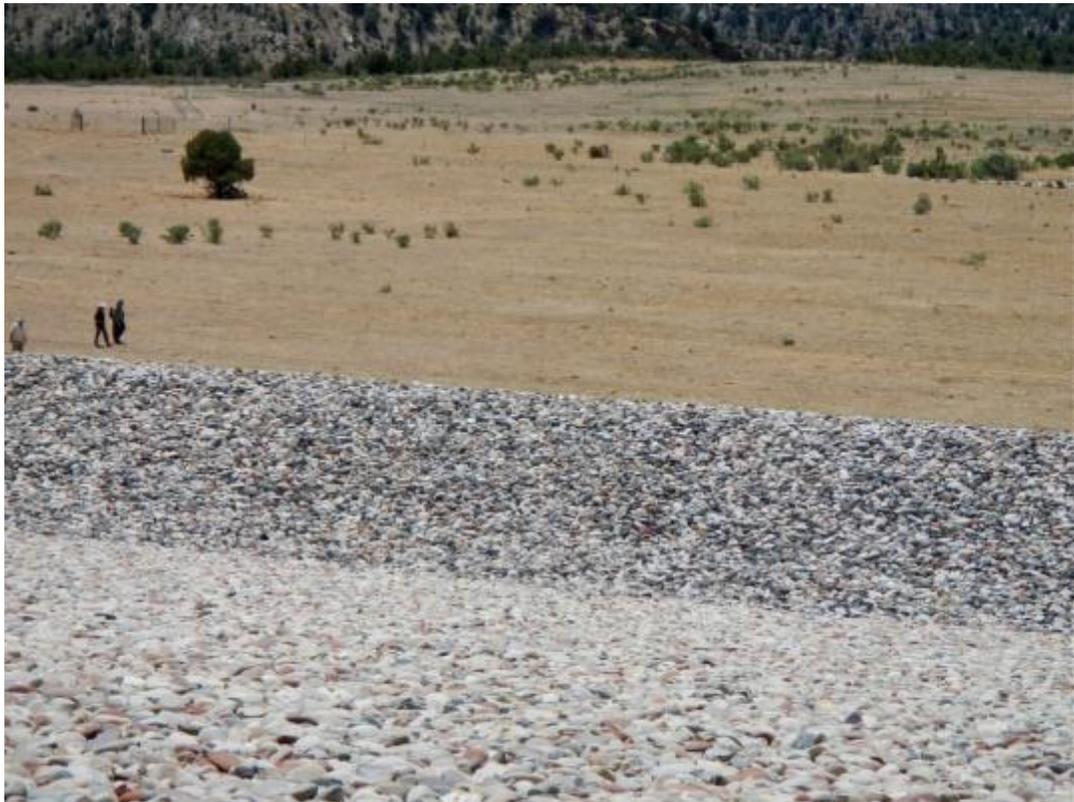
RFL 6/2012. PL-6. Looking south from MW-03 at toe of cell and sparse vegetation inside site boundary. Inspectors on left.

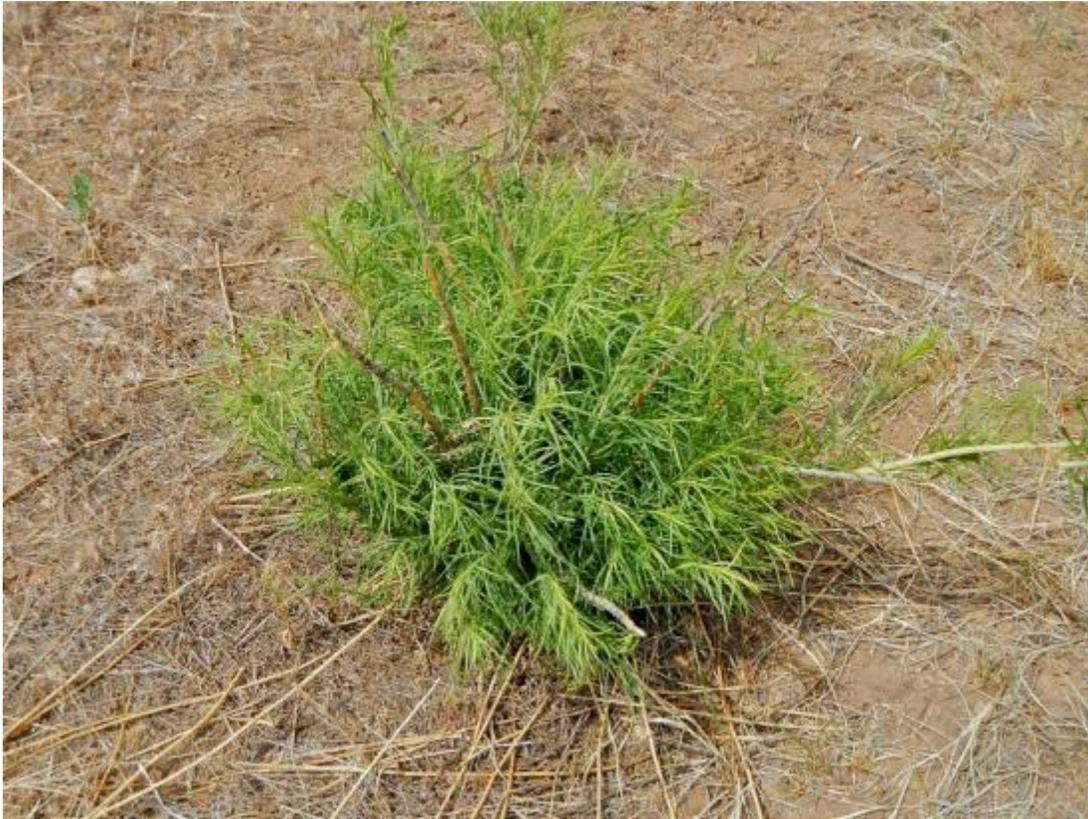
RFL 6/2012. PL-7. Rabbitbrush browsed by cattle.

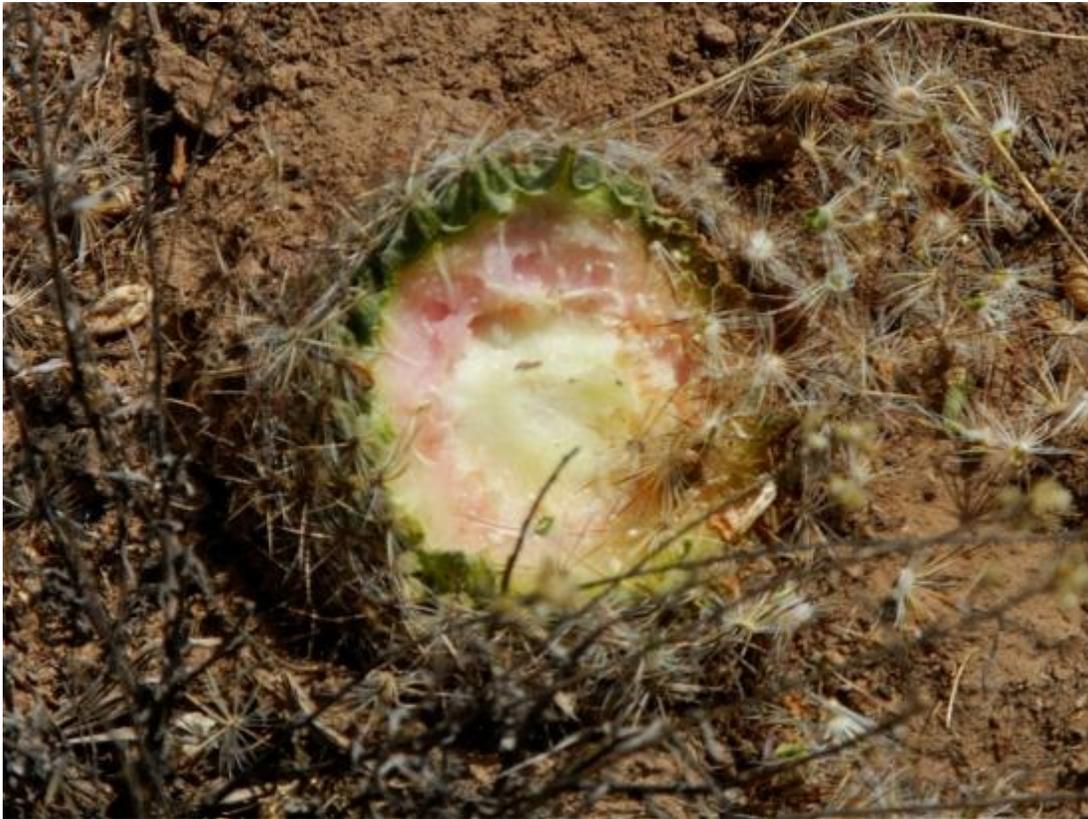
RFL 6/2012. PL-8. Small spiny star cactus browsed by cattle.

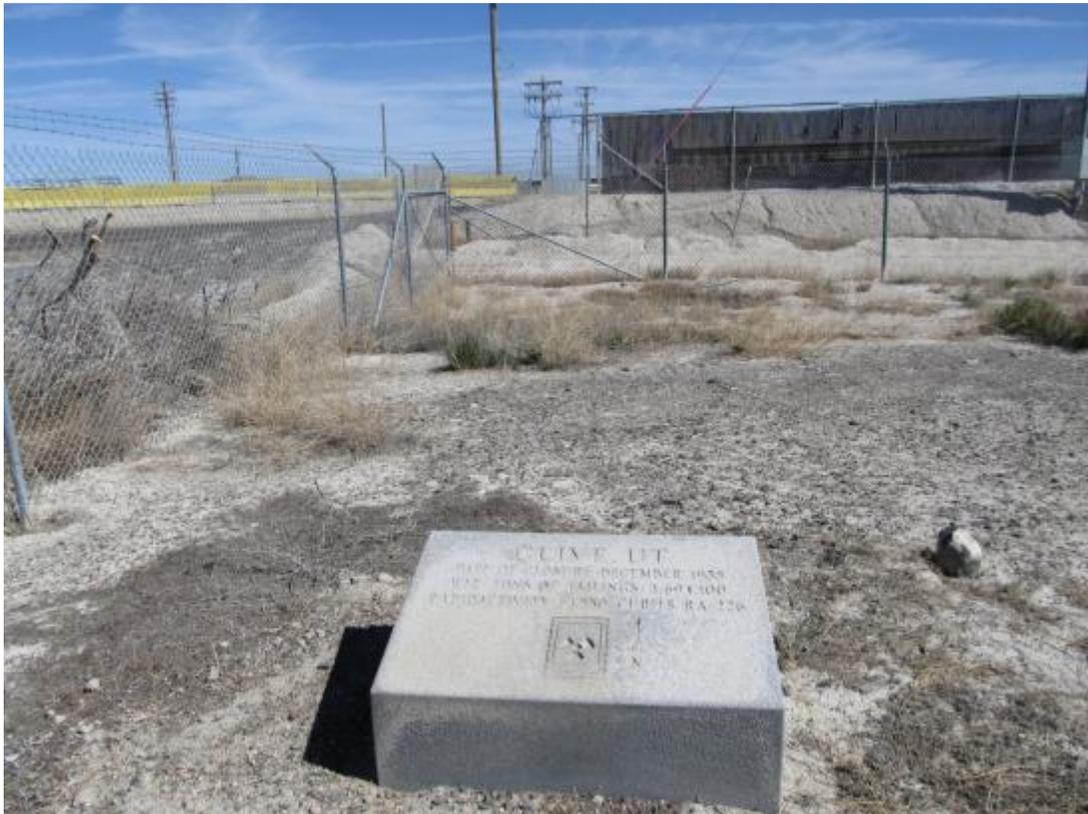
Both of the granite site markers were in excellent condition (PL-1 and PL-2). Site marker SMK-1 is etched from windblown sand and dirt, but it is legible. EnergySolutions had removed vegetation to clear the area surrounding SMK-1.

SLD 5/2012. PL-1. Site marker SMK-1's pitted surface.

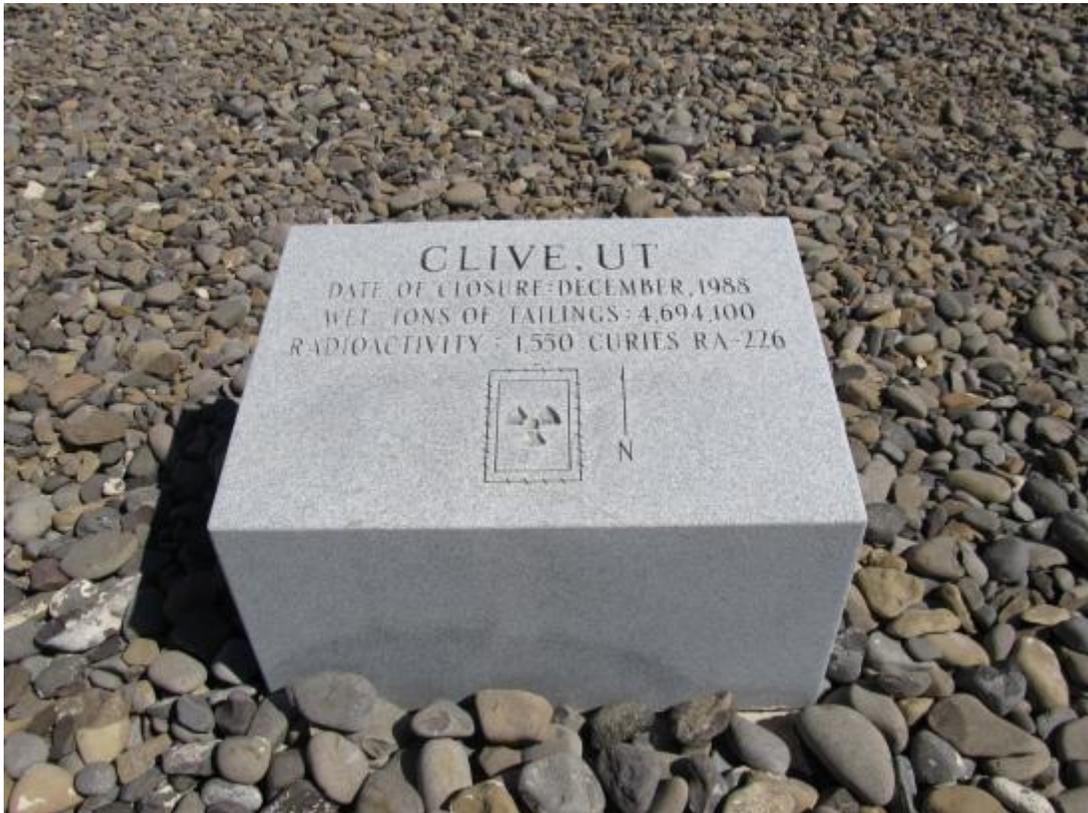
SLD 5/2012. PL-2. Site marker SMK-2.

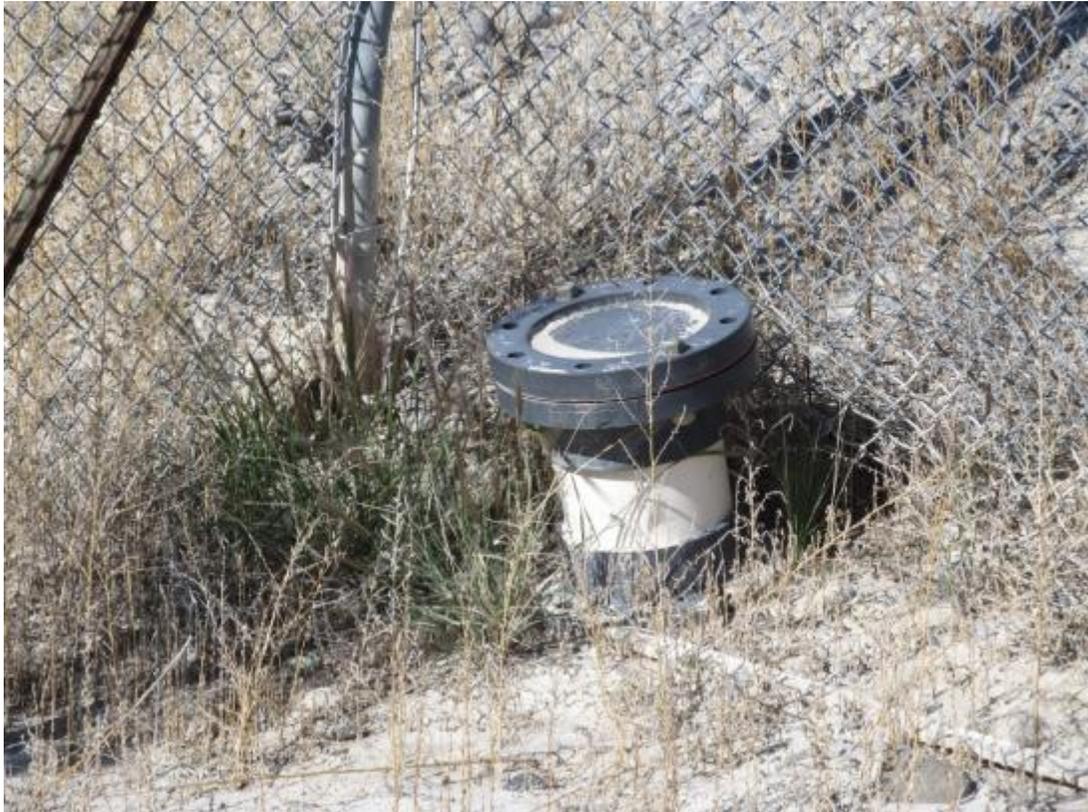
All four boundary monuments were observed to be in good condition. The EnergySolutions protective casings at all four of the locations (PL-3) appeared to be working well for protection from surrounding earth moving activities.

SLD 5/2012. PL-3. Boundary corner number 4.

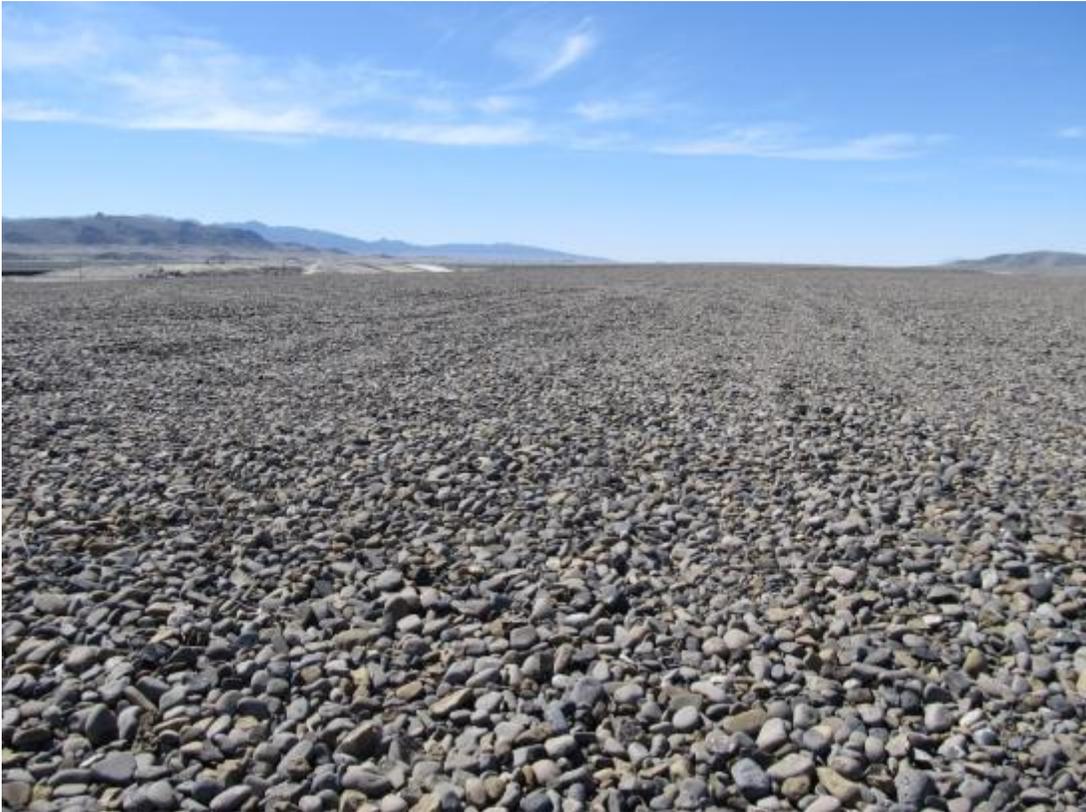
disposal cell (PL-5). The riprap was in good condition, and no evidence of erosion or slumping of the side slopes was observed. Several slight depressions in the riprap have been observed during previous inspections along the slopes of the cell, and they appear to have been created by the heavy equipment tracks during installation of the riprap (PL-6). These depressions continue to be monitored to ensure settlement is not occurring.

SLD 5/2012. PL-5. View across the top of cell.
