U.S. DEPARTMENT OF  
**ENERGY**

Legacy  
Management

# 2012 Annual Site Inspection and Monitoring Report for Uranium Mill Tailings Radiation Control Act Title I Disposal Sites

February 2013

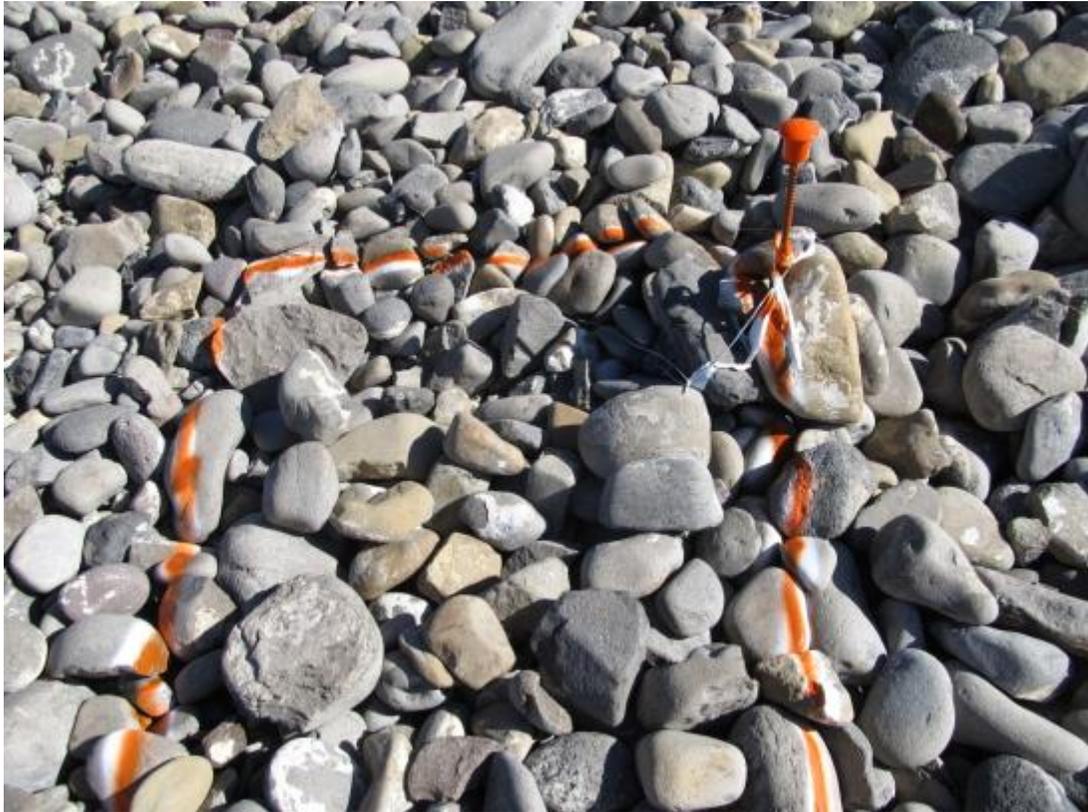
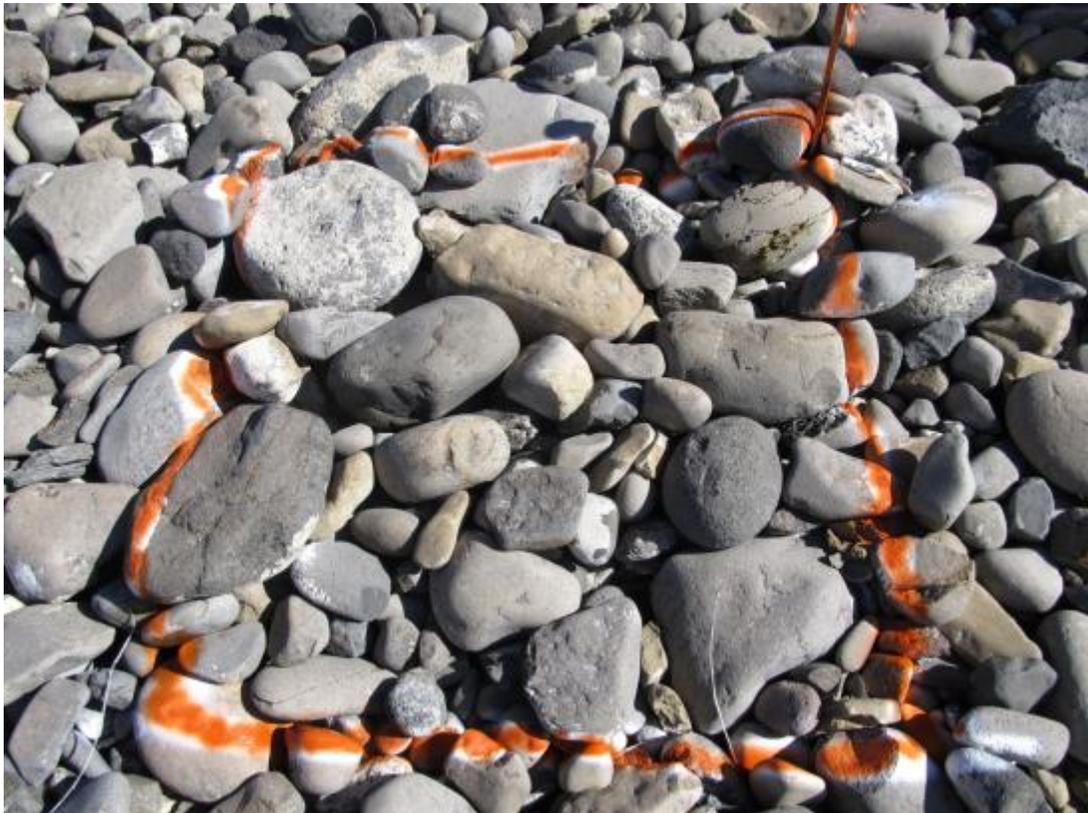
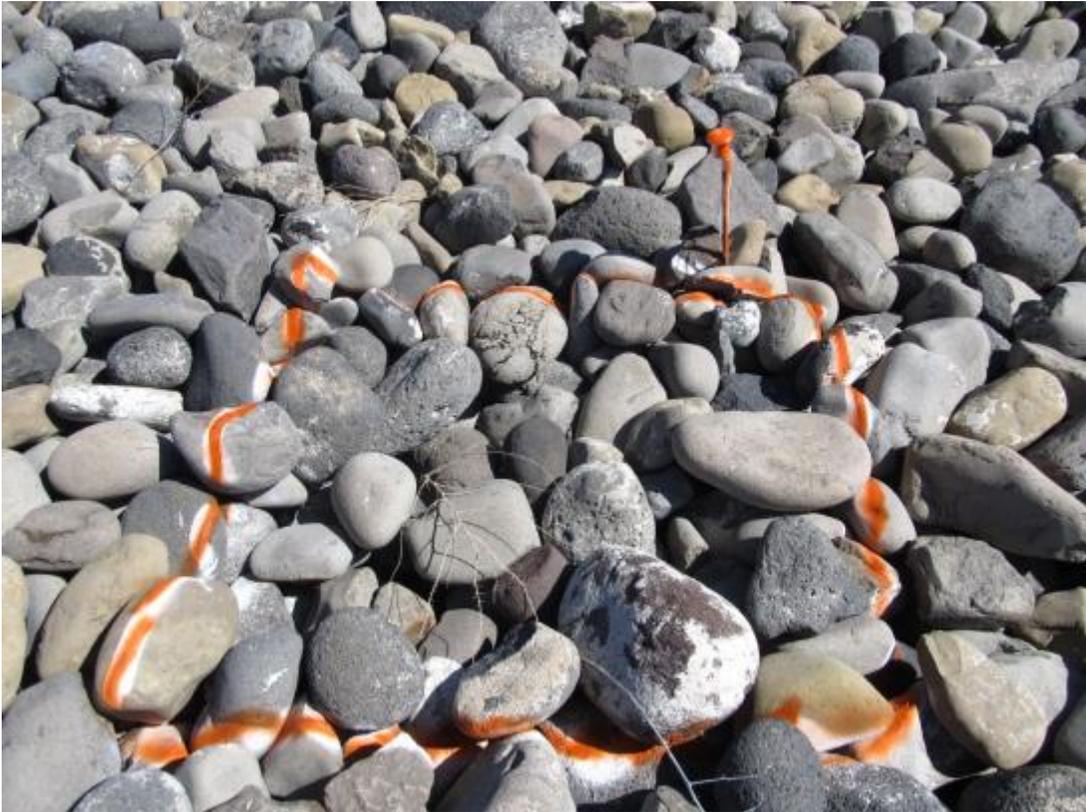
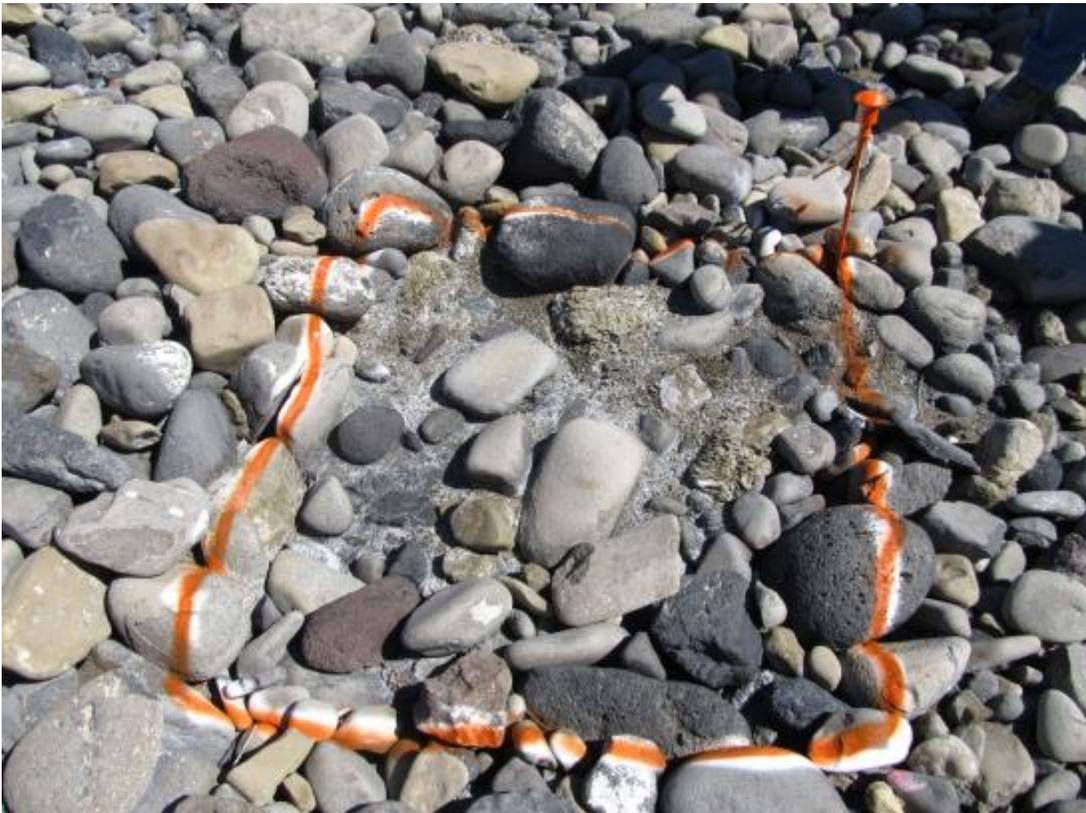
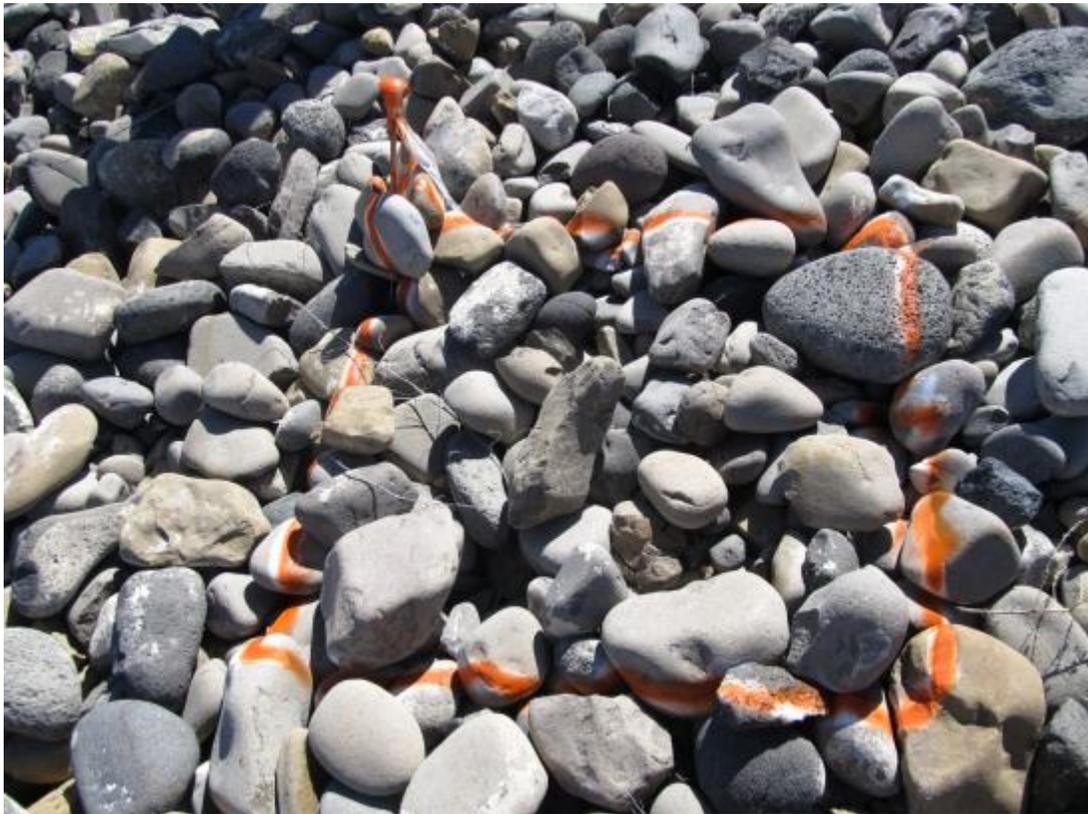
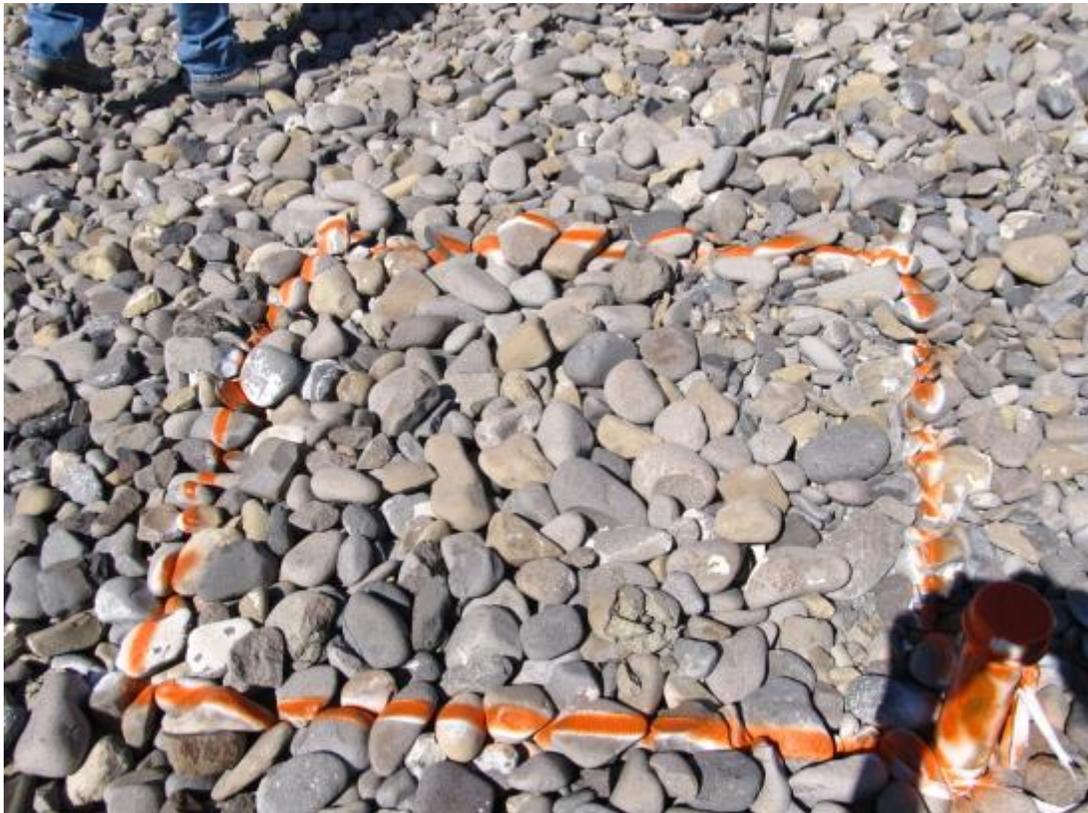
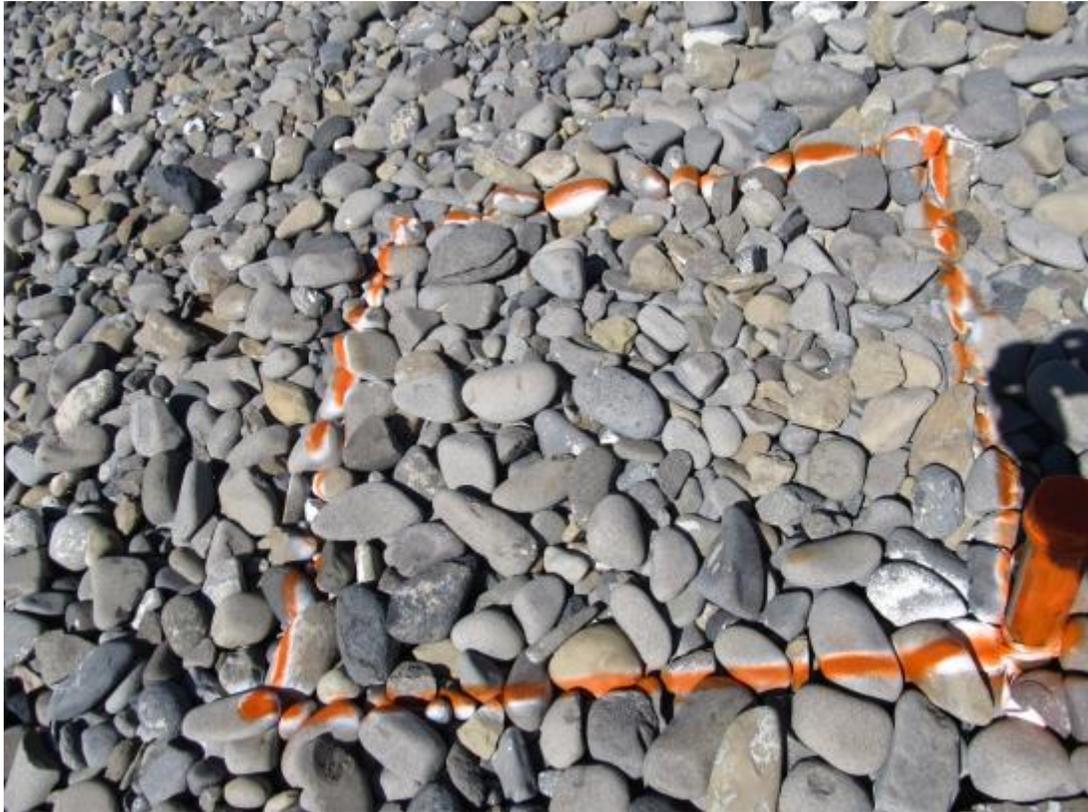
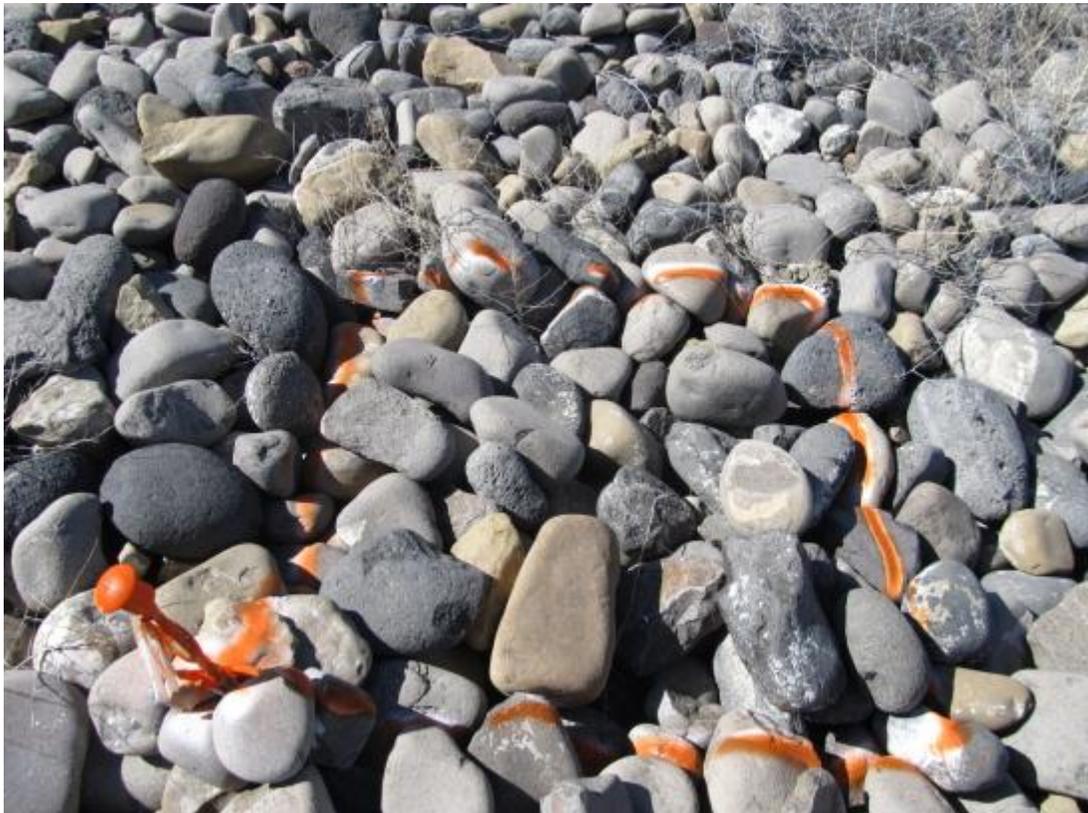
15A A minor portion of the riprap, approximately 1 percent (the percentage determined using eight square-meter grids installed during the 2010 inspection), showed signs of weathering (PL-7 through PL-14). The rock type was consistent, and the weathering effects were all similar. The material weathering does not pose a problem at this time, due to the estimated low percentage observed, but the eight square-meter grids have been permanently located as illustrated on the figure and will continue to be monitored during future inspections.

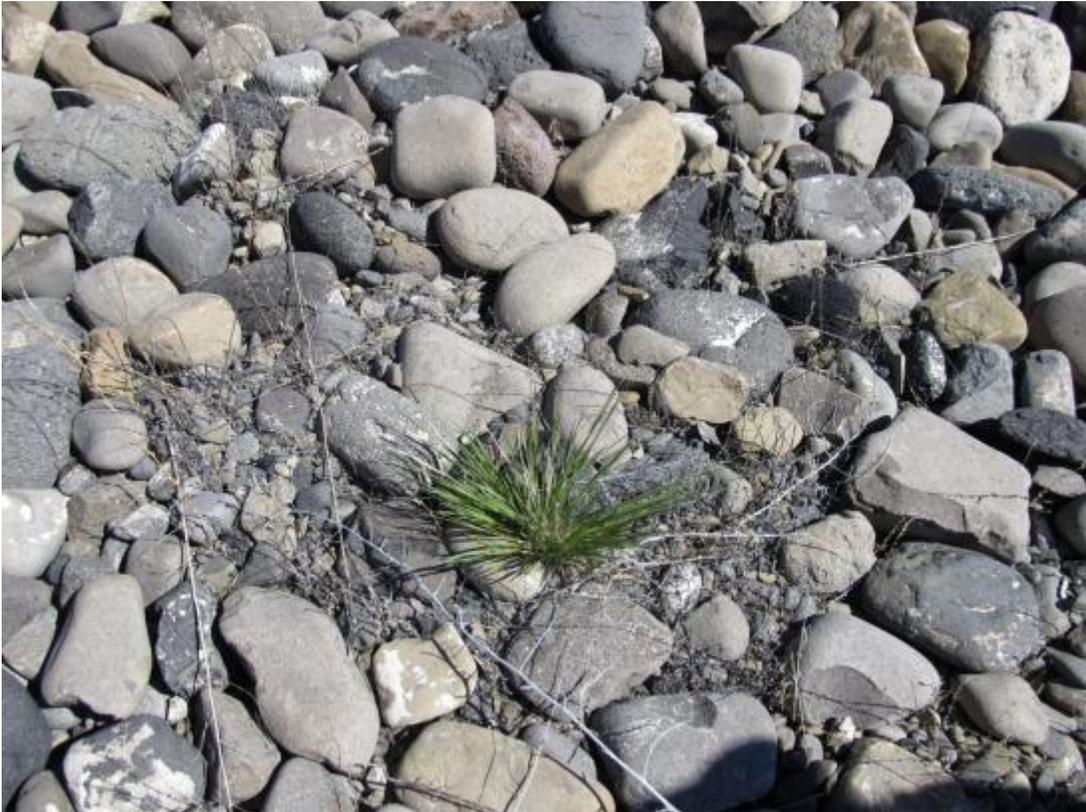
No deep-rooted plants were found growing on the top or side slopes of the cell. However, vegetation was observed on the cell (PL-15), in areas where finer-grain material is filling voids, but does not pose a threat at this time.

SLD 5/2012. PL-15. Clump of grass in finer-grain materials.

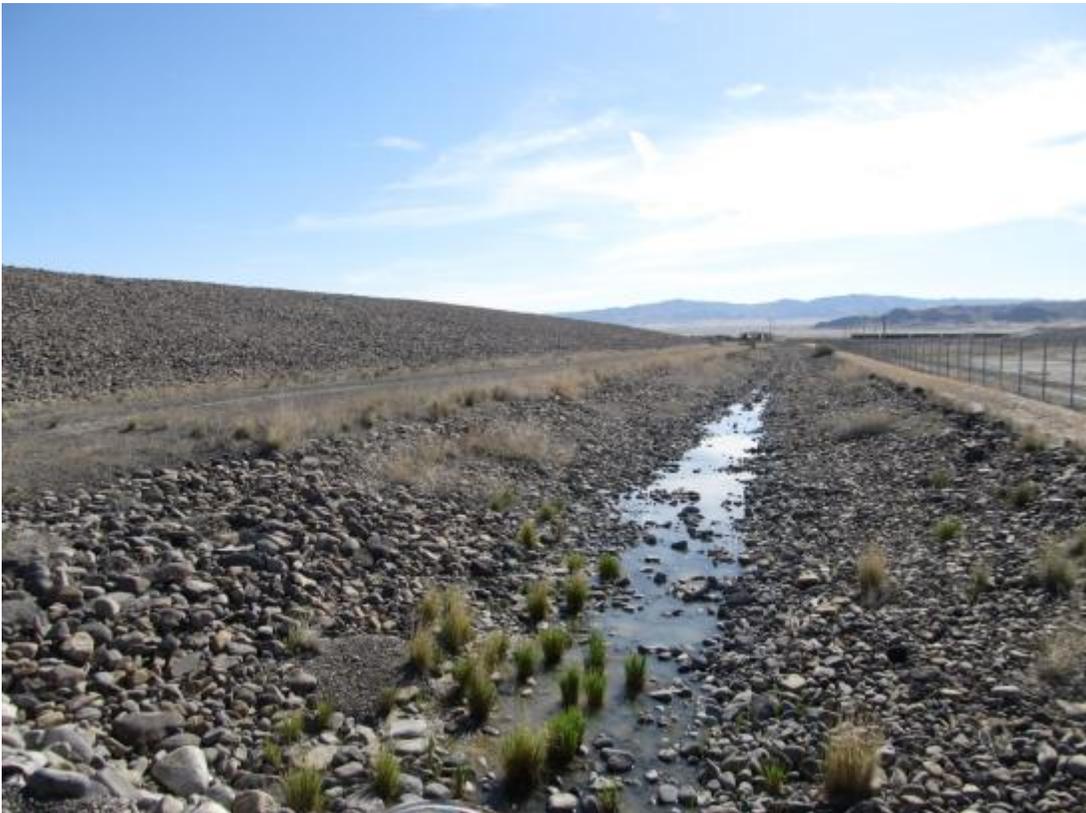
The perimeter road was in good condition. All surface water diversion channels were operating and in good condition during the 2012 inspection. Some standing water from recent precipitation was ponded in channels on the east and south sides (PL-16).

SLD 5/2012. PL-16. Standing water in drain south side of perimeter road.

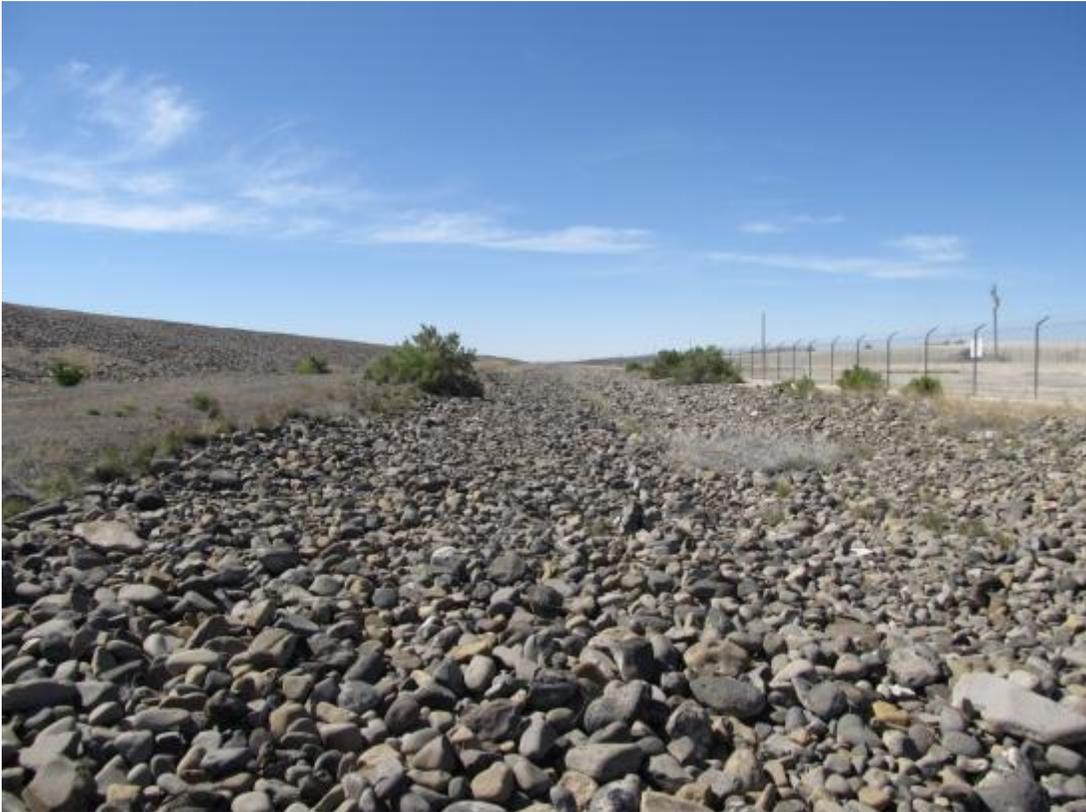
Minor plant encroachment has occurred within the diversion channels, with a few scattered greasewood plants observed growing along the top edge of these channels (PL-17). This vegetation does not interfere with the performance of the channels, but its size has increased since the last inspection. EnergySolutions has removed the larger vegetation.

SLD 5/2012. PL-17. View along drainage west of perimeter road with greasewood.

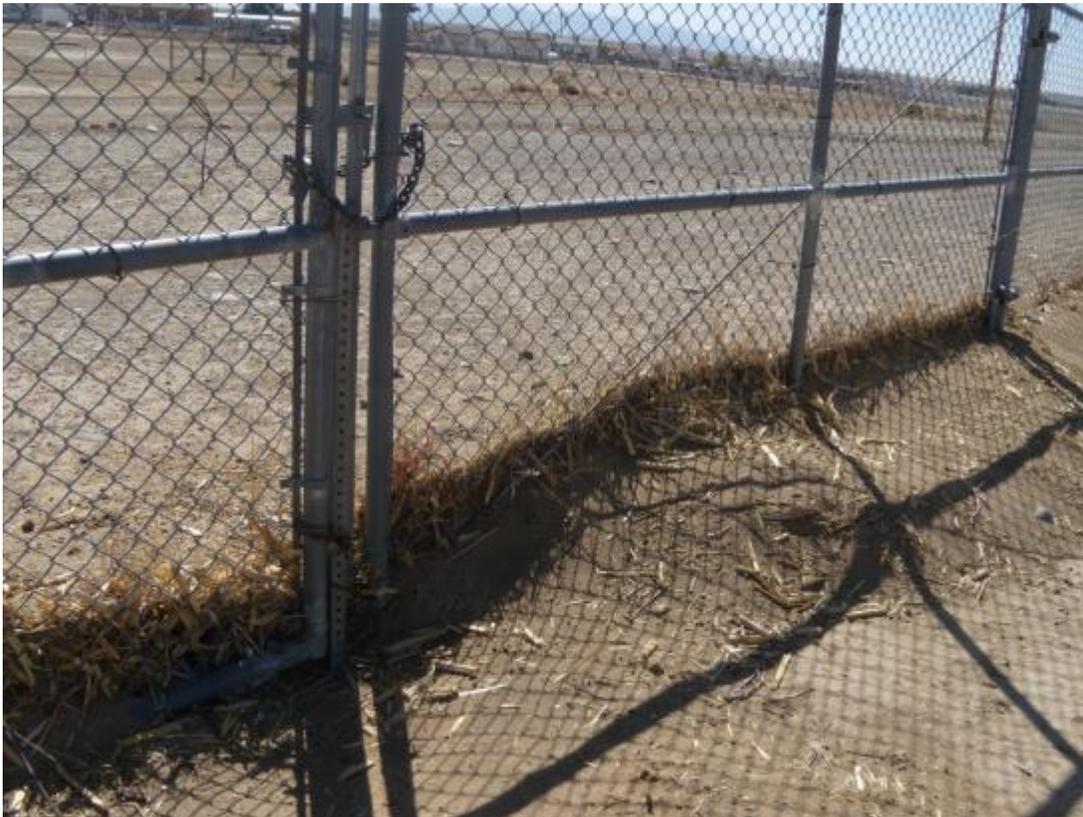
SHP 5/2011. PL-2. Sediment buildup along southwest gate.

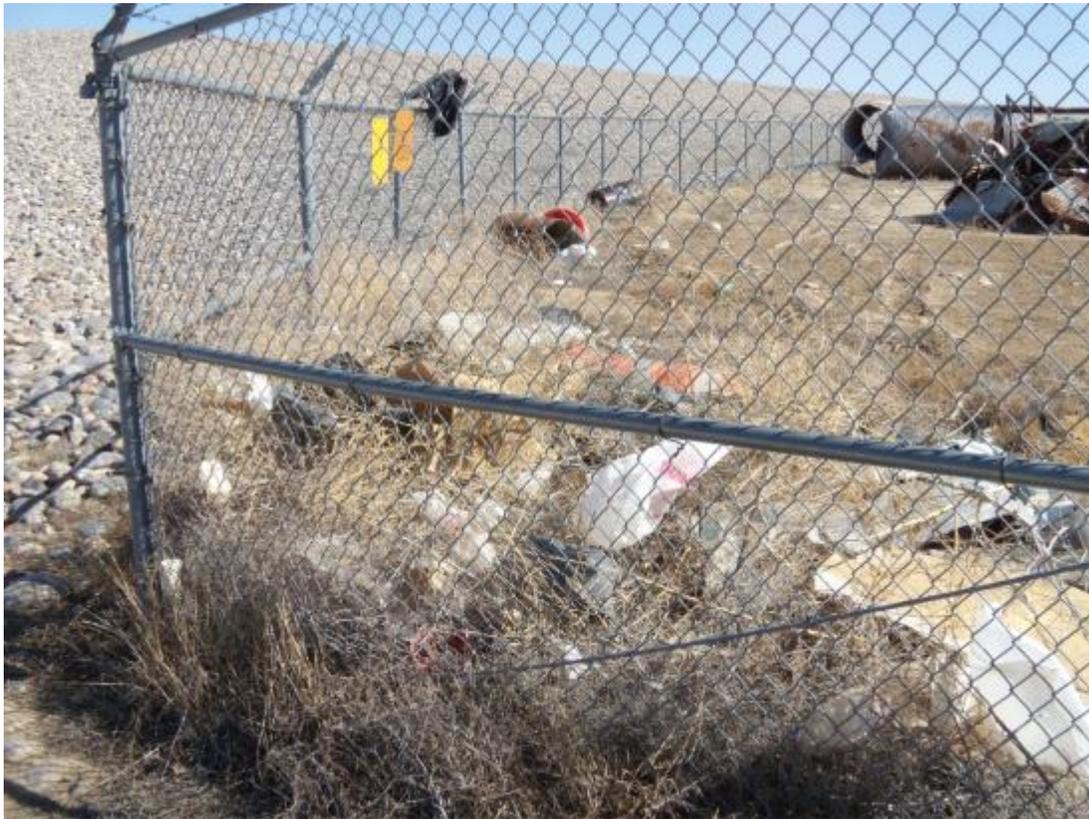
SHP 5/2012. PL-3. Trash and tumbleweed buildup in fence corner by perimeter sign P14.

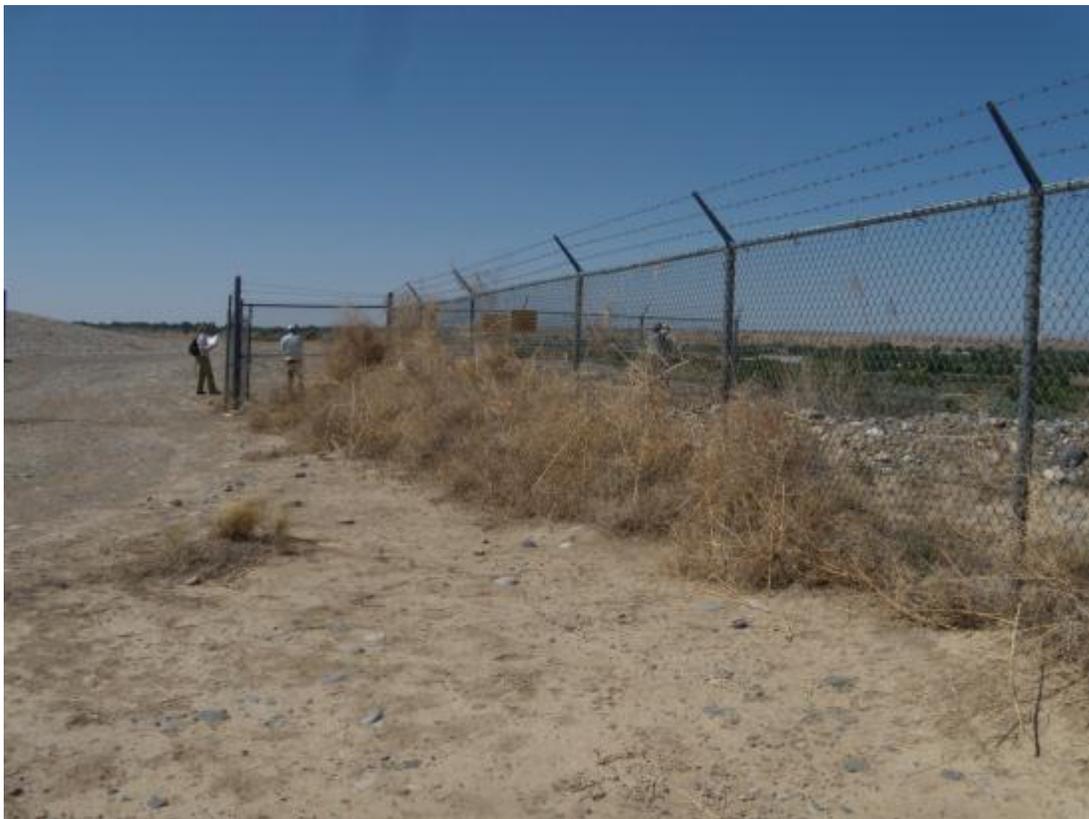
SHP 5/2012. PL-4. Tumbleweed buildup near the east gate.

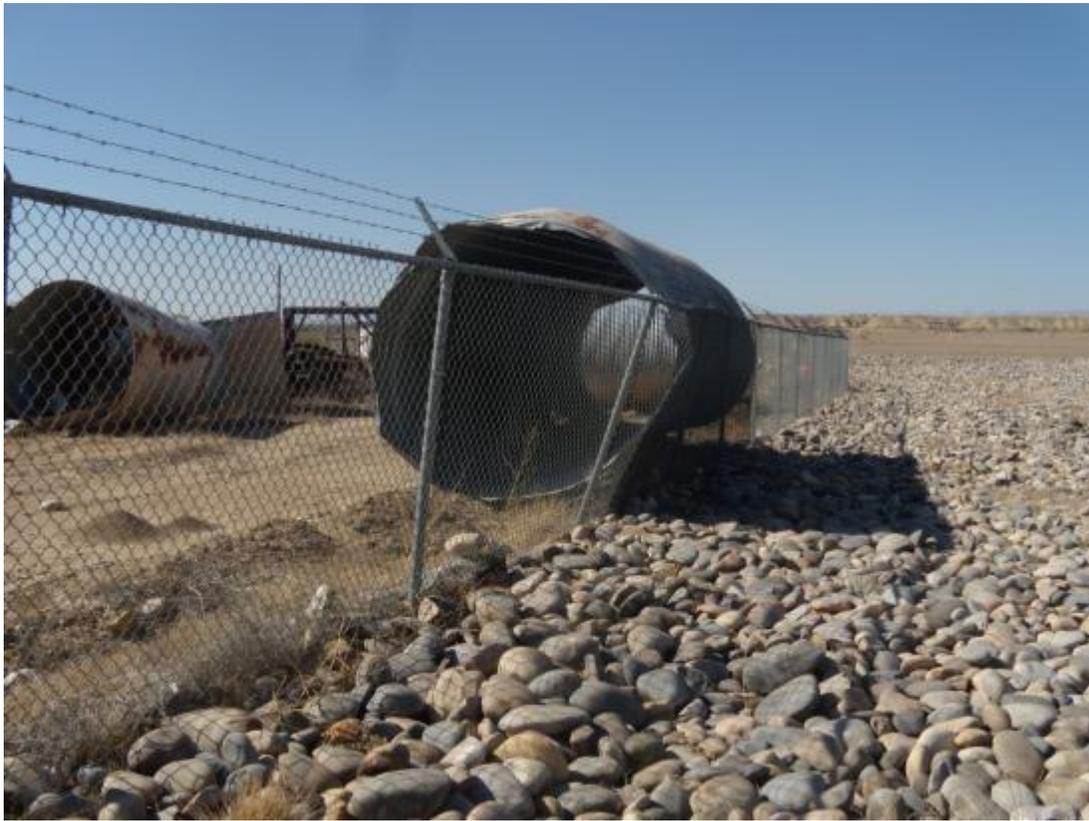
SHP 5/2012. PL-5. Bent fence (still intact) from large culvert in NECA yard near perimeter sign P13.

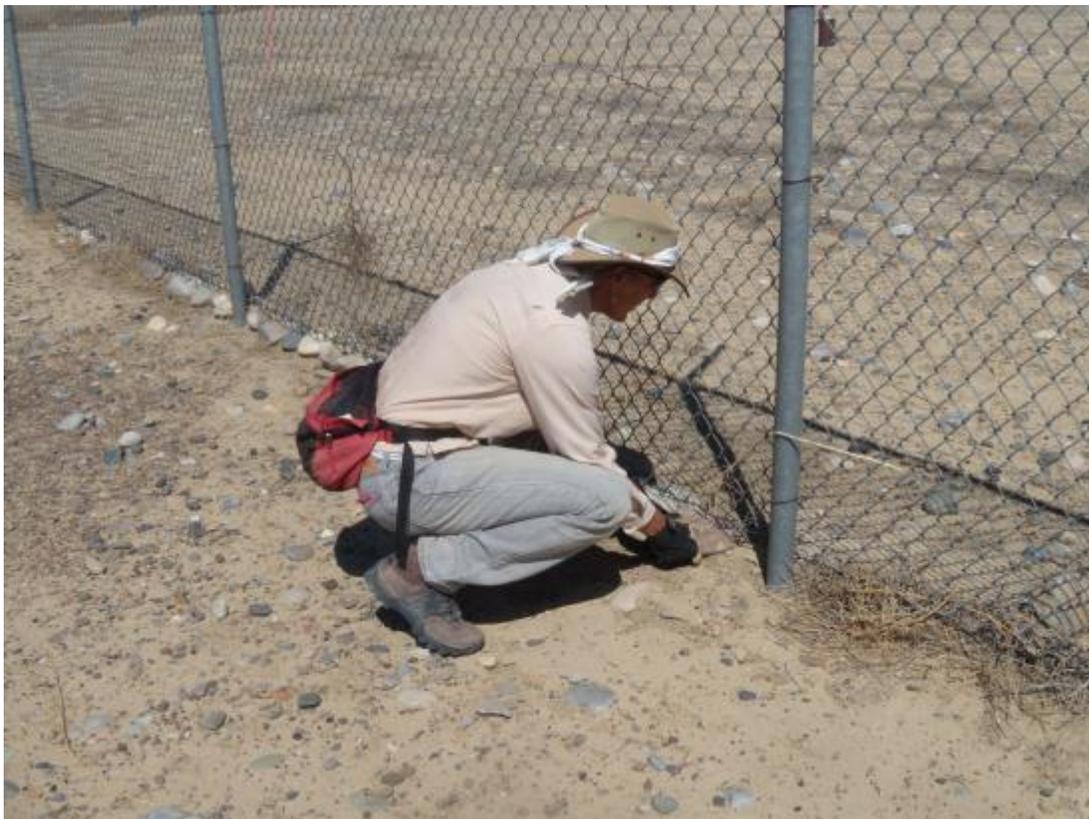
SHP 5/2012. PL-6. Placing rocks in hole under perimeter fence.

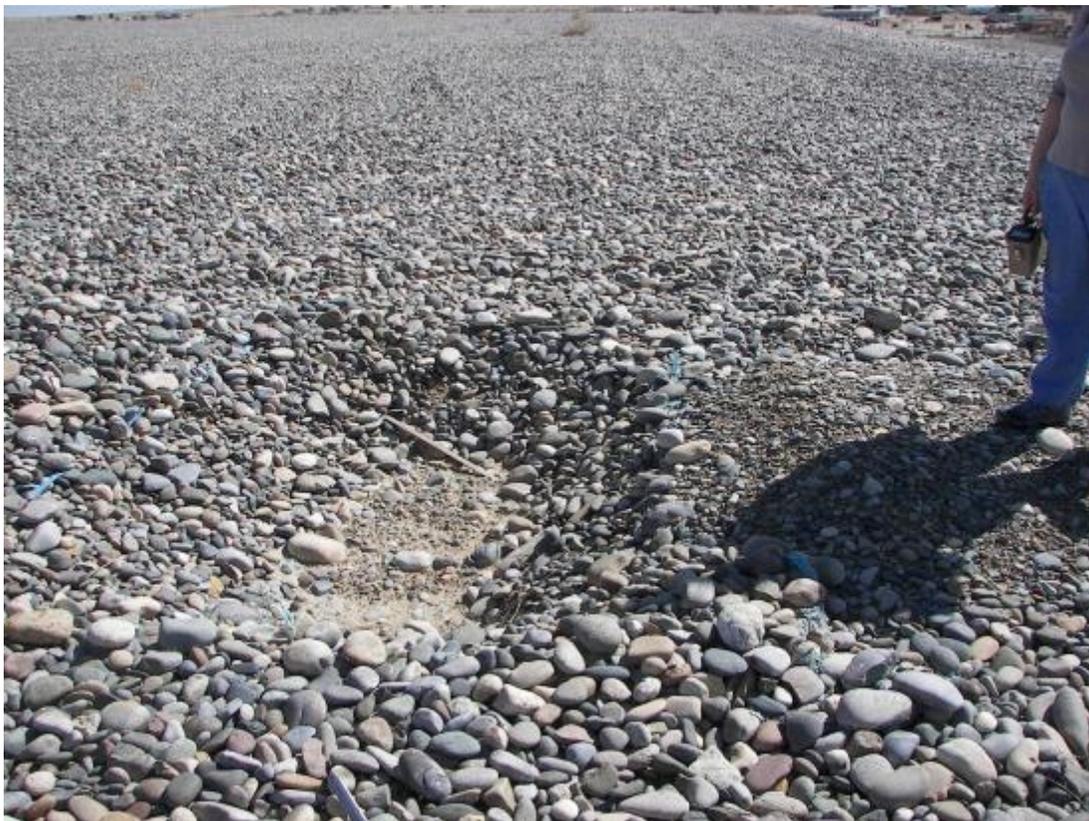
SHP 5/2012. PL-10. Open test pit on western portion of cell.

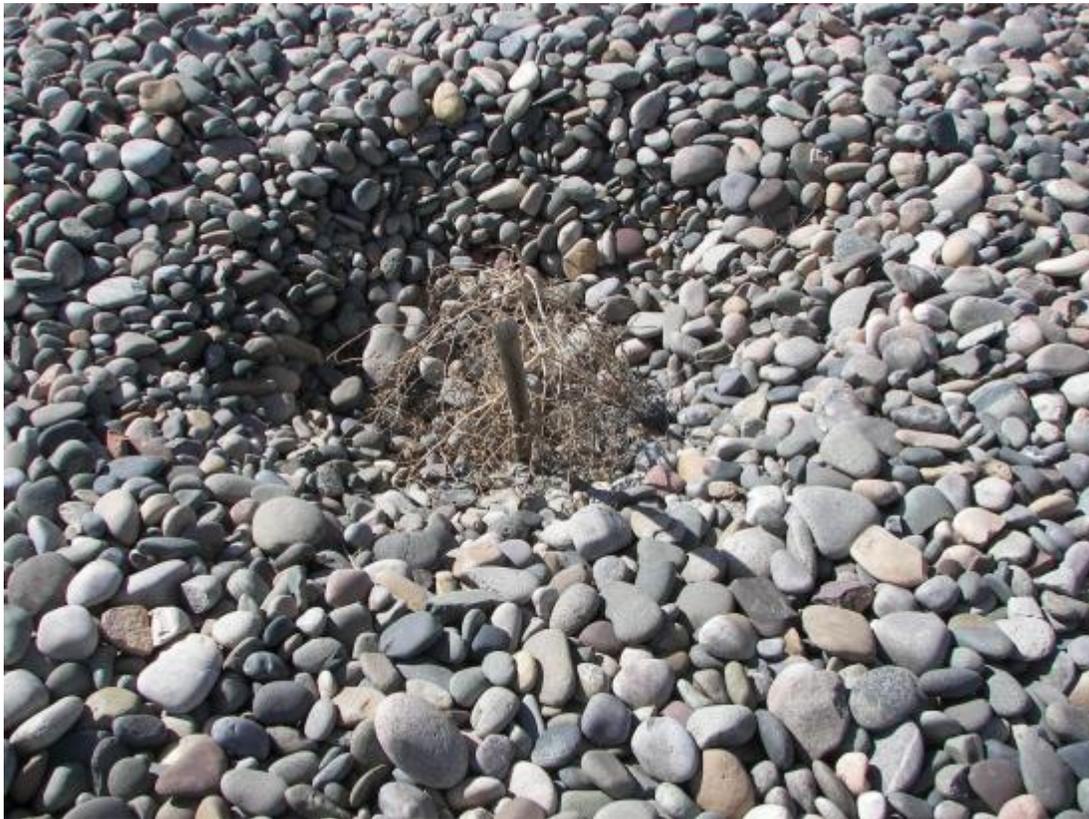
SHP 5/2012. PL-11. Historical test pit on eastern edge of cell.

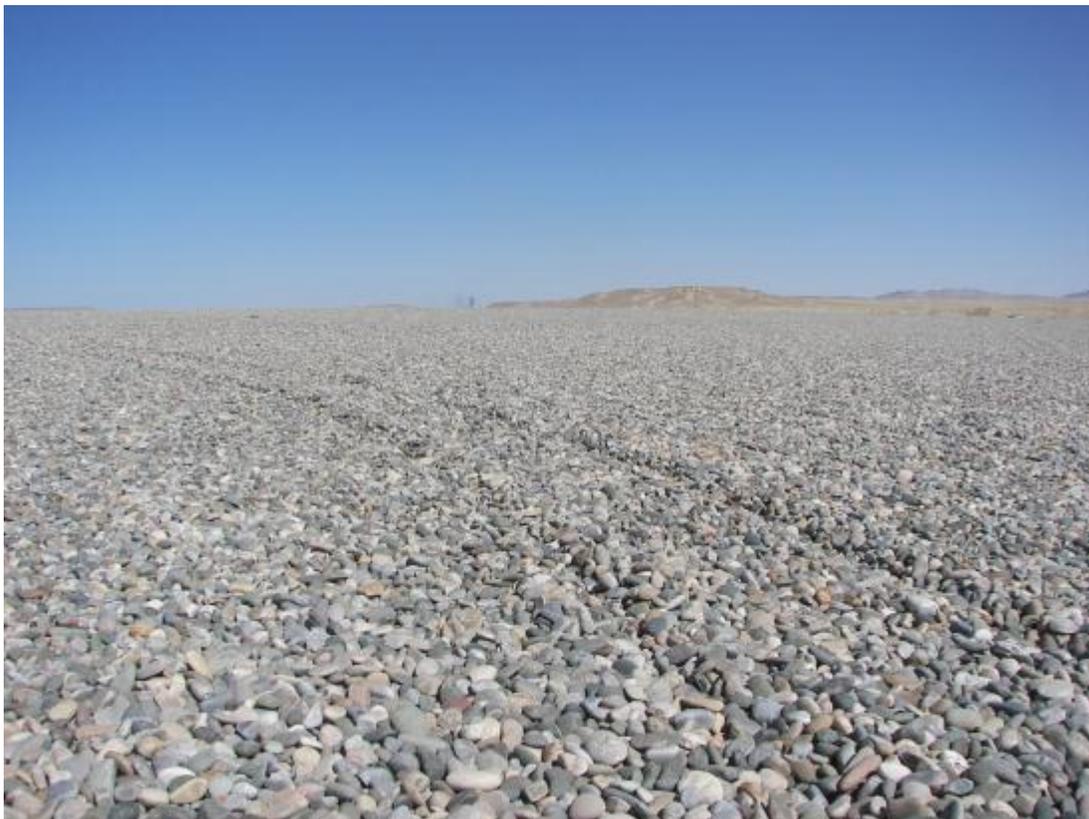
SHP 5/2012. PL-12. Vehicle tracks visible on disposal cell cover, southwest portion of cell.

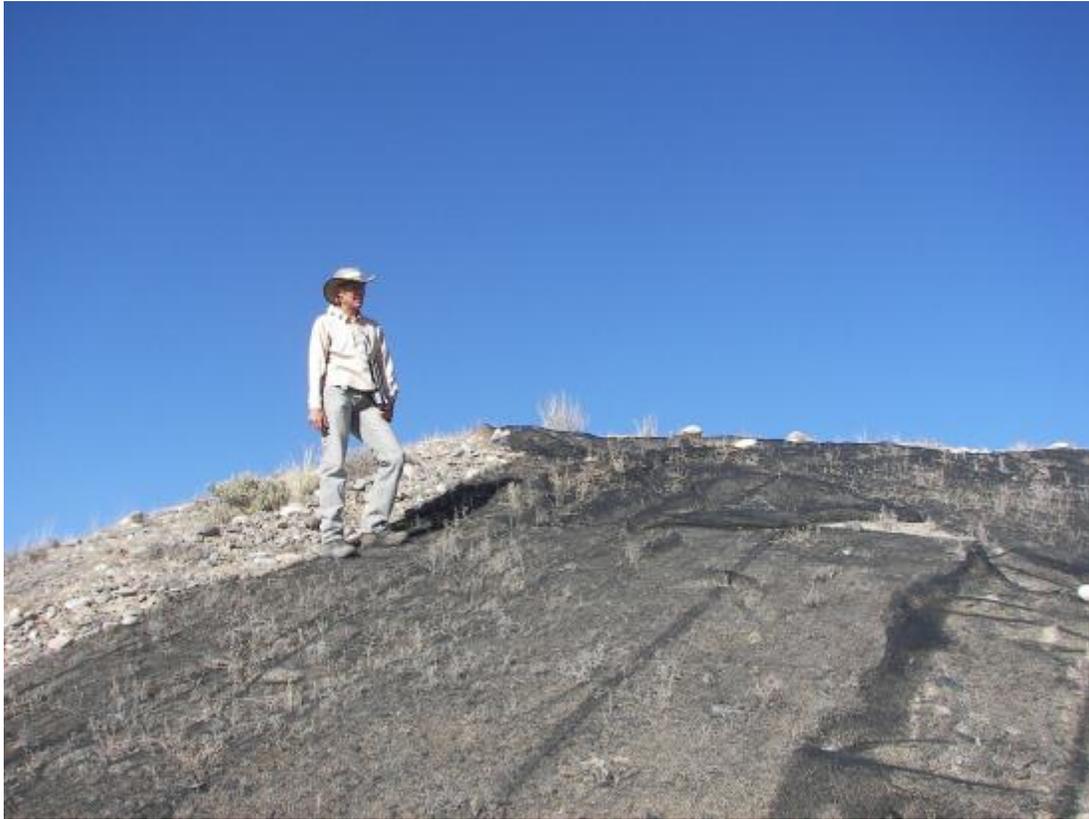
SHP 5/2012. PL-15. Erosion control fabric along outflow channel.

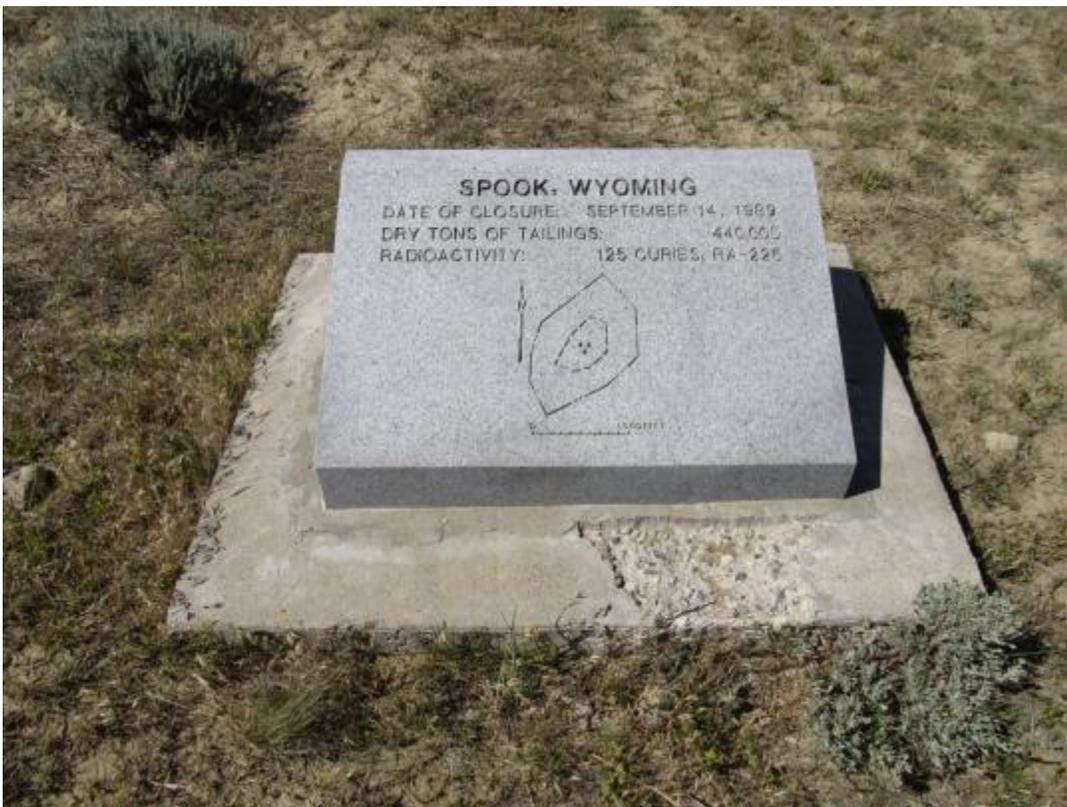
SPK 6/2012. PL-2. Site marker SMK-1.

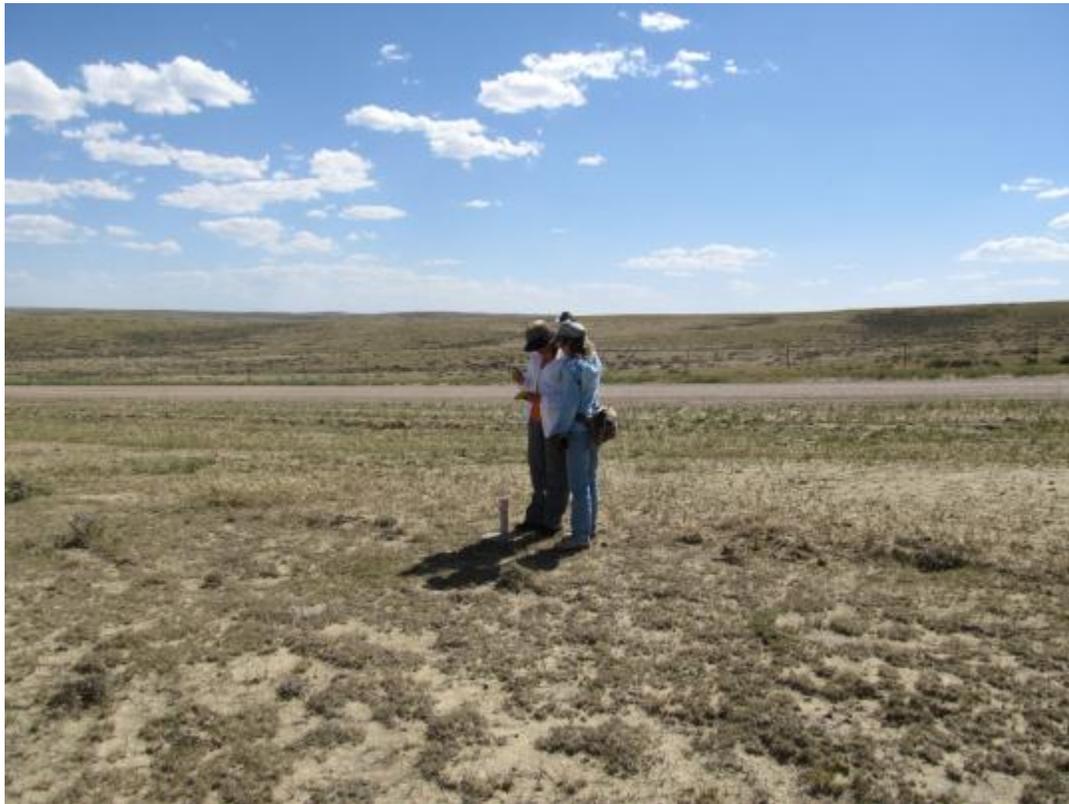
SPK 6/2012. PL-3. Collecting GPS coordinates at boundary monument BM-5.

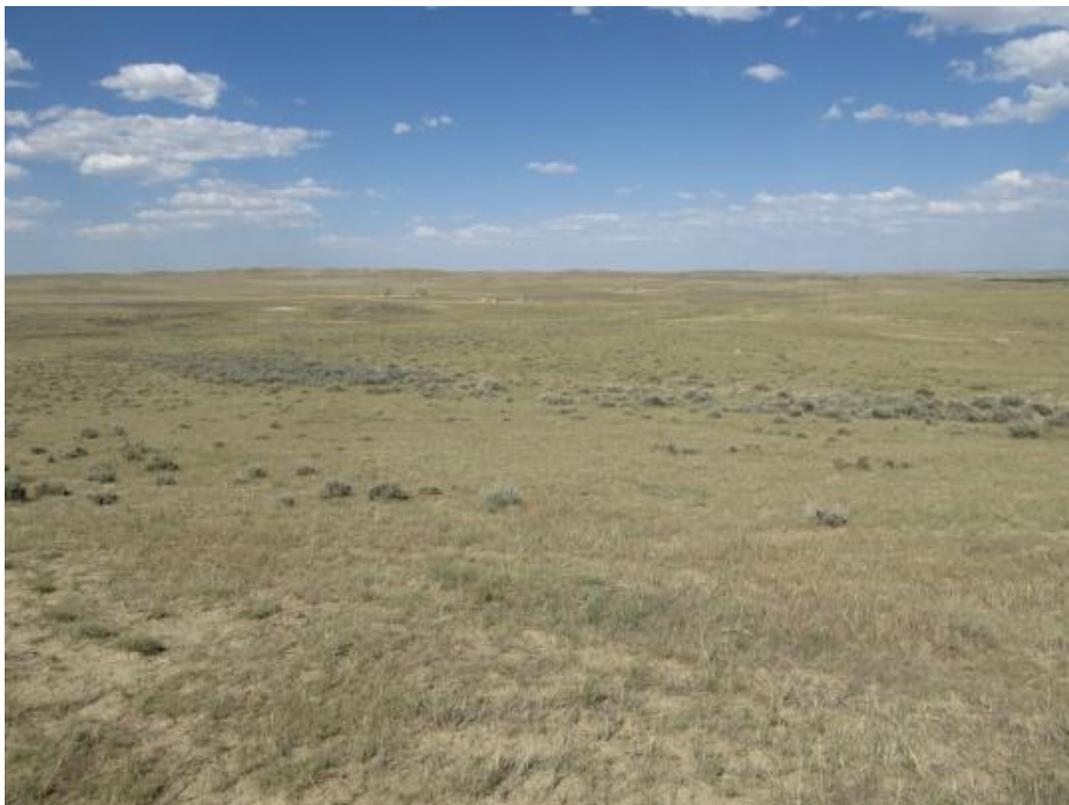
The site is unique among Title I sites in that tailings were encapsulated in the bottom of an open pit mine and covered with 40 to 60 feet of clean fill and topsoil. As such, many of the observations and concerns routinely associated with above-grade disposal cells—such as the quality of the riprap, the stability of side slopes, or the presence of deep-rooted plants (biointrusion) above the radon barrier—do not apply to this site. The surface of the 5-acre disposal cell, completed in 1989, was in excellent condition. No evidence of settling was observed over the former mine pit. Vegetation across the cell, consisting of grasses and forbs, appears healthy and is indistinguishable from that which grows on the surrounding hills and valleys. The same species are present, and the overall health and density of vegetation are similar (PL-4).

SPK 6/2012. PL-4. Northeast view across the disposal cell.

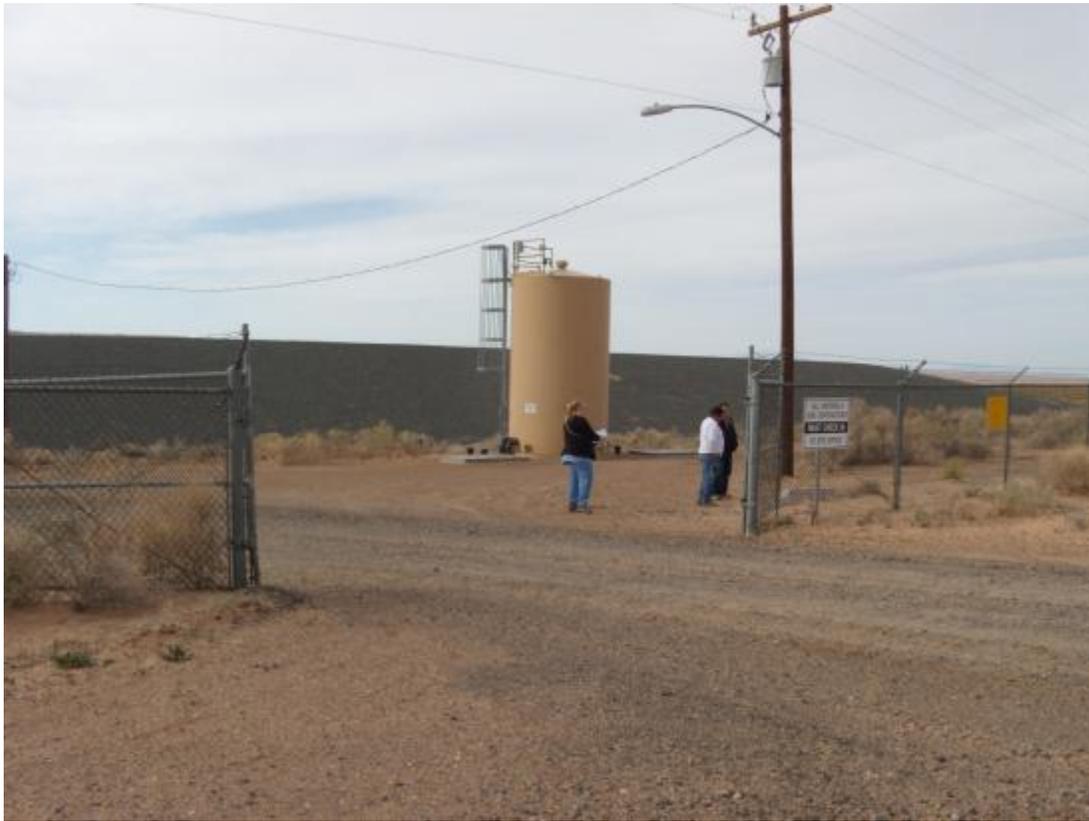
The site is accessed directly from U.S. Highway 160. Perpetual access to the site is granted by the Custodial Access Agreement. A gate in a fence on the highway right-of-way allows access to the site along a gravel access road; the site entrance gate is at the perimeter security fence. The access gate, road, and entrance gate to the site were in good condition. The gates were open at the time of the inspection because of ongoing groundwater remediation operations at the site (PL–1). The entrance signs posted on both gates were in good condition.

TUB 4/2012. PL-1. Site entrance gate.

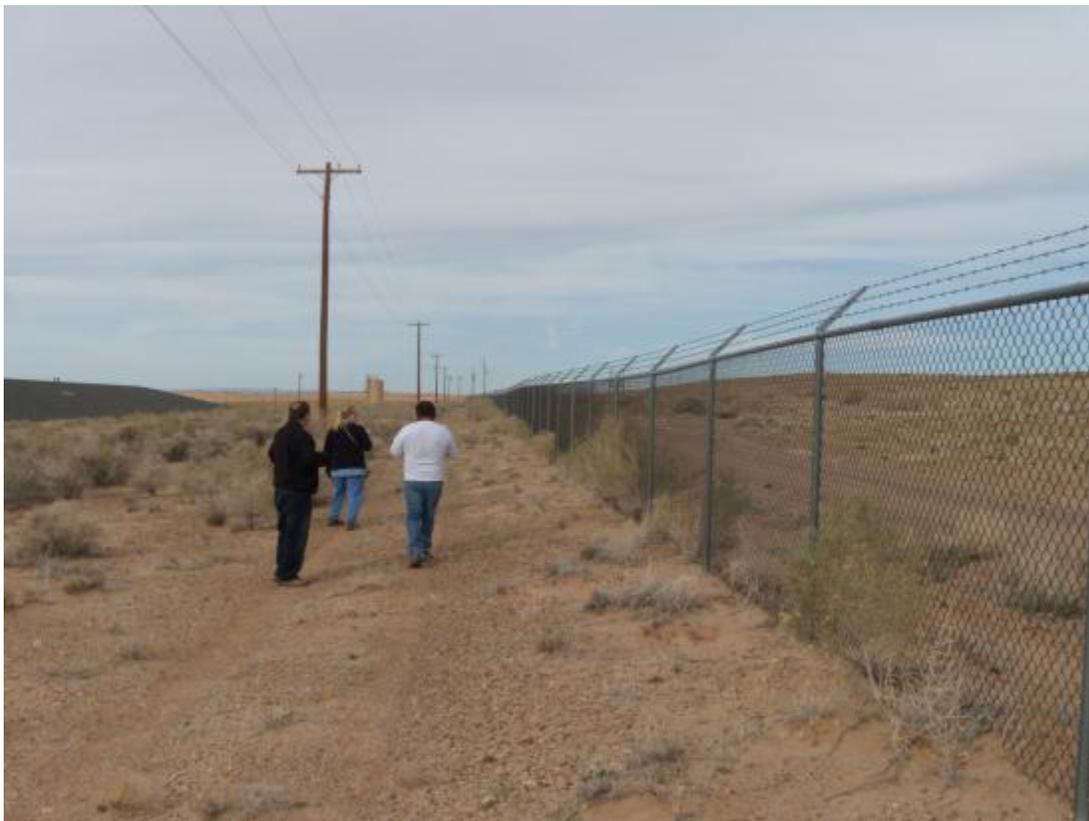
The security fence around the site perimeter was in good condition (PL–2).

TUB 4/2012. PL-2. Northwest security fence line.
