U.S. DEPARTMENT OF  
**ENERGY**

Legacy  
Management

# 2012 Annual Site Inspection and Monitoring Report for Uranium Mill Tailings Radiation Control Act Title I Disposal Sites

February 2013

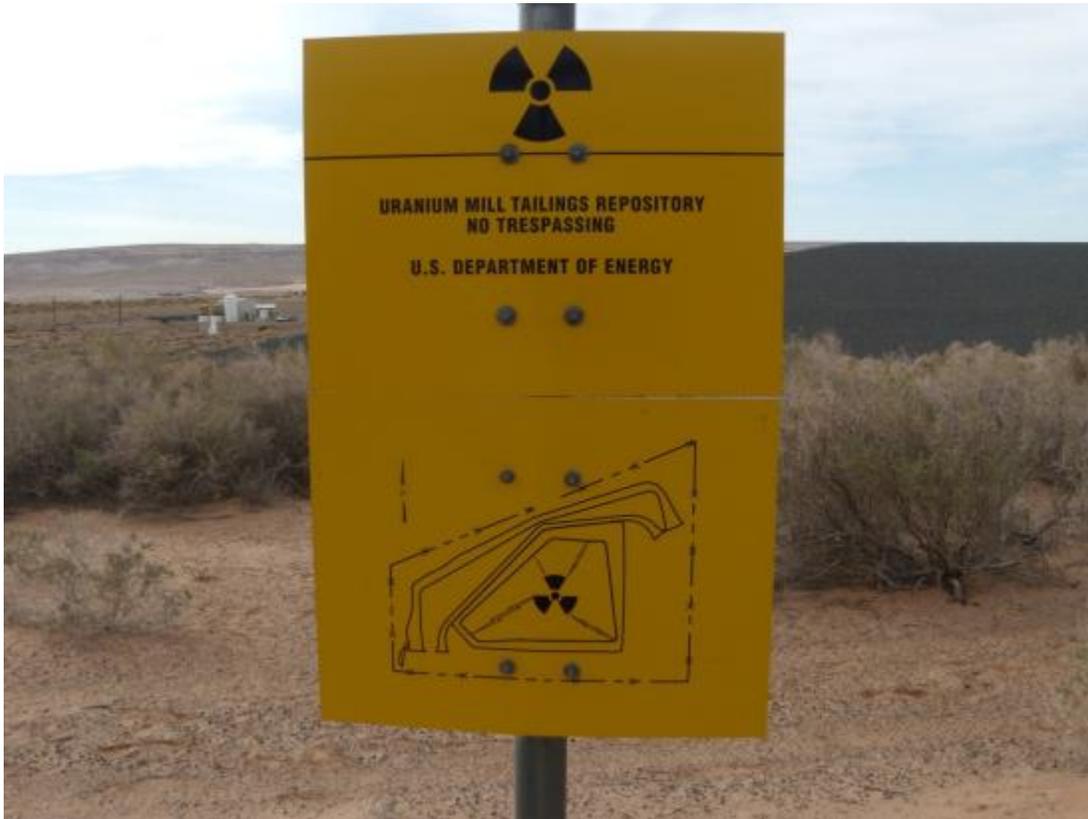
Perimeter signs are posted in pairs at regular intervals around the site perimeter. Each sign pair, secured to a metal post, consists of a “No Trespassing” sign with a radioactive materials trefoil symbol and a schematic sign with a diagram of the disposal cell (also identified by the radioactive materials trefoil symbol) and the site boundary (PL–3). All of the signs were in good condition.

TUB 4/2012. PL-3. Perimeter sign P30 near the entrance gate.

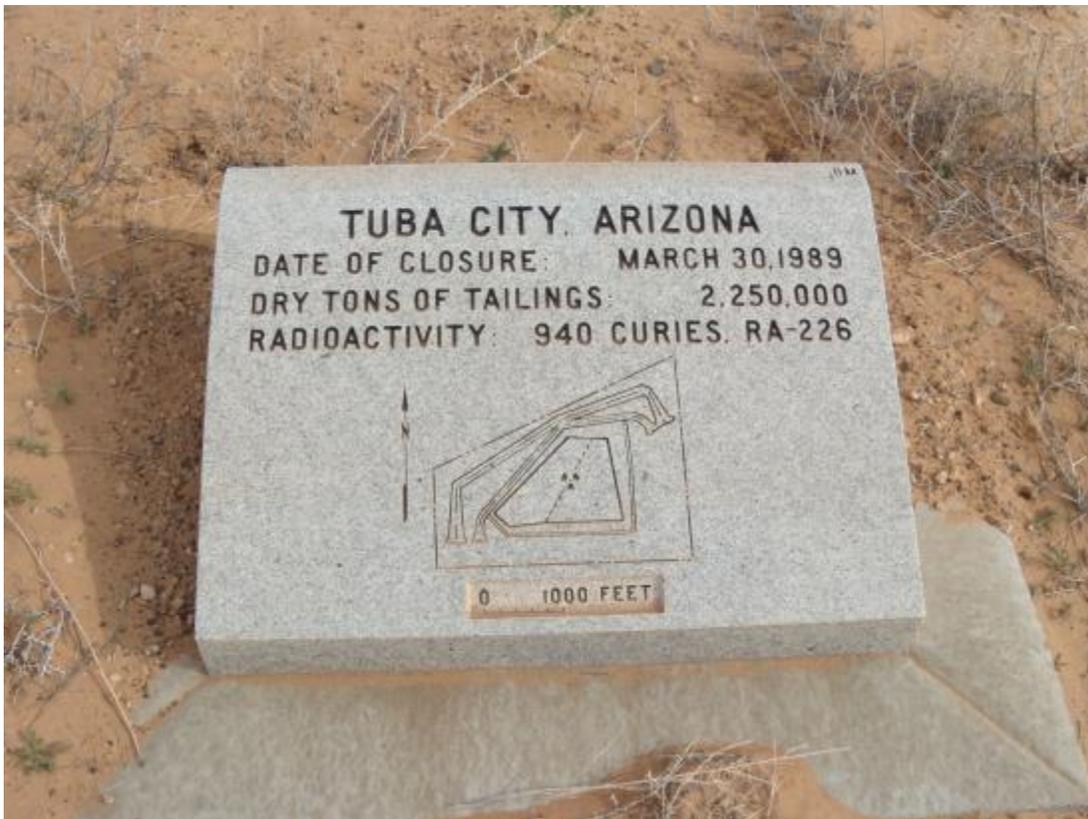
The two granite site markers, one just inside and to the right of the entrance gate (PL-4) and the other on top of the disposal cell, were in good condition.

TUB 4/2012. PL-4. Site marker SMK-1 near the entrance gate.

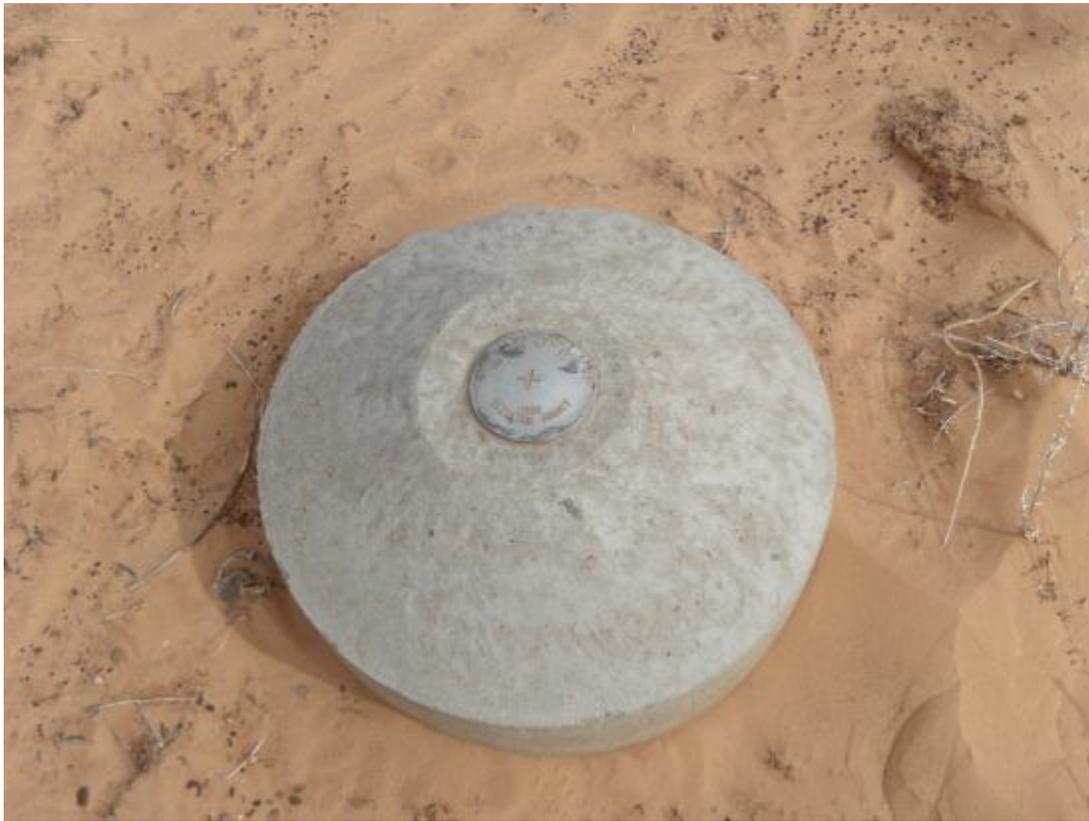
The survey and boundary monuments that were observed were in good condition (PL-5). Boundary monument BM-3, at the northeast corner of the site, was buried by windblown sand.

TUB 4/2012. PL-5. Boundary monument BM-2.

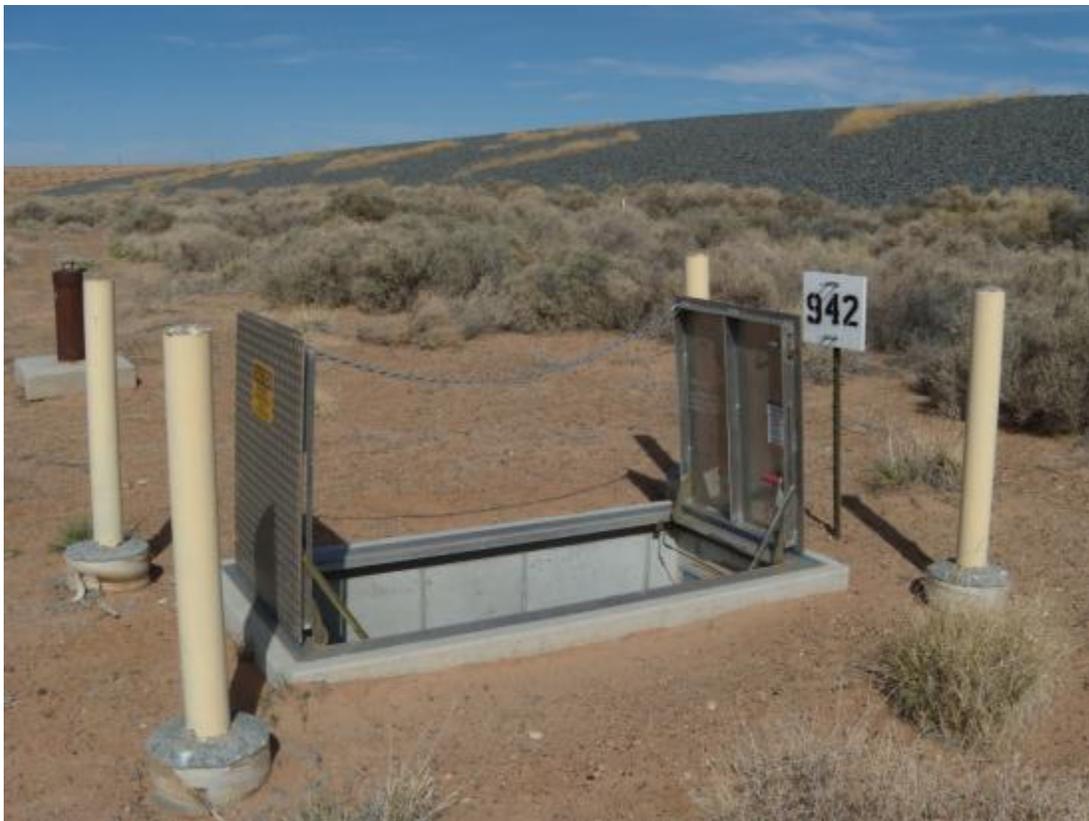
Seven wells constitute the cell performance monitoring network: 0903, 0906, 0908, 0940, 0941, 0942, and 0945. Five wells inside and immediately adjacent to the site were in good condition and locked. The vault cover for well 0942 was open for well maintenance at the time of the inspection (PL-6). Monitoring well 0903, located about 0.25 mile south of the disposal cell, was not inspected.

TUB 4/2012. PL-6. Monitoring well 0942 vault open for maintenance.

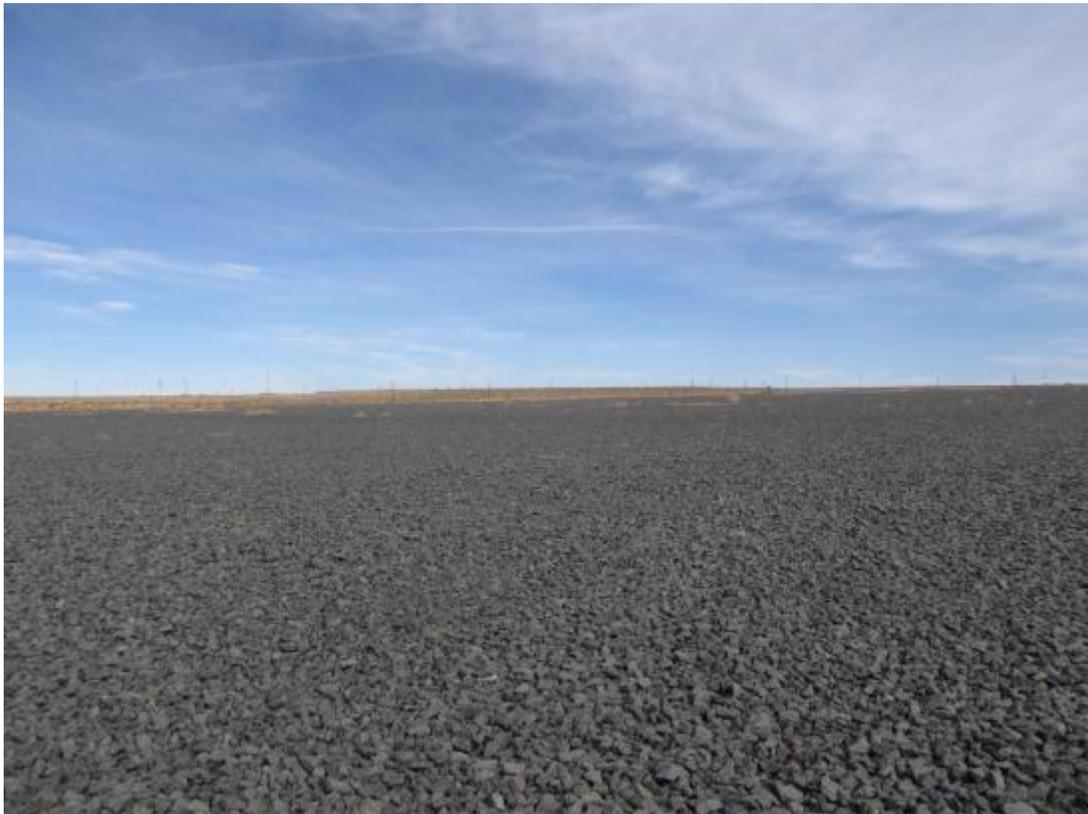
The disposal cell is covered with riprap to control erosion. The rock cover material was in excellent condition and showed no signs of deterioration. No evidence of differential settlement or slumping was observed, and all visible components of the disposal cell and cover were in excellent condition (PL-7 and PL-8).

TUB 4/2012. PL-7. View northwest across the disposal cell cover.

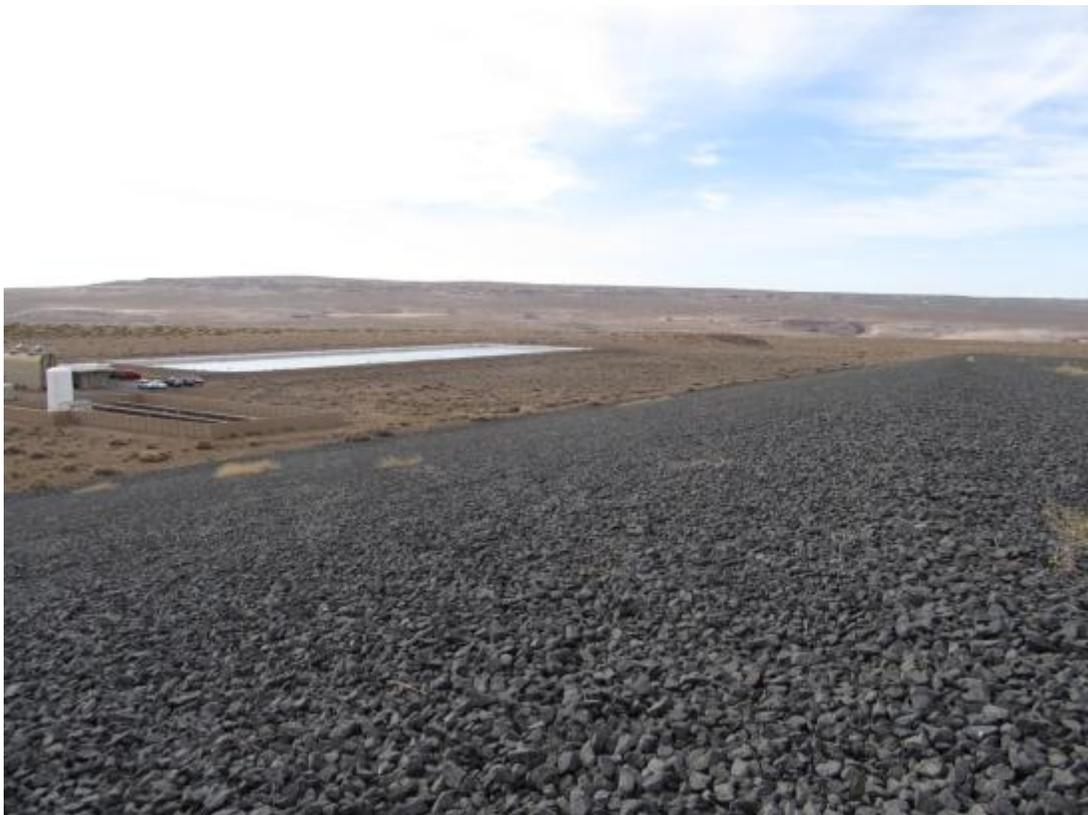
TUB 4/2012. PL-8. East side slope of the disposal cell and the groundwater treatment plant facilities.

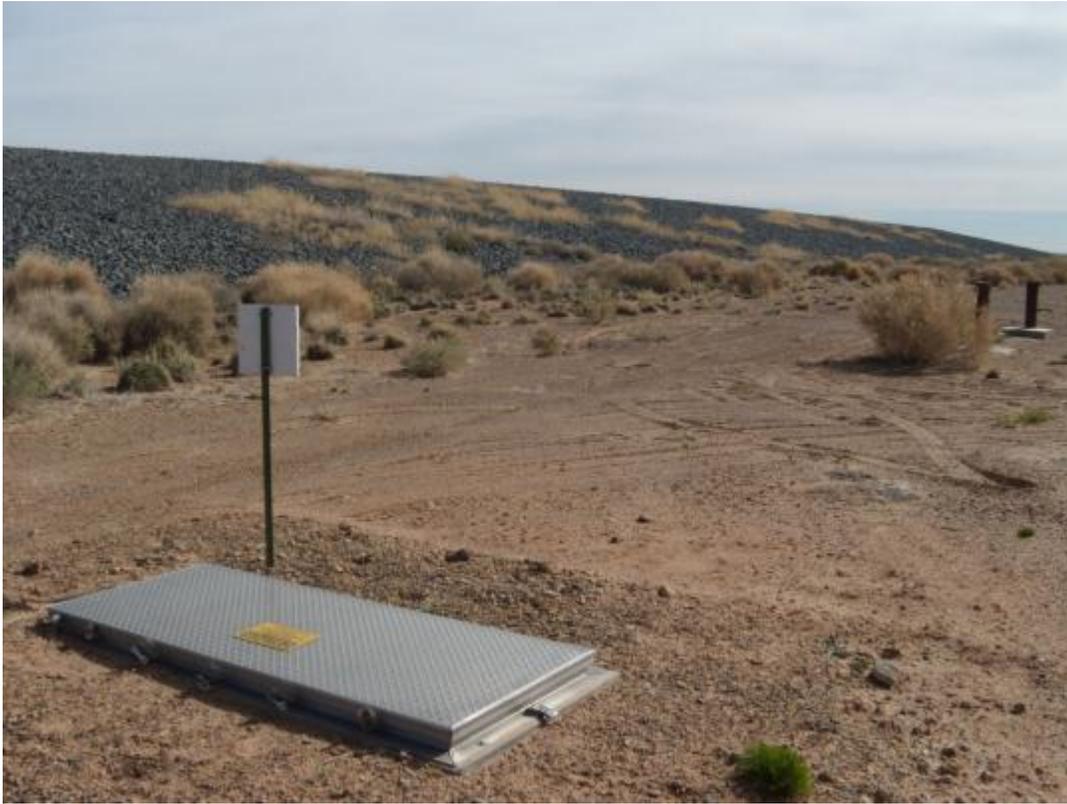
Sand accretion and vegetation encroachment are still evident at several locations along the south side slope of the disposal cell. Photographs are taken at these locations annually to document changes in sand accretion and vegetation conditions (PL-9, PL-10, and PL-11). The gradually increasing vegetation coverage likely indicates that sand accumulation on the rock-covered slope continues to increase.

TUB 4/2012. PL-9. Vegetation encroachment on the south side slope of the disposal cell. Repeat photograph taken from extraction well 1107.

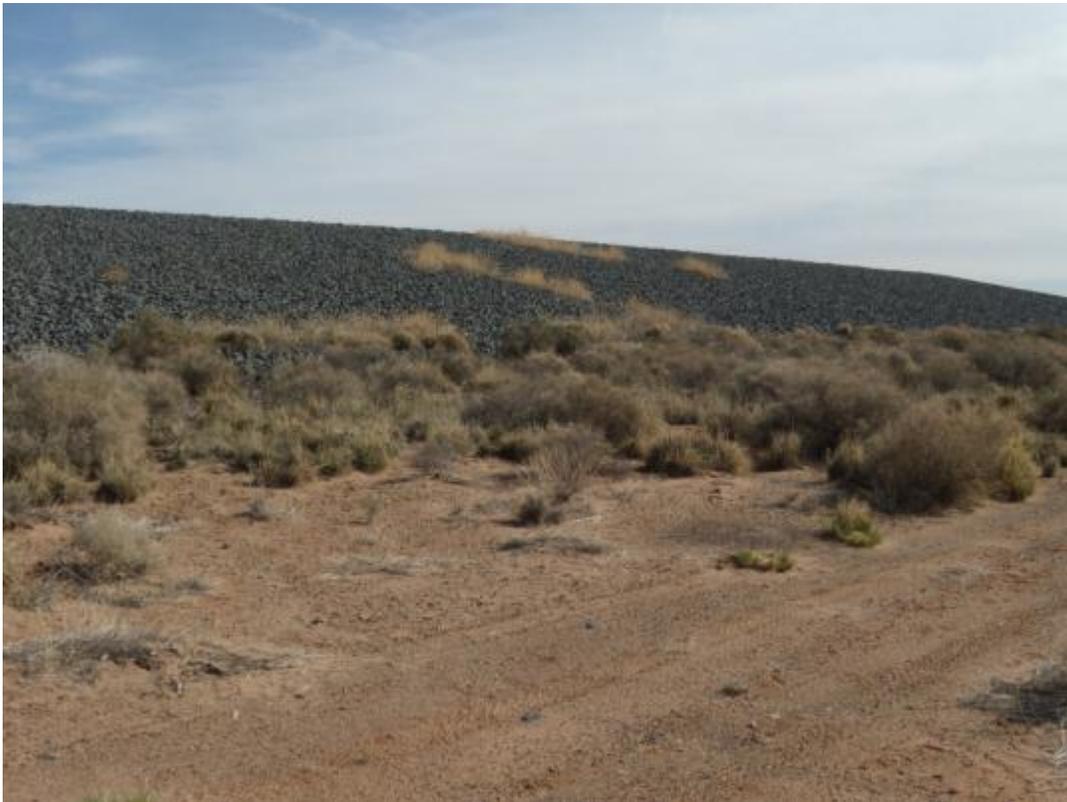
TUB 4/2012. PL-10. Vegetation encroachment on the south side slope of the disposal cell. Repeat photograph taken from extraction well 1105.

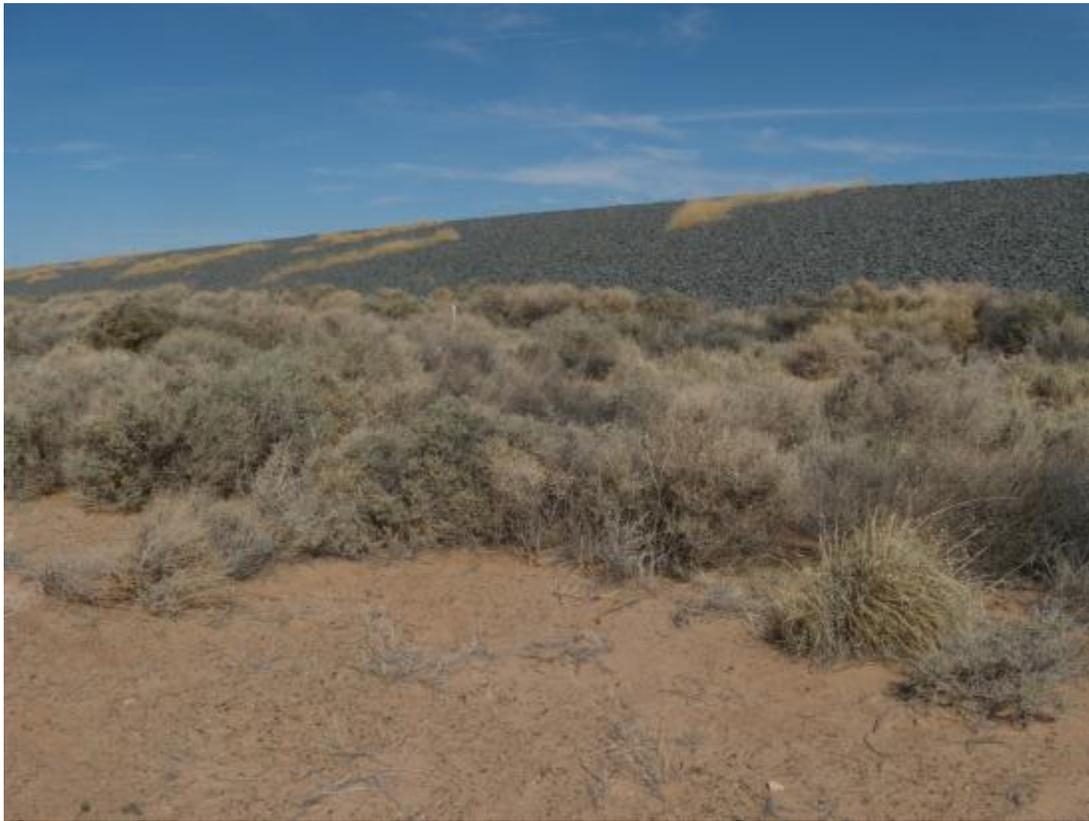
TUB 4/2012. PL-11. Vegetation encroachment on the south side slope of the disposal cell. Repeat photograph taken from monitoring well 0942.

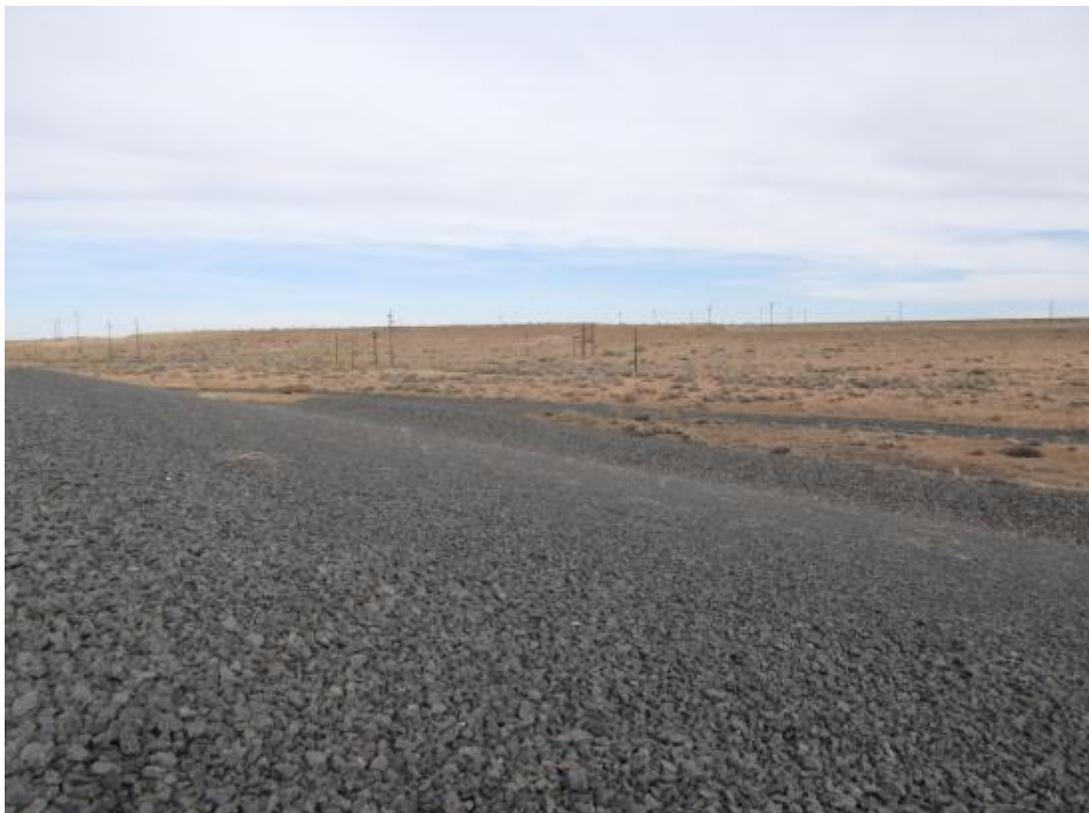
The apron drainage ditch at the base of the disposal cell and the diversion channel, both located along the north and northwest sides of the cell, were in good condition (PL-12). Windblown sand deposition continues to be monitored at the site because unstable dunes in outlying areas can contribute to sand accumulation along fence lines (PL-13), in diversion channels, and in the rock cover of the disposal cell. Sand accretion and vegetation encroachment have been checked annually since 2001 in the diversion channel and apron drainage ditch on the north and northwest sides of the cell (PL-14 and PL-15). The sand tends to periodically accumulate and scour. The accumulations are not adversely affecting the performance of these features.

TUB 4/2012. PL-12. North side slope of the disposal cell, apron ditch, and diversion channel.

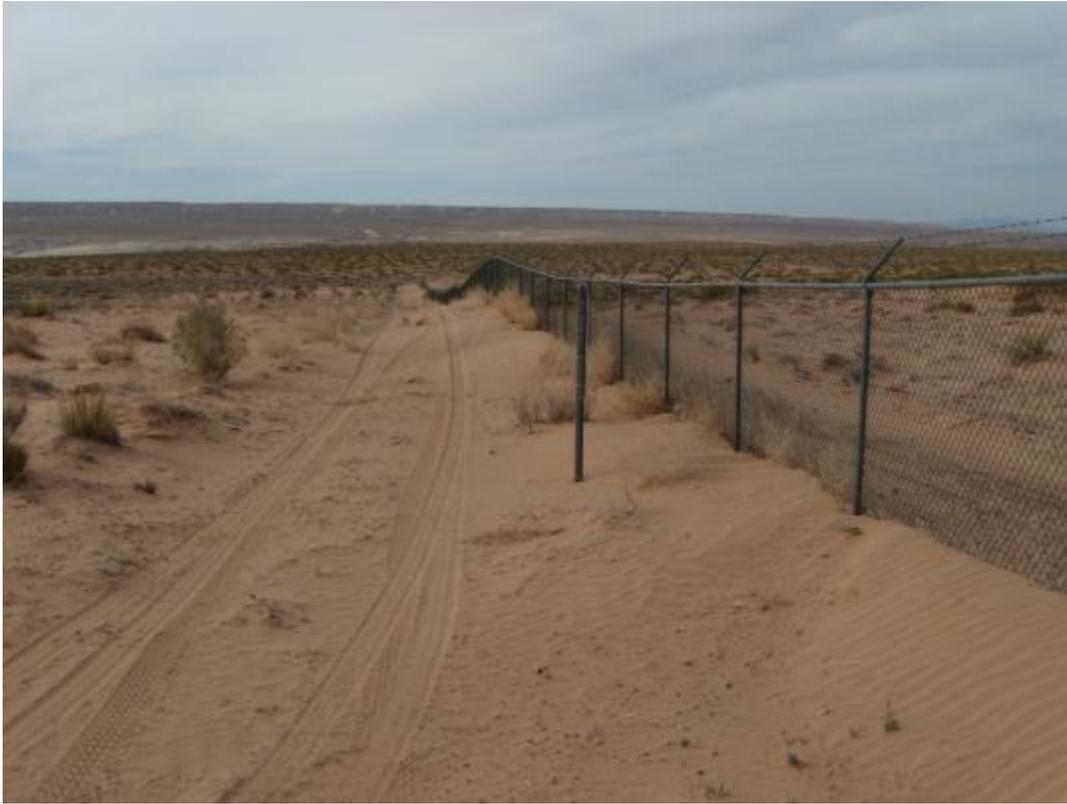
TUB 4/2012. PL-13. Sand accumulation along the west fence line.

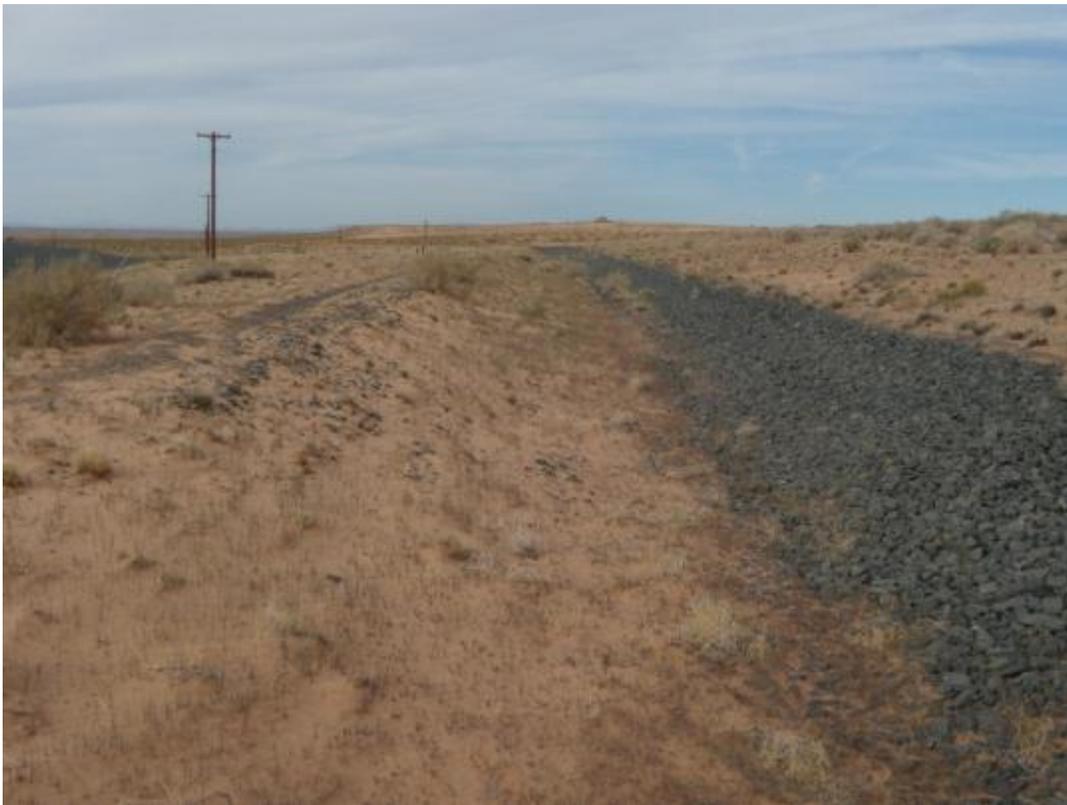
| Photo Location Number | Azimuth | Photograph Description |
|---|---|--|
| PL-14 | 240 | Windblown sand deposition on the south bank of the west diversion channel. Repeat photograph taken from the footbridge. |

TUB 4/2012. PL-14. Windblown sand deposition on the south bank of the west diversion channel.  
Repeat photograph taken from the footbridge.

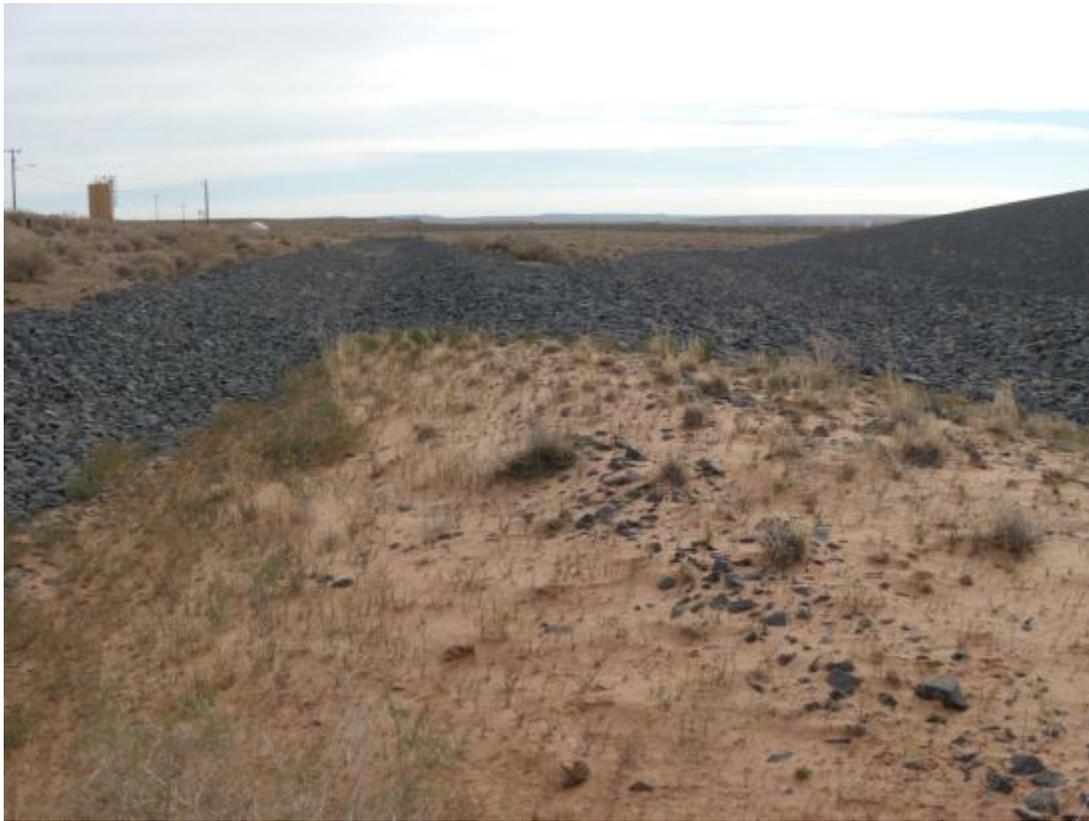
| Photo Location Number | Azimuth | Photograph Description |
|---|---|--|
| PL-15 | 90 | East diversion channel and apron ditch viewed from the footbridge. |

TUB 4/2012. PL-15. East diversion channel and apron ditch viewed from the footbridge.
